Flinders Township and Tanti Creek Geotechnical Information Pack

Geotechnical assessment for landslip susceptibility and investigation zoning: Flinders
Foreshore Mornington Peninsula, January 2008

GEOTECHNICAL ASSESSMENT FOR LANDSLIP SUSCEPTIBILITY AND INVESTIGATION ZONING

**FLINDERS FORESHORE
MORNINGTON PENINSULA**

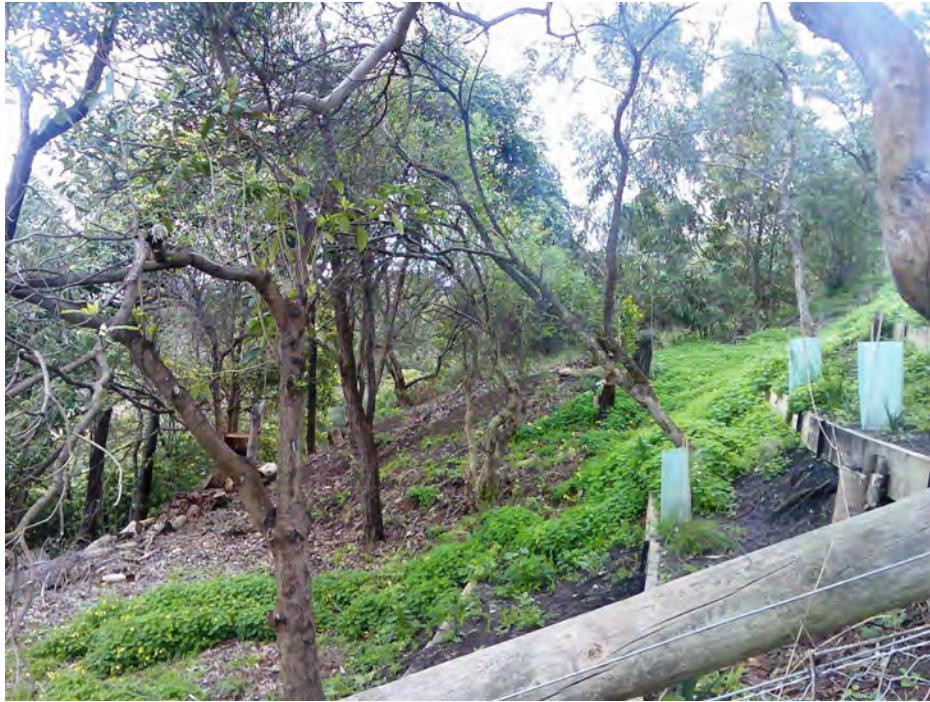
Plate 7.1: Scarp of landslide between Spindriff Avenue and Bluff Avenue

The steep slopes of the main scarp elements at the head of the landslide are probably potentially unstable. No cuts into their profiles should be made. Any cuts into slopes in the area of displaced material of the zone of accumulation would endanger their stability. The ground water conditions on the site have not been studied, but the groundwater is below 10m. To maximise ground stability, good drainage is nonetheless essential.

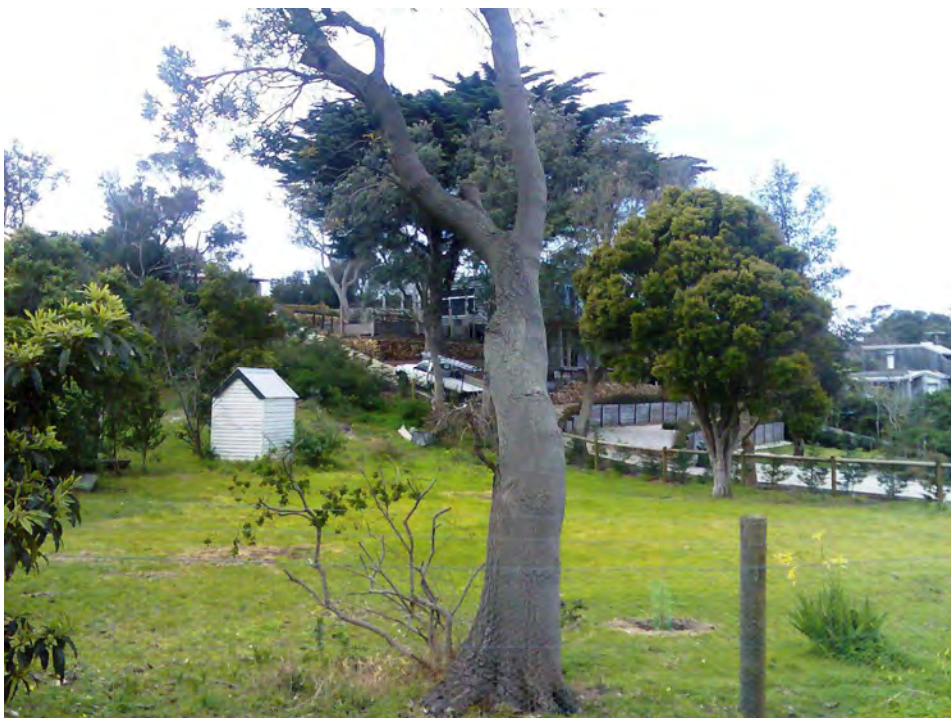
Plate 11.1: Steep Slope below Ridge

Signs of creep such as leaning trees were observed on the steep sides of the ridges at several locations indicating the potential for further creep movement. However, no significant signs of movement were observed.

In our opinion, there is likely to be little likelihood of a slope failure occurring within this area, although creep movement could occur, especially along the steep slopes of the ridges.

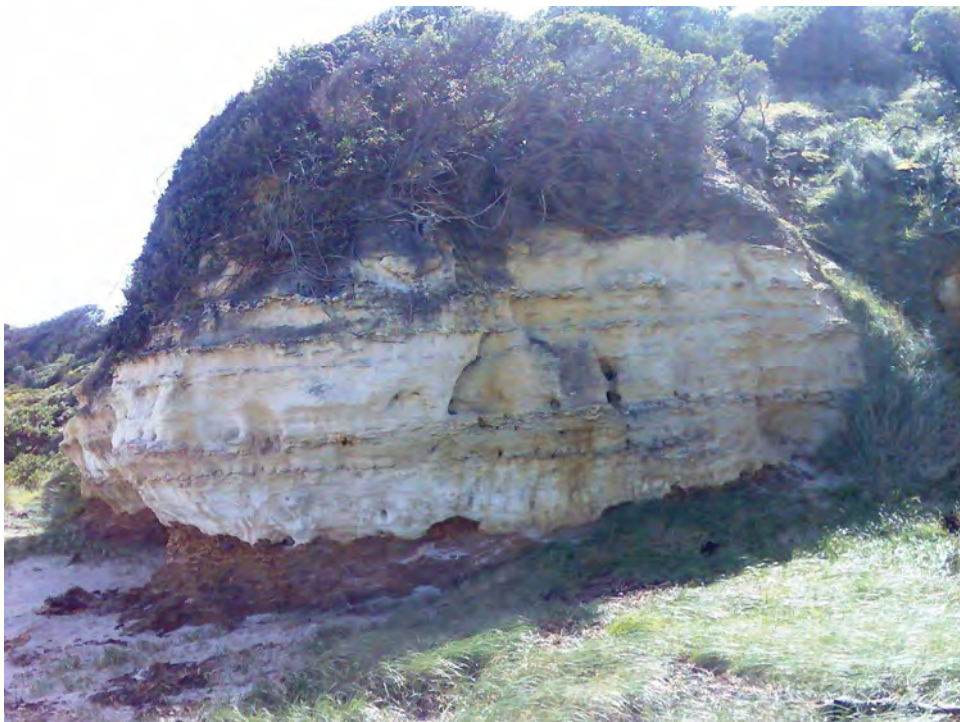
Plate 12.1: Exposed Limestone Breccias

Along the coastline limestone breccias are noted in several locations overlying the basalt. This was confirmed on site with several outcrops of limestone within the cliffs.

As well as the potential for landslides along the cliffs there is potential for toppling and block failures of the cliffs in the vicinity of the limestone breccias.

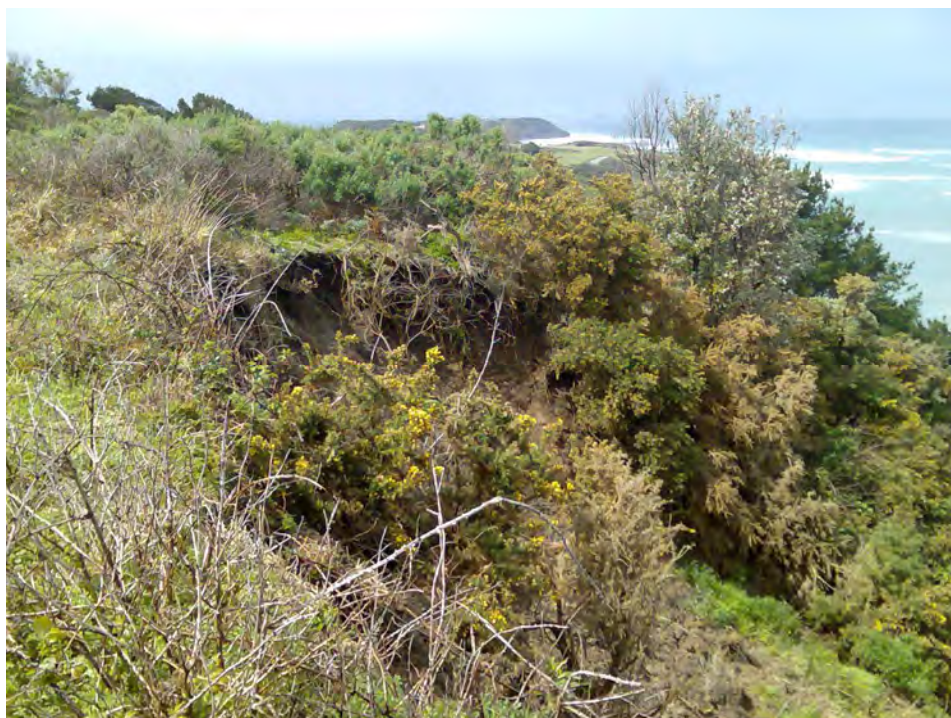
Plate 12.2: Scarp with Active Erosion and Movement

The field study identified numerous locations where movement may still be occurring. At this stage this movement is expected to have minimal impact on the residential properties. However, Golf Links Road and the golf course have the potential to be affected should the movement continue.

Should further development be required in the vicinity of the cliffs, then a high level of geotechnical investigation is recommended.
