ROAD SAFETY ASSESSMENT EXISTING CONDITIONS

Arthurs Seat Road, between Nash Lane and Mechanics Road, Red Hill

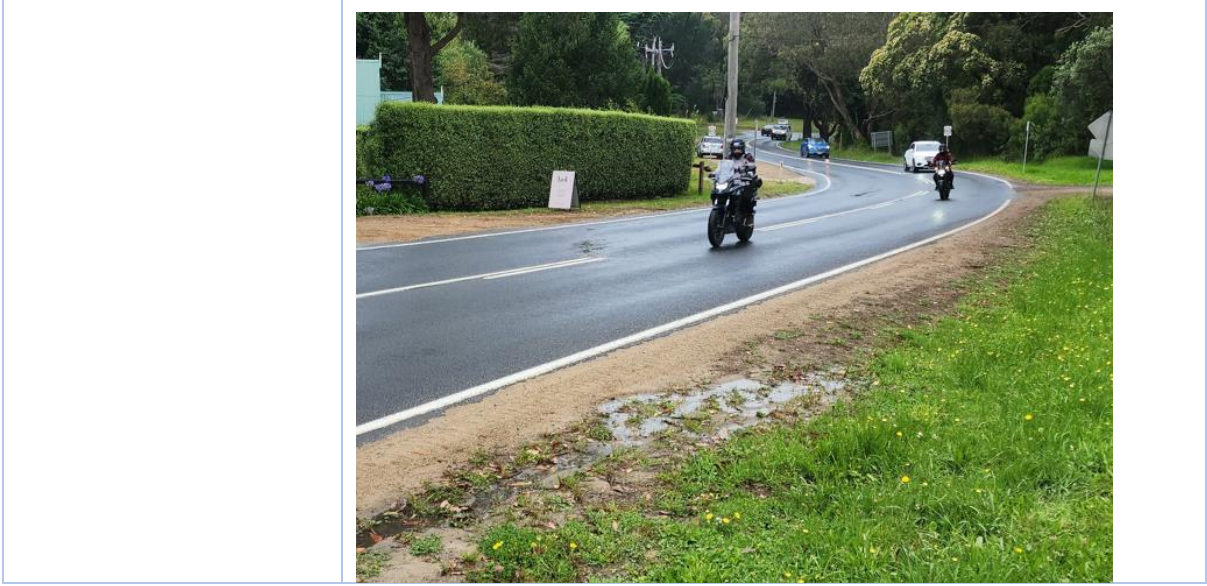
Table 2: Identified parking risks

Identified risk	Issues
<p>Pedestrian risks</p>	<p>Pedestrians are crossing Arthurs Seat Road at every point where a vehicle can be stopped along the roadside. The risk is exacerbated when crossing occurs just north-west of Mechanics Rd. It was observed that vehicles generally approach the bend at high speeds where there is low visibility.</p>  
<p>Rear end crash</p>	<p>When a parking spot is made available, immediately another car will take its place. In most cases, the only way to park is to reverse. That creates a 'rear-end' collision risk that may lead to serious injuries.</p>  
<p>Motorcycle risk</p>	<p>The road is frequented by motorcycle riders, and that was also observed during the site visit despite wet conditions.</p> <p>The shoulder parking is bringing gravel onto the road creating a run-off-the-road risk for motorcyclists.</p>

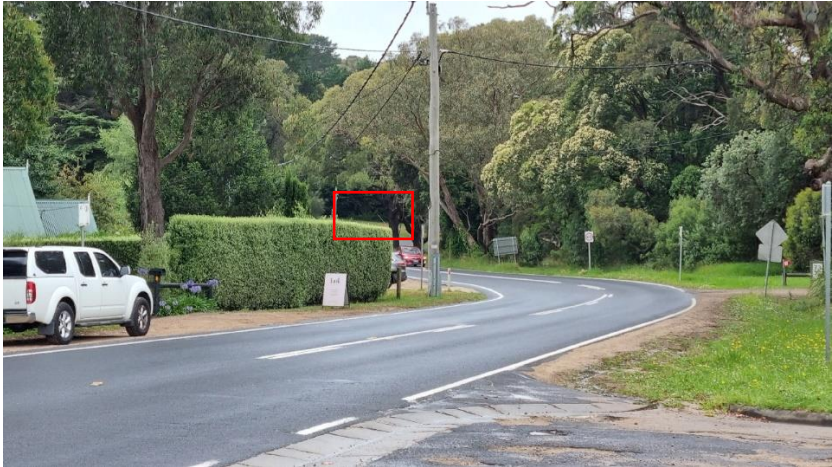
Safety Concern No. 1	Risk Rating	Recommendations	Response
<p>The hedge at the indicated property (66 Arthurs Seat Road) slightly reduces advanced visibility of oncoming traffic from around the curve, which increases the likelihood of a head-on collision as well as side crashes with vehicles reversing from the formal parking area.</p>

<p>Likelihood Possible</p> <p>Severity Insignificant</p> <p>Risk rating Low</p>	<p>It is recommended that the indicated hedge is trimmed.</p>	<p>Accepted:</p> <p><input type="checkbox"/> Yes <input type="checkbox"/> No</p> <p>Comments:</p>

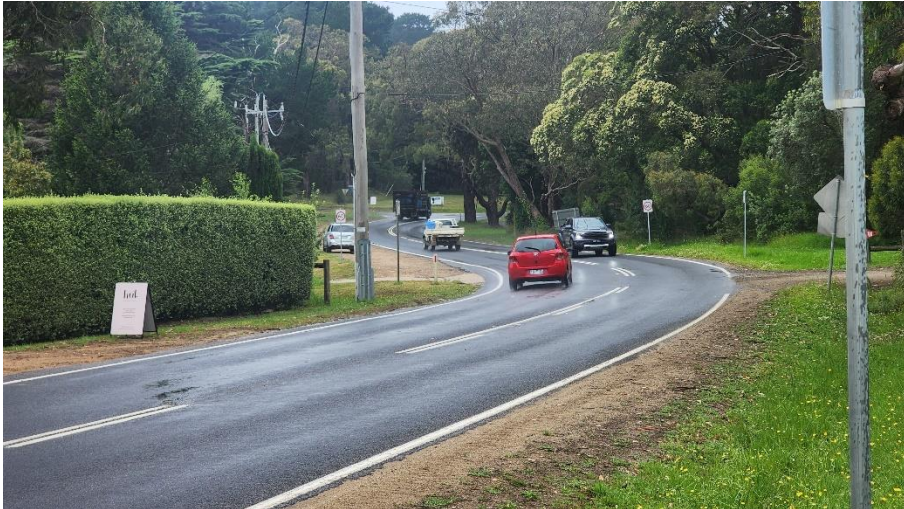
Safety Concern No. 2	Risk Rating	Recommendations	Response
<p>There is no curve advisory signage at the indicated location which provides advanced warning of the road geometry ahead and/or a safe speed for navigating the curve. There is a risk that a vehicle which is unaware of the proceeding curves approaches at an inappropriate speed, resulting in a run-off road crash. This risk is increased for motorcyclists, and during wet weather.</p>

<p>Likelihood Unlikely</p> <p>Severity Moderate</p> <p>Risk rating Medium</p>	<p>It is recommended that a ball-bank indicator test is undertaken to determine a safe curve speed and that the relevant curve advisory signage is implemented.</p>	<p>Accepted:</p> <p><input type="checkbox"/> Yes <input type="checkbox"/> No</p> <p>Comments:</p>

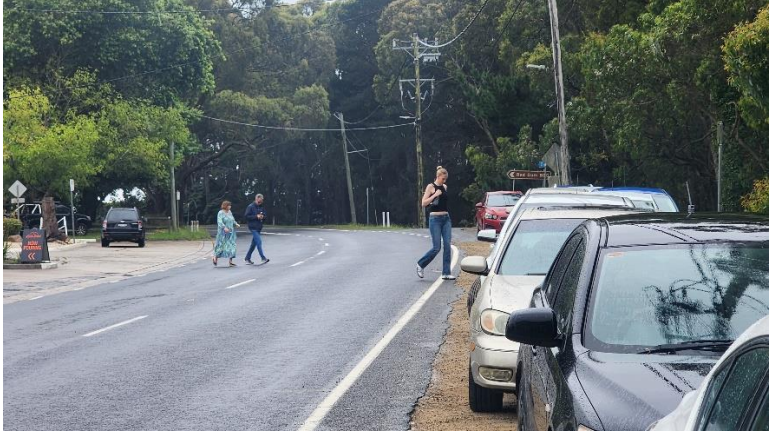
Safety Concern No. 4	Risk Rating	Recommendations	Response
<p>Uncontrolled pedestrian midblock crossings have been observed to frequently occur between the road shoulder parking and the shops on the opposite side of the road. Considering the posted speed limit of 60 km/h and the presence of sight-restricting curves which have a negative impact on pedestrian visibility, uncontrolled pedestrian crossings present a high risk of serious injury.</p>

<p>Likelihood Unlikely</p> <p>Severity Serious</p> <p>Risk rating High (FSI)</p>	<p>It is recommended that:</p> <ul style="list-style-type: none"> - Pedestrian refuge crossing is installed to facilitate midblock crossings between the road shoulder parking and the opposing shops. <p>In addition, considering that the posted speed limit is above a pedestrian survivable impact speed, it is also recommended that:</p> <ul style="list-style-type: none"> - Perceptual pavement treatment is installed in advance of the pedestrian crossing area on both approaches - Pedestrian warning signs are installed. 	<p>Accepted:</p> <p><input type="checkbox"/> Yes <input type="checkbox"/> No</p> <p>Comments:</p>
