To	[REDACTED] [REDACTED] Mornington Peninsula Shire	From	[REDACTED] [REDACTED] Stantec
Project	Beleura Cliff Path, Mornington	Date	22 December 2023
Subject	Executive Summary for Landslide Risk Assessment	Ref No.	304400705Report05.1

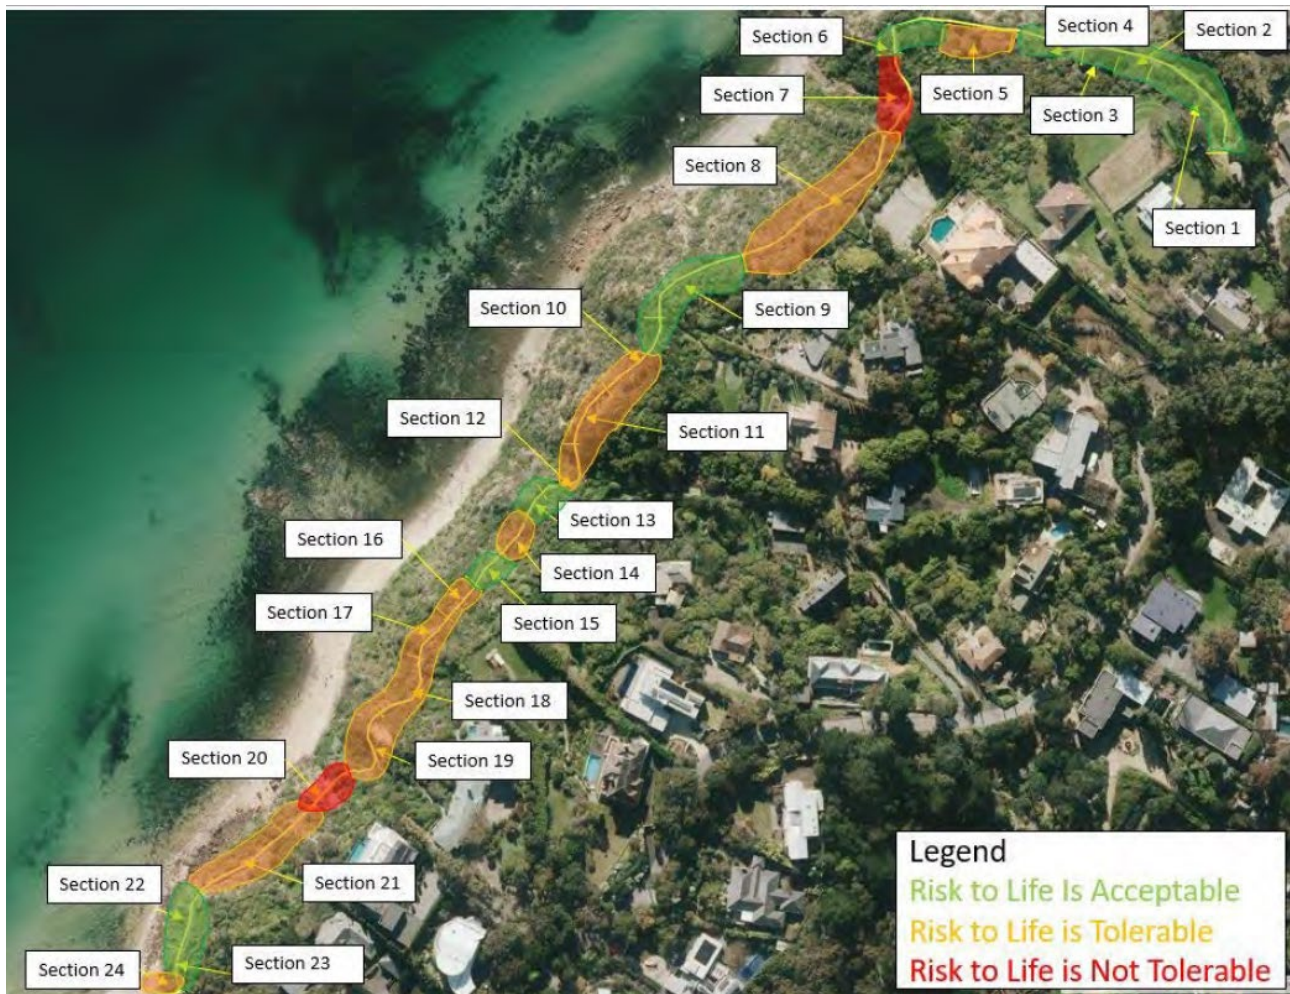
Figure 4-1 – Societal risk map

The analysis indicates that the societal risk is 'not tolerable' for Sections 7 and 20. Elsewhere the societal risk is assessed as 'tolerable' or 'acceptable'. A summary societal risk map is provided in Figure 4-1.
