Landslide Risk Assessment

Beleura Cliff Path, Caraar Creek Road to Mills Beach, Mornington

PREPARED FOR:
Mornington Peninsula Shire

December 11, 2023
RFP: V220152Report02.3

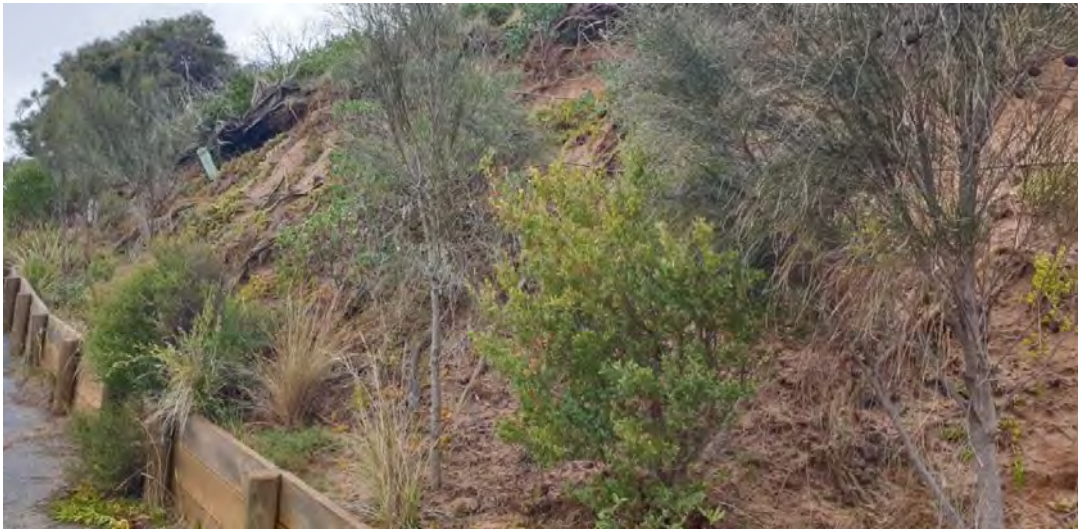
- The path crosses areas of historic landslide activity in multiple locations. An example of this is shown in Figure 4-6.

Figure 4-6 – Example of path crossing a zone of historic landslide activity (Section 11)

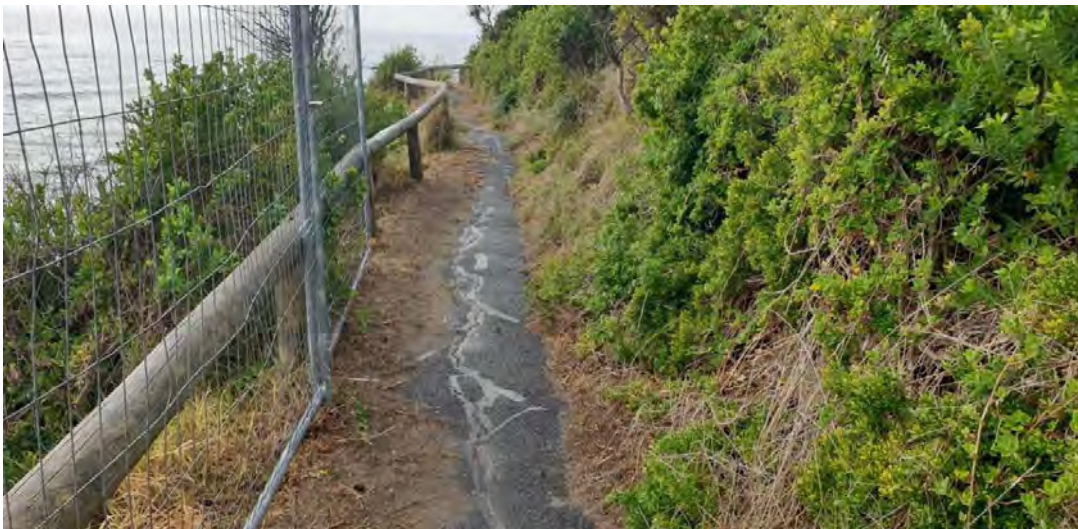
- In multiple locations along the length of the path, cracking was observed in the asphalt surface of the path.
 - a. Straight cracking was observed in sections of path constructed on fill, indicating a general, comparatively uniform settlement of the fill material downslope. An example is shown in Figure 4-7.
 - b. Arcuate cracking was observed in sections of the path where landslide activity is occurring. An example is shown in Figure 4-8.

Figure 4-7 – Example of straight cracking (Section 22)

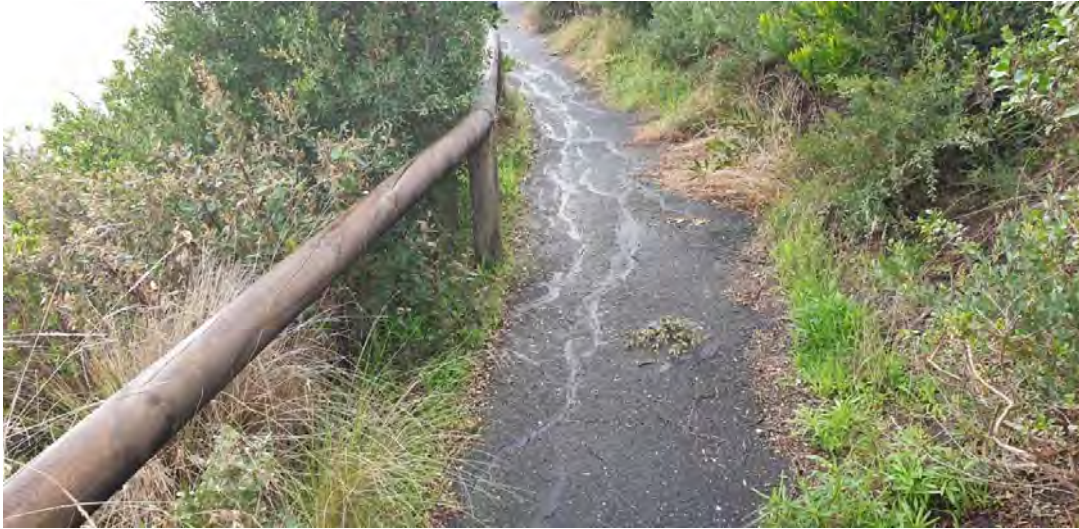
Figure 4-8 – Example of arcuate cracking (Section 16)

Generally, a large proportion of the cracking has been sealed with bitumen, although in some locations sealing or resealing needed to be carried out at the time of the site inspection.

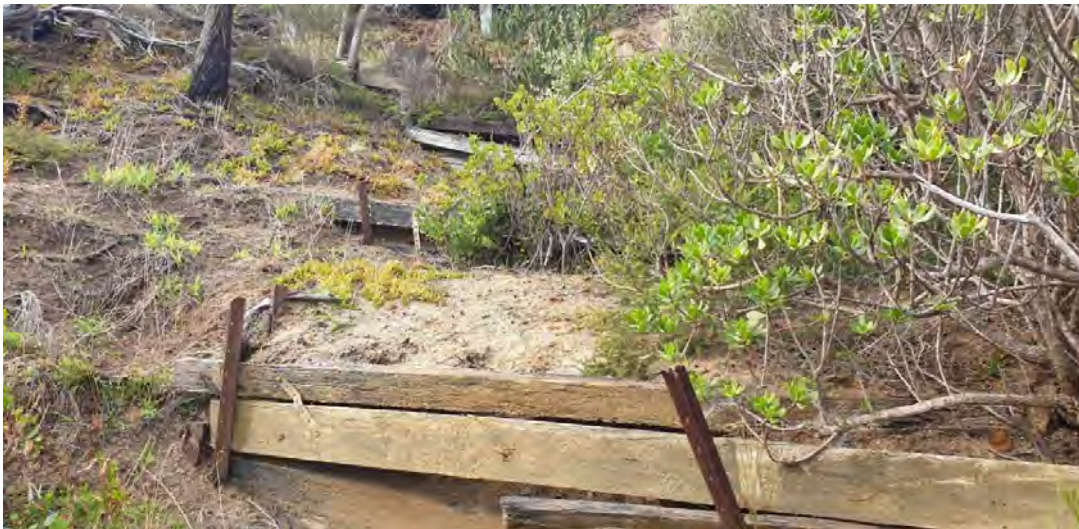
- In multiple locations informal retaining walls were observed adjacent to the path. An example of these retaining walls is presented in Figure 4-9. In some instances, walls that were originally built to catch debris from minor upslope slips are full and have been planted. An example of overflowing catch walls is presented in Figure 4-10.

Figure 4-9 – Example of informal retaining walls (Section 11)

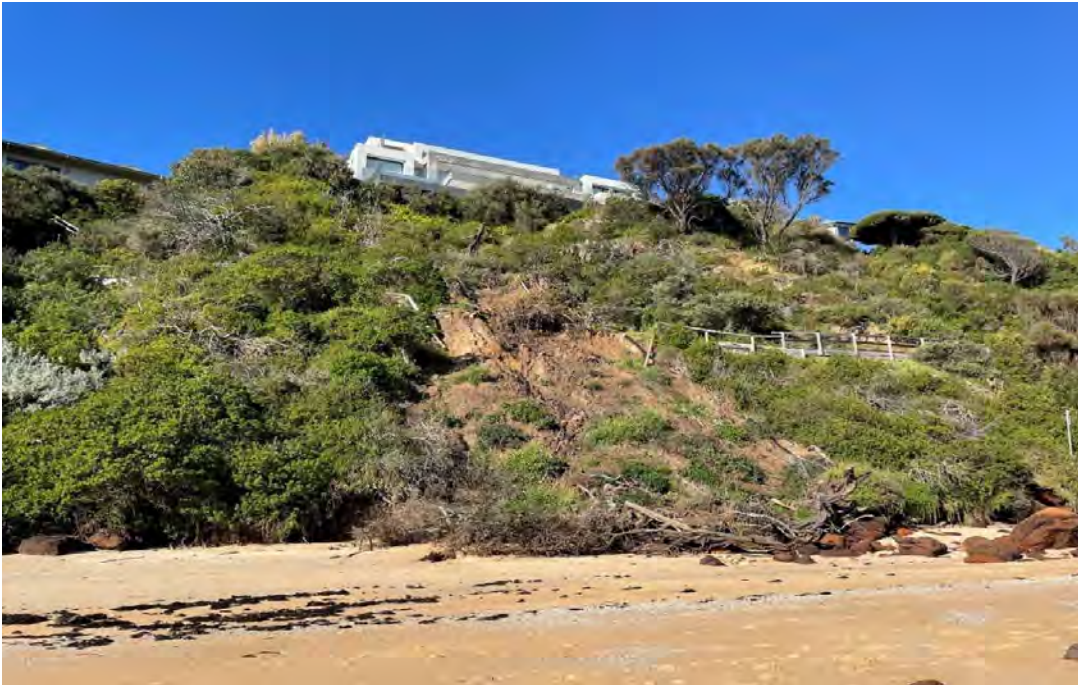
Figure 4-12 - Section 20: Recent Landslide

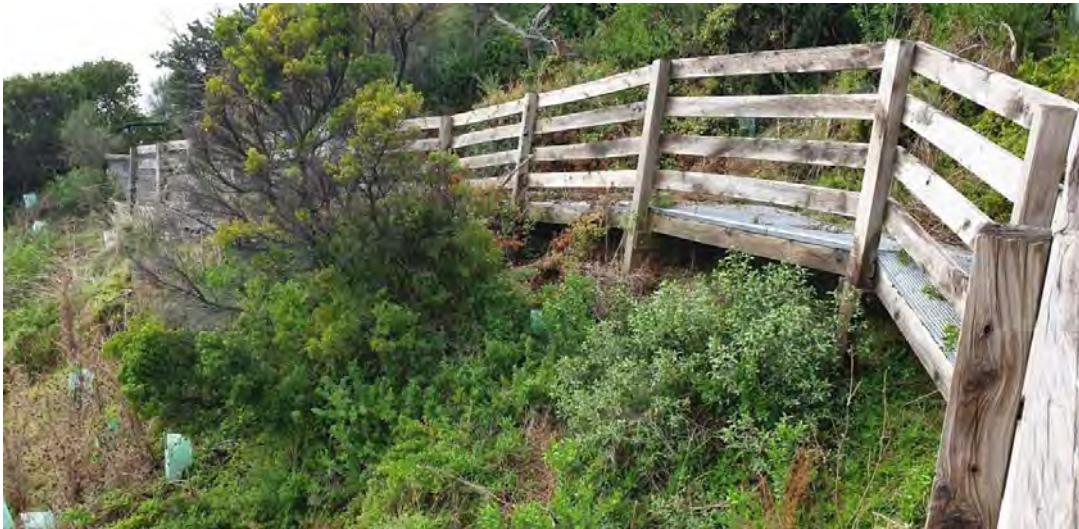
- In Section 18, following damage from a landslide the asphalt path has been replaced by a timber walkway, known as the 'Hump Bridge', as shown in Figure 4-13.

Figure 4-13 – The Hump Bridge (Section 18)

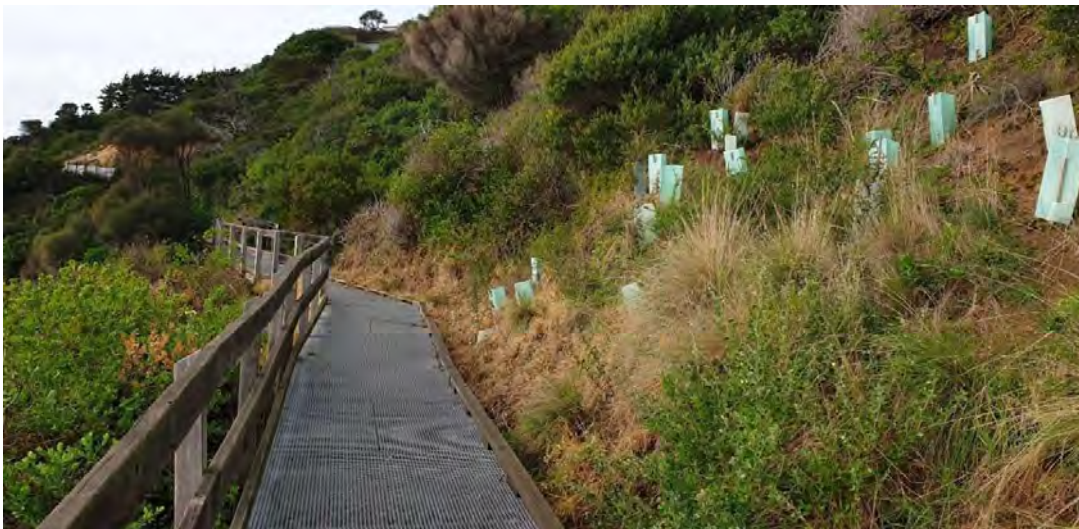
- In Section 21, following damage from a landslide, the asphalt path has been replaced by a section of boardwalk, as shown in Figure 4-14.

Figure 4-14 – Timber boardwalk (Section 21)

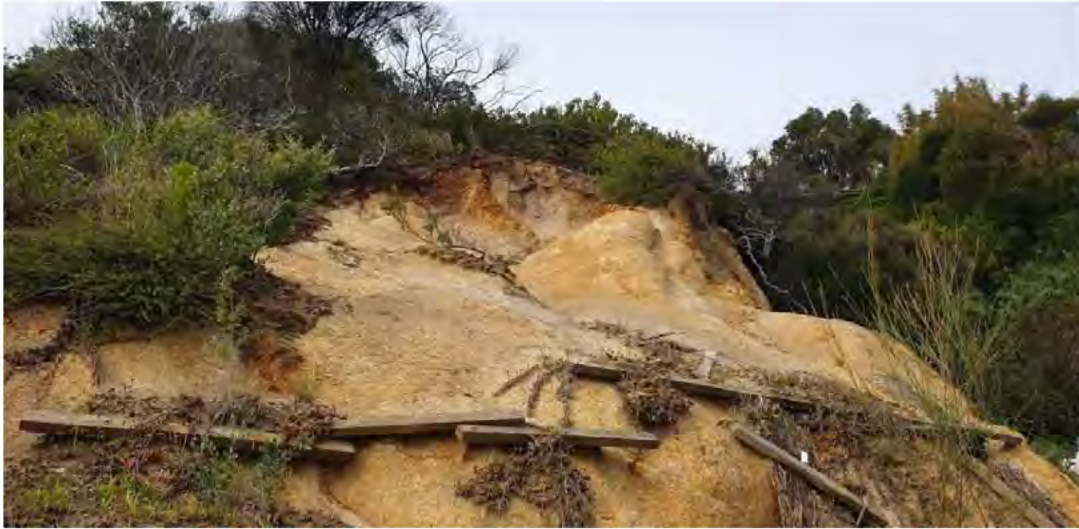
- Upslope of Section 19, informal remediation works have been implemented, in the form of timber boards nailed into the side of the cliff and a wire fence has been erected on the upslope side of the path to reduce future landslide material impacting/blocking the path, shown in Figure 4-15.

Figure 4-15 – Informal remedial works in Section 19

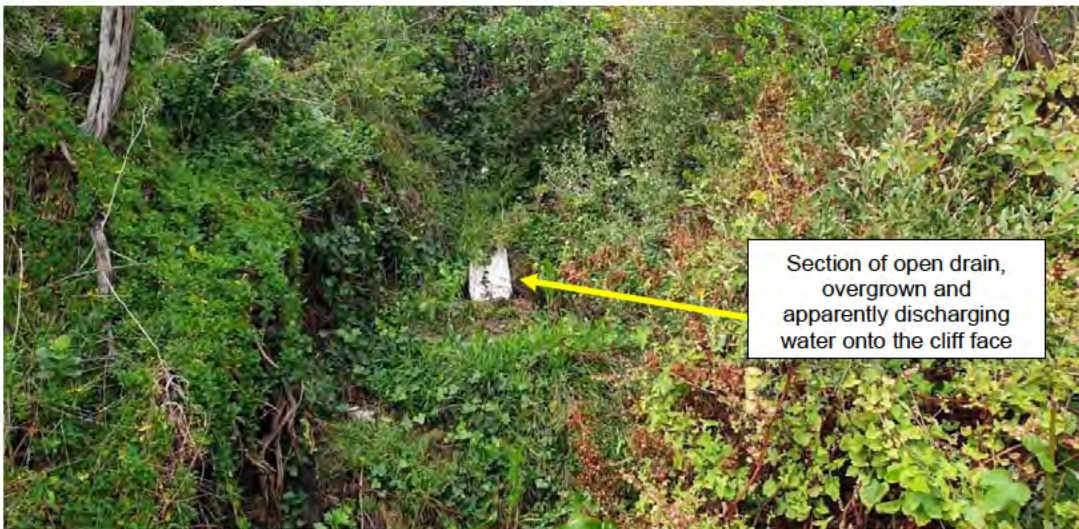
- In multiple locations, drainage pipes and systems were observed. Some drains appeared to be in poor condition. An example of a drain in a poor condition is presented in Figure 4-16.

Figure 4-16 – Section of open drain (Section 18).

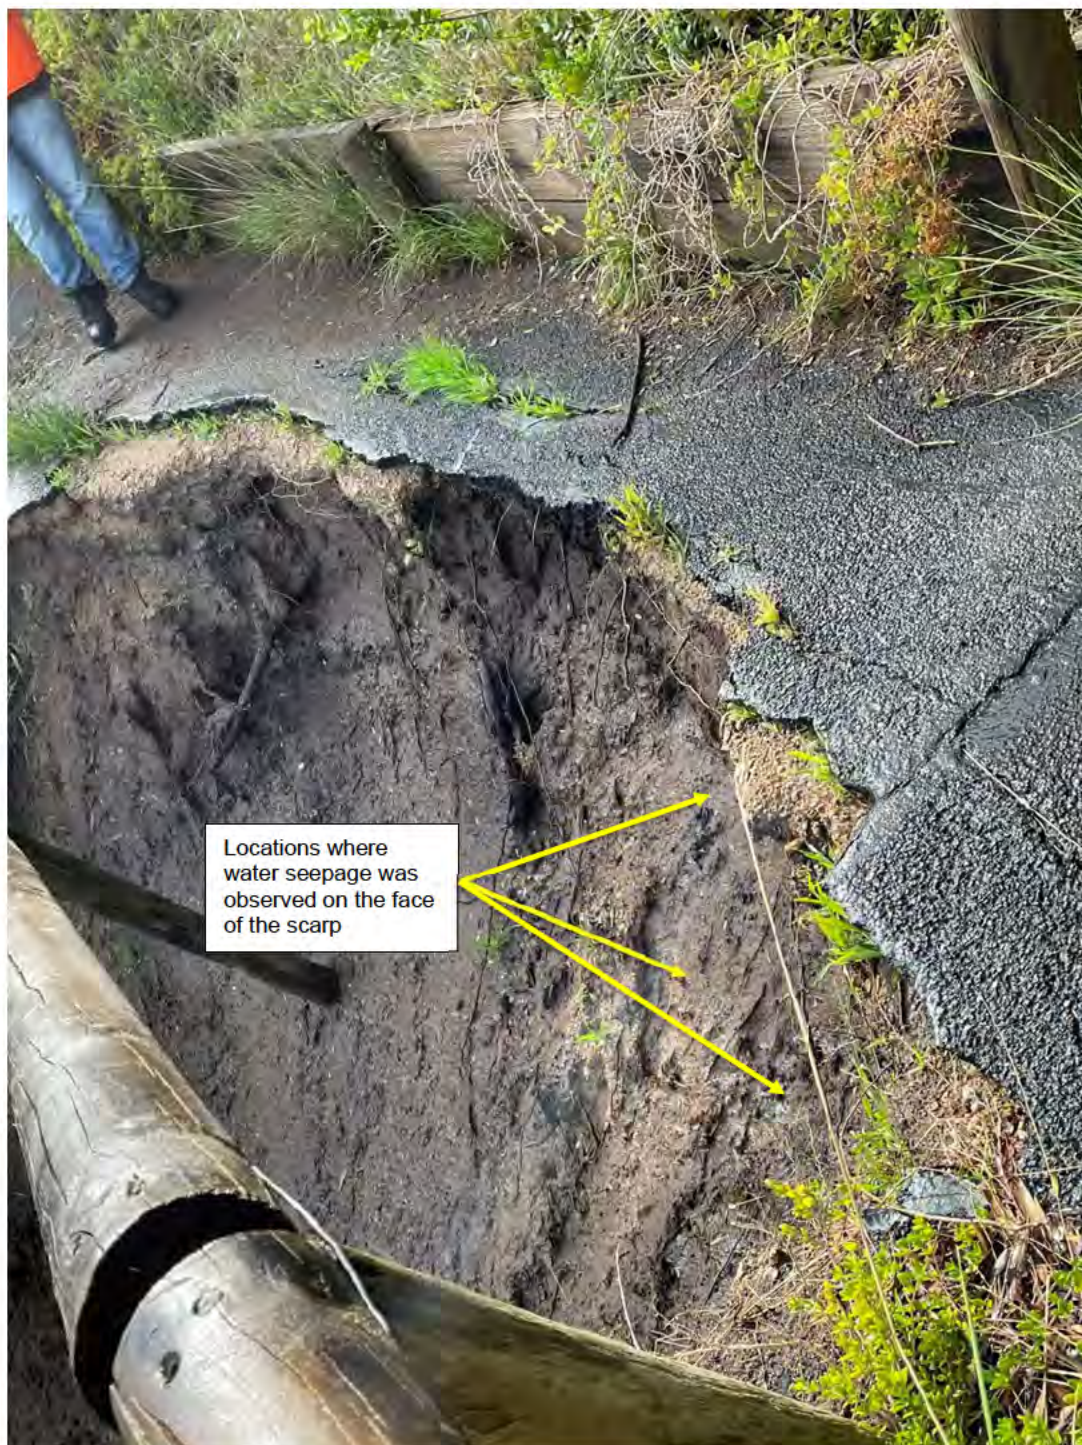
- At the locations of the active landslides, water was observed seeping through the scarps. This is shown in Figure 4-17 and Figure 4-18.

Figure 4-17 – Water seepage observed on the scarp (Section 7).

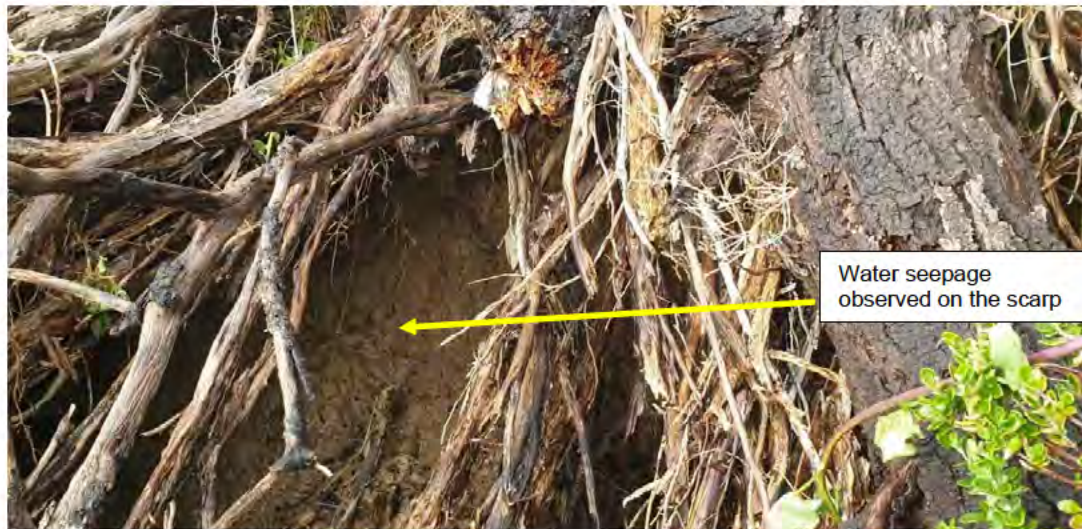
Figure 4-18 – Water seepage observed on the scarp (Section 20).

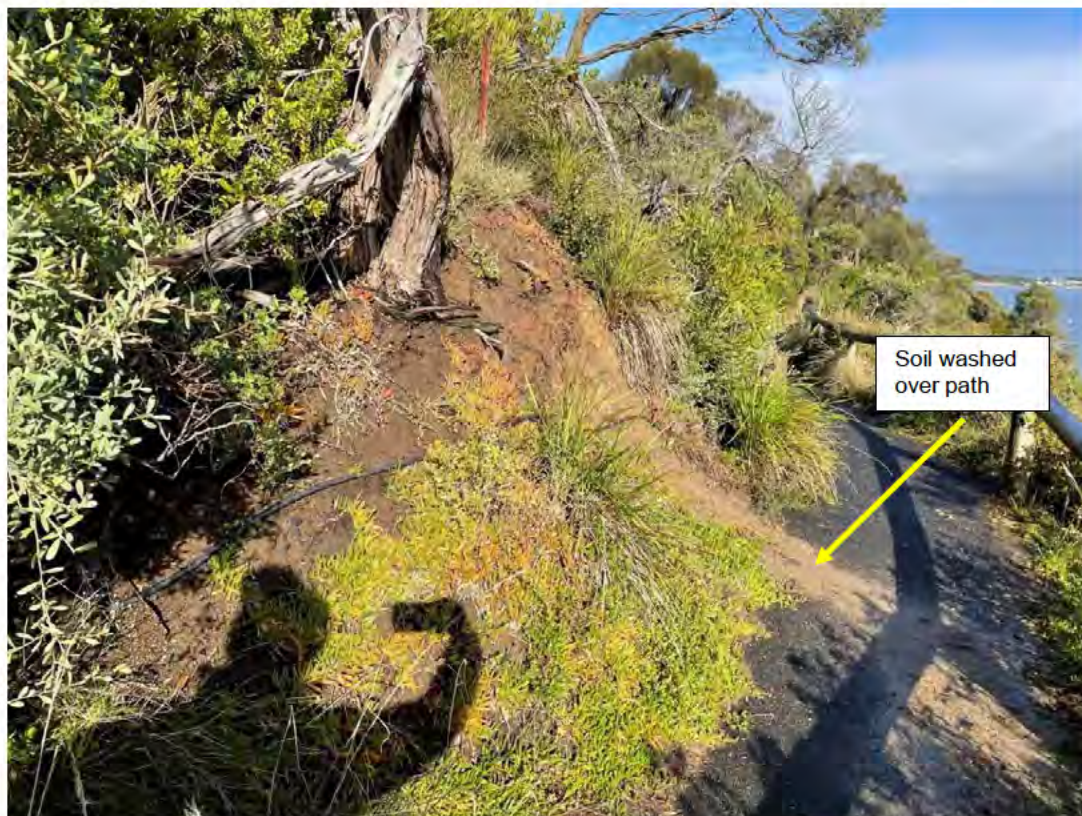
- In some locations, it was observed surface water run off is washing soil material onto the path. An example of this is shown in Figure 4-19.

Figure 4-19 – Surface water run off has resulted in material deposited on the path (Section 8).

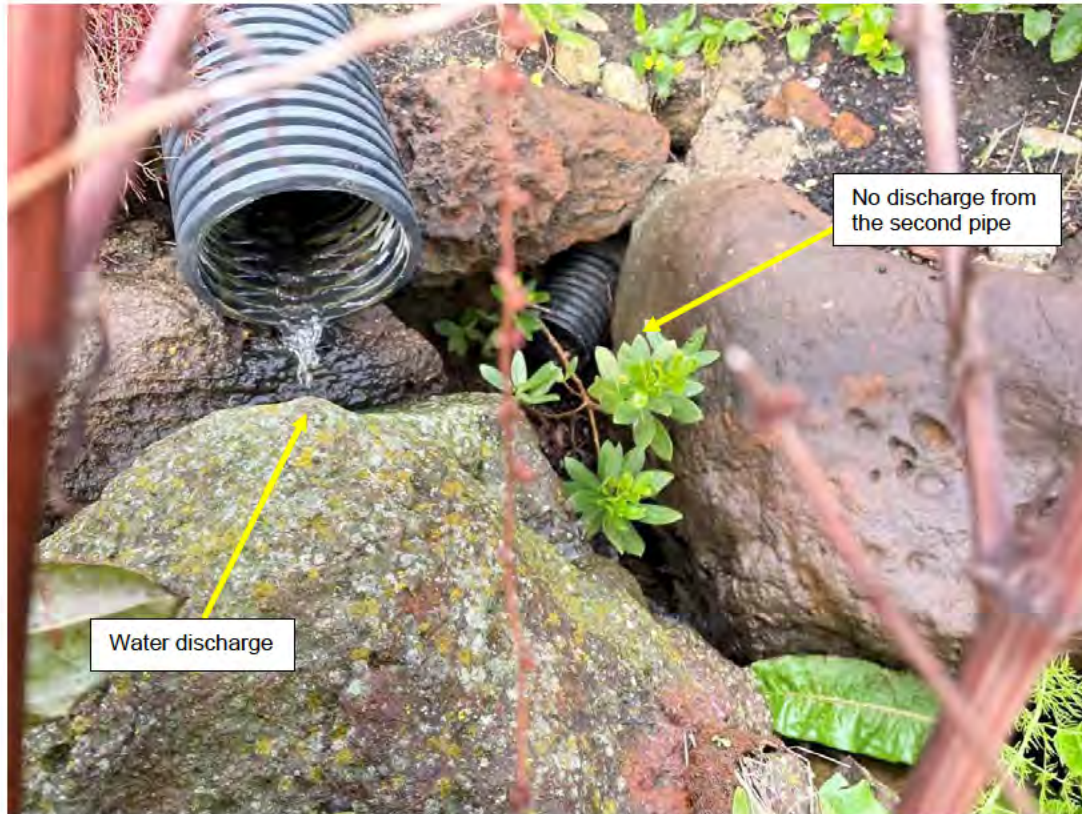
- In multiple locations along the beach, drainage pipes were observed with outfalls onto the beach. Although rainfall had occurred prior to the site inspection, water was discharging from some of the drainage pipes but not all of them, indicating the presence of breaks or blockages in the pipes. An example of this is shown in Figure 4-20.

Figure 4-20 – Not all pipes positioned to discharge on the beach had water coming out of them (Section 19).

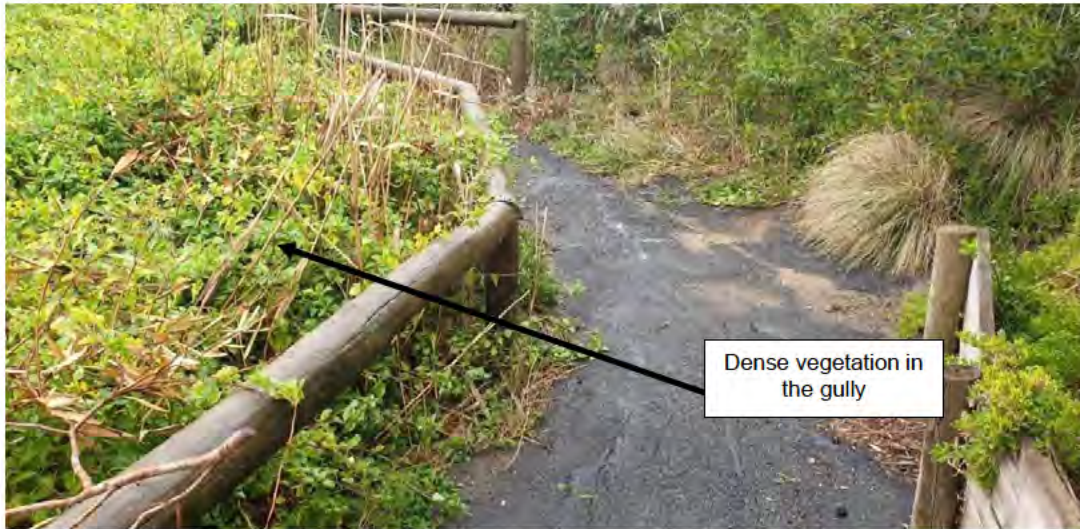
- Where gullies were identified during the desktop study, their locations were confirmed during the site inspection. In Section 12, the change in vegetation type was observed and confirmed that it is indicative of prolonged wet ground conditions. This is shown in Figure 4-21 below.

Figure 4-21 – The gully observed in Section 12 contained dense, water-intense vegetation

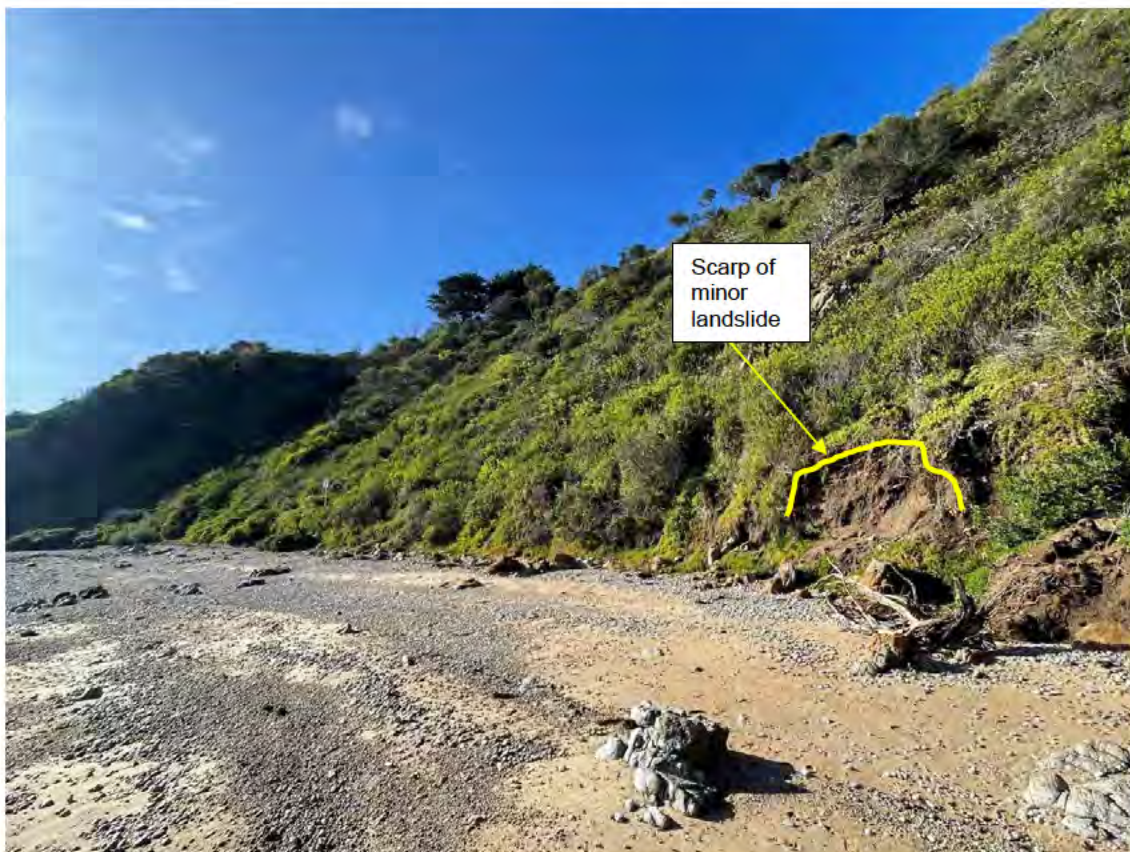
Figure 4-22 – A view of the cliff from the beach

The site inspection also included observations of the cliff from the beach and extended the full length of the path. The view provided in Figure 4-22 is representative of a significant portion of the cliff downslope of the path with small, discrete zones of localised landslide activity observed towards the

base of the cliff. It is inferred that these small landslides result from erosion of the toe by wave action. The shape of the cliffs overall indicates that this erosion is occurring very slowly and is not currently contributing to the deterioration of the path. It is anticipated that a rise in sea levels has the potential to increase the rate of erosion at the toe of the cliff, but that it would remain unlikely to result in an immediate increase in risk to the stability of the path upslope.

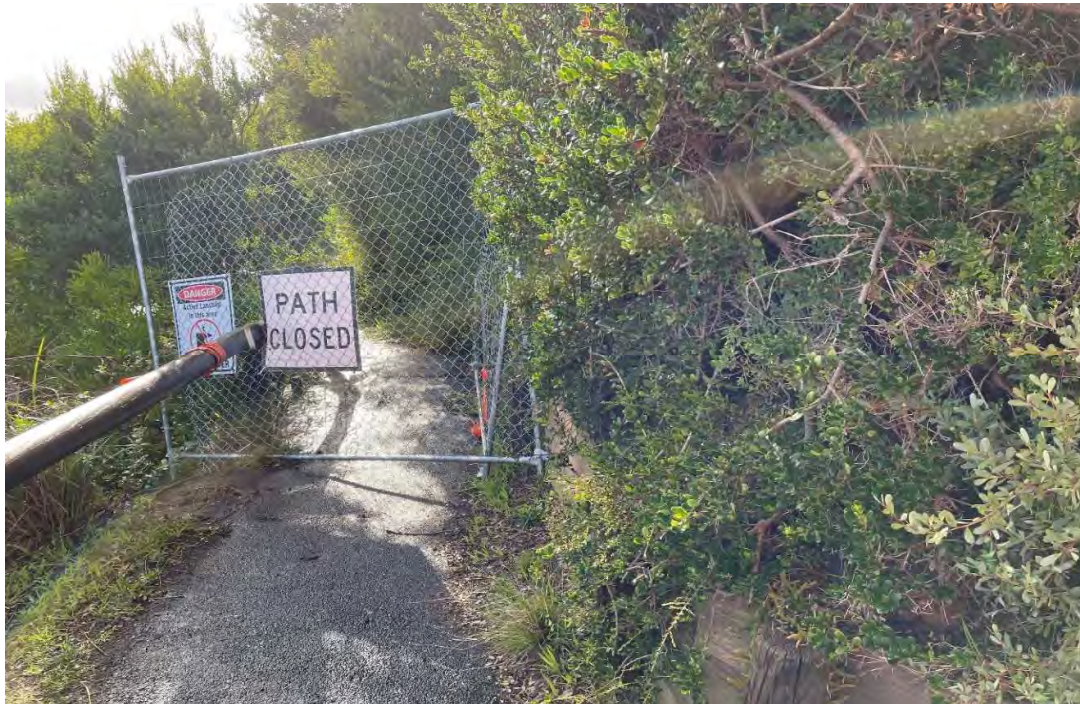
In addition to this, fencing has been put in place on both sides of each of the active landslides. An example of this is presented in Figure 6-2 on the south side of the debris flow landslide (Section 7).

Figure 6-2 – Fencing on the southern side of the active failure in Section 7

It is noted that whilst the fences are in place, some members of the public choose to enter the area by avoiding the fences. It was observed that some fencing that had been positioned on either side of the active landslides had previously been removed and thrown down the cliff. The replacement fencing that was in place at the time of the site inspection showed signs of having had holes cut in it. The holes had been re-covered with a layer of chain link fencing fixed in place. The presence of tracks around the fencing were observed where people have circumnavigated the fencing to continue using the path. All of these observations indicate that within the path itself, the fences either side of the active landslide have limited effectiveness in preventing people from accessing the high-risk areas.

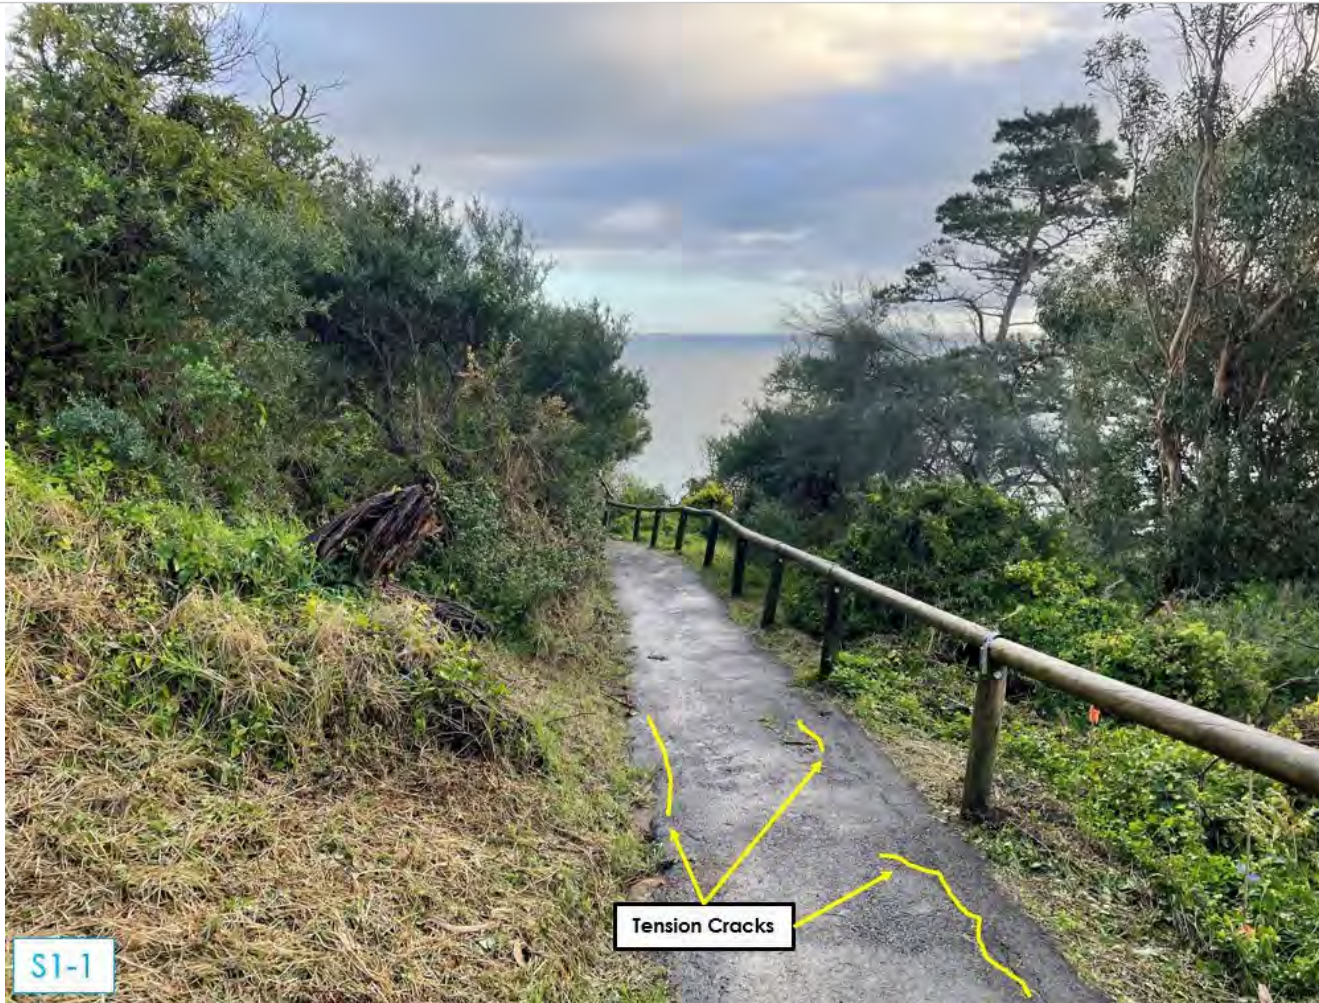
S1-1

Tension Cracks

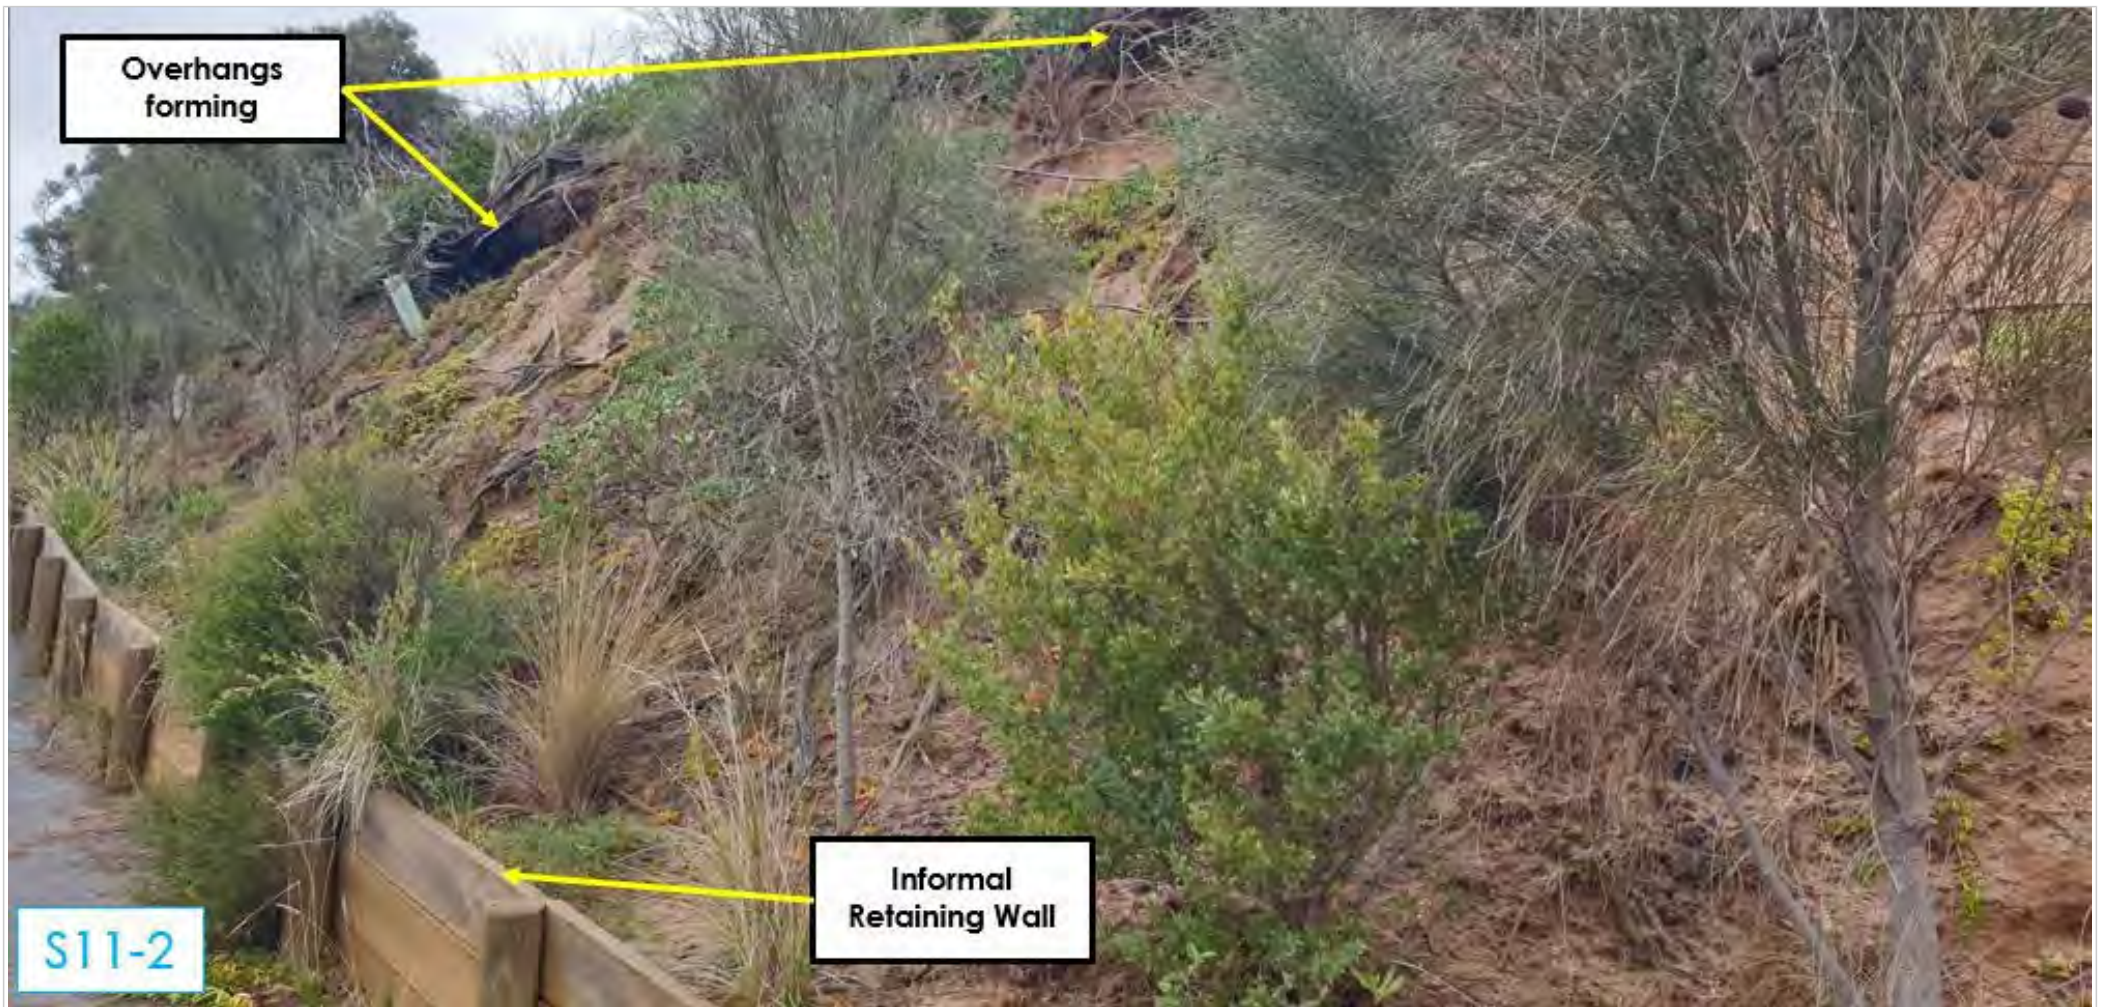
S11-2

Overhangs forming

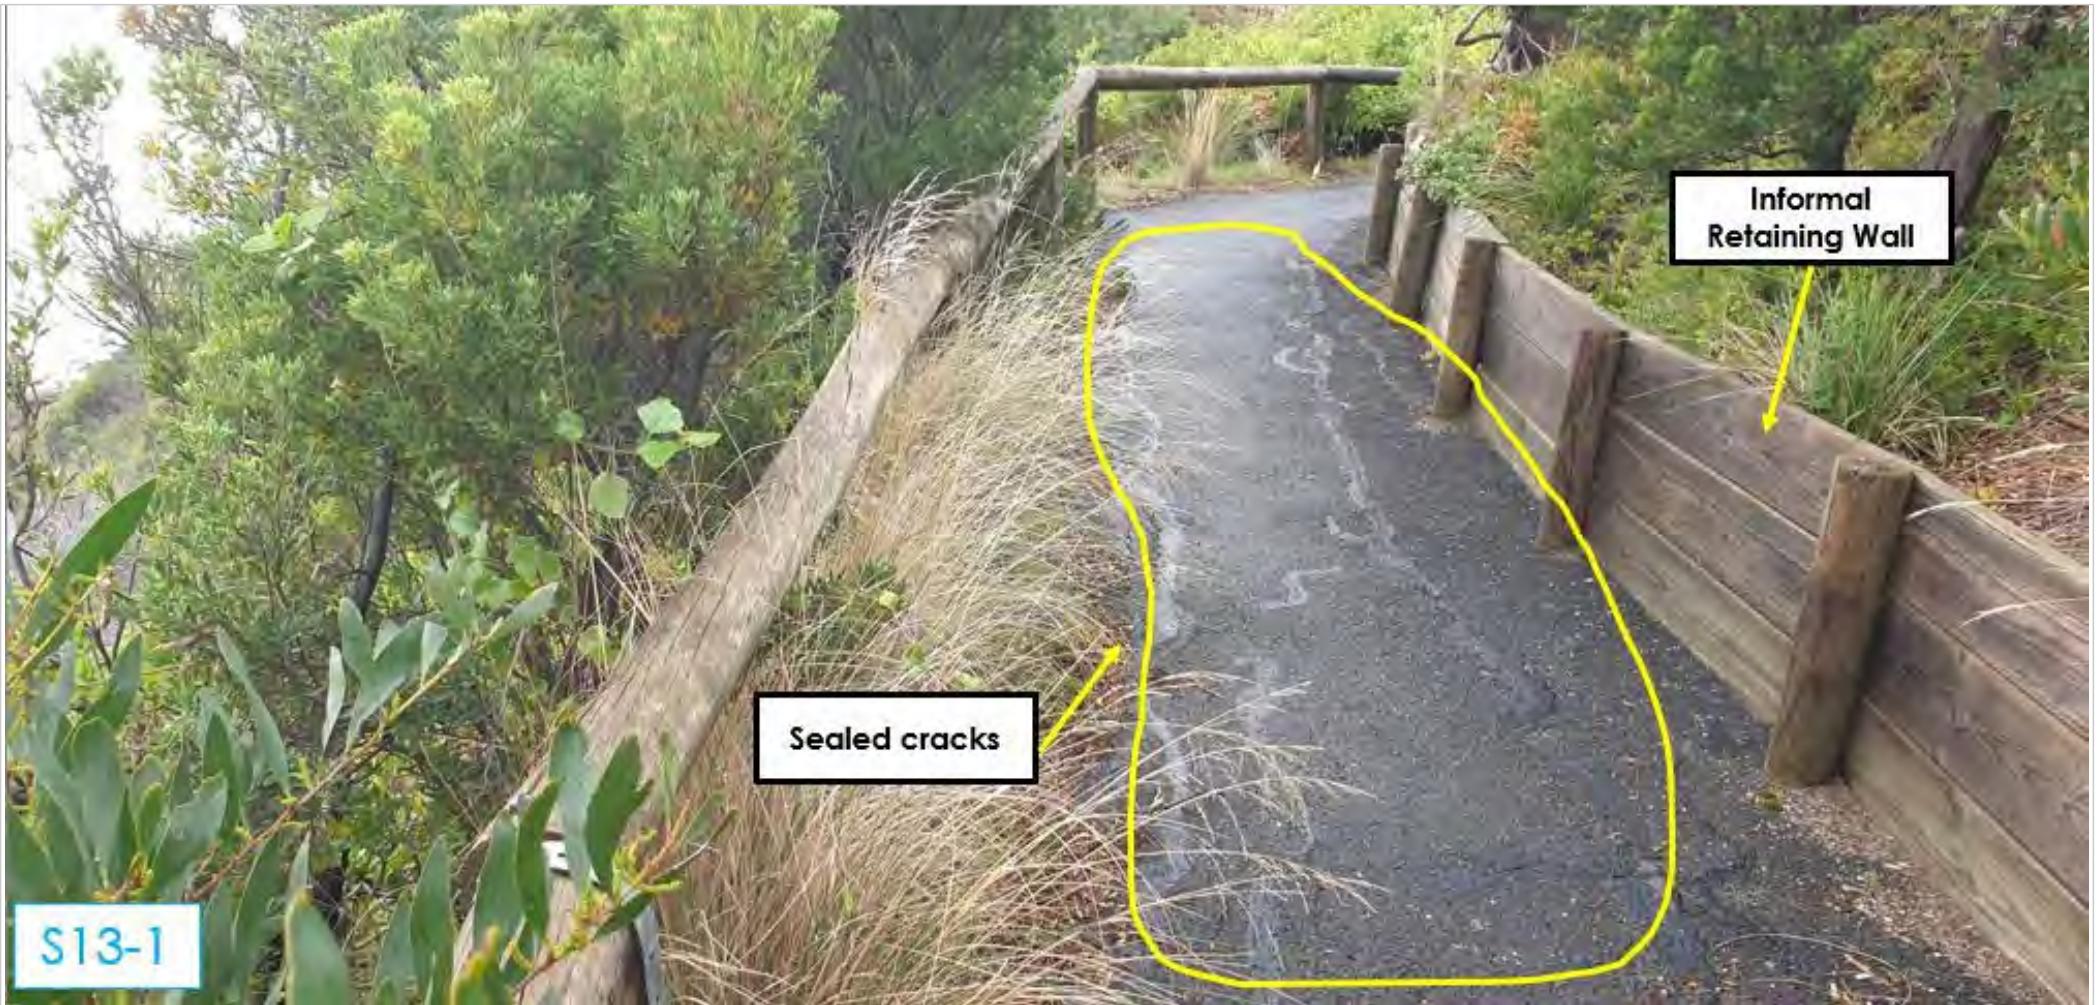
S13-1

Sealed cracks

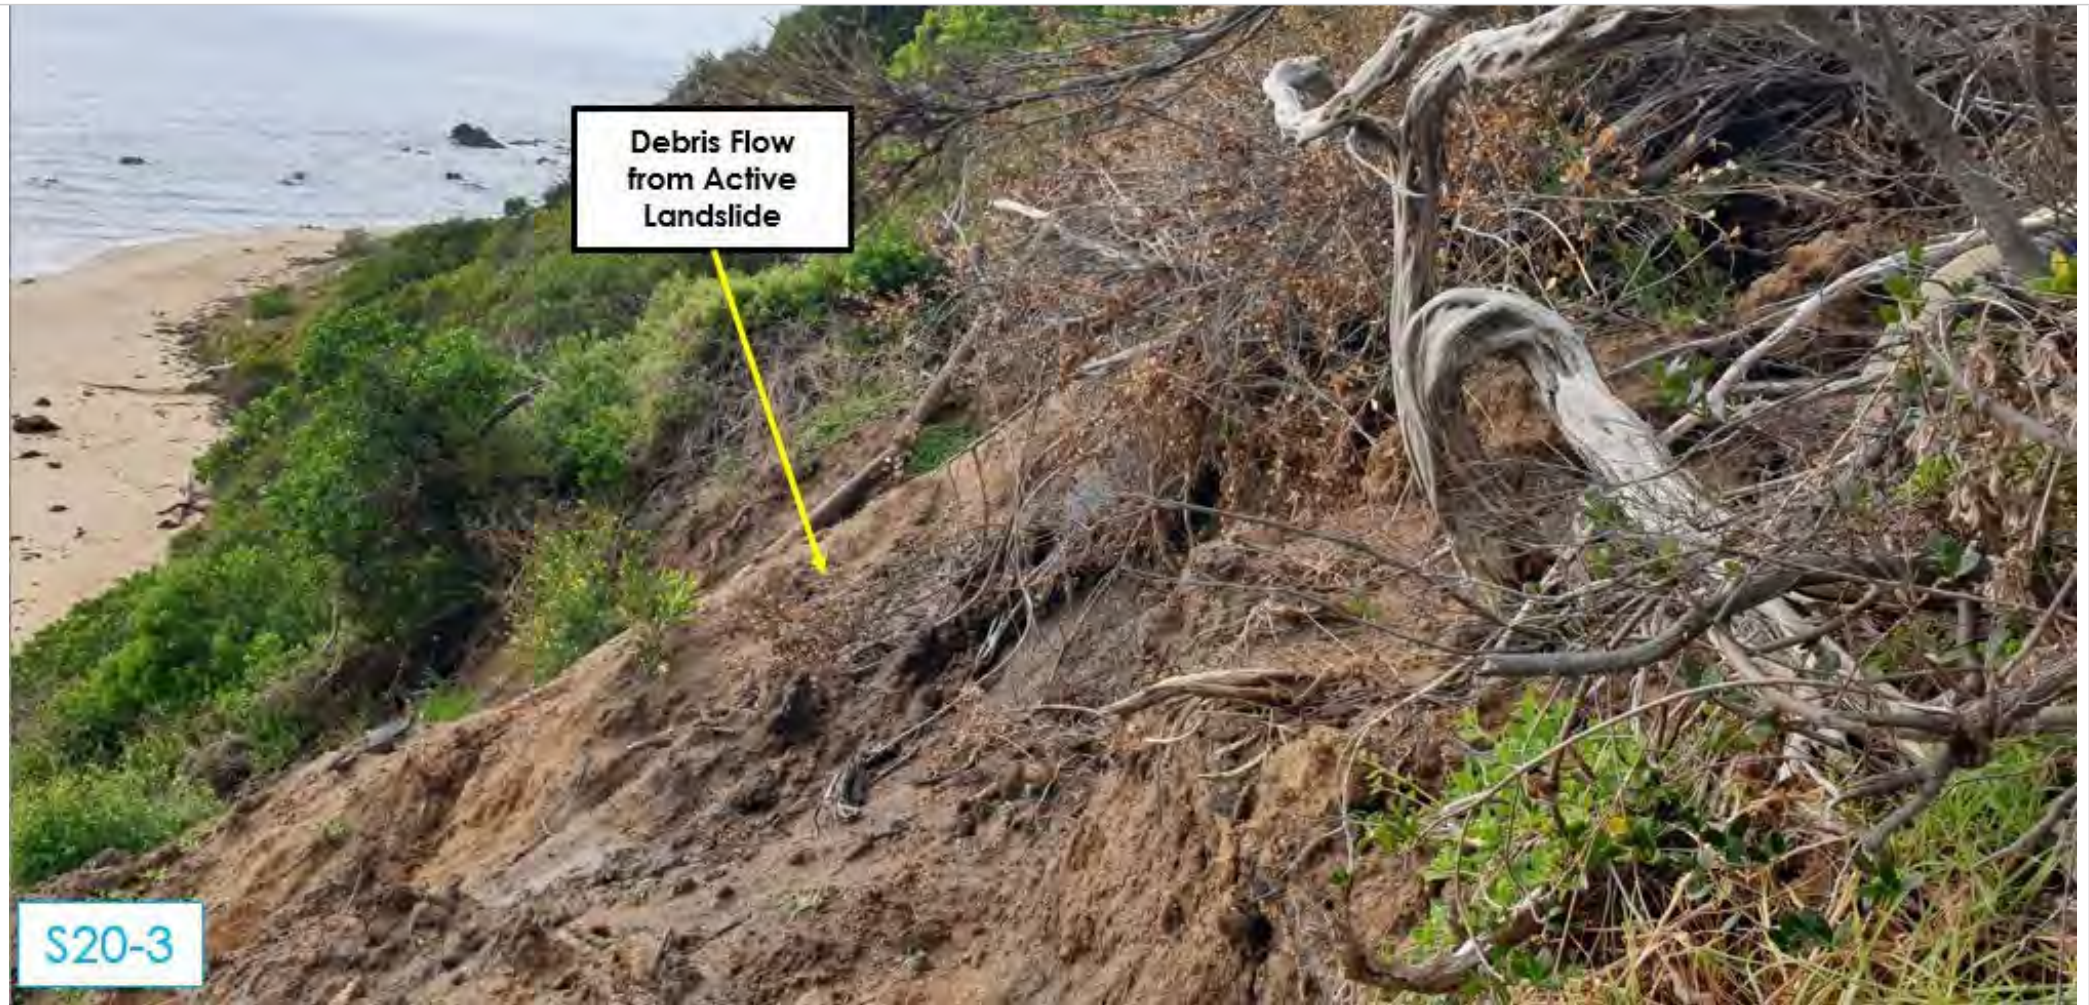
S20-3

Debris Flow
from Active
Landslide

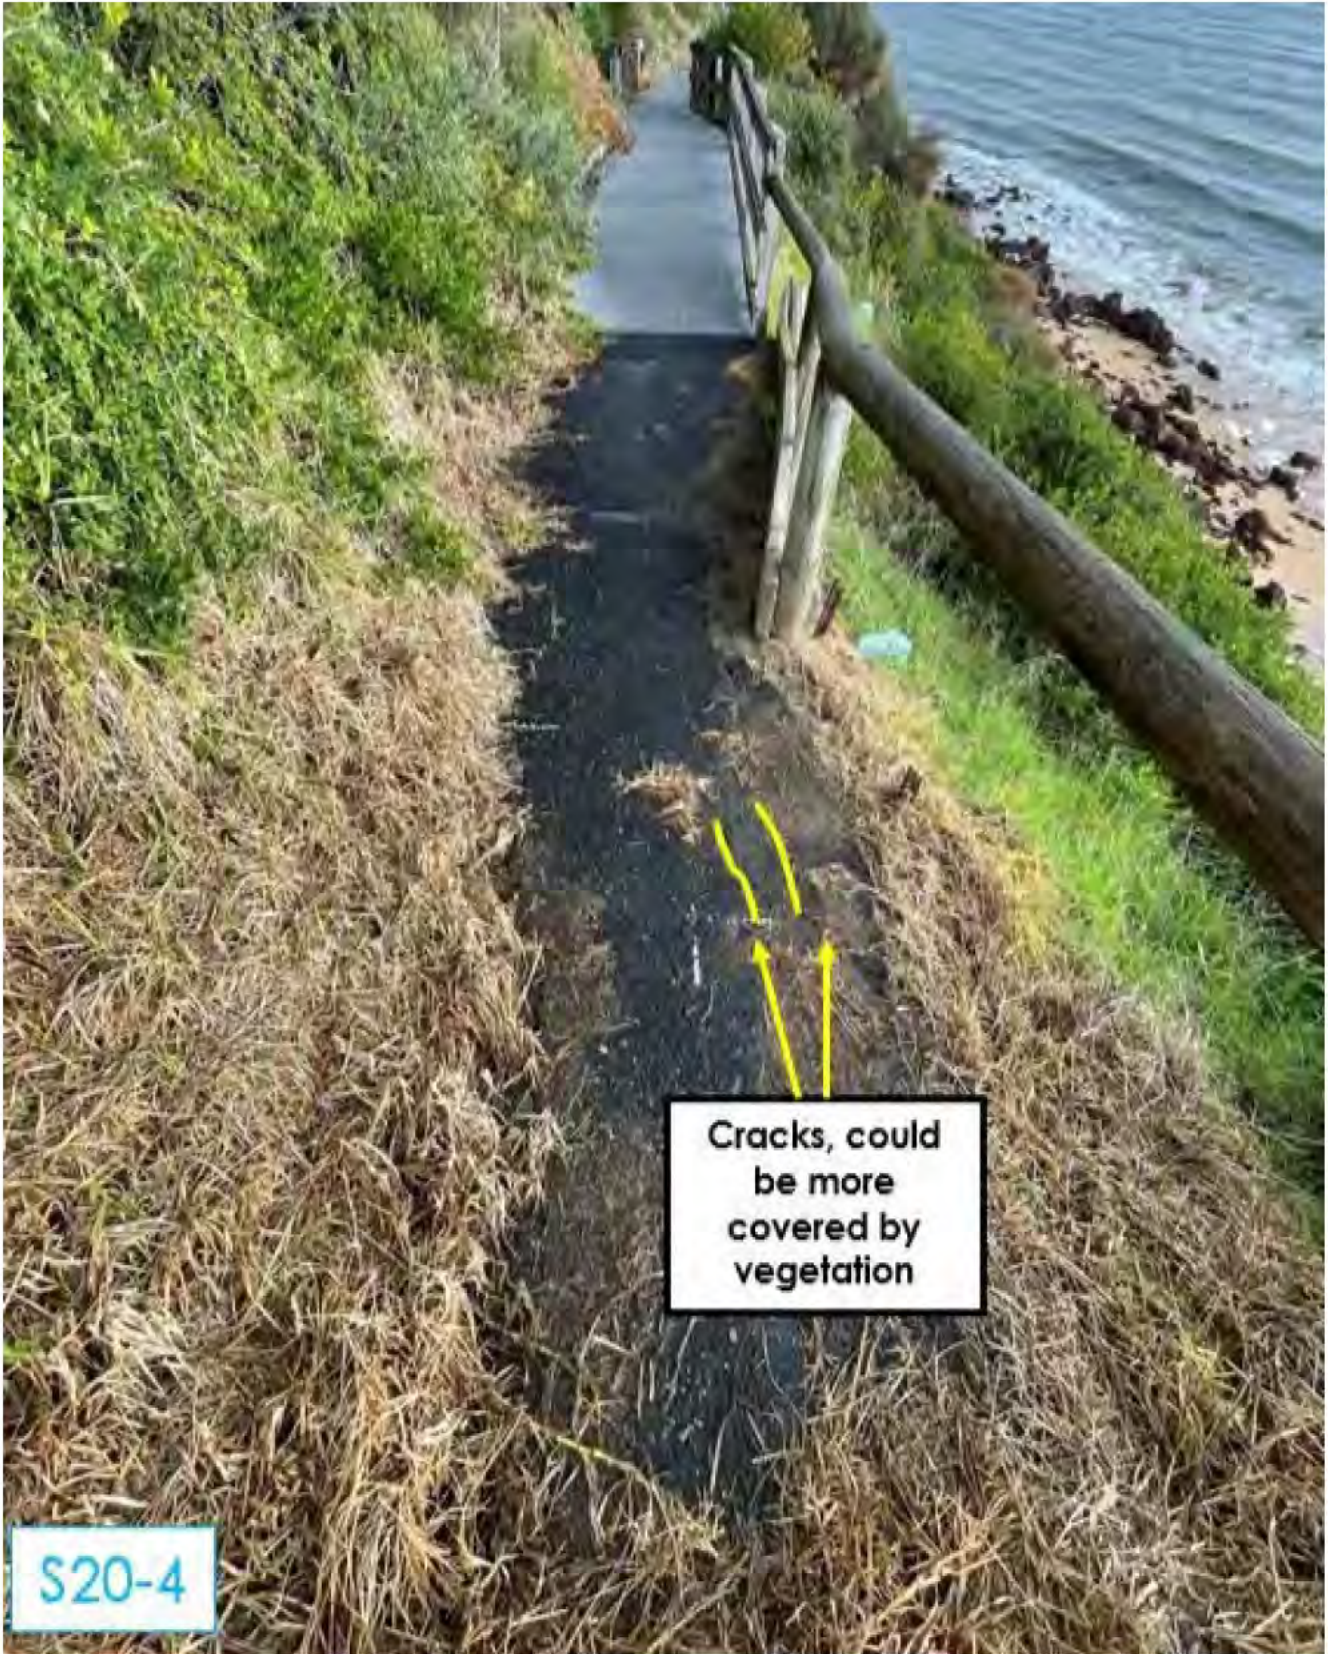
S20-4

Cracks, could be more covered by vegetation
