Landslide Risk Assessment

Beleura Cliff Path, Caraar Creek Road to Mills Beach, Mornington

PREPARED FOR:
Mornington Peninsula Shire

December 11, 2023
RFP: V220152Report02.3

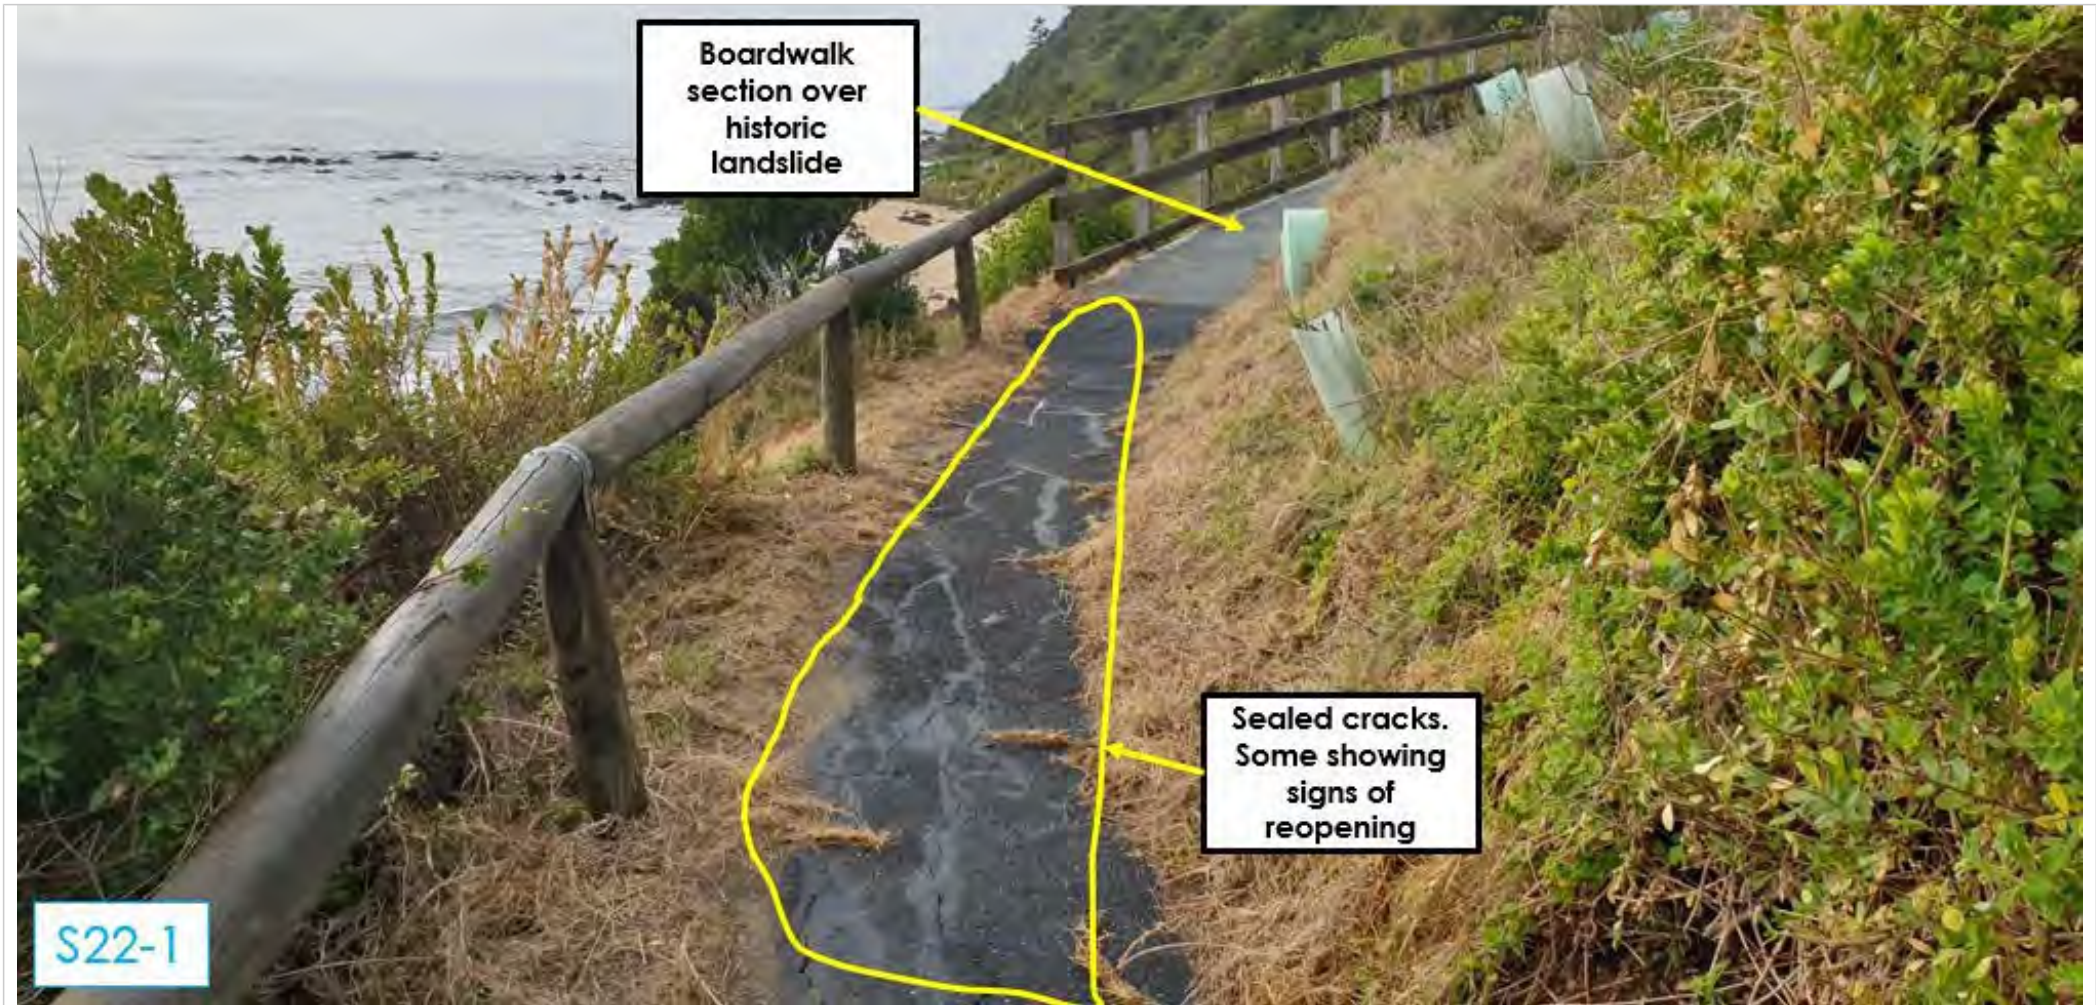
S22-1

Boardwalk section over historic landslide

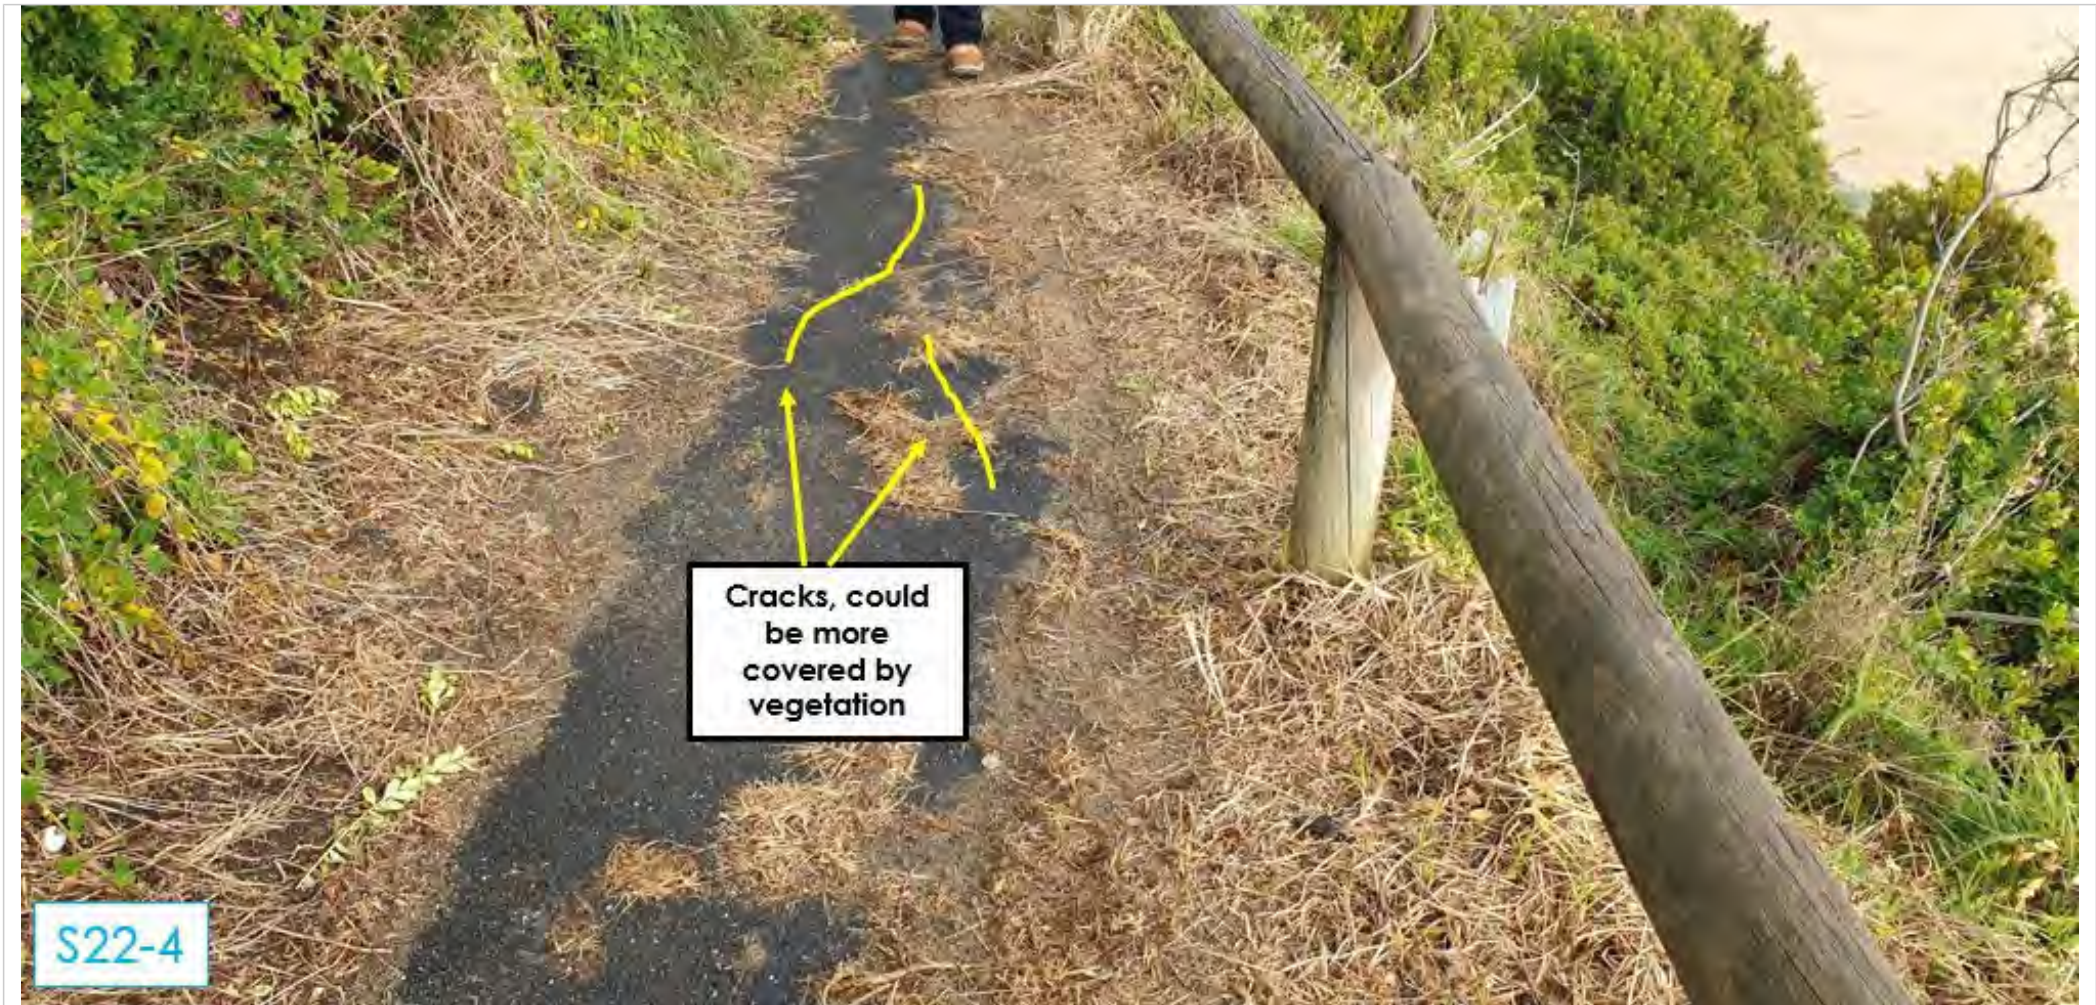
S22-4

Cracks, could be more covered by vegetation

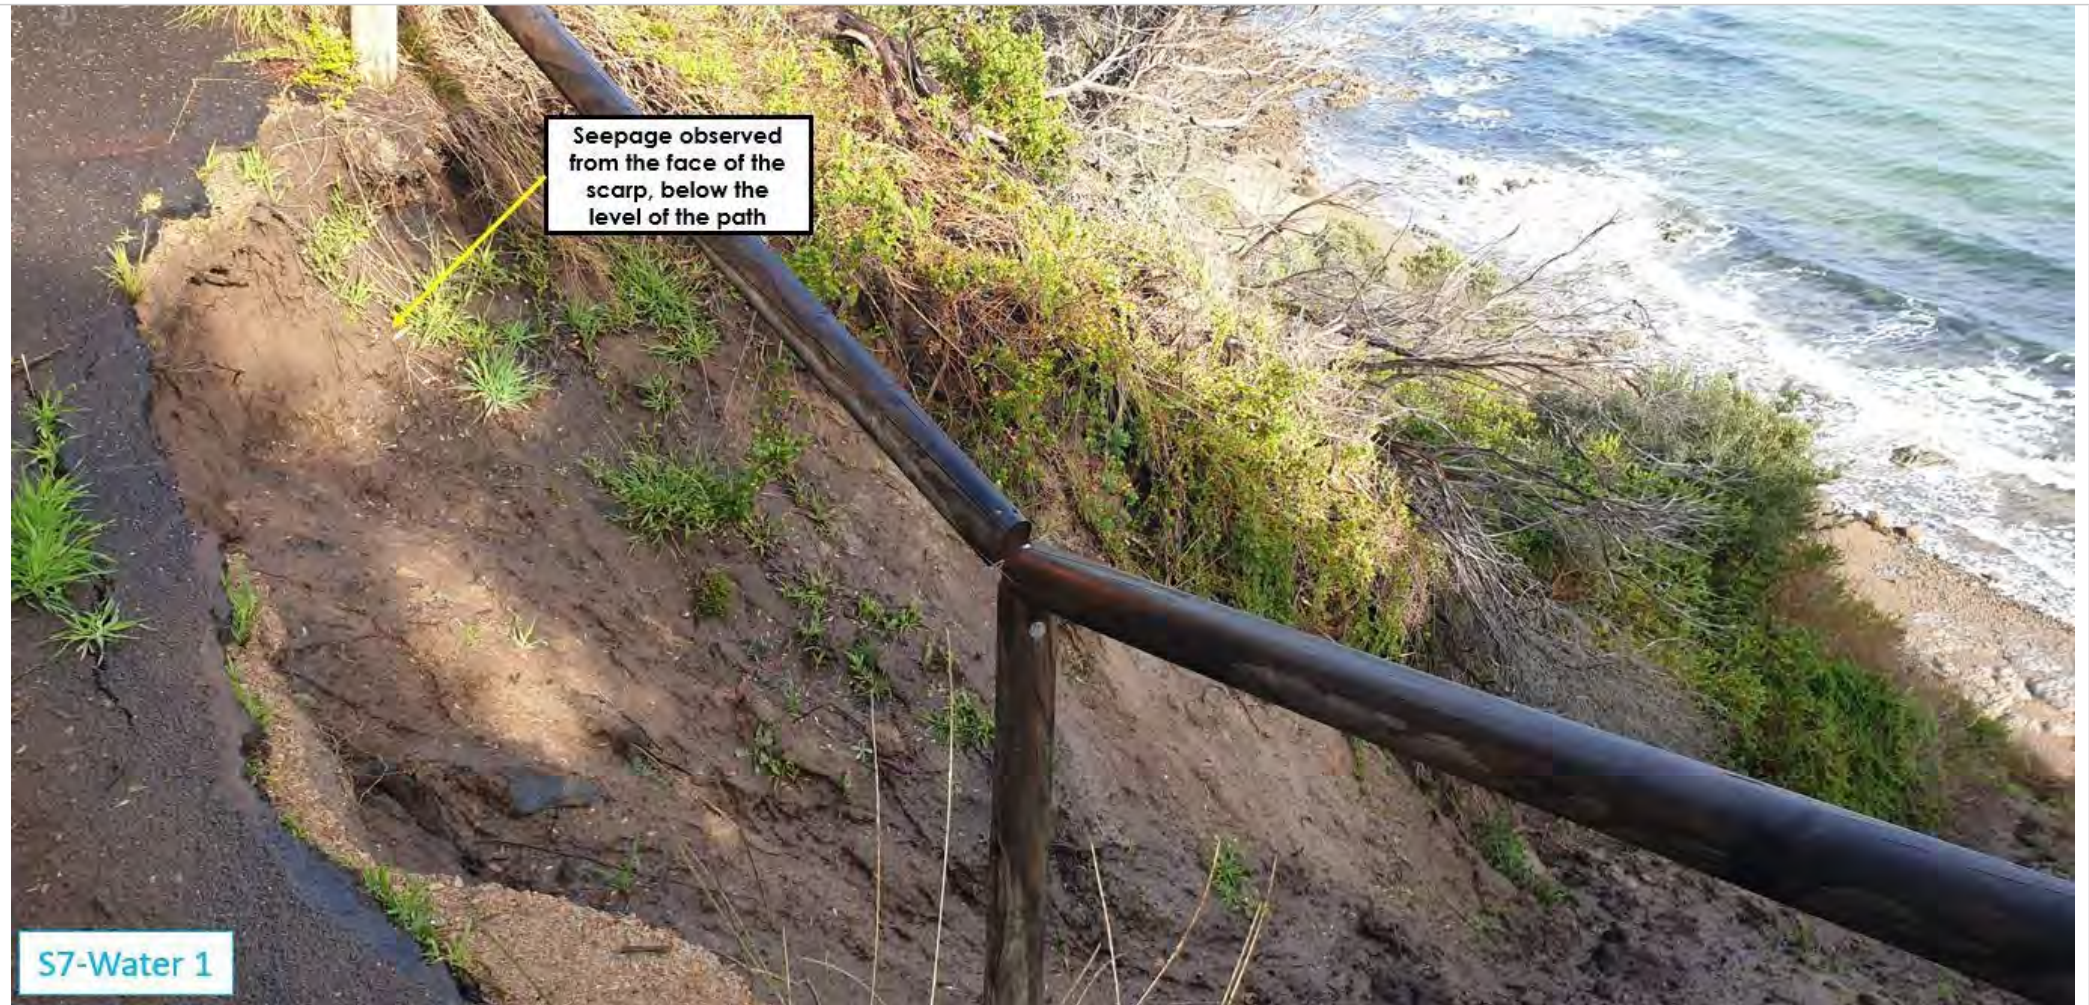
S7-Water 1

Observed water seeping from the face, immediately below the path

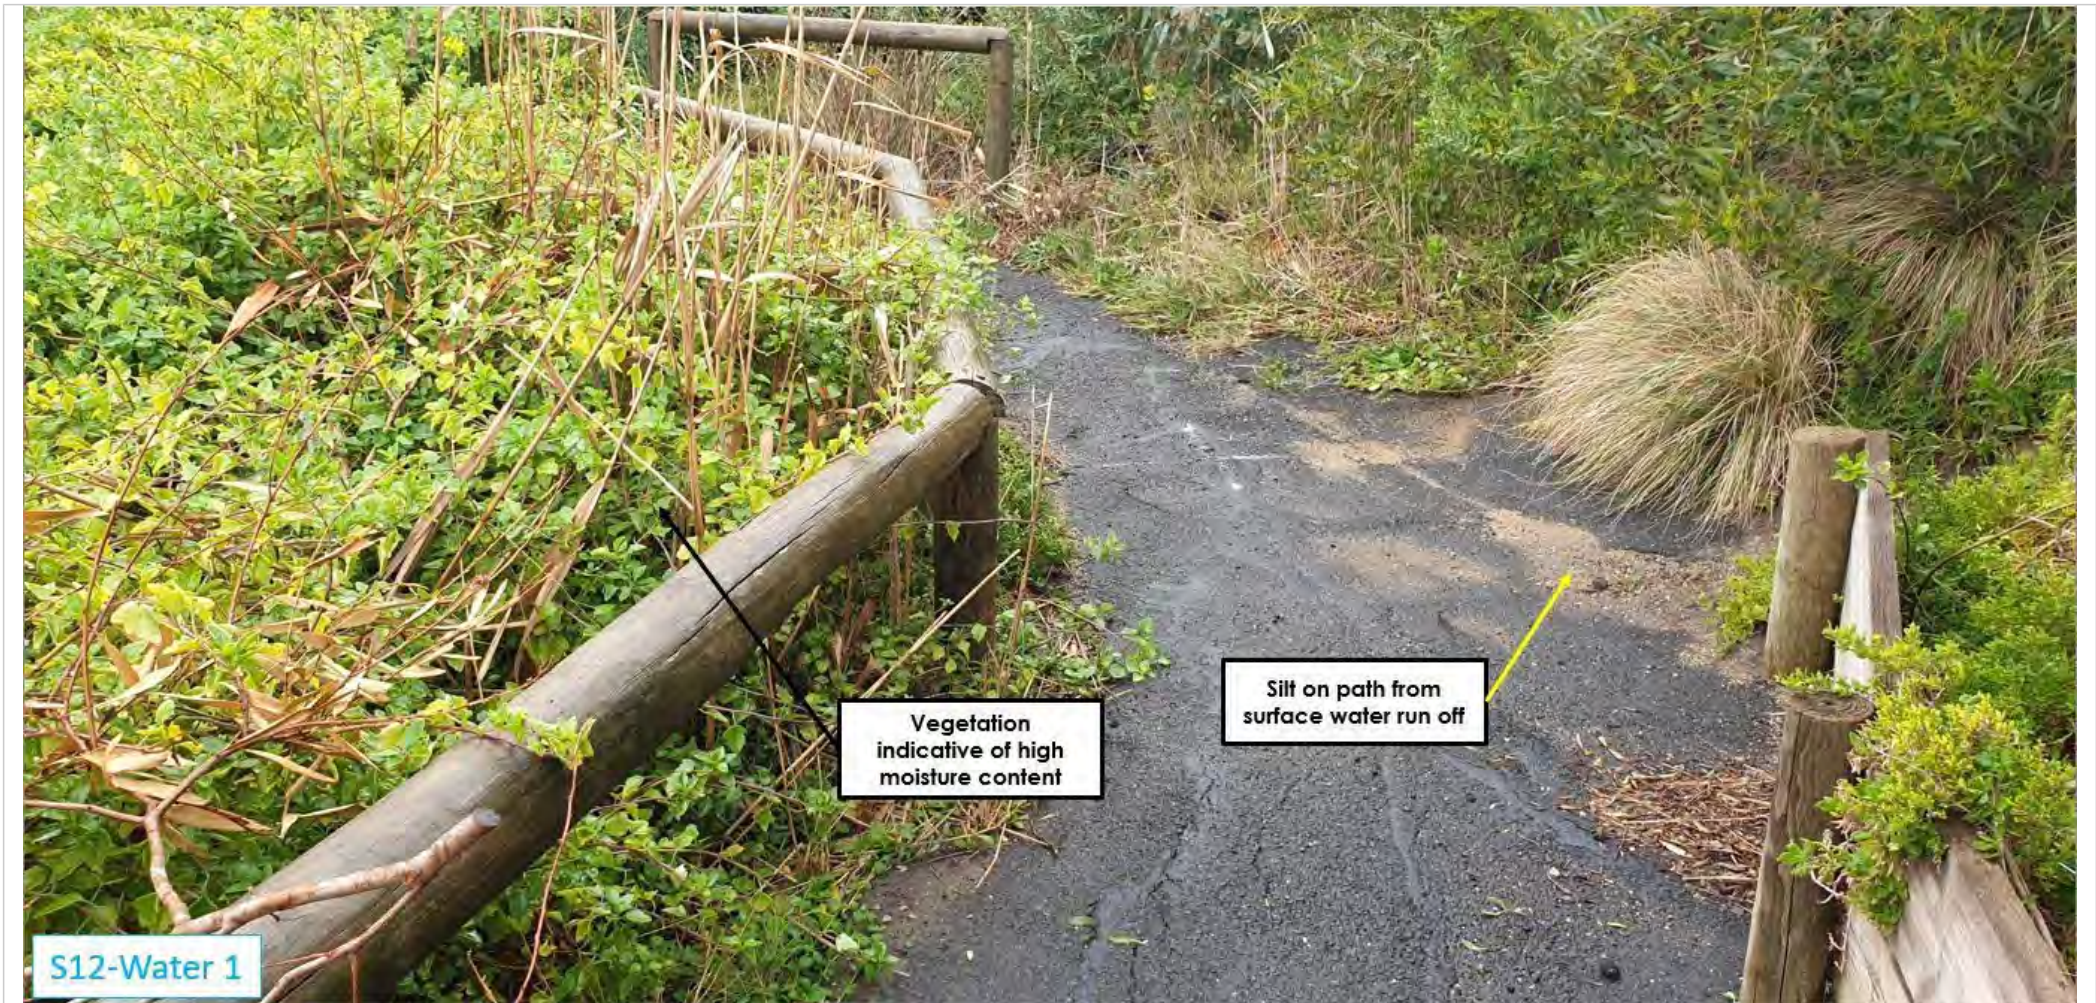
Vegetation
indicative of high
moisture content

Silt on path from
surface water run off

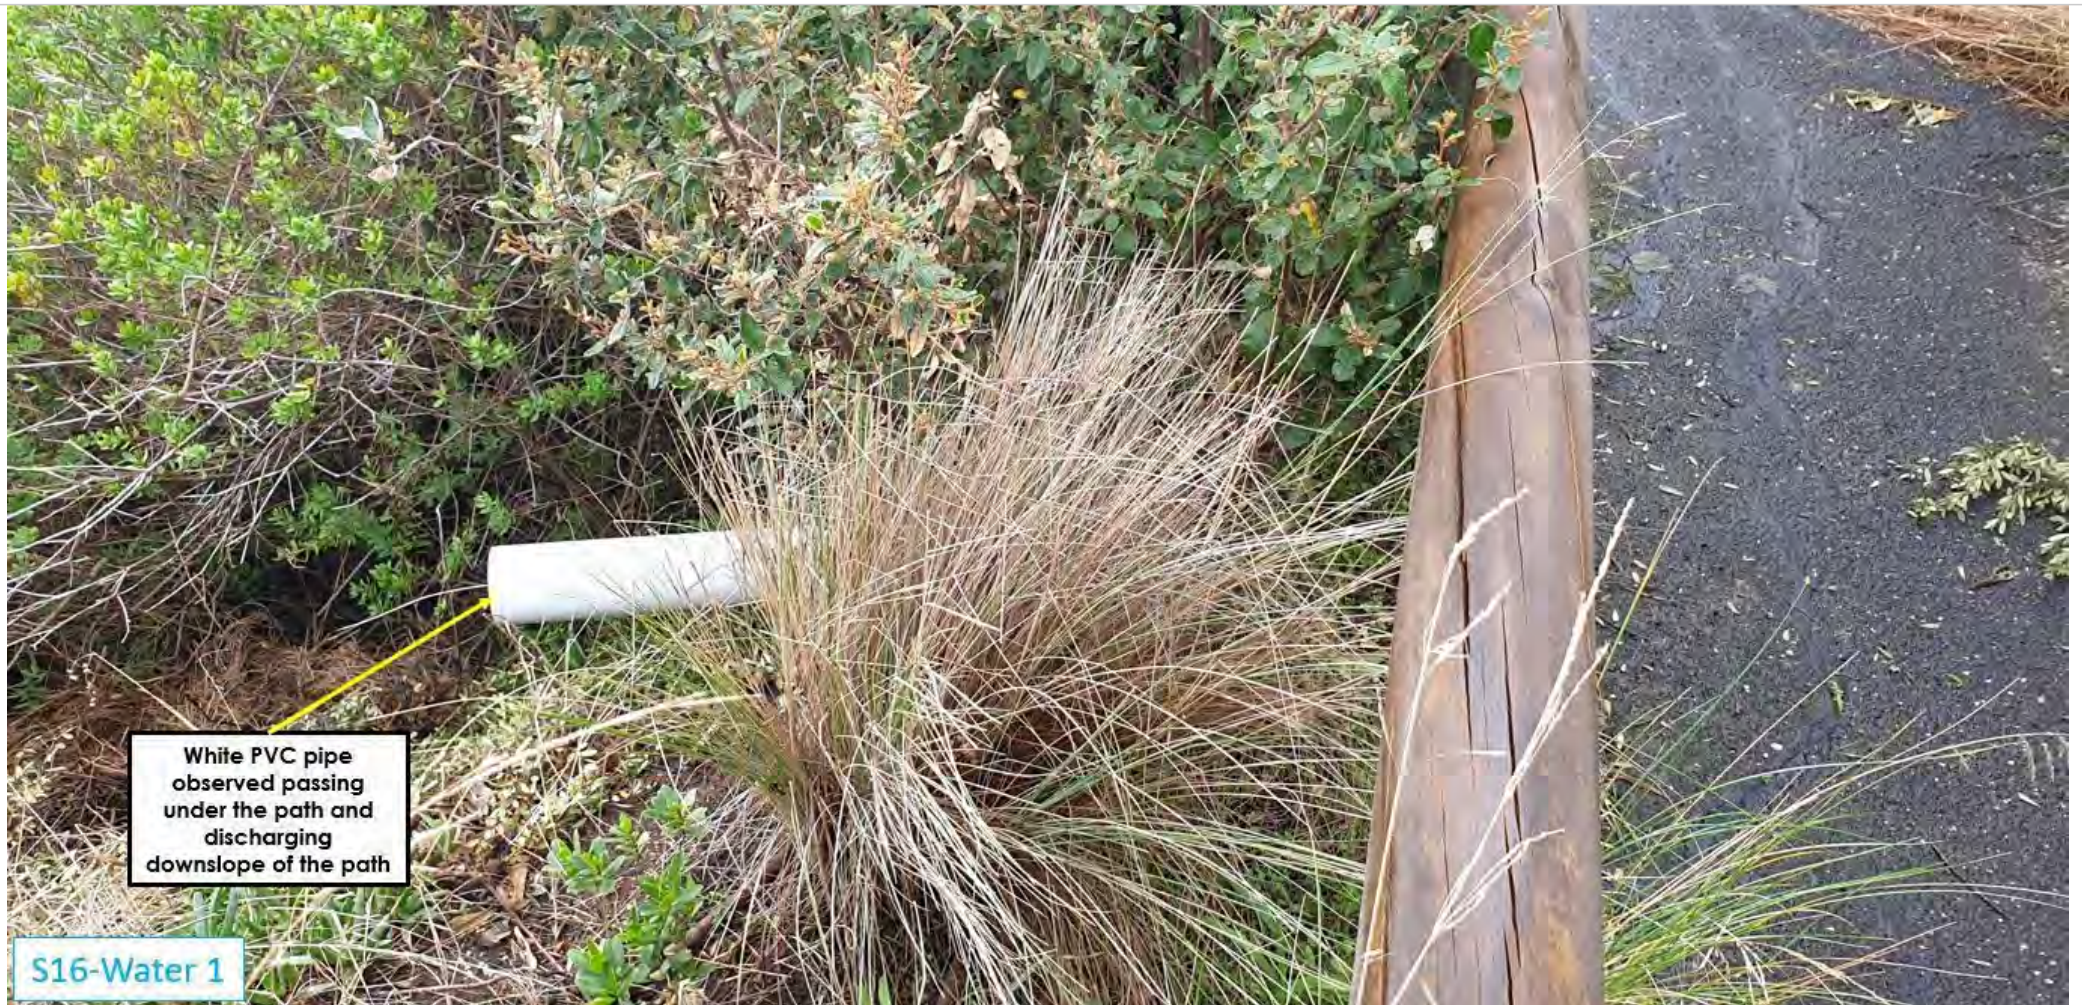
S16-Water 1

White PVC pipe observed passing under the path and discharging downslope of the path

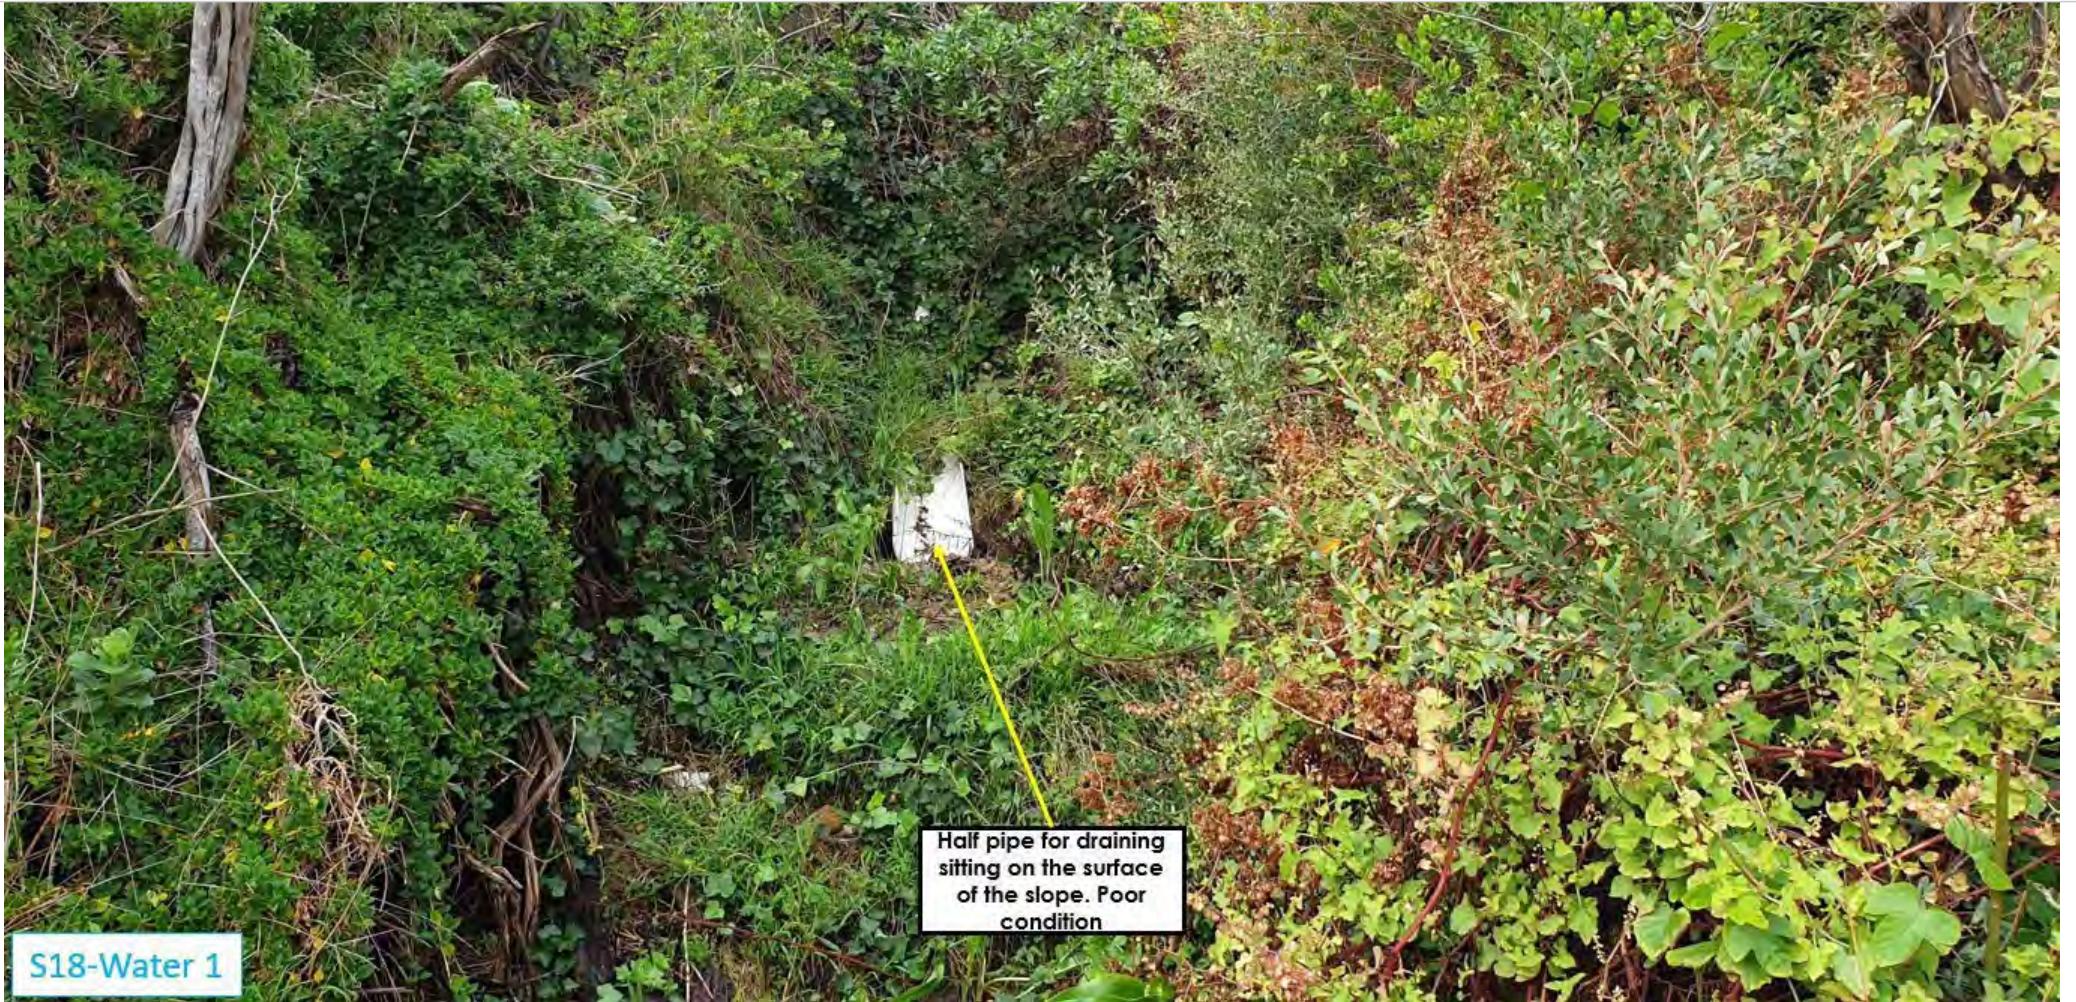
S18-Water 1

Half pipe for draining sitting on the surface of the slope. Poor condition

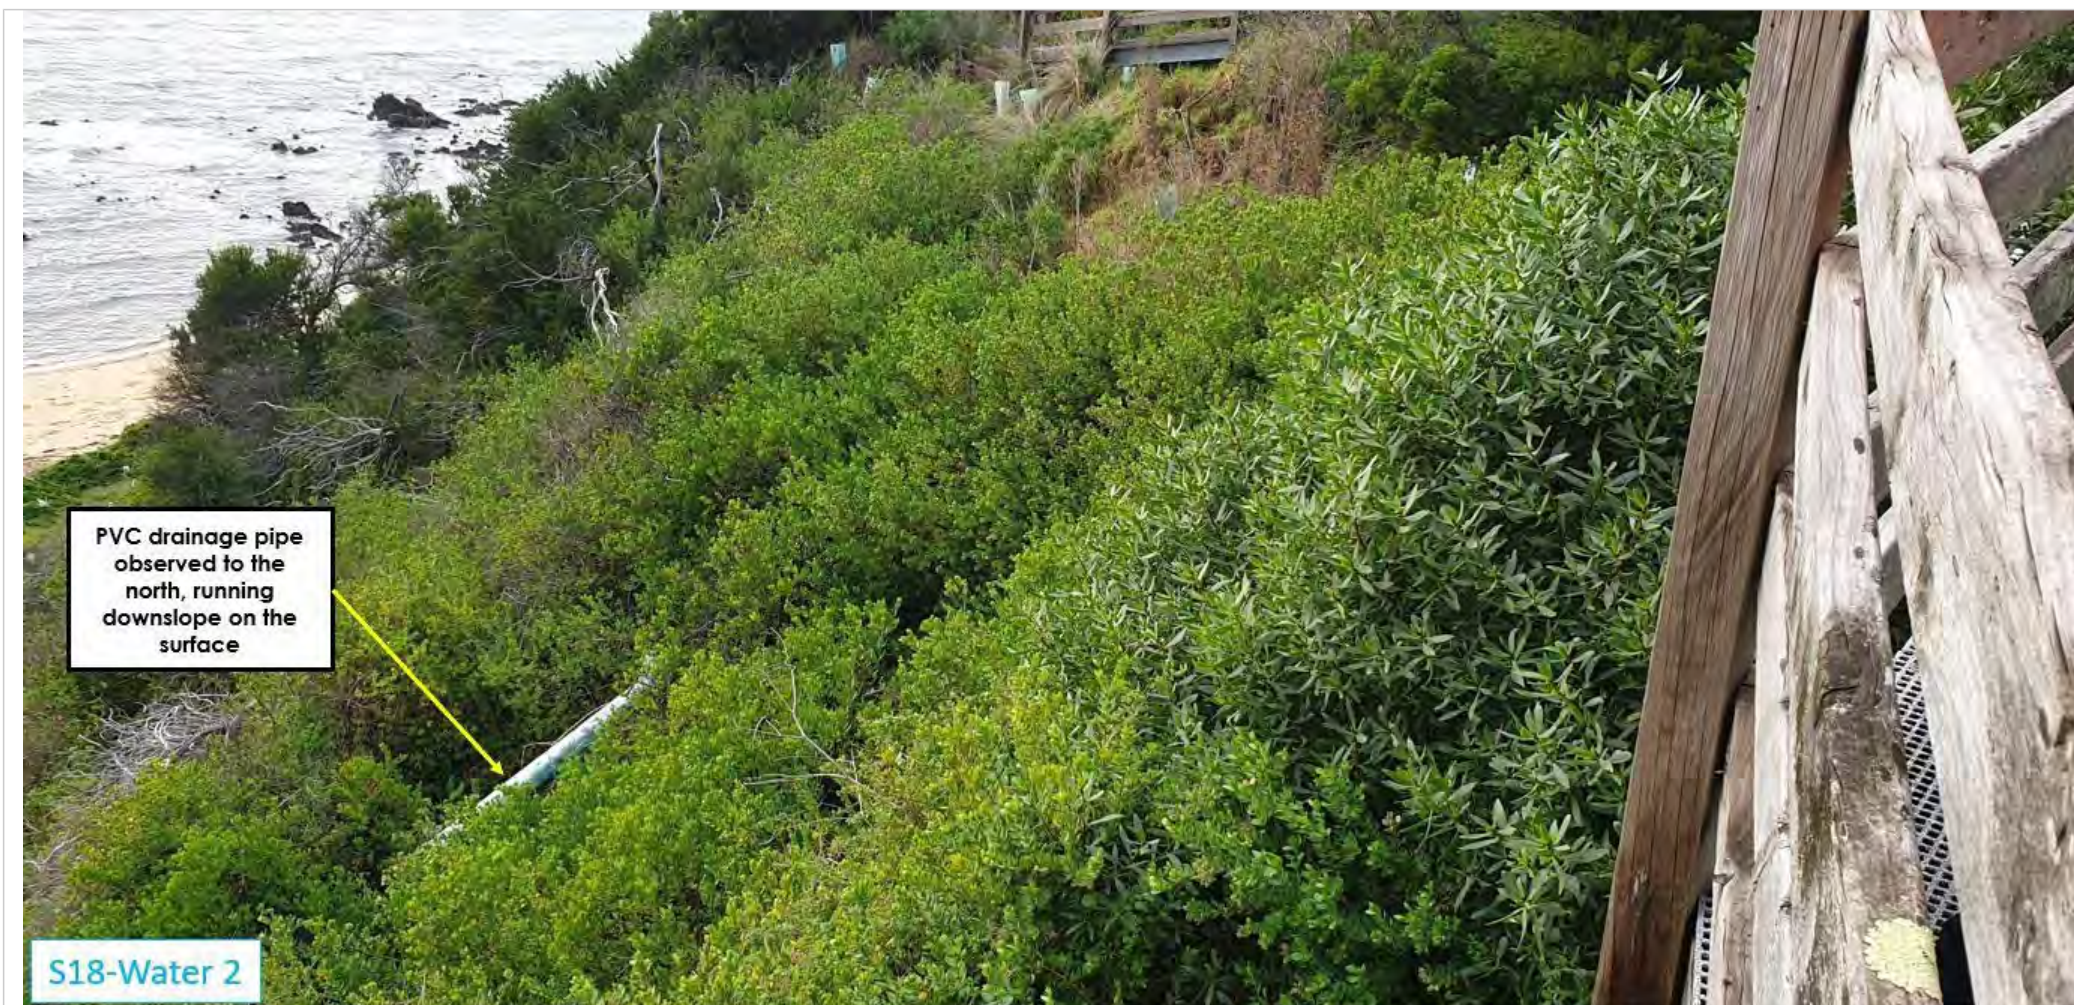
S18-Water 2

PVC drainage pipe
observed to the
north, running
downslope on the
surface

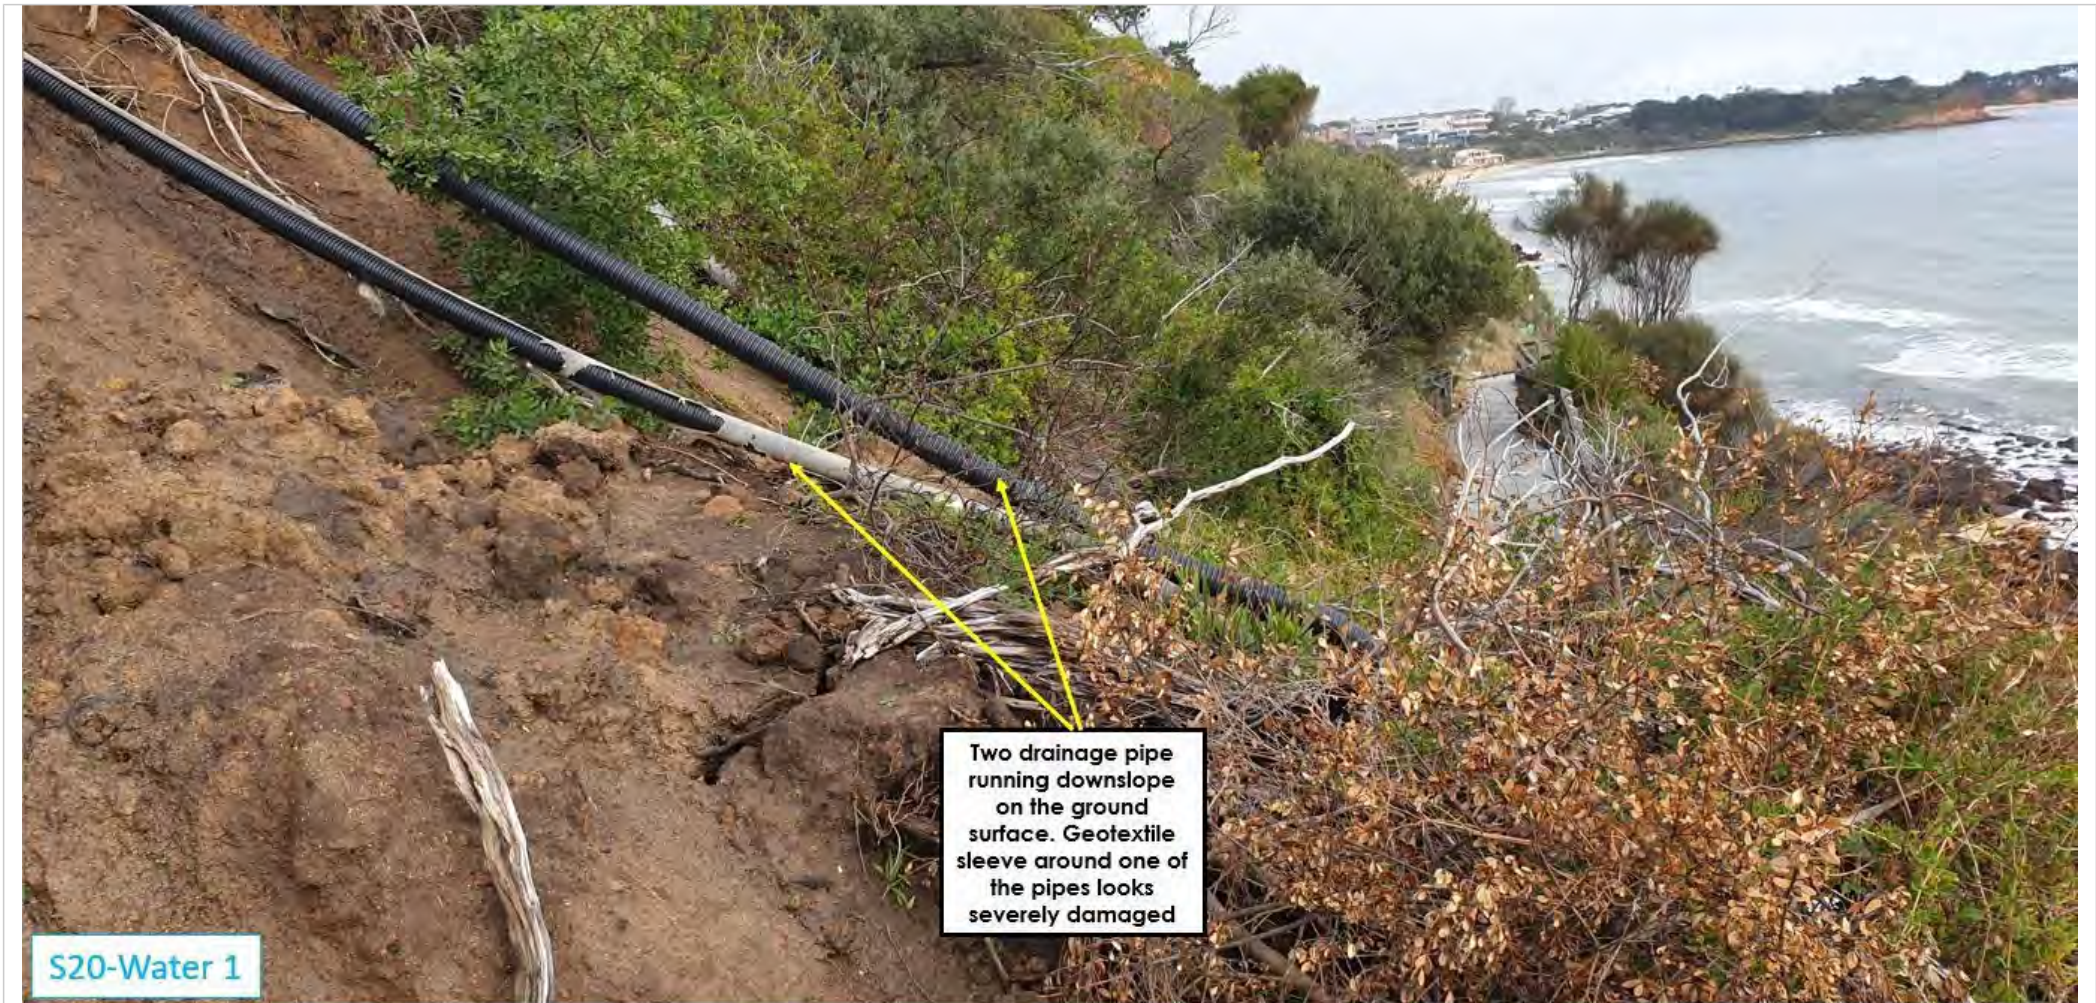
S20-Water 1

Two drainage pipe running downslope on the ground surface. Geotextile sleeve around one of the pipes looks severely damaged

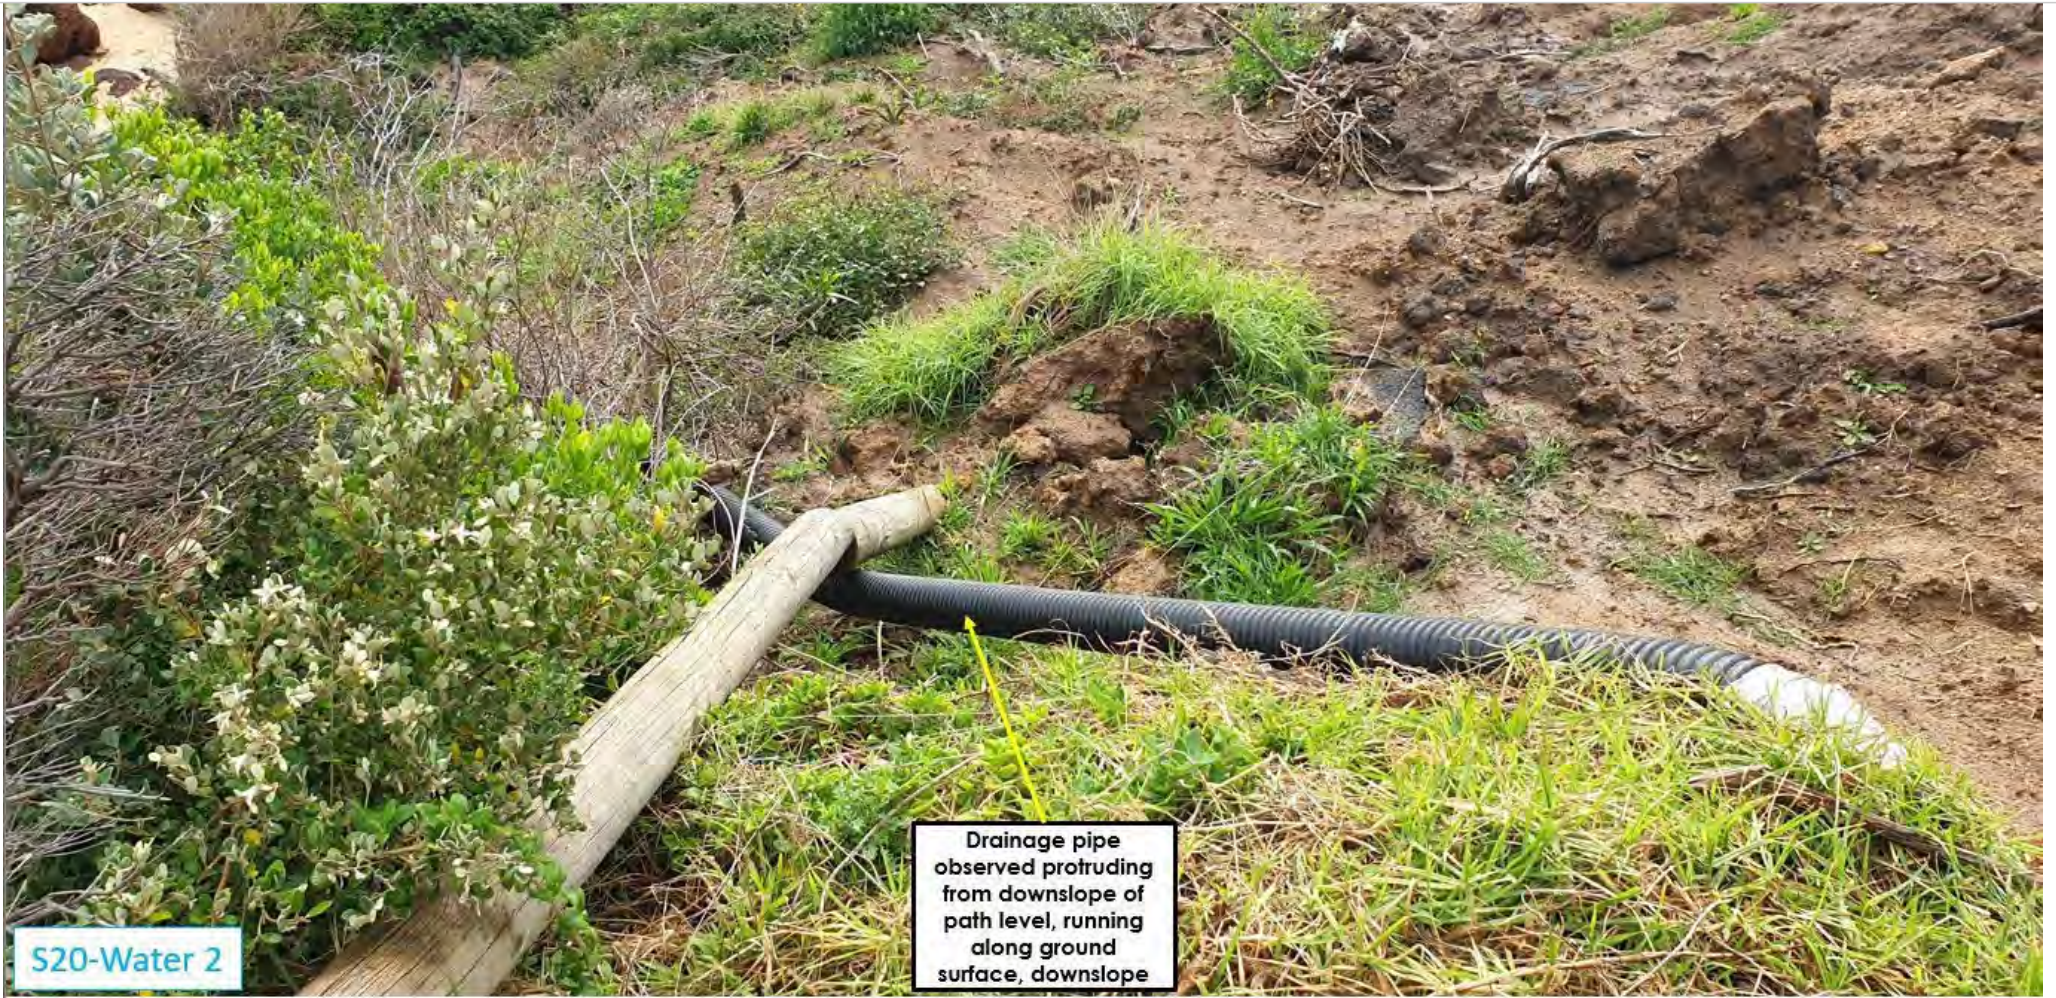
S20-Water 2

Drainage pipe
observed protruding
from downslope of
path level, running
along ground
surface, downslope

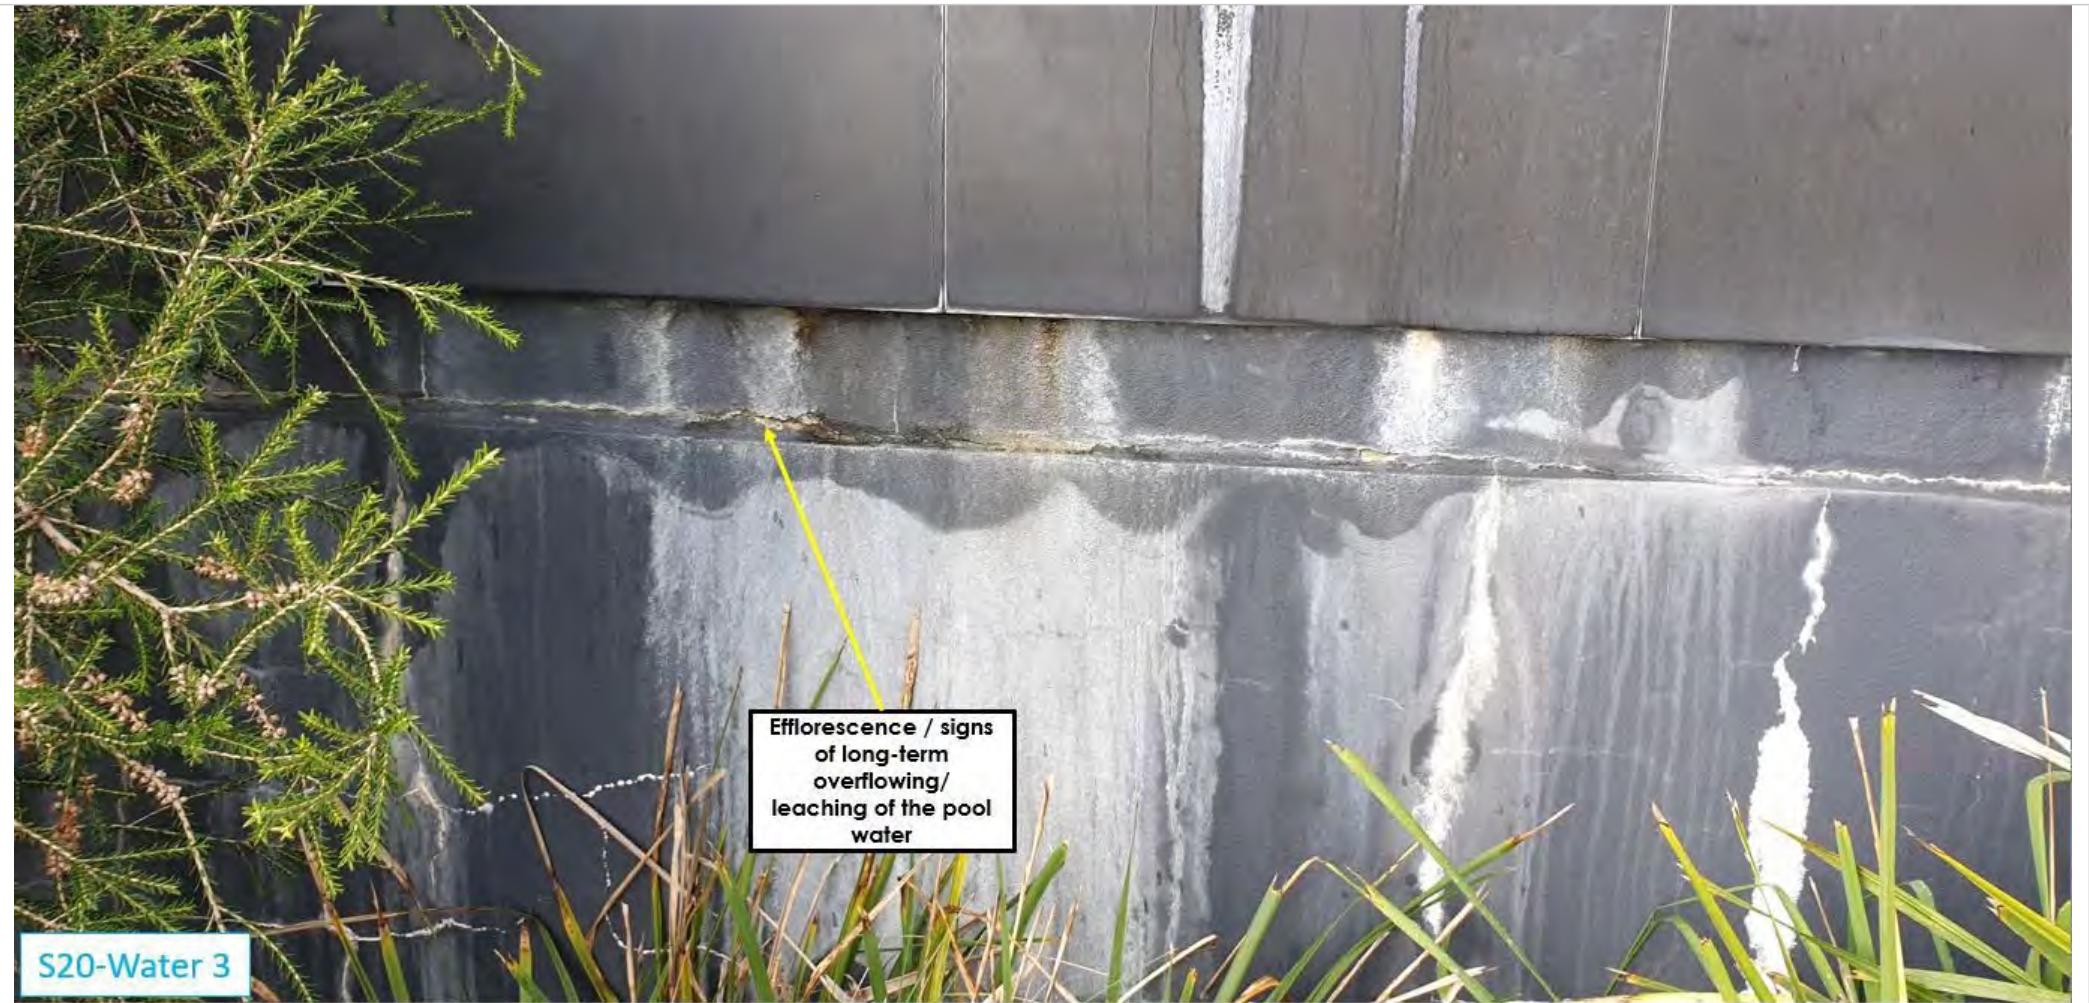
S20-Water 3

Efflorescence / signs of long-term overflowing/ leaching of the pool water

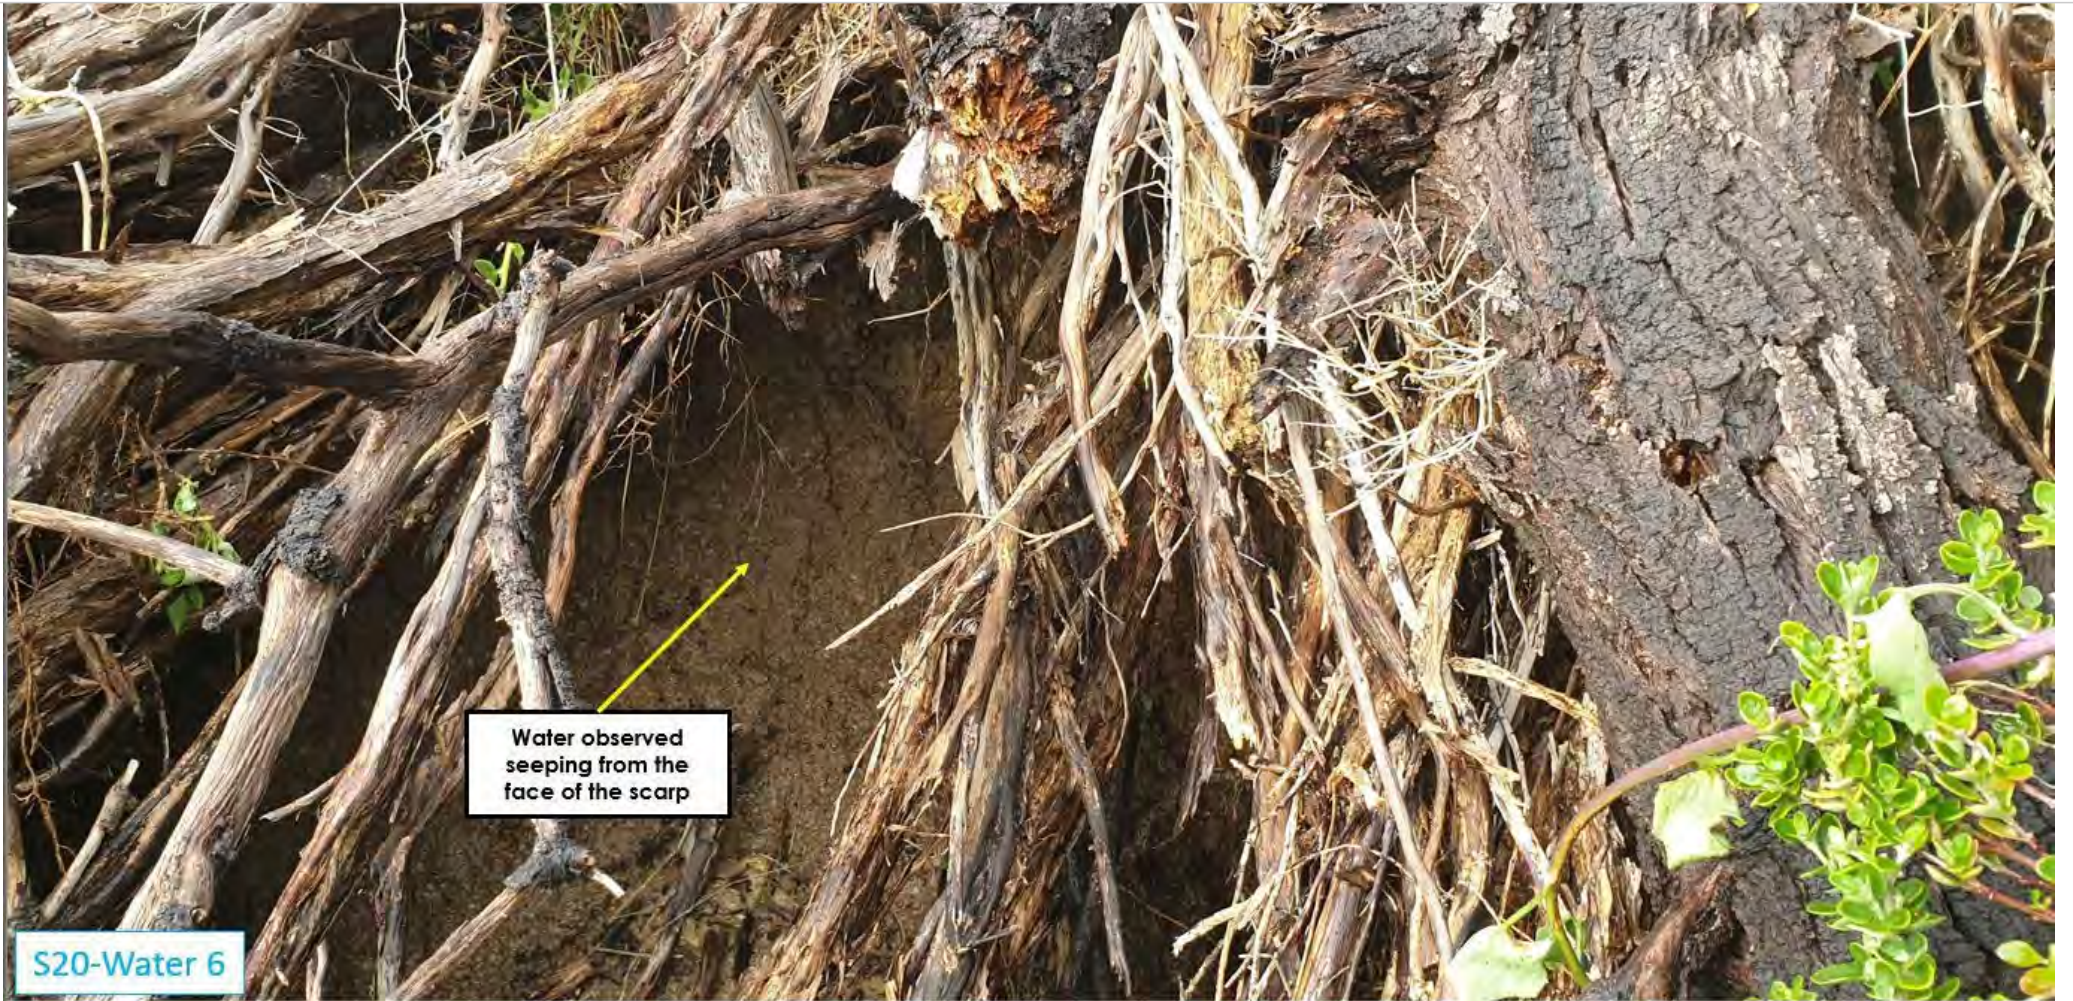
S20-Water 6

Water observed seeping from the face of the scarp
