Landslide Risk Assessment

Beleura Cliff Path, Caraar Creek Road to Mills Beach, Mornington

PREPARED FOR:
Mornington Peninsula Shire

December 11, 2023
RFP: V220152Report02.3

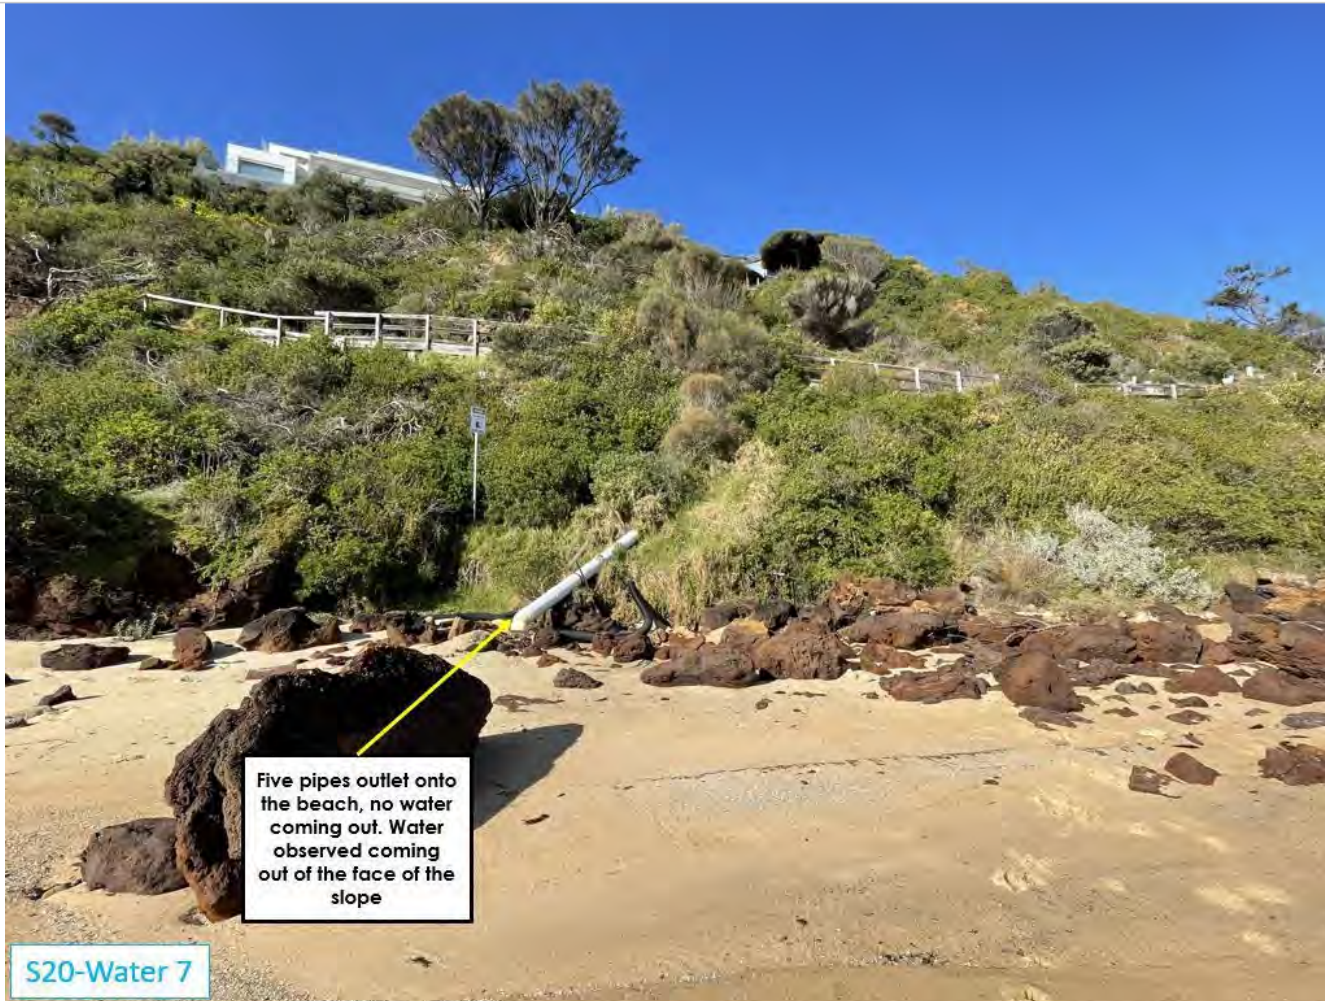
S20-Water 7

Five pipes outlet onto the beach, no water coming out. Water observed coming out of the face of the slope

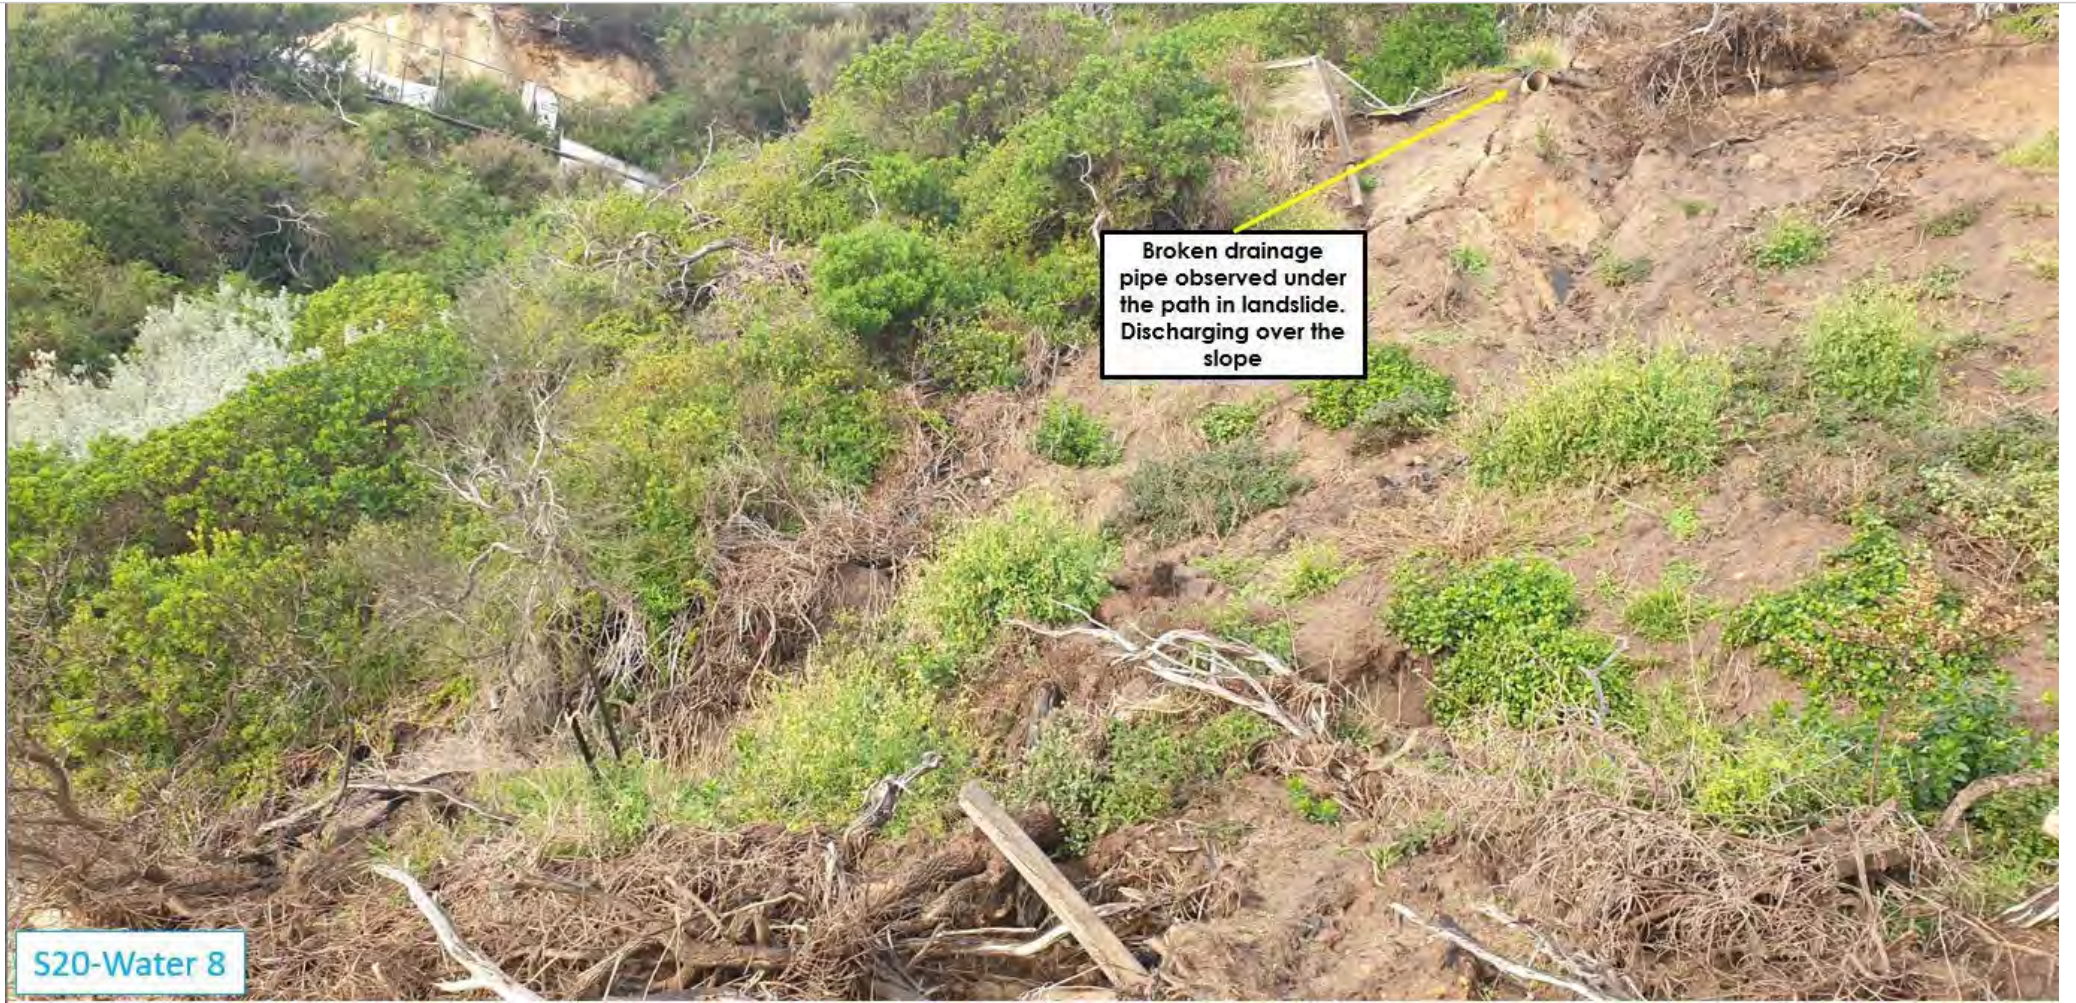
S20-Water 8

Broken drainage pipe observed under the path in landslide. Discharging over the slope

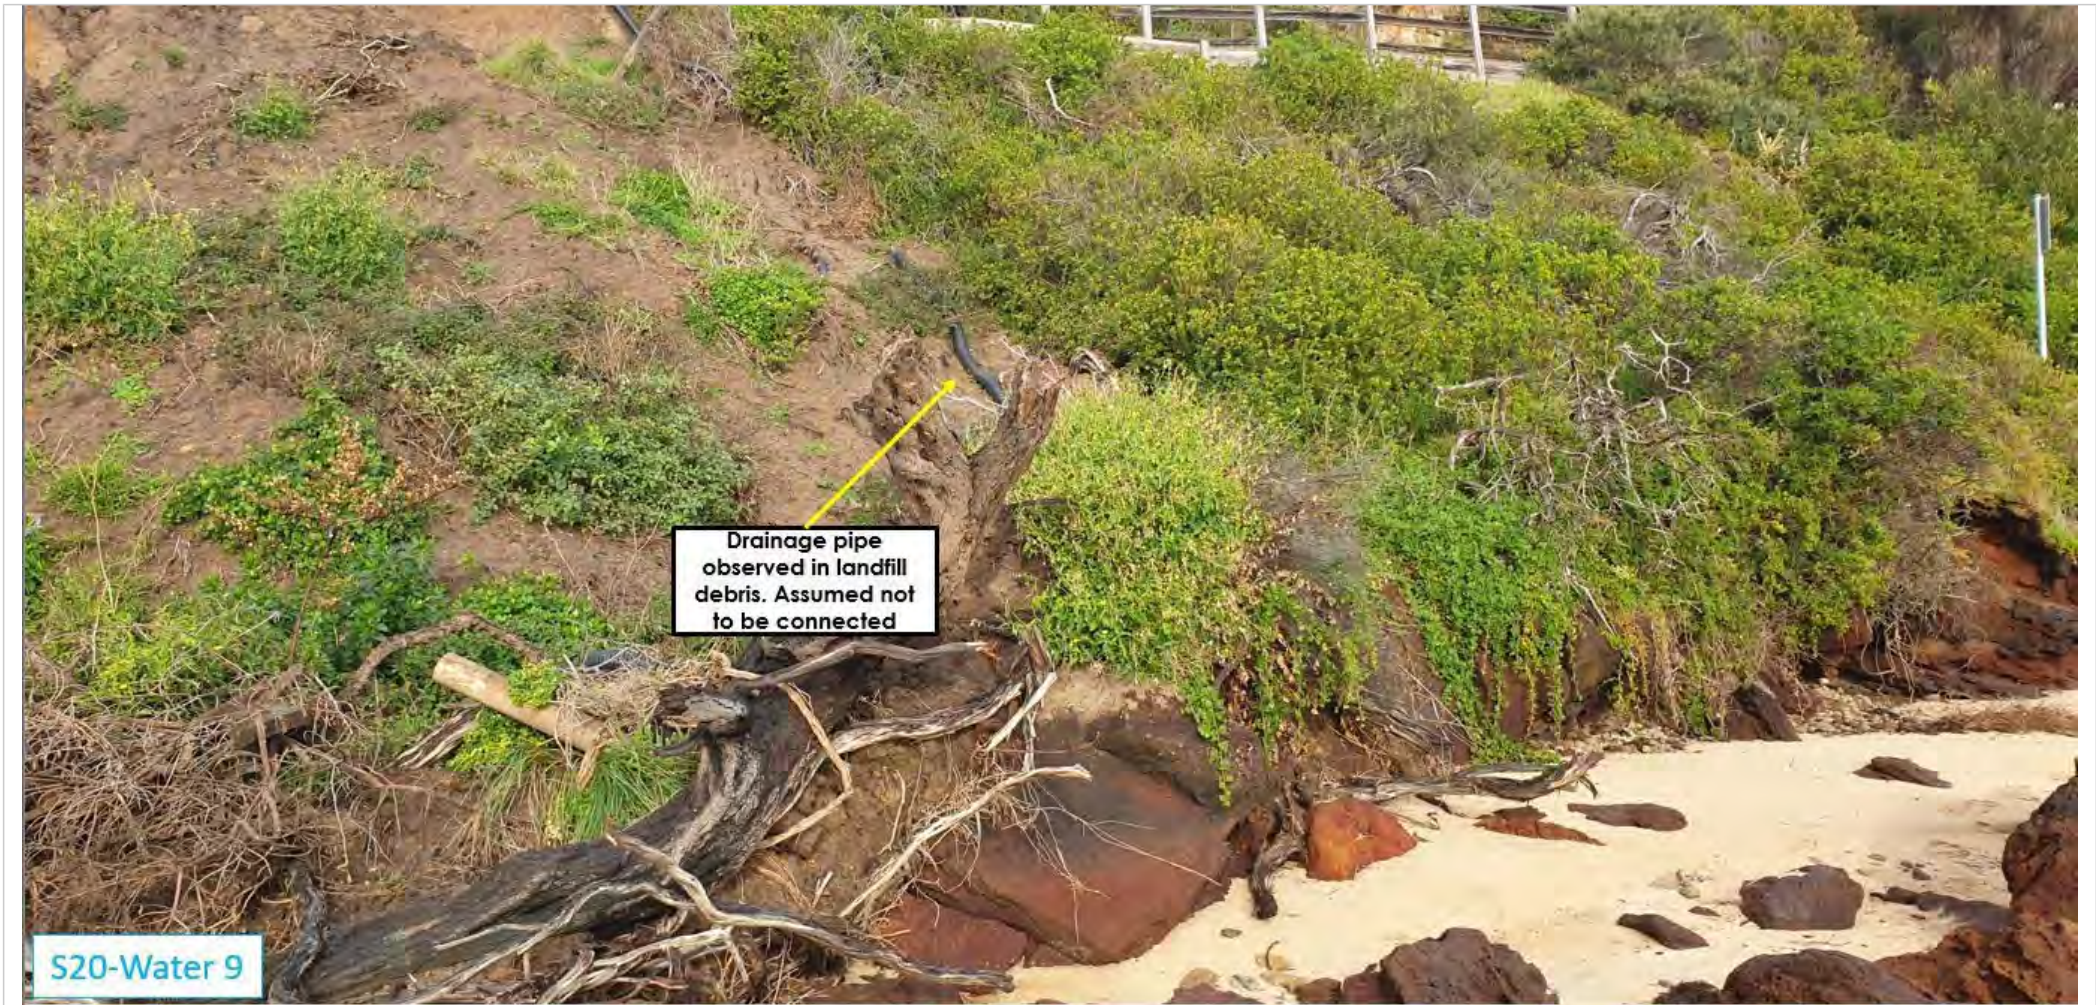
S20-Water 9

Drainage pipe observed in landfill debris. Assumed not to be connected
