DEACONS, LAWYERS
LANDSLIDE ZONING, BALLAR CREEK,
MT ELIZA, VICTORIA

M4164/1-AV
11 July 2000

RE: **LANDSLIDE ZONING, BALLAR CREEK,
MT ELIZA, VICTORIA**

This letter presents our report on landslide zoning at Ballar Creek, Mt Eliza for use with the Mornington Peninsula Planning Scheme Amendment C17.

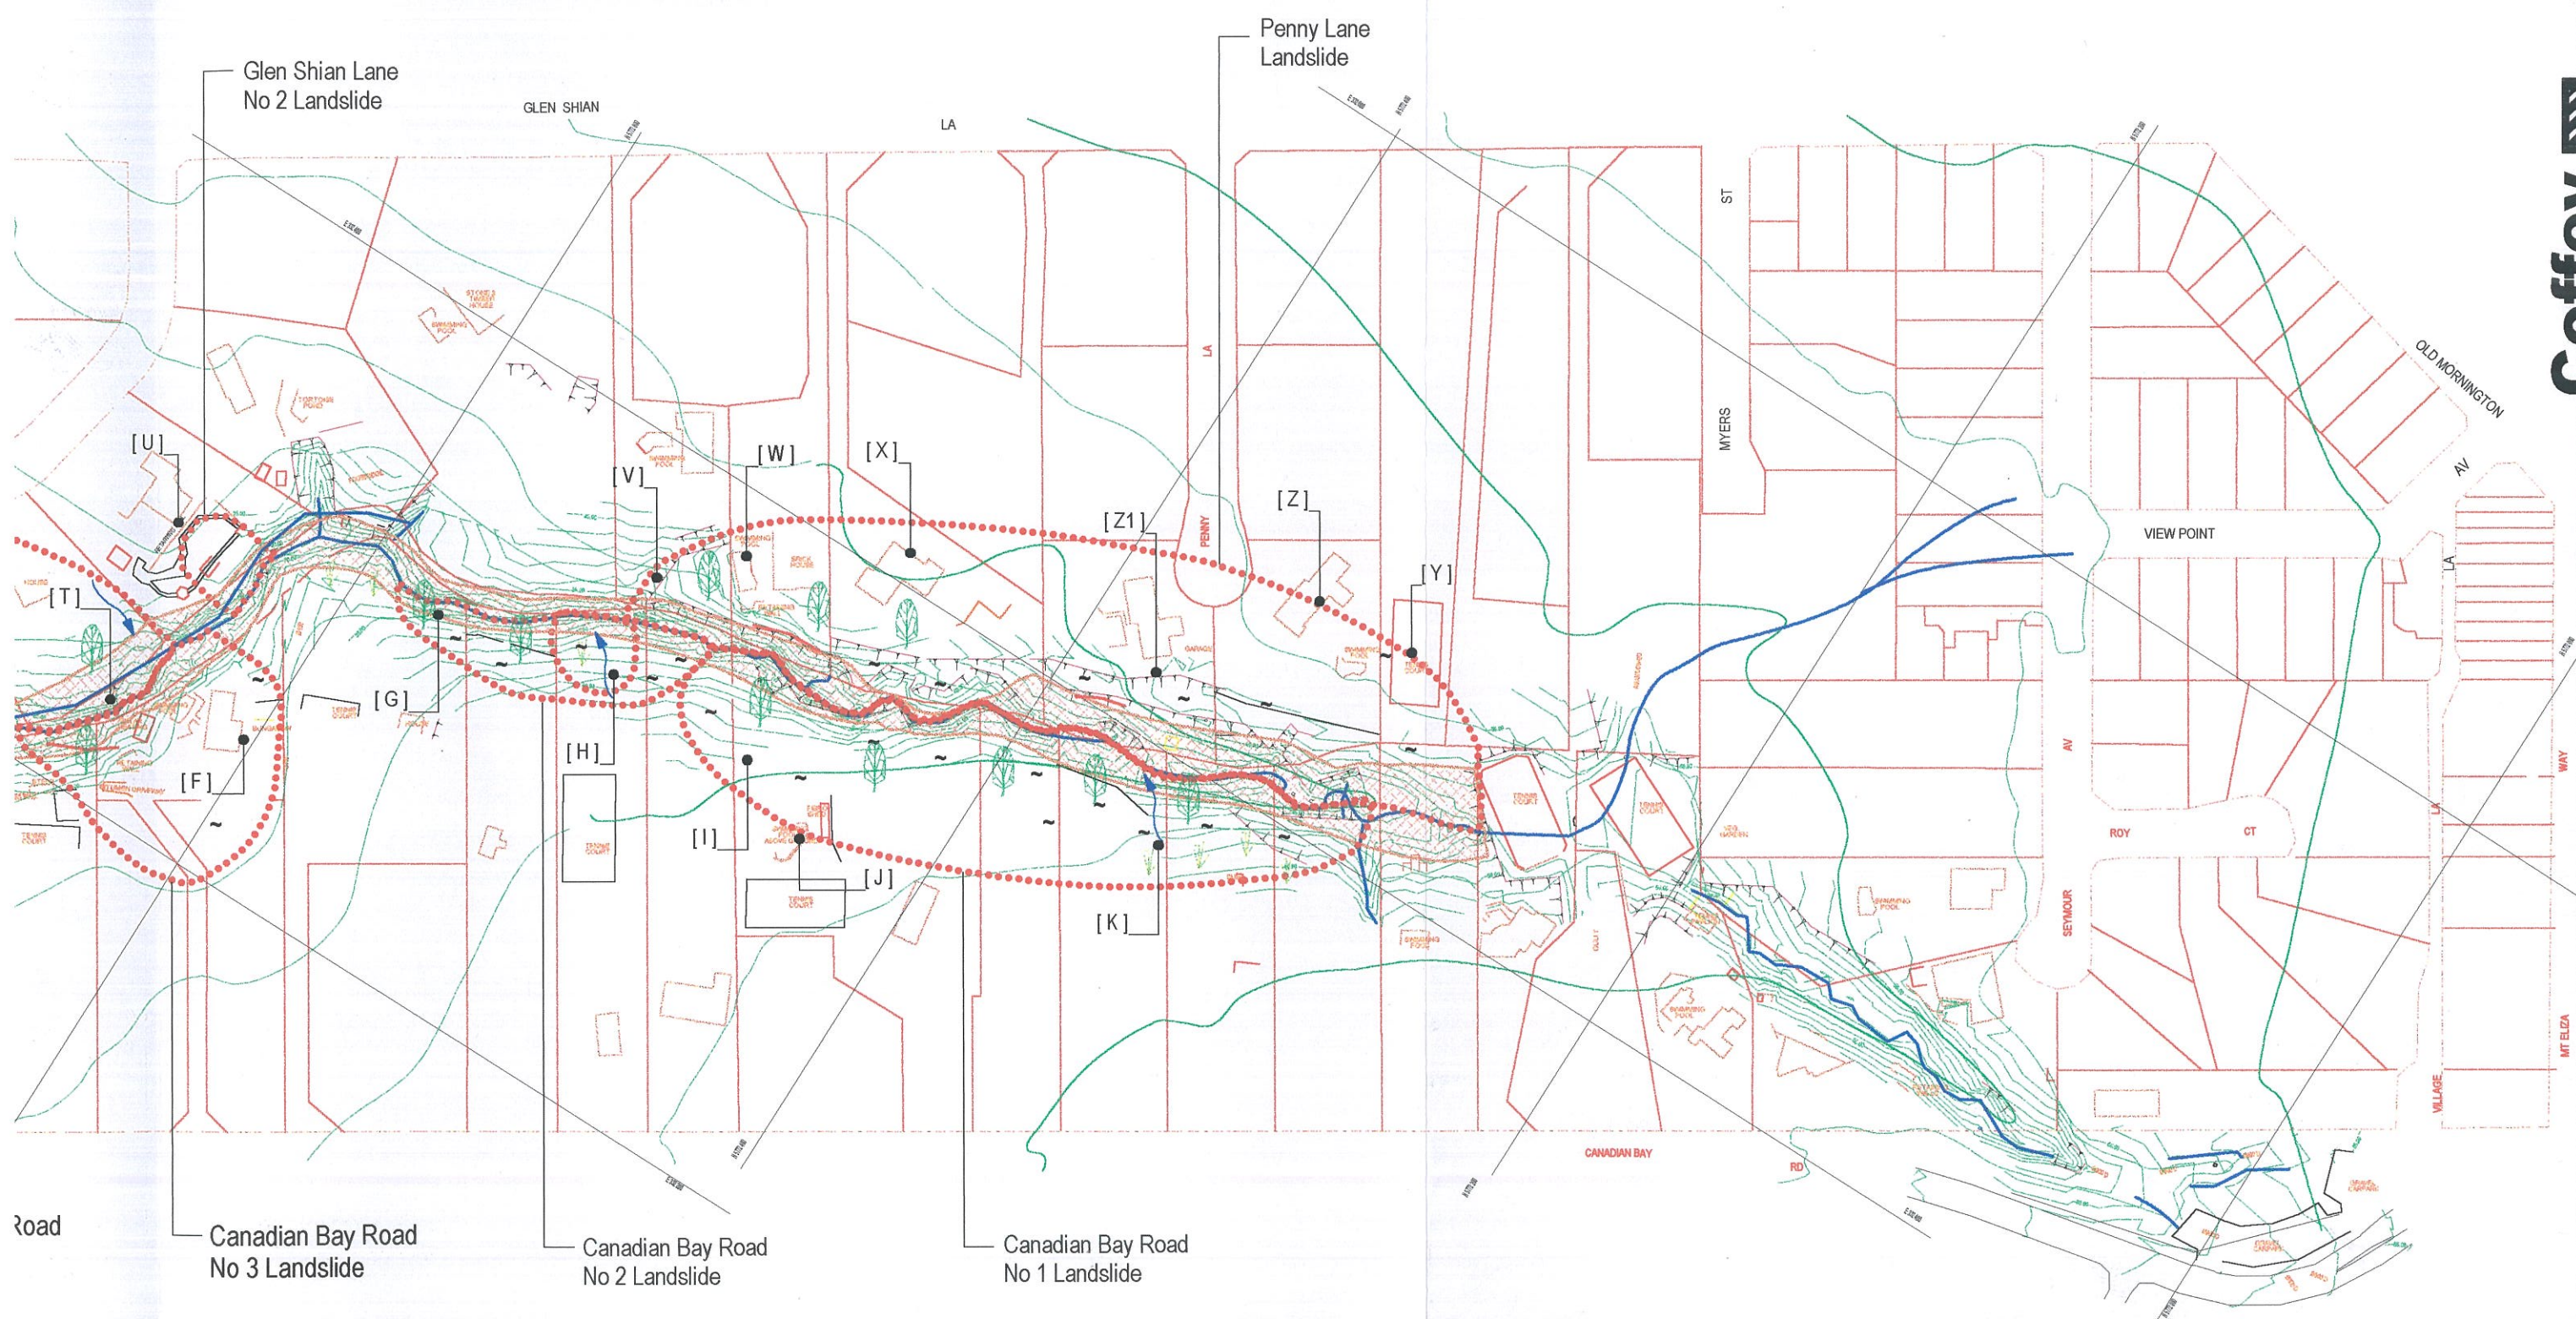
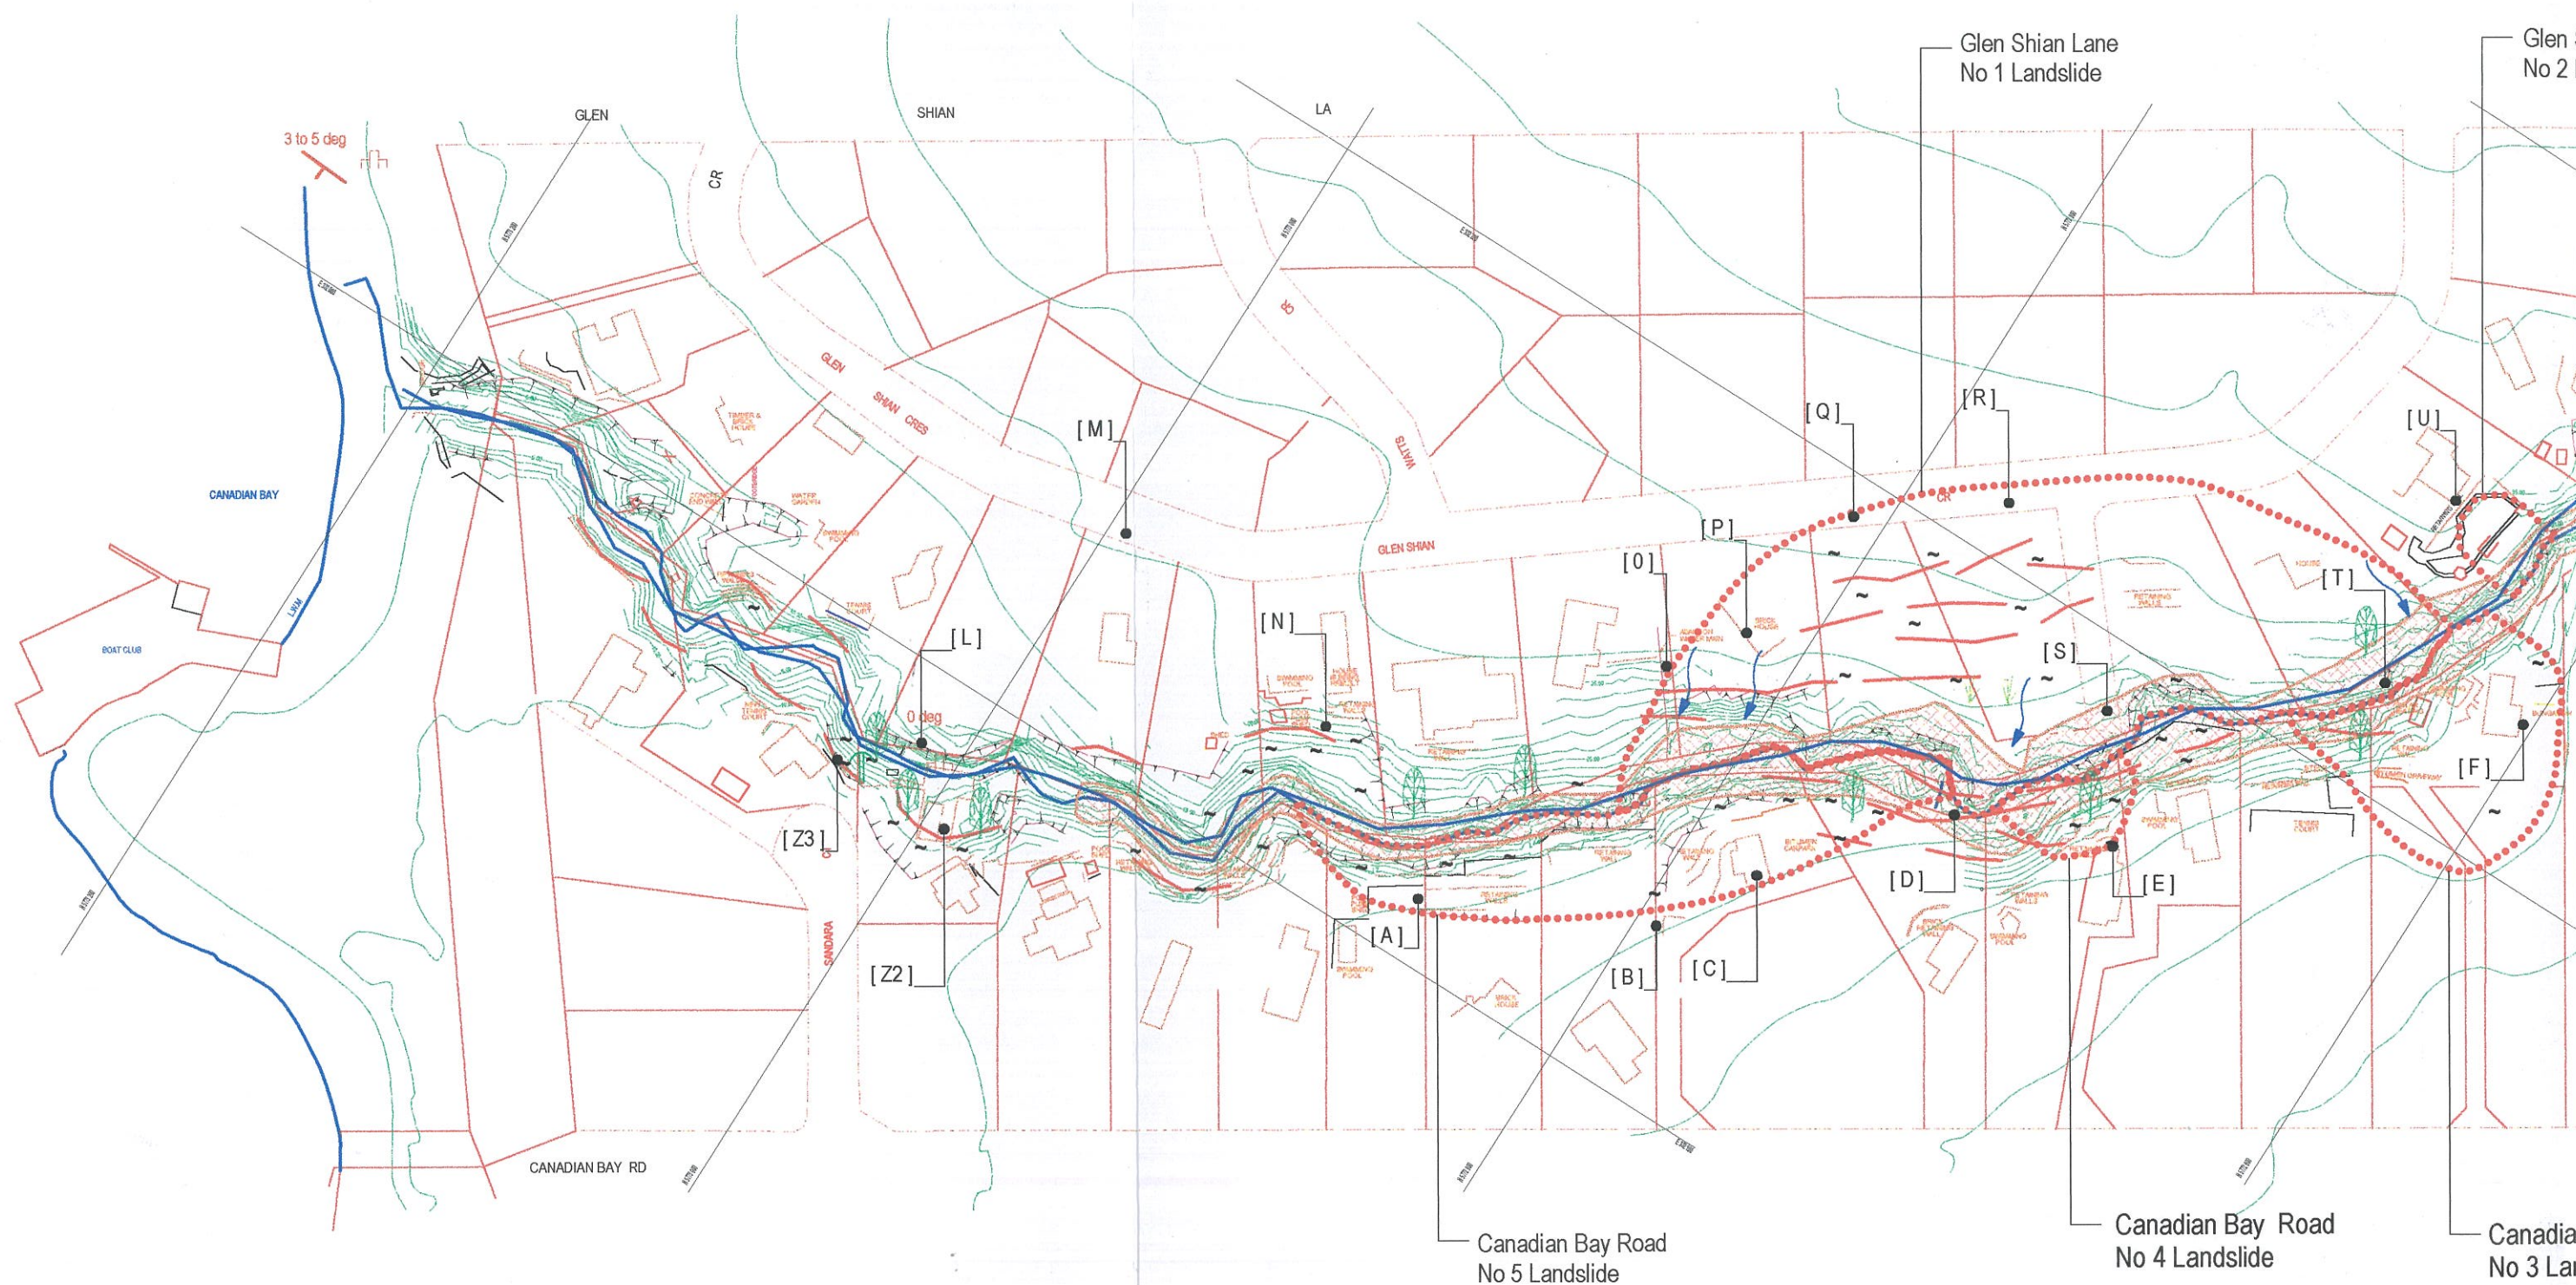
FIGURE 1
 Job No.: M4164/1 - AV

Several water seepage zones were located during the course of the study (see Figure 1). Some of these seepages lie well above the level of the standing watertable recorded by Piper. It is considered these seepage zones are where perched seasonal water tables exist close to the ground surface.

The large landslides are related to areas where the Balcombe Clay outcrops in the creek. The large landslides match the extent of the engineered fill (see Figure 1) and, as previously discussed, the distribution of the fill closely approximates the distribution of Balcombe Clay outcrops in the creek.

NOTE: Previous exposures of Balcombe Clay in the sides and the base of Ballar Creek have been covered by the Engineered Fill (see discussion in the text of the report).

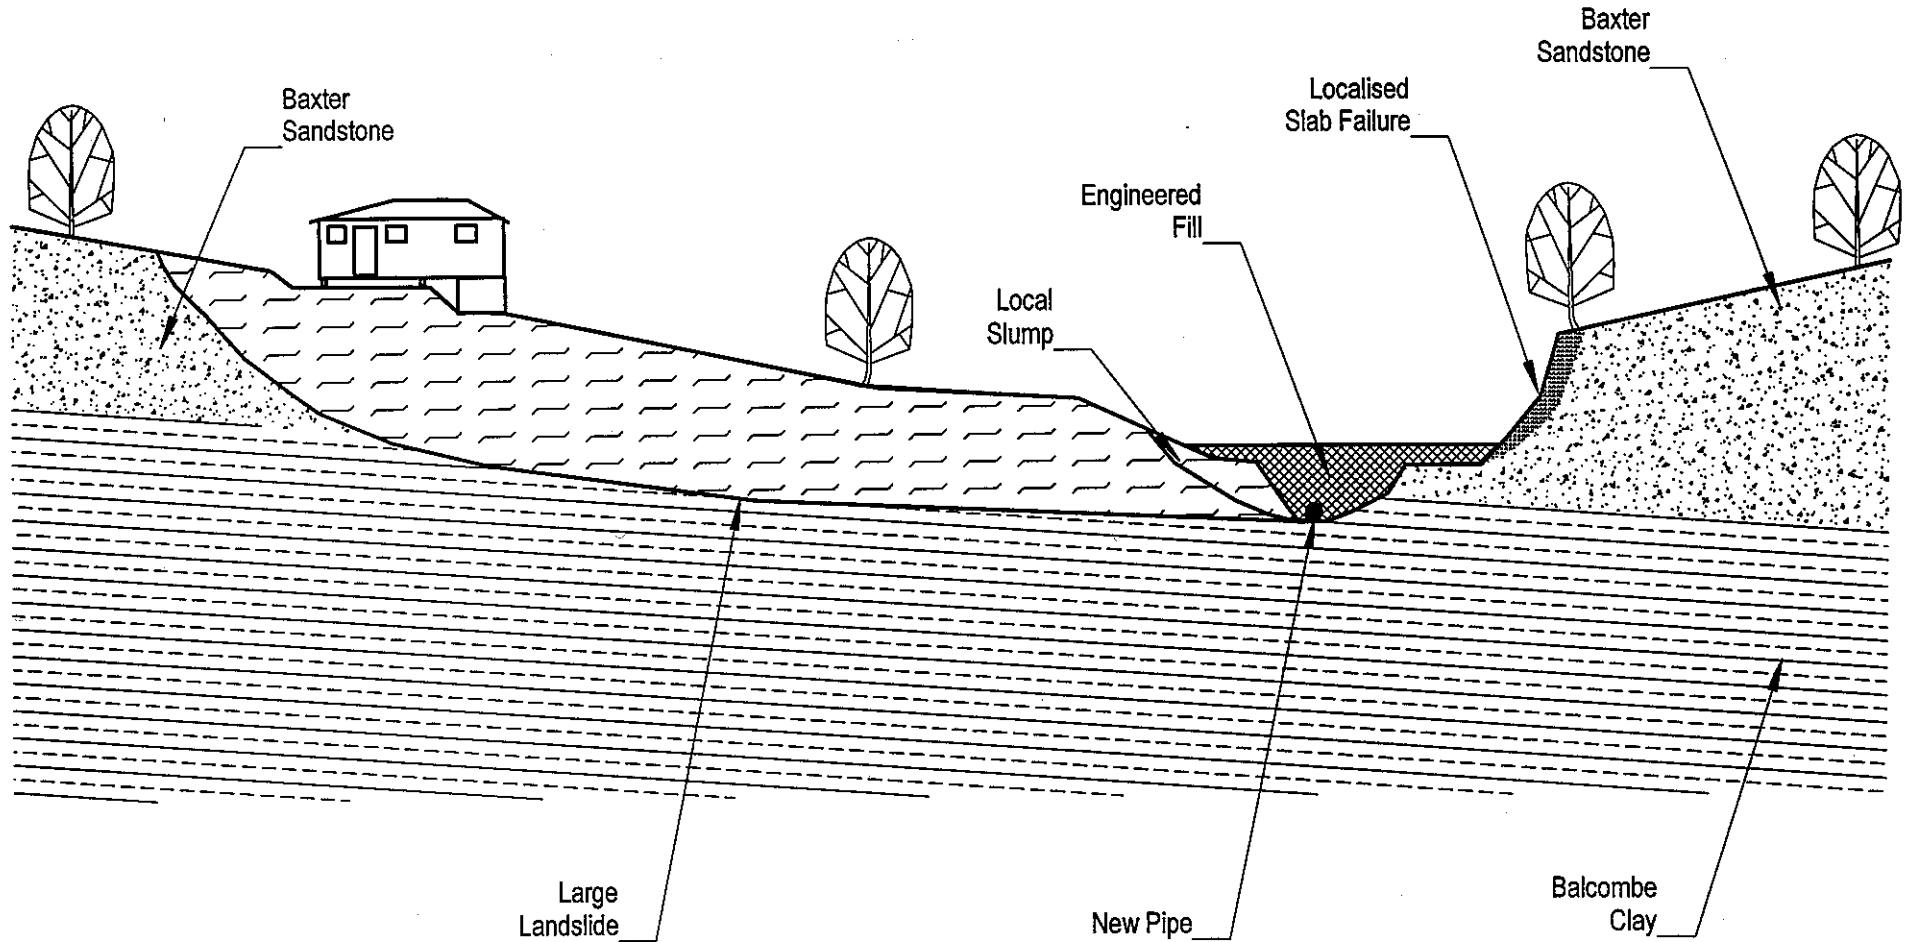
Not to Scale	Revision	Description	Drawn	Approved	Date	Drawn	RW	MORNINGTON PENINSULA SHIRE COUNCIL BALLAR CREEK, MOUNT ELIZA DIAGRAMATIC SECTION	FIGURE 2
						Checked	<i>[Signature]</i>		
						Date	3/7/00		
								Job No.: M41641 - AU

Three main mechanisms of slope instability have been identified along Ballar Creek (see Figure 2). These are:

1. Localised slab failures immediately adjacent to the creek. These failures typically involve small volumes of material (say $< 2 \text{ m}^3$).
2. Localised slumping of steep creek bank slopes. These failures typically involve small to moderate volumes of material (say 2 to 50 m^3).
3. Large landslides affecting several lots, the largest of which has a volume in the order of $70,000 \text{ m}^3$.

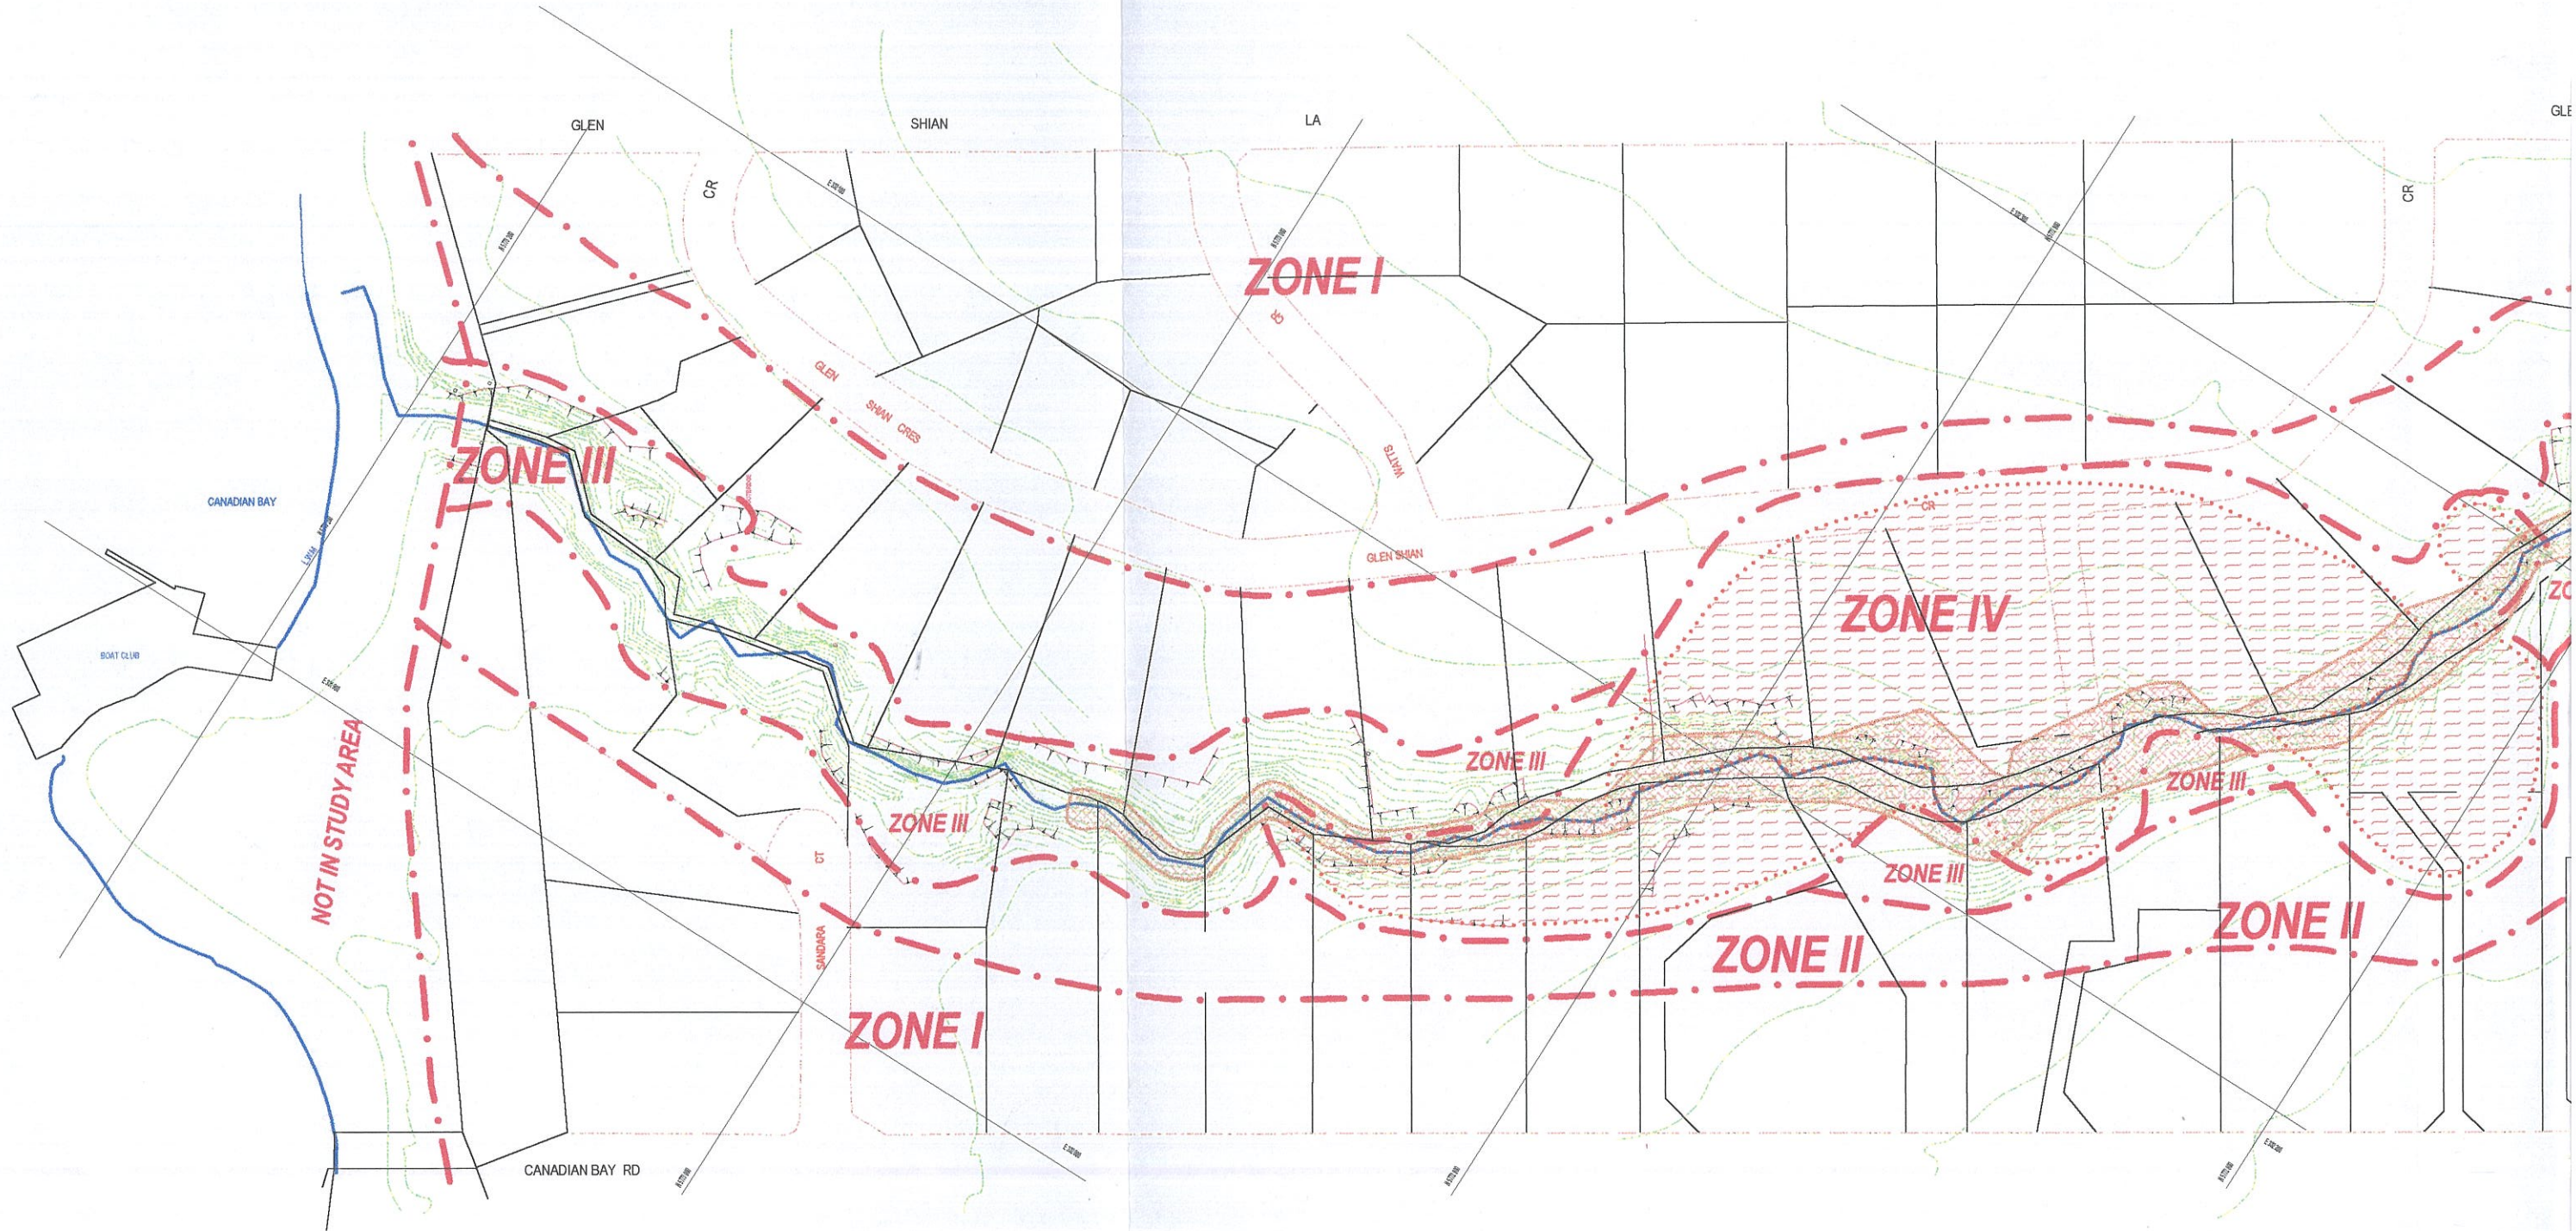
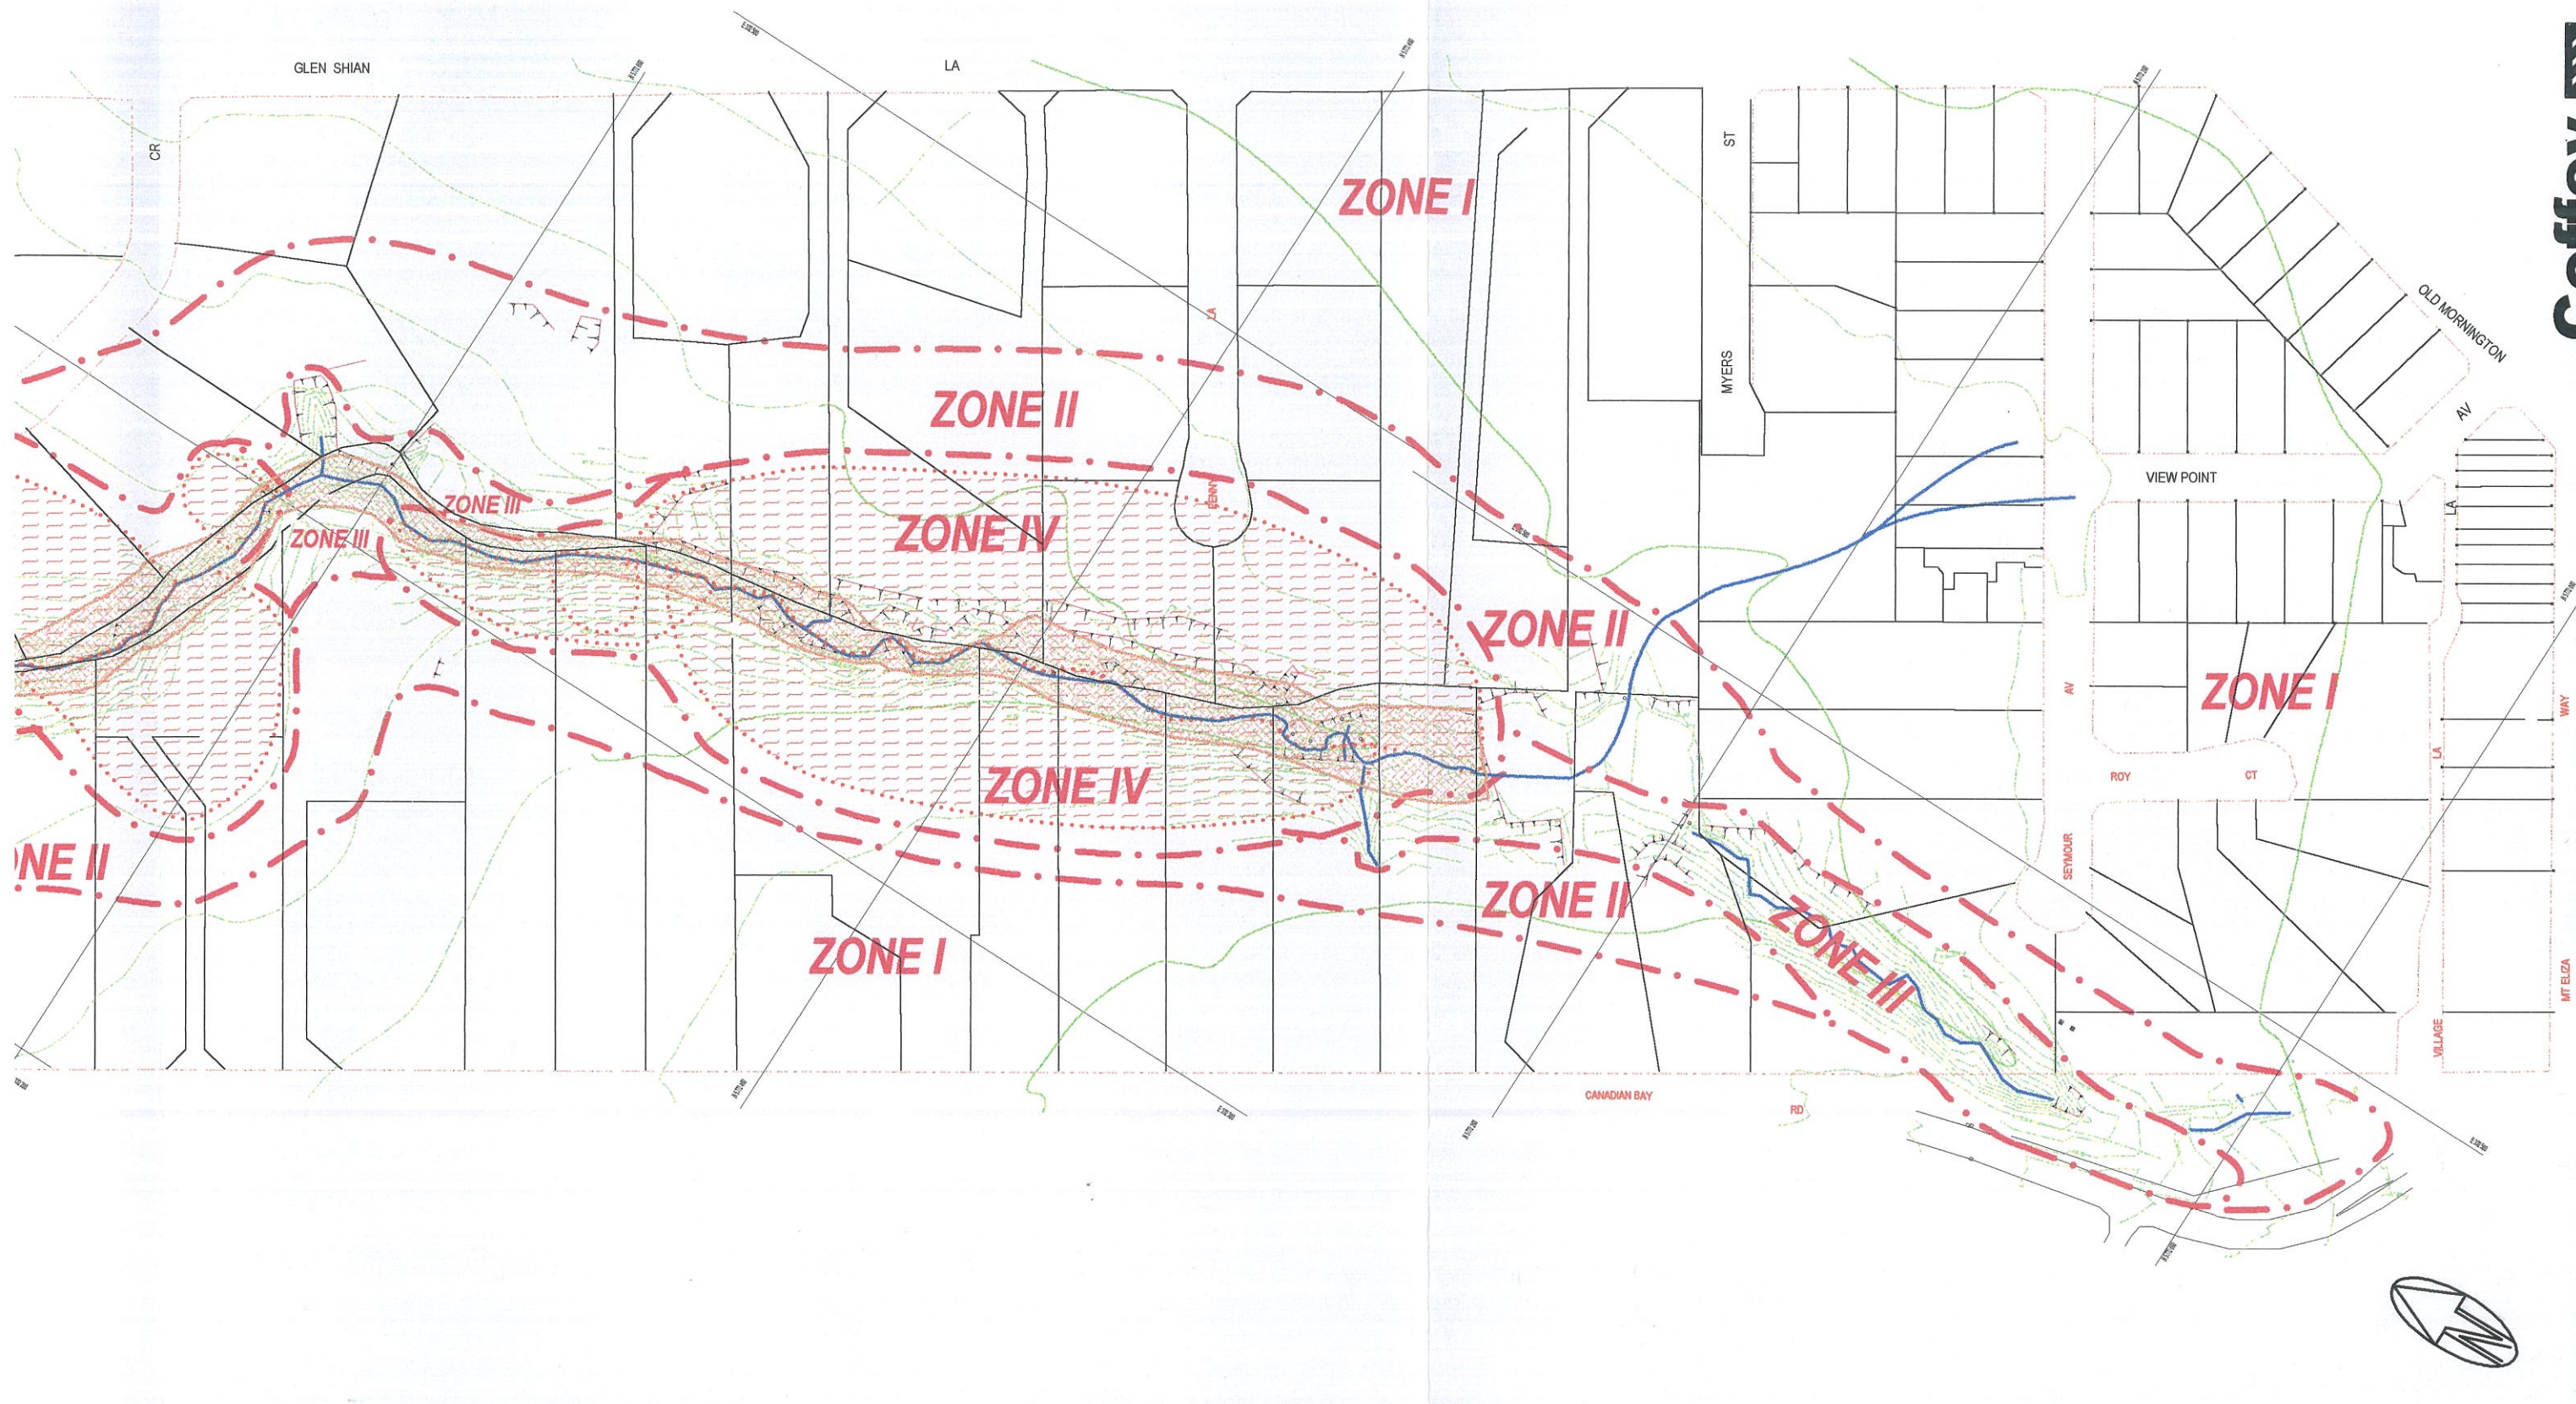
FIGURE 3
 Job No.: M4164/1 - AV

The adopted system is outlined in Table 2 and is described in the following sections. Four zones have been defined, the boundaries of which are shown in Figure 3. Key features of the scheme are as follows:

These are areas where there is evidence of past landslide movements and where there is potential for future landslide movements. The large landslides are included in this zone, together with a nominal up-slope buffer area which varies from about 5 to 10m depending on the landslide.

The zone boundaries have been drawn regardless of title boundaries. It is recommended that where a zone boundary crosses a title boundary on small sites (eg standard 0.1 Ha house blocks), or where development is proposed within 20 metres of a zone boundary on large sites, the more conservative risk category should be adopted for initial evaluation purposes.
