**GEOTECHNICAL
ASSESSMENT OF SLOPE
STABILITY, TANTI CREEK,
MORNINGTON**

**Mornington Peninsula Shire
Council**

March 2010

Doc Ref: 23019report01.7

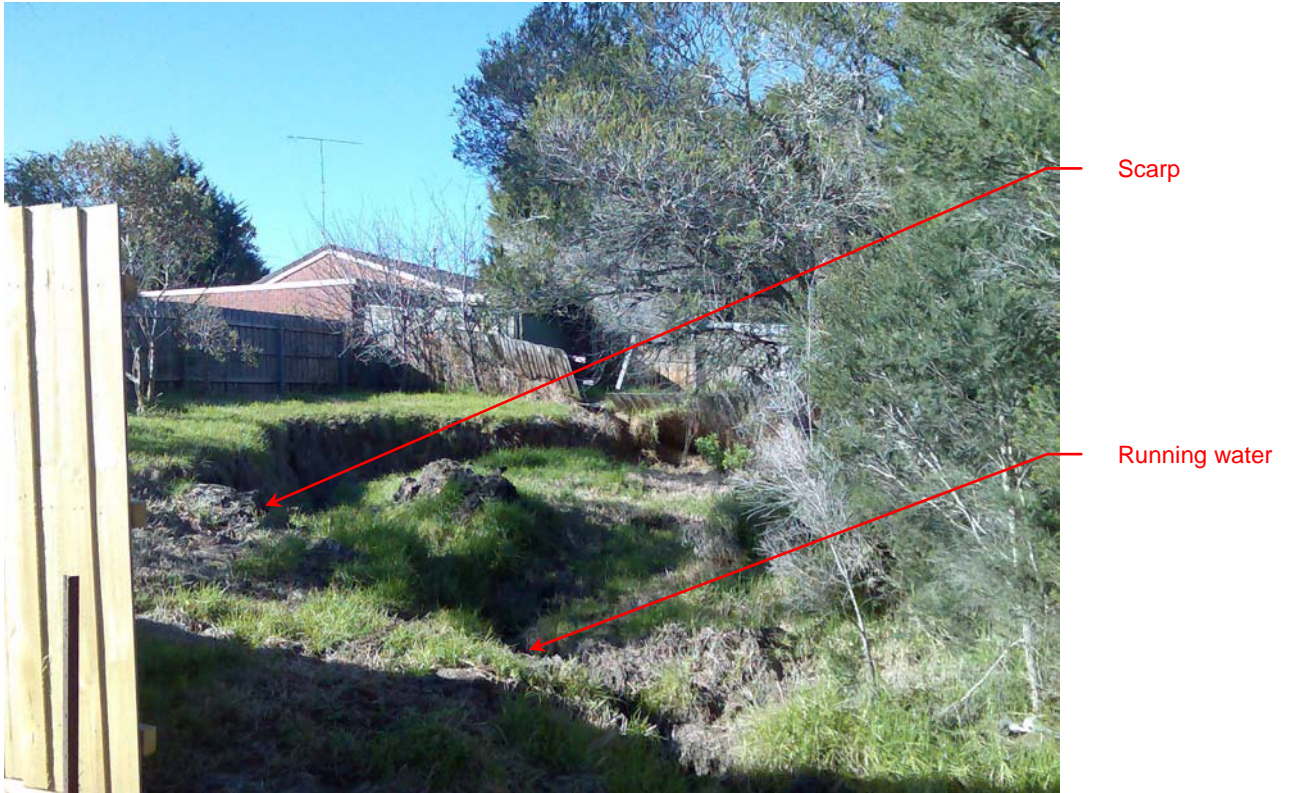
Figure 9-1: Rear of 65 Herbert Street

Of the unlined section of the creek, the area between 77 Herbert Street and Strattons Lane appears to be the most affected by erosion and landslip. This area has numerous landslips and areas of seepage.

Note that the existing slope failures at the end of 65 and 69 Herbert Street will have a factor of safety of less than 1.

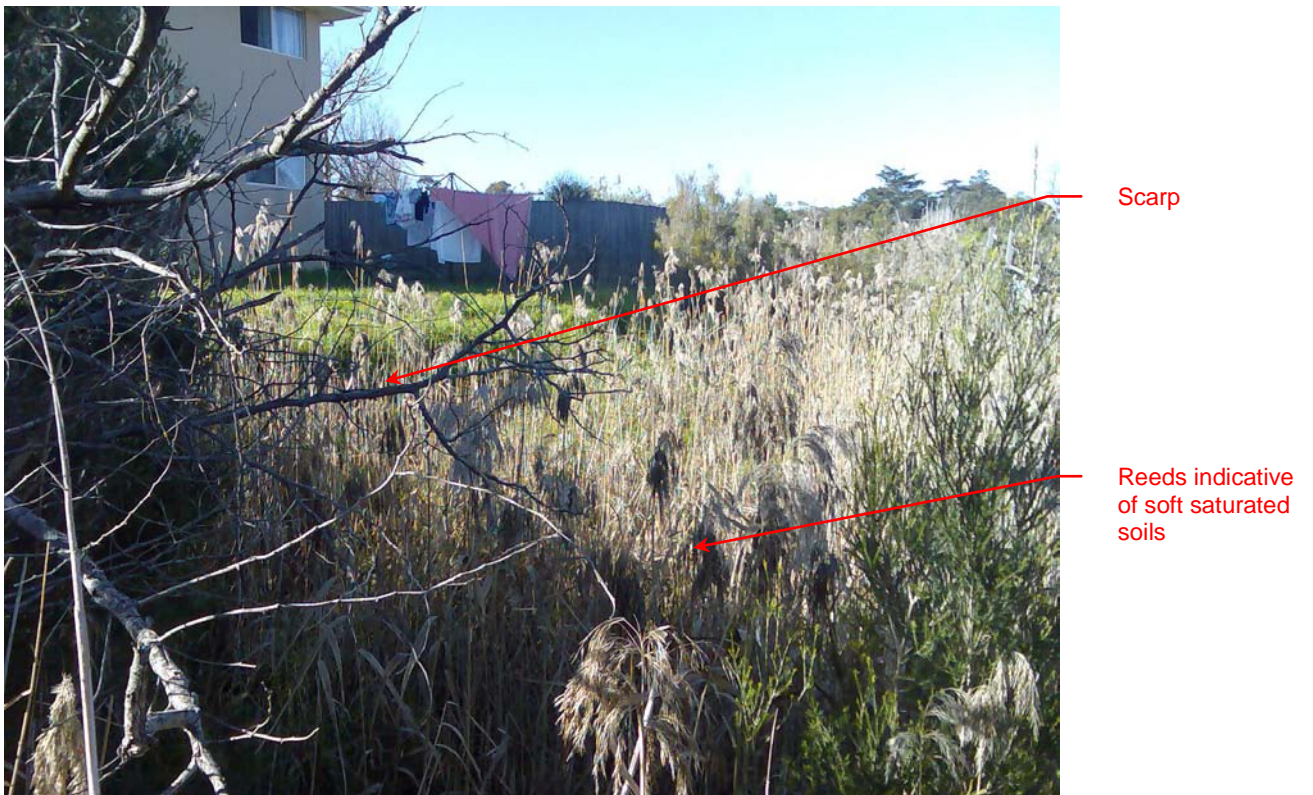
Figure 9-2: Rear of 69 Herbert Street

These results were calibrated against the known failures, particularly the shallow slips at the rear of 67-69 Herbert Street. The results of the calibrations are included in Appendix E.

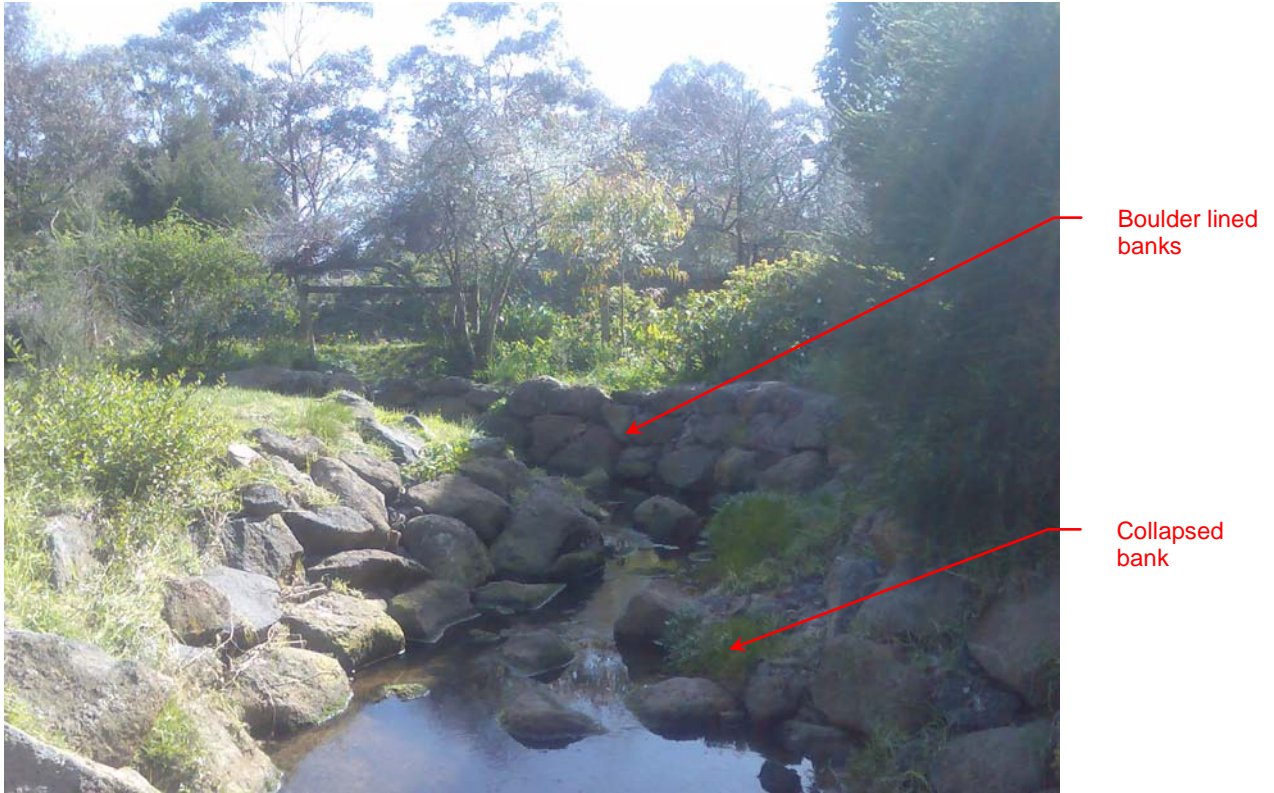
Figure 9-5: Creek between Marchington Avenue and Shelbourne Court

The length of creek between Barkly Street and 13 Marchington Avenue has been rock lined since our previous investigation, although the southernmost 40m is predominantly covered in silt. There have been some slumps within this silt material. In general the rock lining appears to have helped stabilise the banks. However, in the section of creek between 13 Marchington Avenue and 11 Shelbourne Court where scarps were previously noted the rock lining has collapsed, indicating movement is still occurring. Figure 9-5 and Figure 9-6 show the collapsed rock lining.

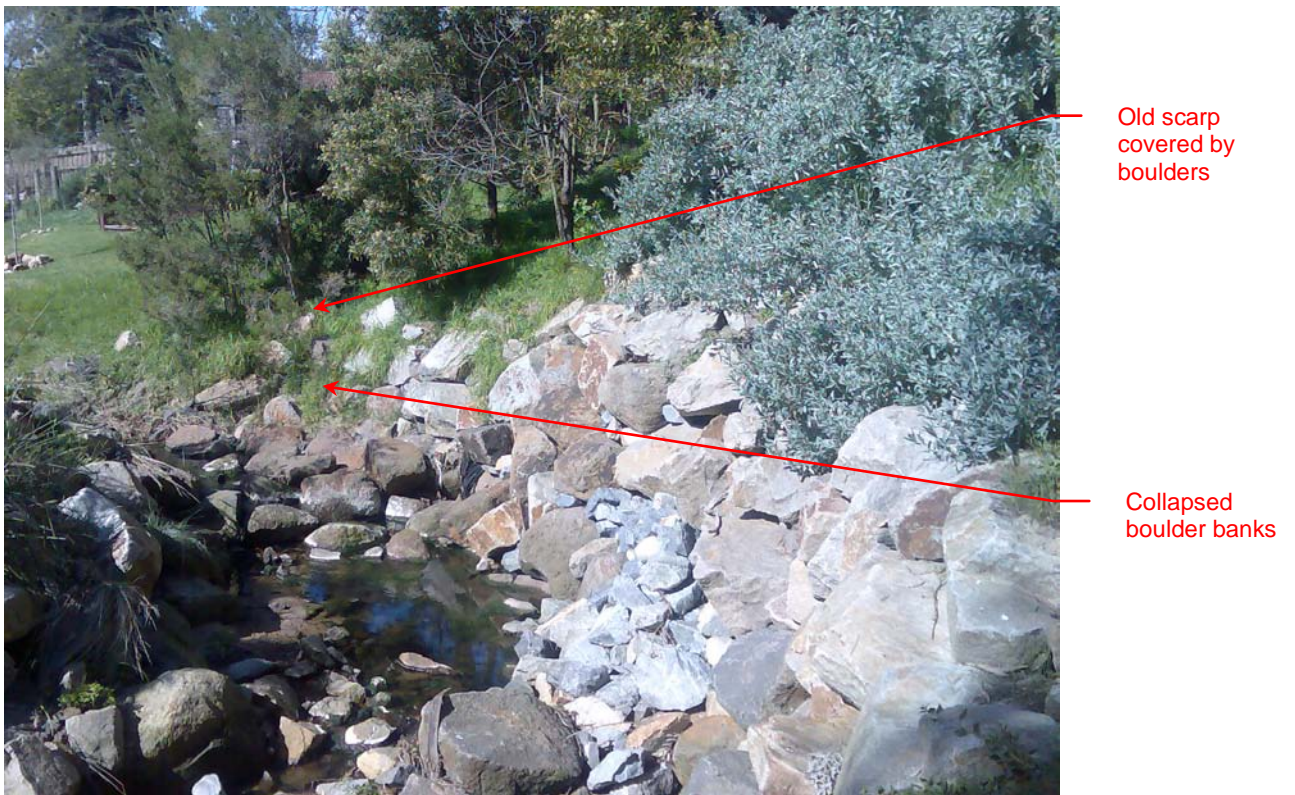
Figure 9-6: Collapsed rock lining behind 11 Shelbourne Court

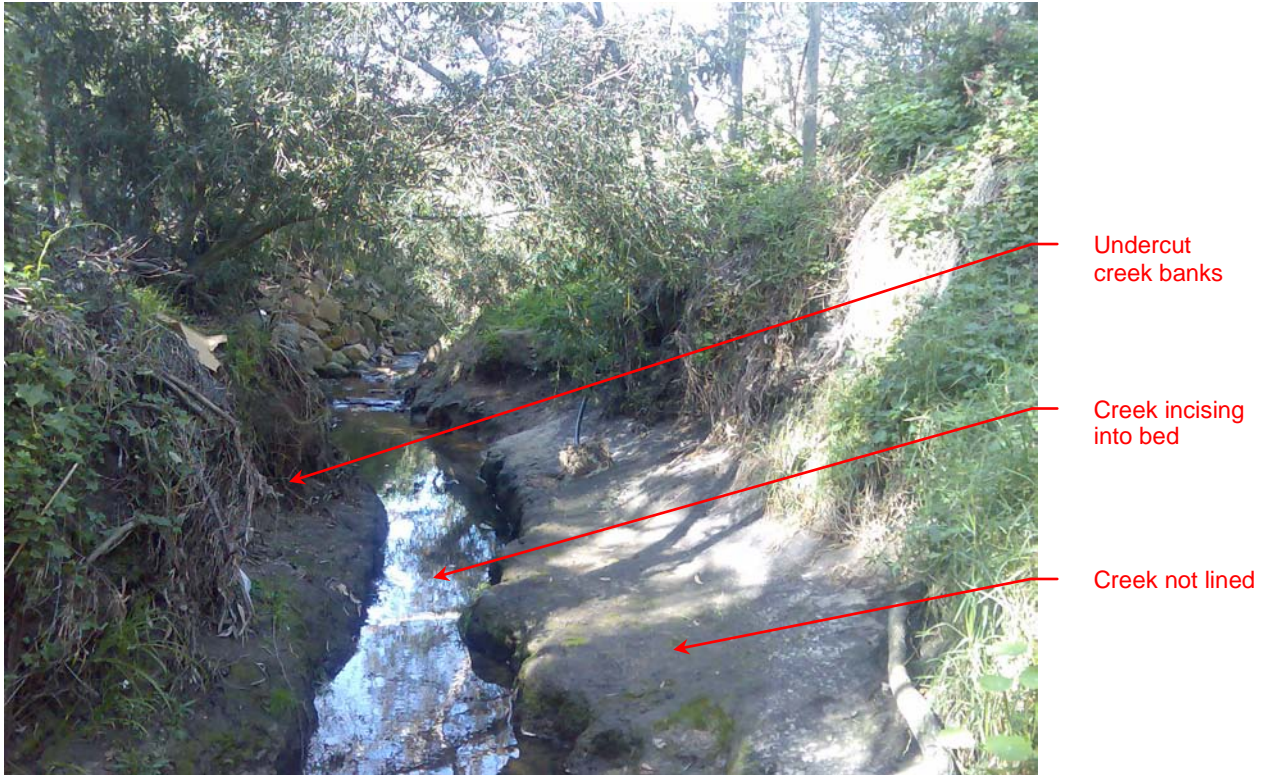
Figure 9-7: Undercut banks to rear of 9-11 Marchington Avenue

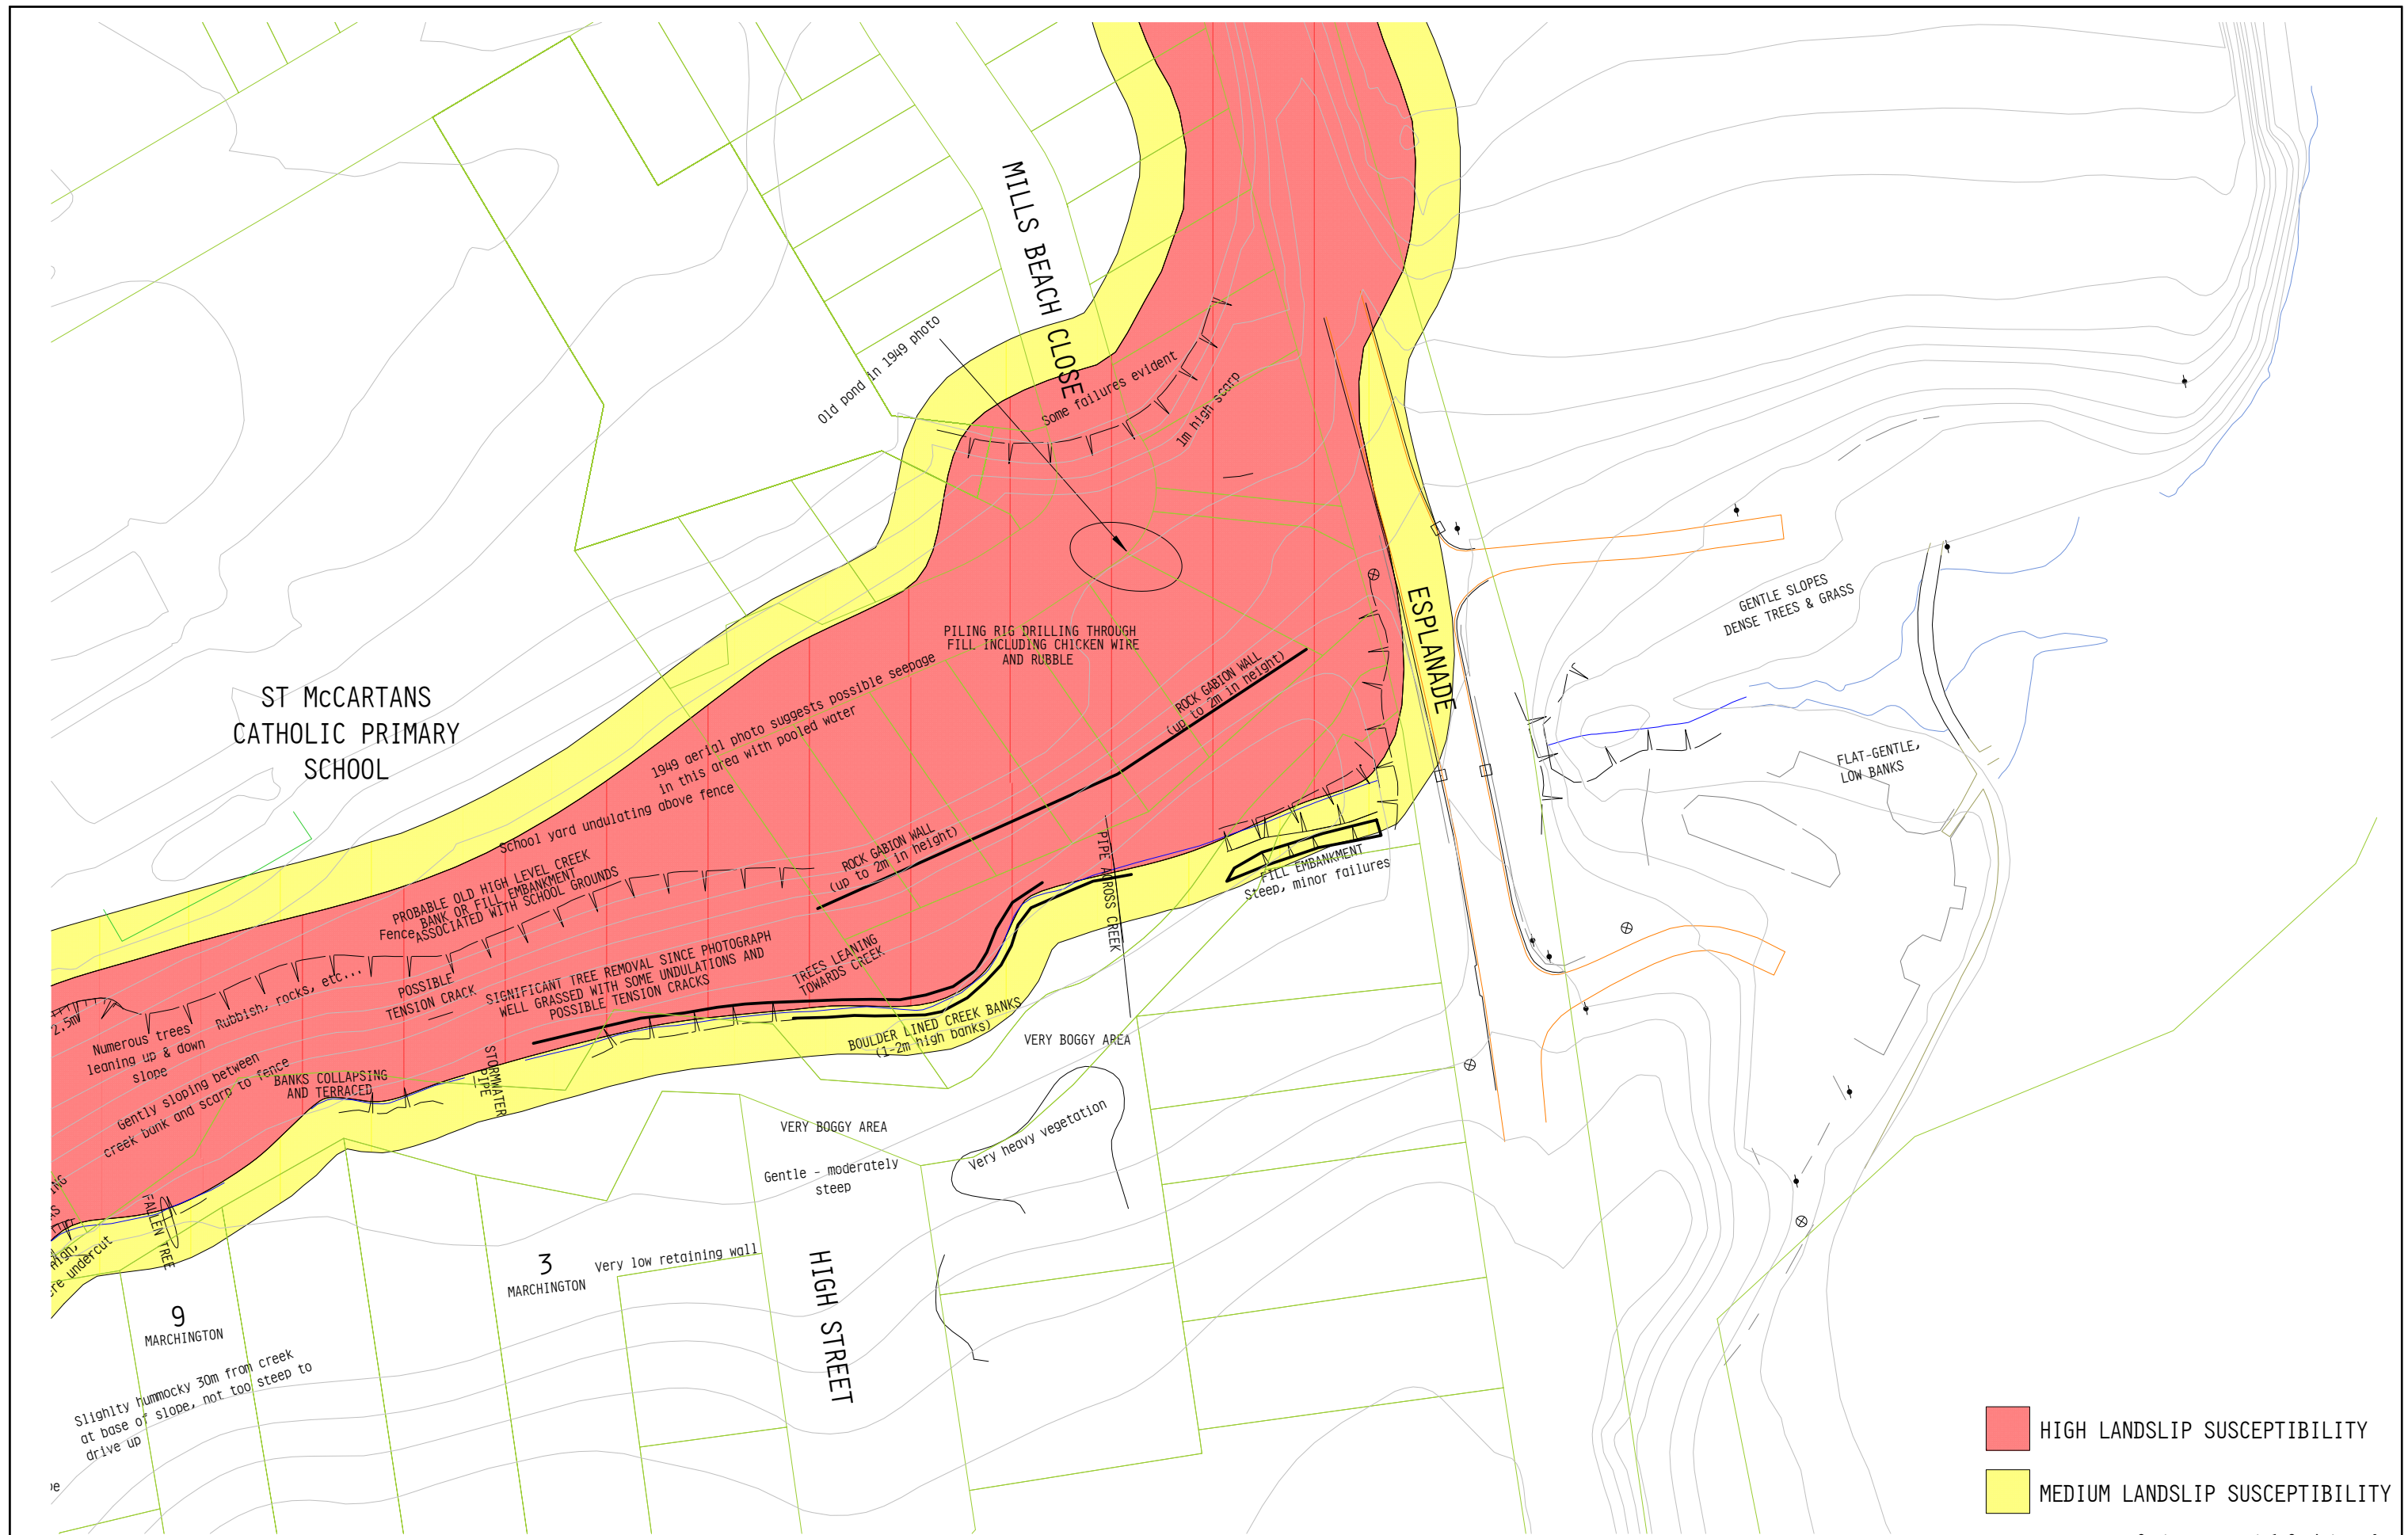
TITLE	SITE PLAN
REF: 23019-Site Plan-3-10

During floods the toes of the slopes are commonly eroding laterally. This leads to lack of support for the steeper slopes, inducing mass wasting down-slope and some likely shallow-seated failures suggested by scarp-like features. Active slope movements are shown in Figure Nos. 2 – 6, Appendix A.

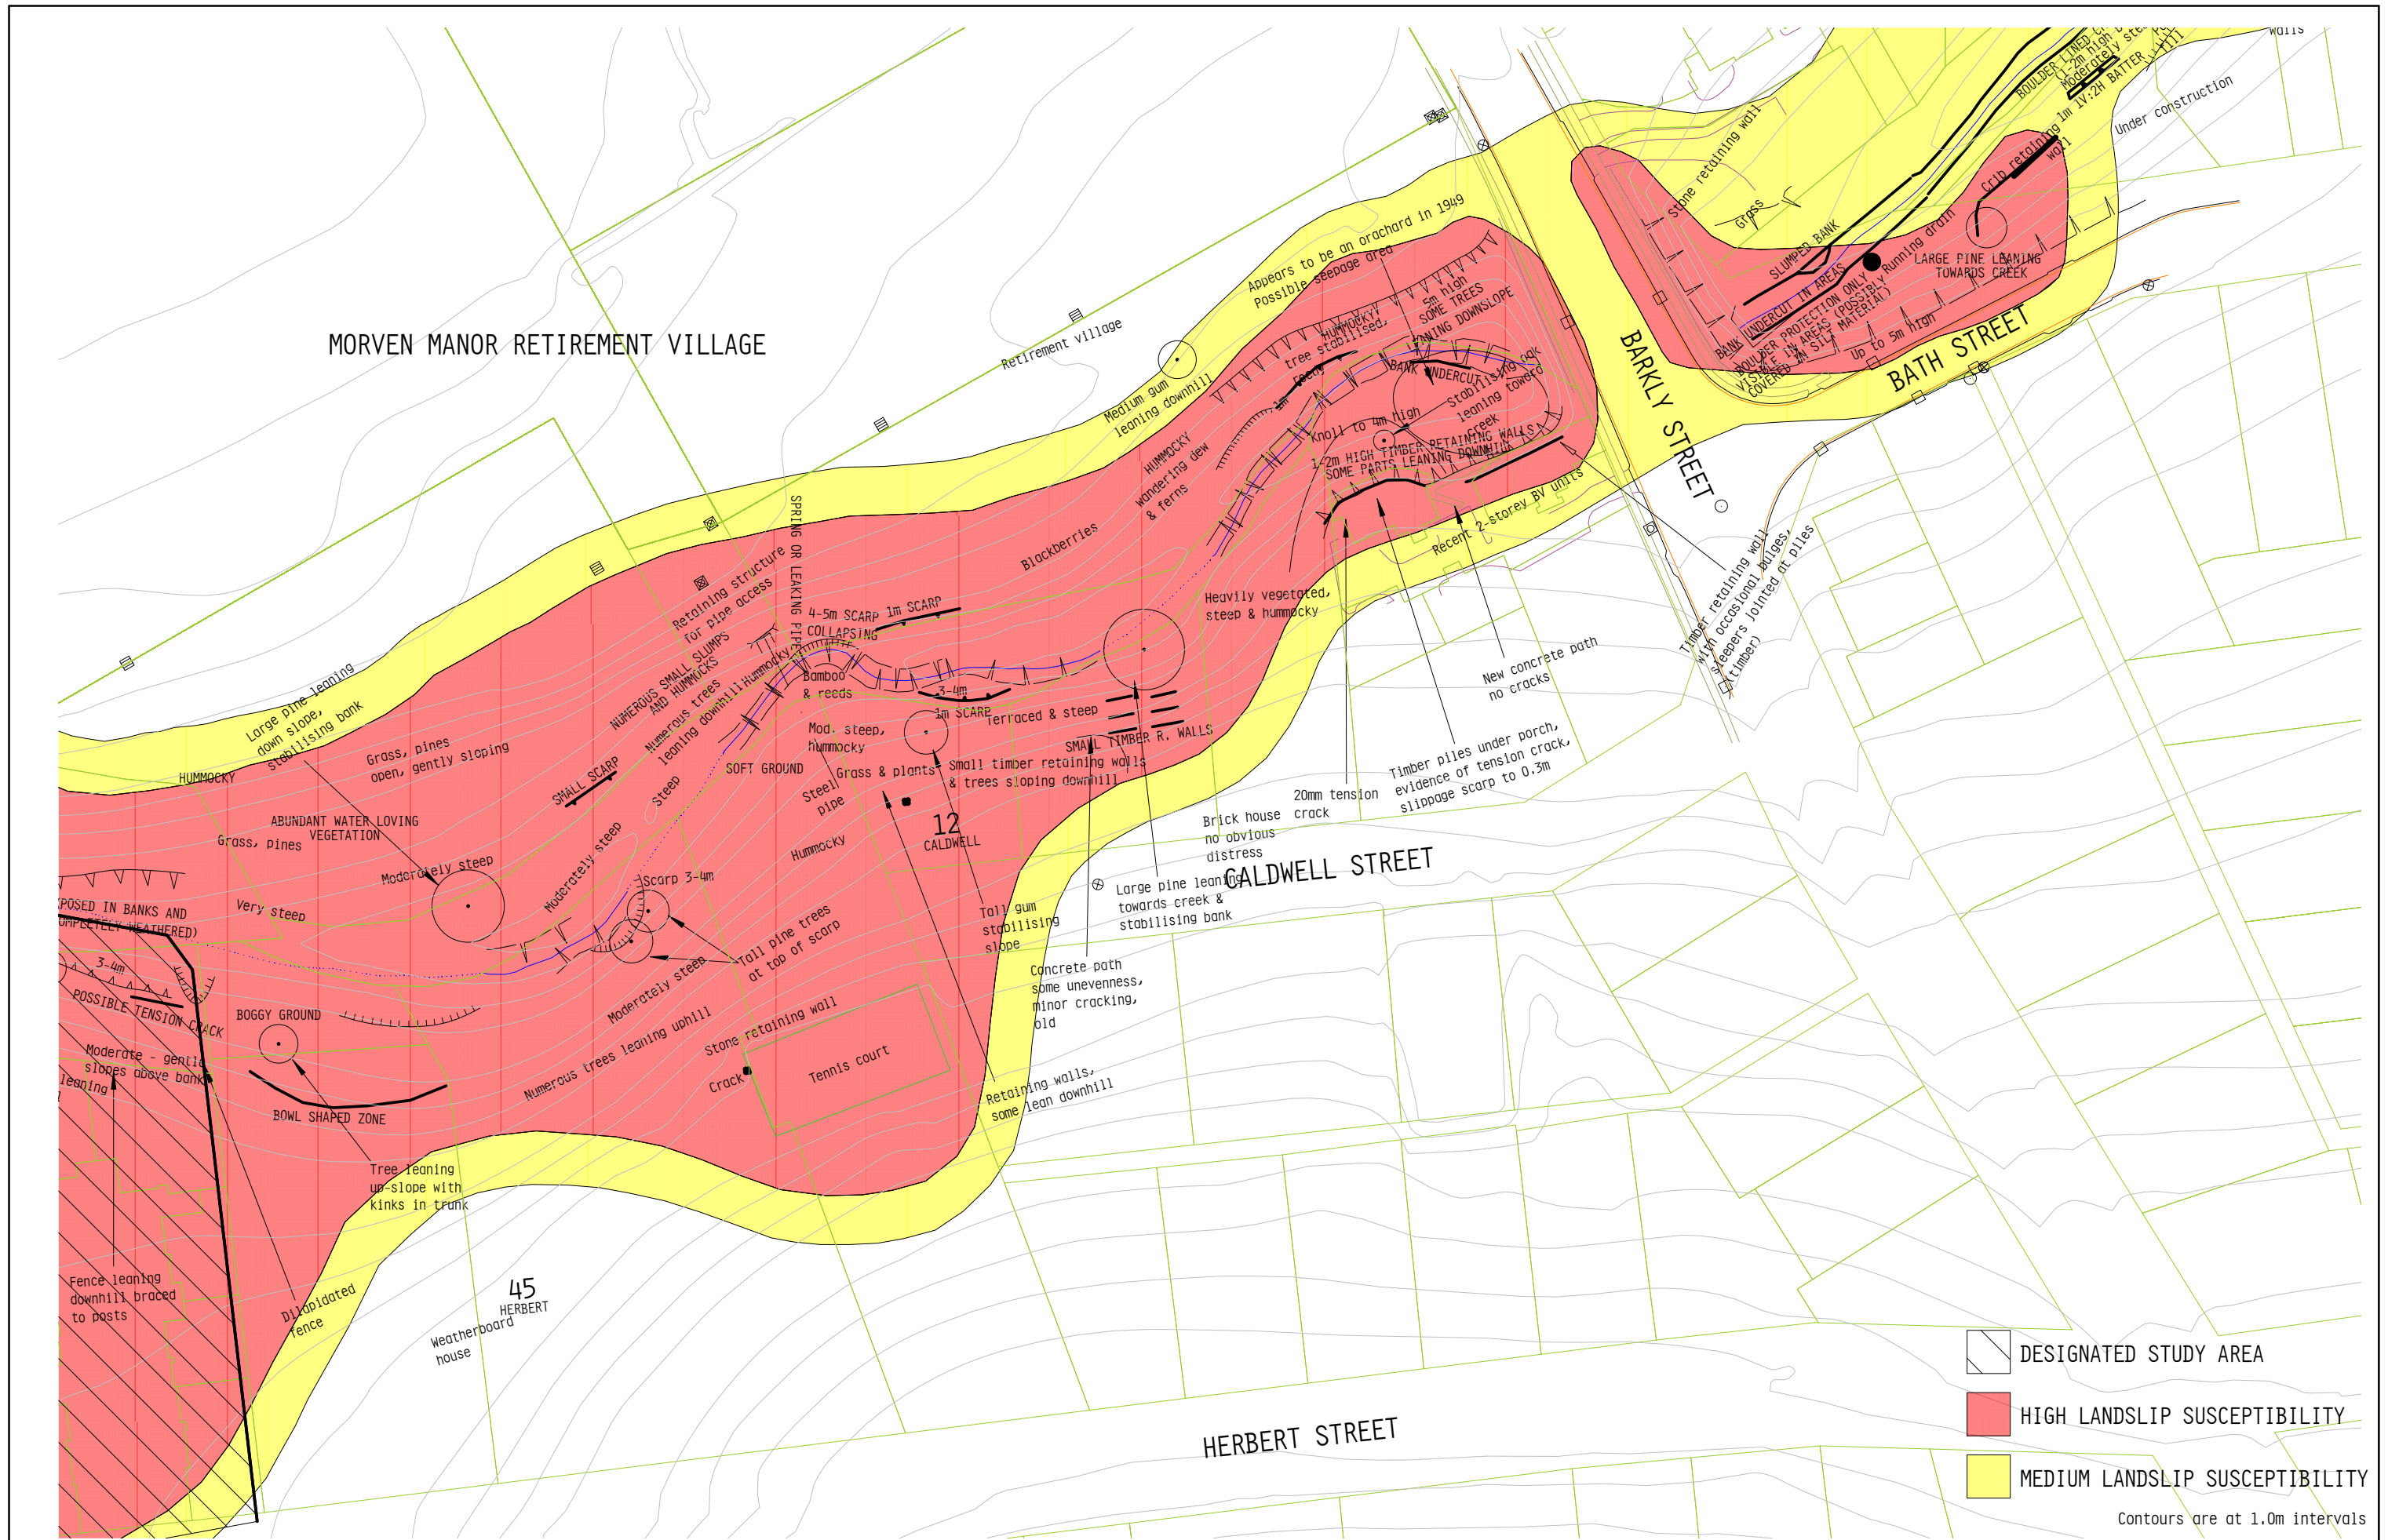
TITLE
SITE PLAN
 REF: 23019-Site Plan-3-10

At least four slope failures in the creek banks on the eastern side of the creek were identified during an initial site inspection. This area was known as the 'Designated Detailed Study Area' for this assessment, as indicated on Figure Nos. 4 & 5, Appendix A.
