Mornington Peninsula Drainage Outlets Assessment

TBL and MCA Approach

CG150198

Prepared for
Mornington Peninsula Shire

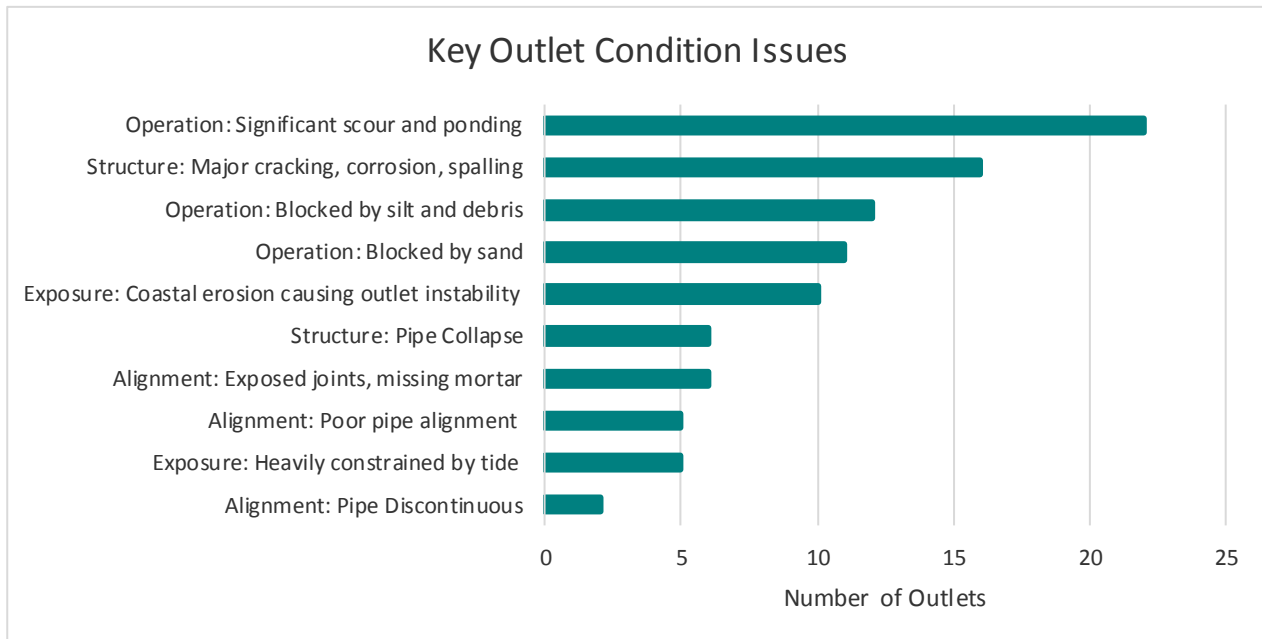
Figure 5-2 Key Outlet Condition Issues

In order to highlight key outlet condition issues apparent among assets investigated, all assets given a score of 3 or 4 for MCA criteria including Alignment, Structure, Operation and Exposure in Table 3-1 were identified. Pipe condition issues evident in each of these assets were then identified. As shown in

K, the most prevalent issue identified among outlets was significant scour and ponding, affecting outlet operation. Structural issues including major cracking, corrosion and spalling were also identified in a number of outlets.

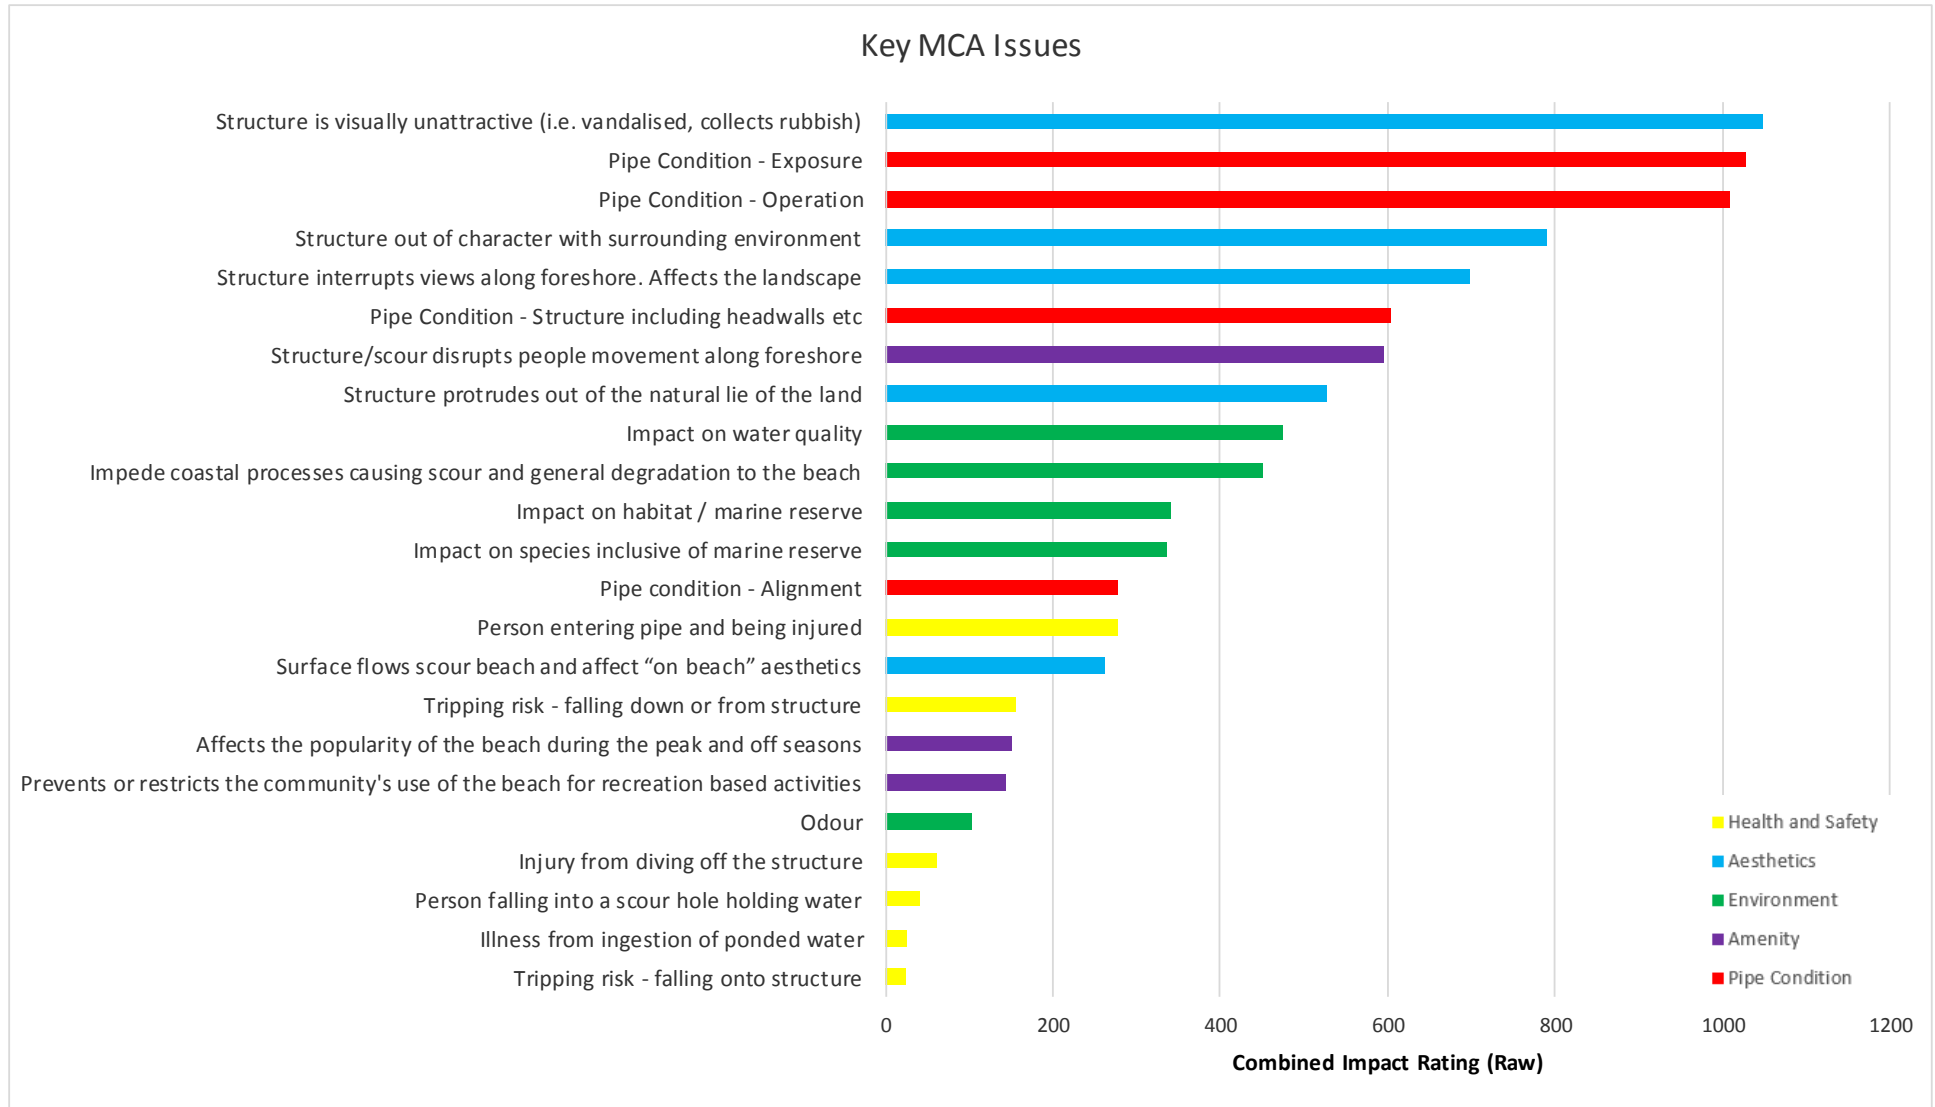
Figure 5-4 Key MCA Issues

The key outlet issues considering property, environment, aesthetics, amenity and health and safety have been identified in Figure 5-4. Impact scores outlined in Table 3-3 were assigned to each asset for each of the developed assessment criteria. The key issues present among foreshore assets were then identified by adding the impact of each MCA criteria assessed. The most significant issue identified was the visual unattractiveness of outlet structures. It is evident from Figure 5-4 that issues within the categories of Aesthetics and Pipe Condition are considered to have the greatest impact. Issues within the category of Health and Safety have a relatively low impact compared to other categories because the likelihood of occurrence is relatively low, however, in some cases the consequence of Health and Safety issues is high.

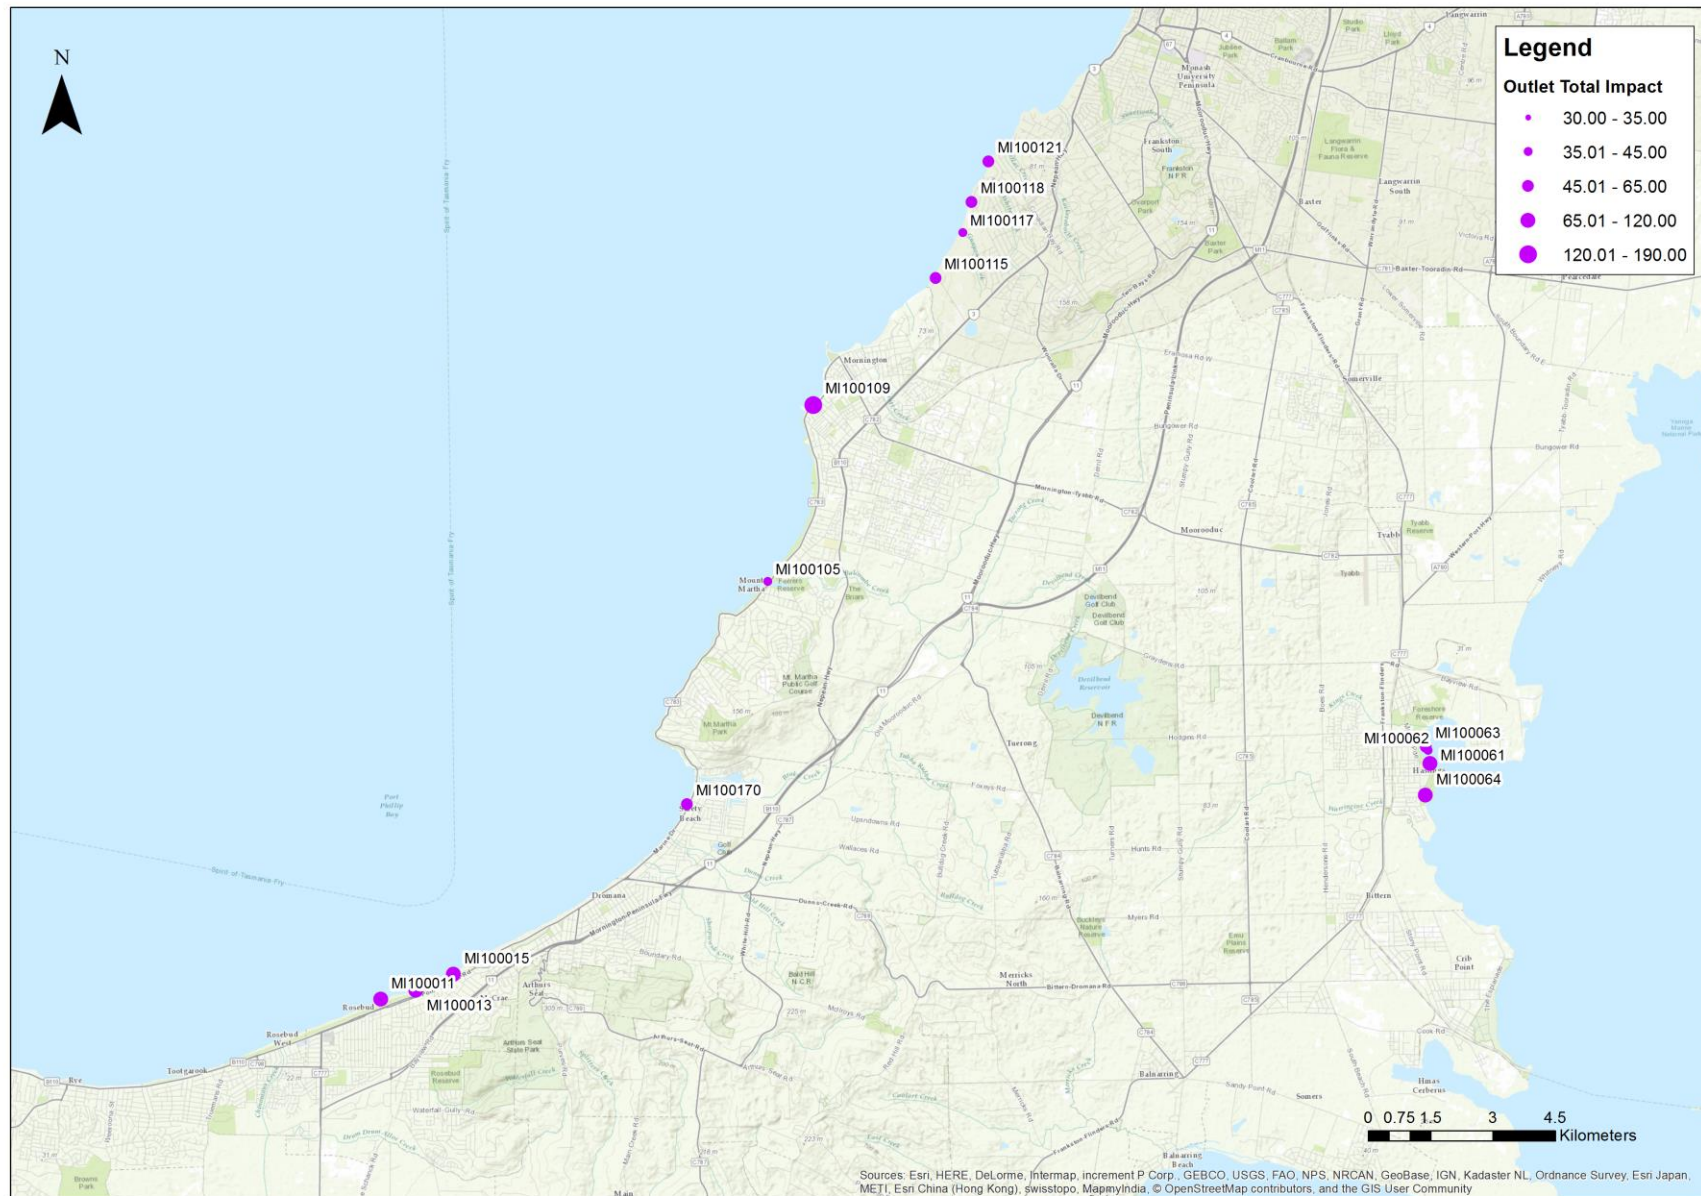
Figure 5-5 20 Highest Priority Assets based on Total Impact

ID	Address	Total Impact Rating
1	MI100013	013 : 775 Point Nepean Road McCrae 3938	113.38
2	MI100015	015 : 690 Point Nepean Road McCrae 3938	105.85
3	MI100061	061 : Fred Smith Reserve Hastings 3915	83.73
4	MI100064	064 :25 Skinner Street Hastings 3915	68.34
5	MI100118	118 : 2-4 Kunyung Road Mount Eliza 3930	64.14
6	MI100063	063 : Hastings Foreshore Reserve (Tennis Club) Hastings 3915	63.35
7	MI100121	121 : 47 Rosserdale Crescent Mount Eliza 3930	56.88
8	MI100104	104 : 745A Esplanade Mornington 3932	43.54
9	MI100117	117 : 14 Albatross Avenue Mount Eliza 3930	38.57
10	MI100062	062 : Hastings Foreshore Reserve (Bowls Club) Hastings 3915	38.01
