# **Board of Inquiry** into the McCrae landslide Report

September 2025

On 18 March 2025, the Board of Inquiry was established to inquire into, report on, and make recommendations in relation to, amongst other things, the cause of the landslide that occurred on 14 January 2025 in McCrae on the Mornington Peninsula (**McCrae Landslide**), the adequacy of measures taken to prevent and minimise landslides in McCrae, and measures to be taken for the prevention or mitigation of the risk of similar landslide events occurring again in McCrae.

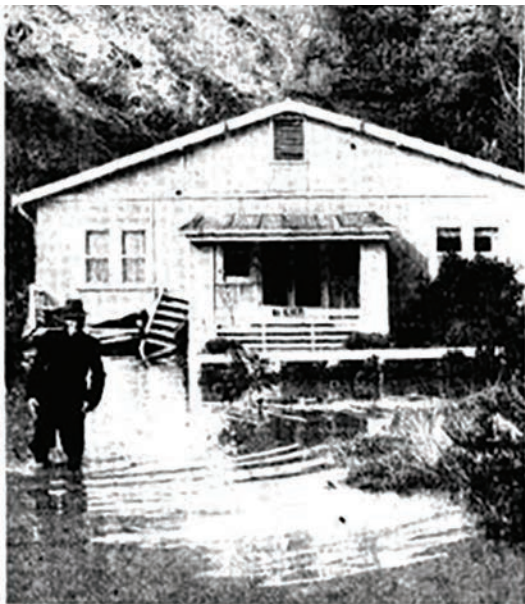
THIS HOUSE, The Rocks, at the foot of Arthur's Seat was pushed forward 10 feet by a landslide today. It collapsed on its basement garage, smashing it to matchwood. See story page one.

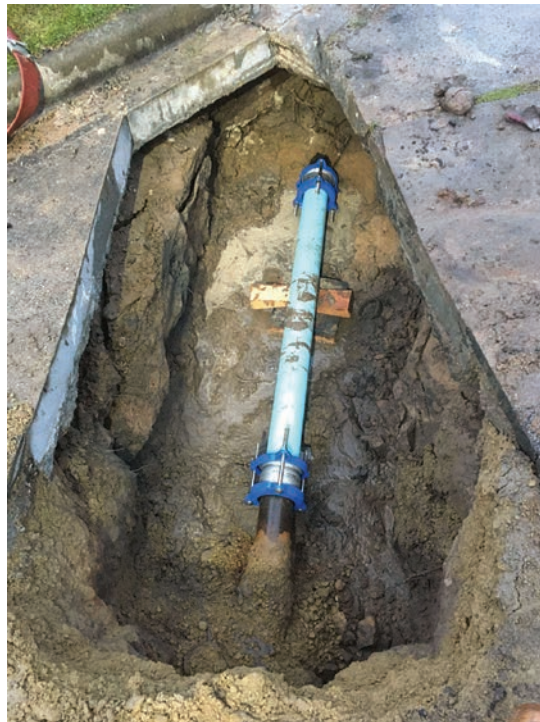
FIGURE 3.15: PHOTO OF THE PIPE POST REPLACEMENT.<sup>126</sup>

81 As is evident from the photographs, the burst was not small. SEW estimates that approximately 900,000 litres of water escaped from the burst pipe, with a peak flow rate of approximately 2.3 megalitres per day just prior to the main being turned off at 6.50pm.<sup>127</sup>

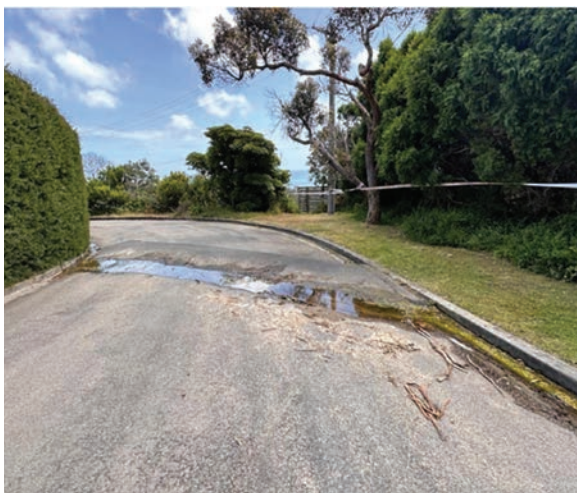
FIGURE 3.20: CRACKS AND PATCHING ALONG THE KERB OF VIEW POINT ROAD.<sup>216</sup>

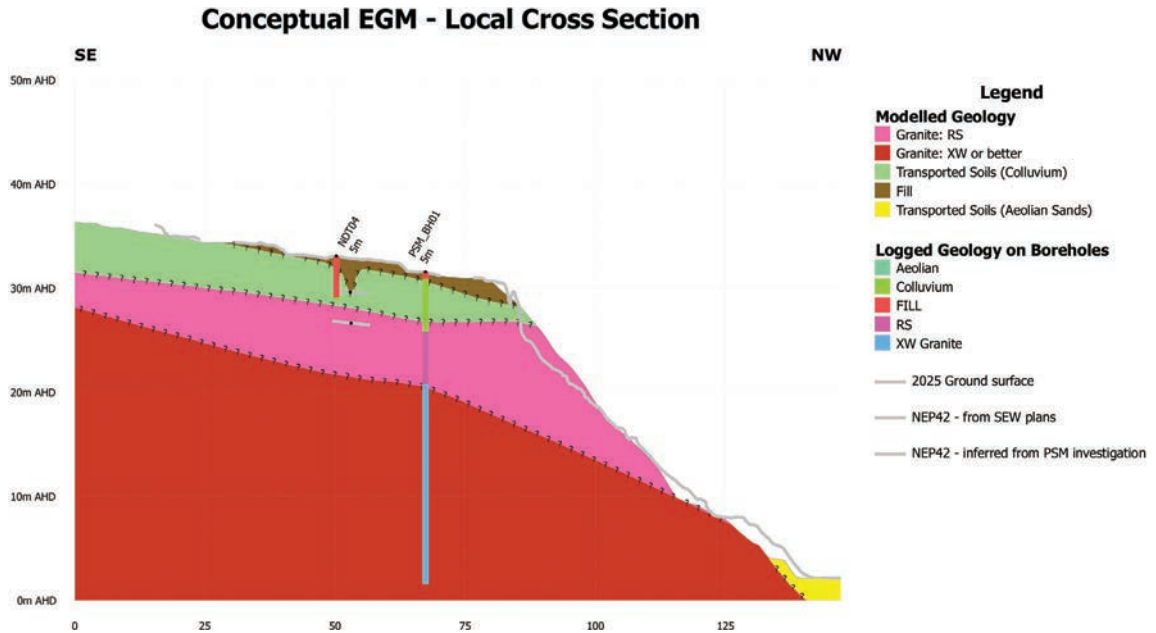
FIGURE 4.4: LOCAL CROSS SECTION OF PSM'S CONCEPTUAL ENGINEERING GEOLOGICAL MODEL – 23 COBURN AVENUE TO 3 PENNY LANE.<sup>24</sup>

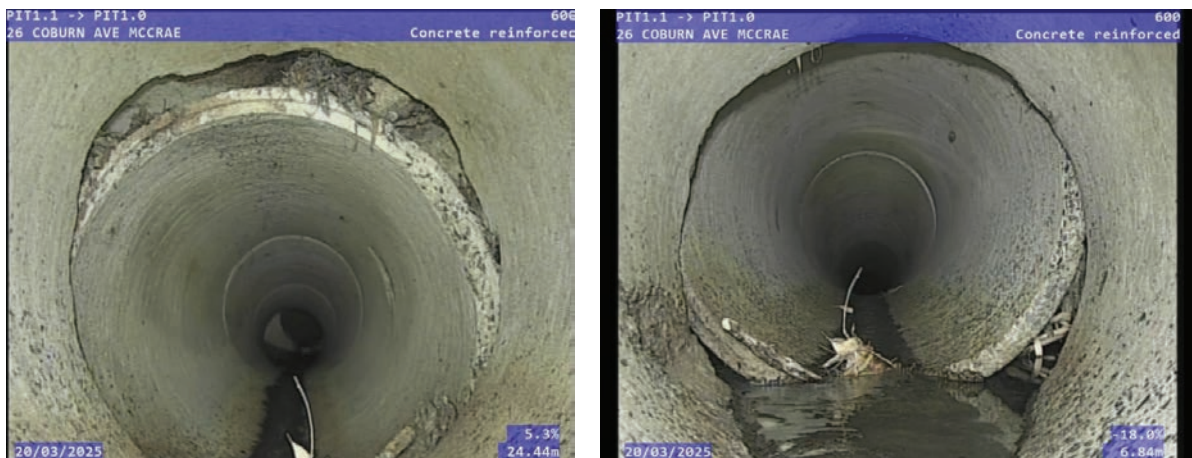
196 The extent of the damage is significant. Plainly, water could, and did, exit the stormwater system through those cracks and holes in the stormwater pipe. Mr Pope estimated that the total leakage volume from the damage at the intersection of Browne Street and Coburn Avenue was in the order of 75 to 1,200 litres per day.<sup>181</sup> In oral evidence, Mr Pope explained that he had not conducted a complete analysis of the entire stormwater channel, rather his focus was on two of the defects at the Browne Street corner.<sup>182</sup> It follows that Mr Pope's estimate is conservative and at least reasonably likely to underestimate the total water loss through the stormwater defects.
