To	[REDACTED]	From	[REDACTED]
Project	Beleura Creek Path, Mornington	Date	24 January 2023
Subject	Access to Beleura Cliff Top Path for maintenance	Ref No.	V220152Letter02.1

1 INTRODUCTION

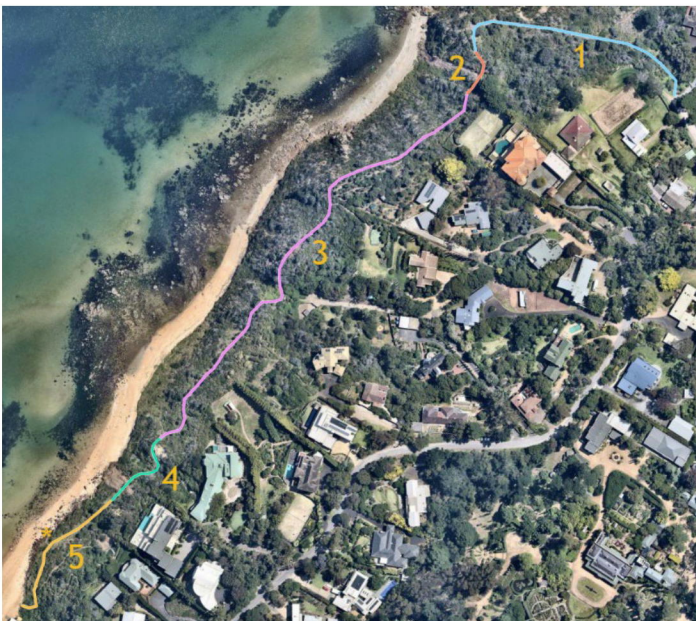
During the inspection it was clear that different sections of the path are currently at different levels of risk. In order to best identify what is required for the different sections of path, the length of the path has been separated into 5 zones as indicated below.

- Upper Path
- Upper Landslide
- Middle Path
- Lower Landslide
- Lower Path
