**MORNINGTON
PENINSULA**
Shire

ATTACHMENTS

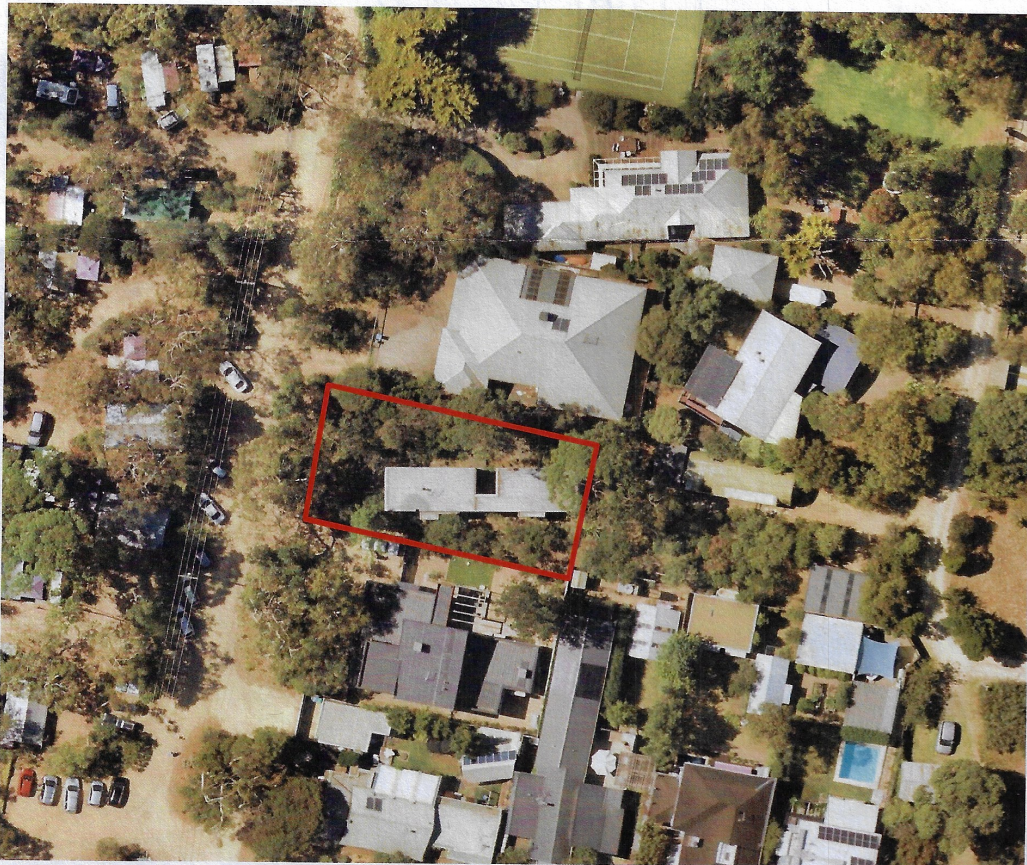
✓ Recommended extent of the Heritage Overlay (red line)
(Source: Nearmap, January 2022)

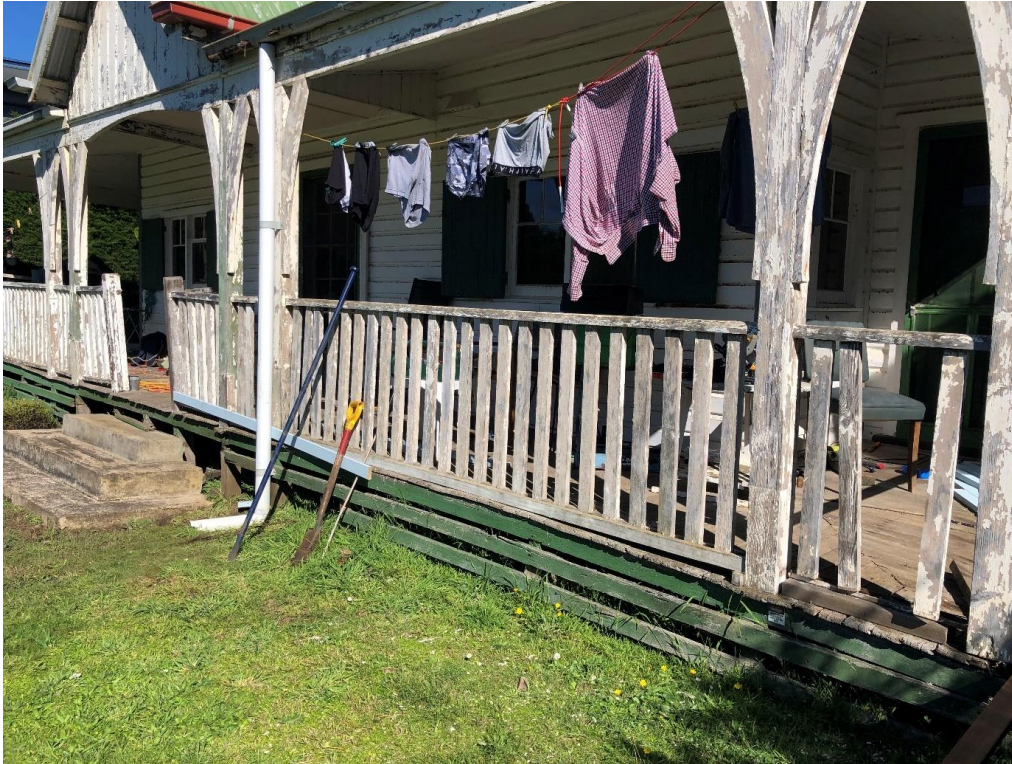
To say receiving the letter dated June 13, 2023 from the Mornington Peninsula Shire was a shock is an understatement, the house has never been listed on previous heritage assessments by the Shire or the previous Shire of Flinders. It has no heritage value and is past its useful life. All materials in the house are rusting, rotting and beyond restoration. The house is in a state of literally falling down.

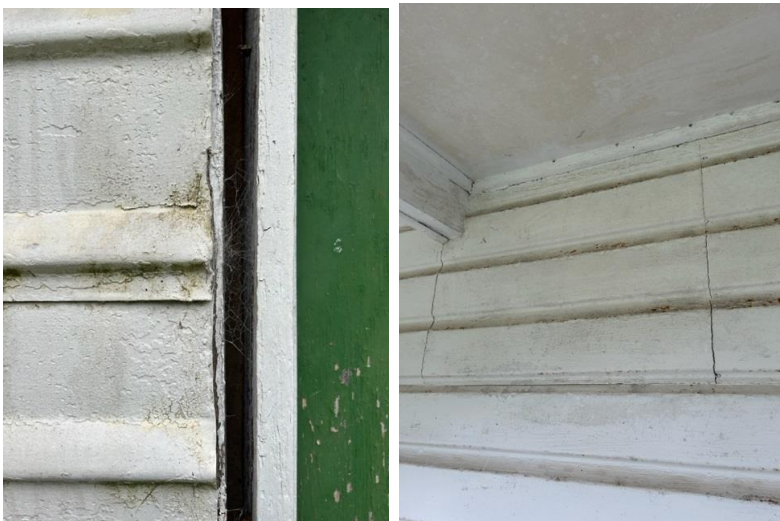
Wide Gaps are throughout the house, vertical cracks in the cladding

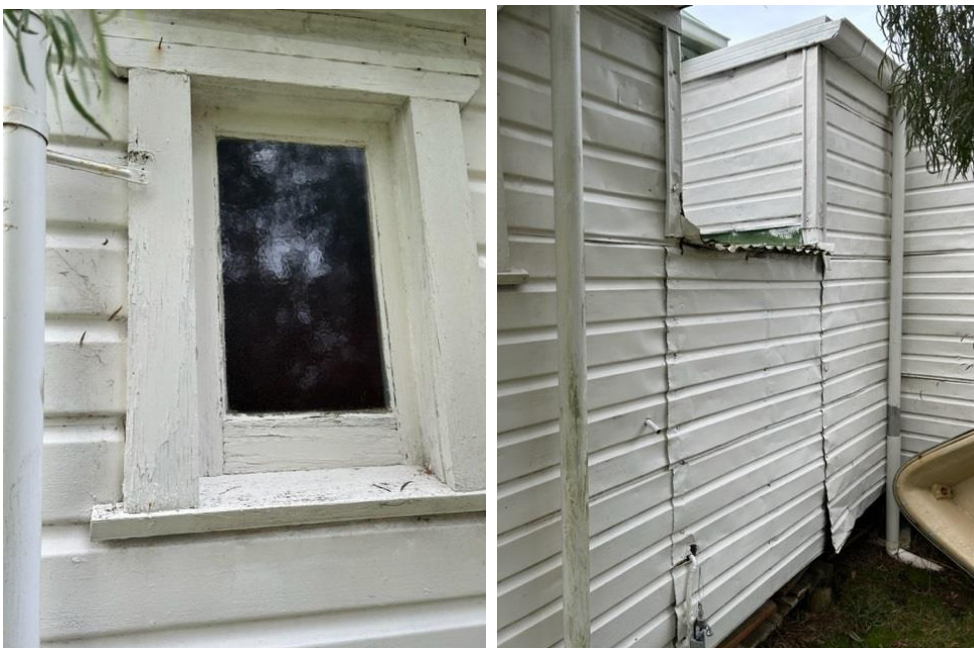
Cladding totally at the end of life. Patched extensively, rusting from both sides.

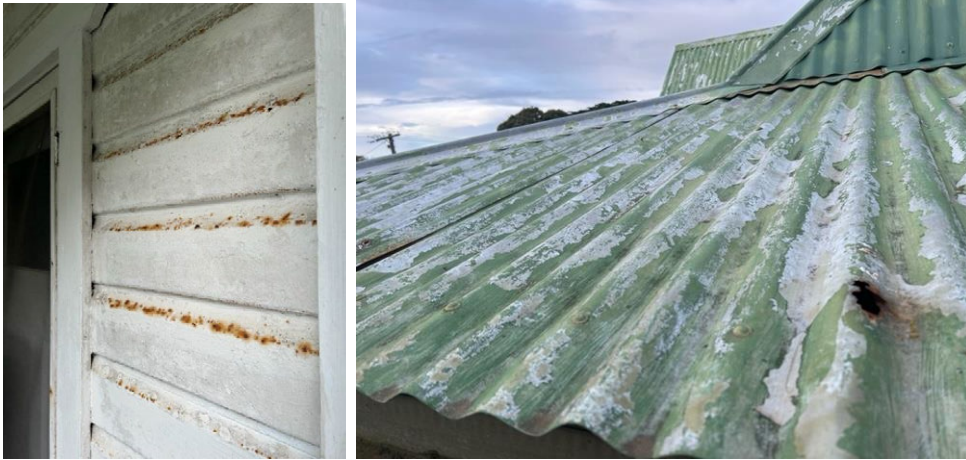
Extensive rust to all cladding. Roof leaks and has extensive holes.

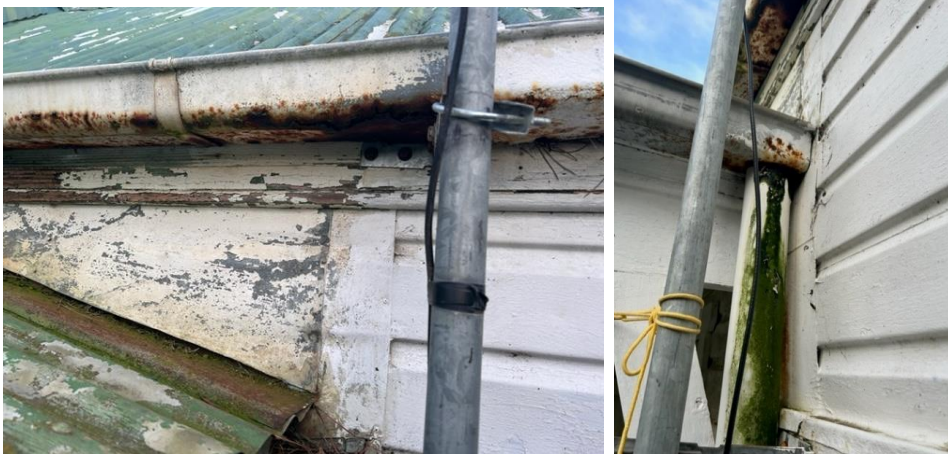
Gutters and drainage dilapidated.

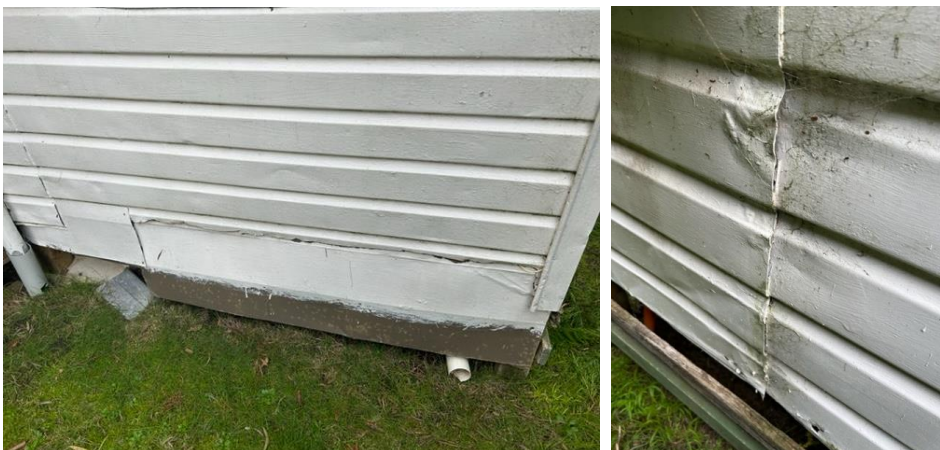
Various patching to exterior cladding to cover rusted out sections.

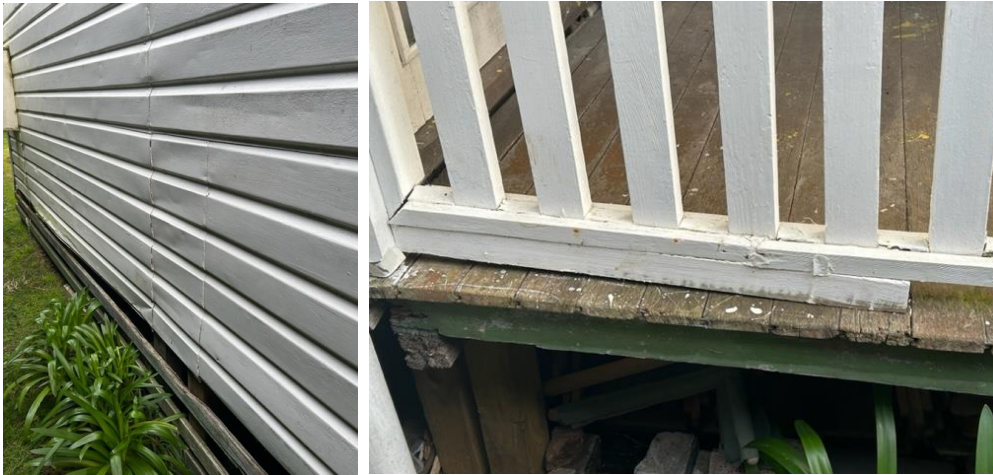
Substructure, stumps, bearers, and beams failed. Temporary concrete blocks to stabilize a 12 – 24 month proposition at best as the reactive clay soil moves up and down depending on seasonal moisture.

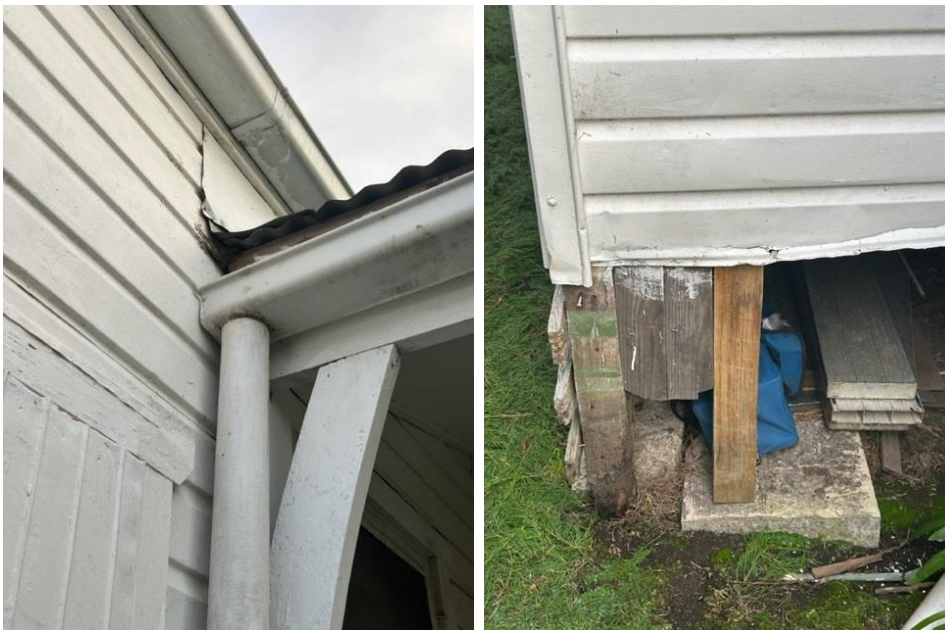
Temporary flashing to cover large rust area, 4 stumps, including latest temporary support with concrete pad sitting on surface. Extensive rust on cladding and bottom section falling off.

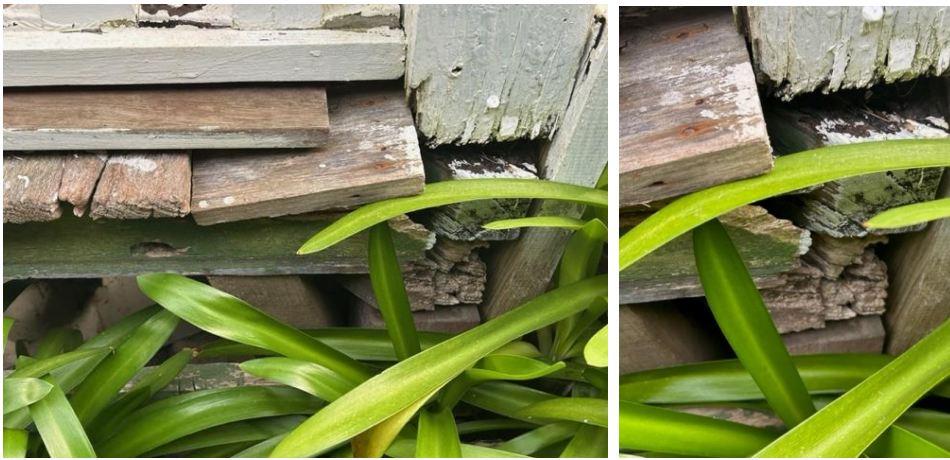
Substructure totally failed.

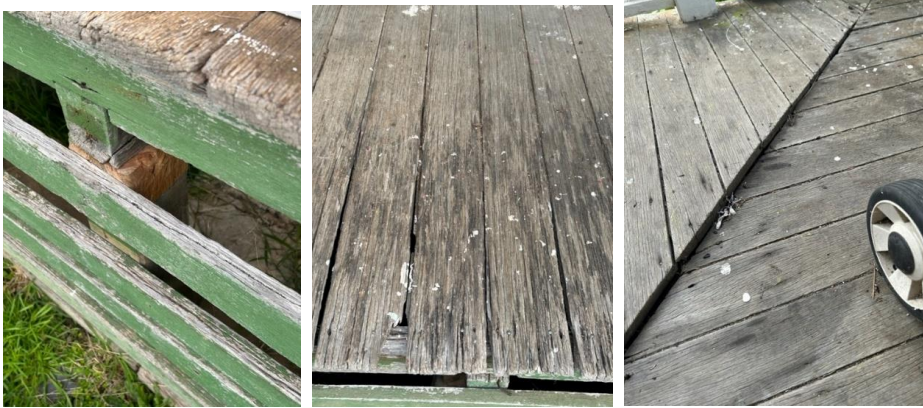
Veranda timber totally failed.

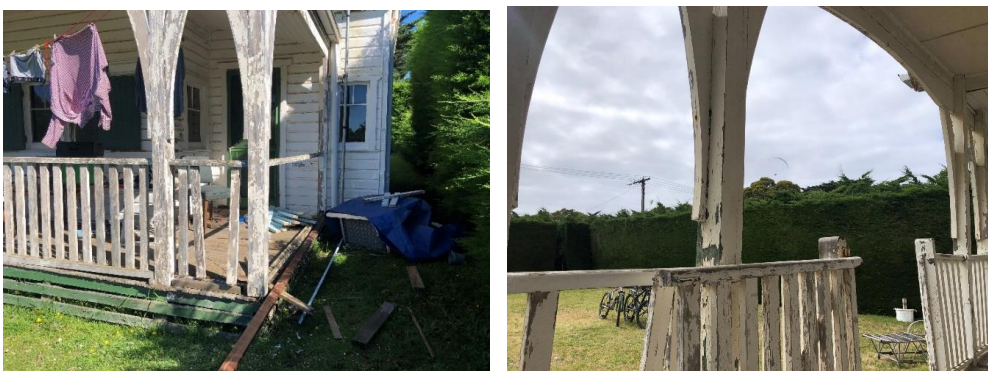
Timbers have been temporarily propped up, but you can see the condition of the timber – it has failed.

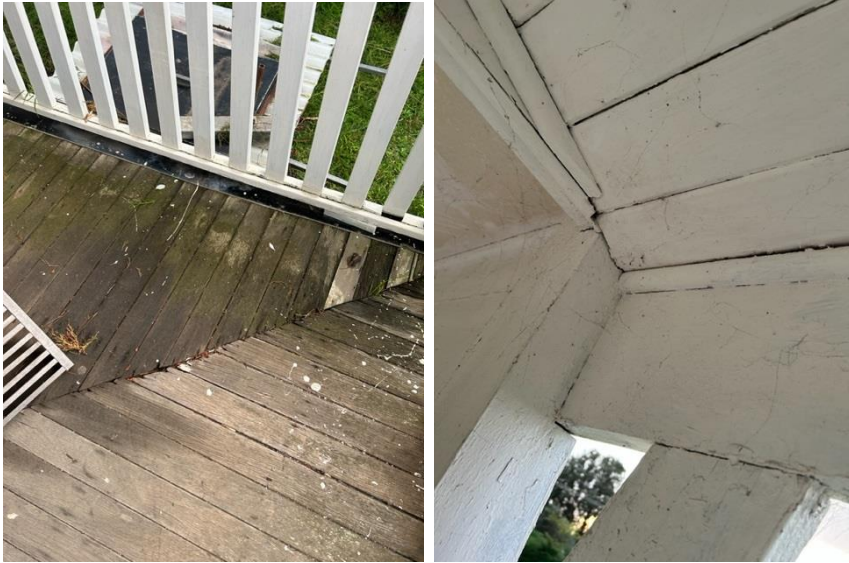
Extensive failure of structure – joints 5mm – 50mm separations. Rotting timbers, total failure.

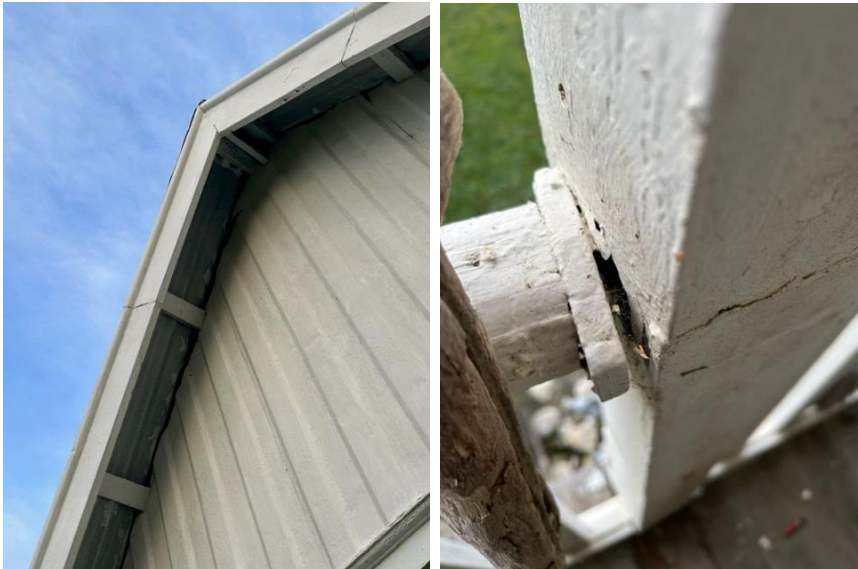
Entire front section failed, and temporary section added to replace rusted section. Balustrading totally failed.

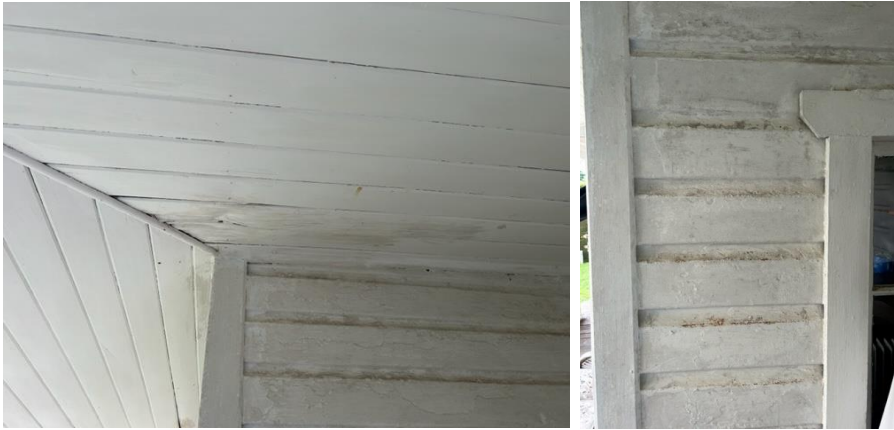
Extensive rust throughout cladding. Rotten lining boards are crumbling away under the leaking ceiling.

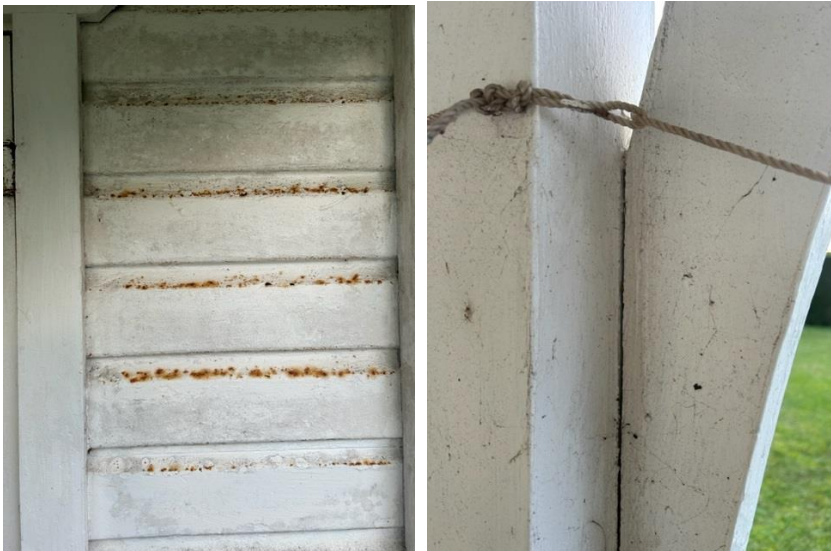
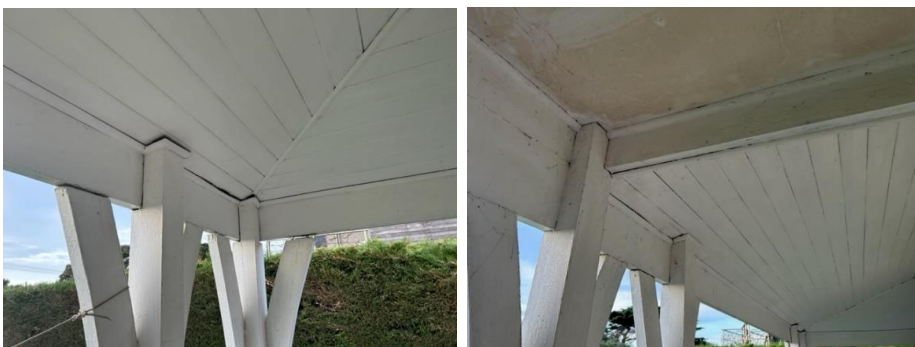
Miss aligned structure supports.

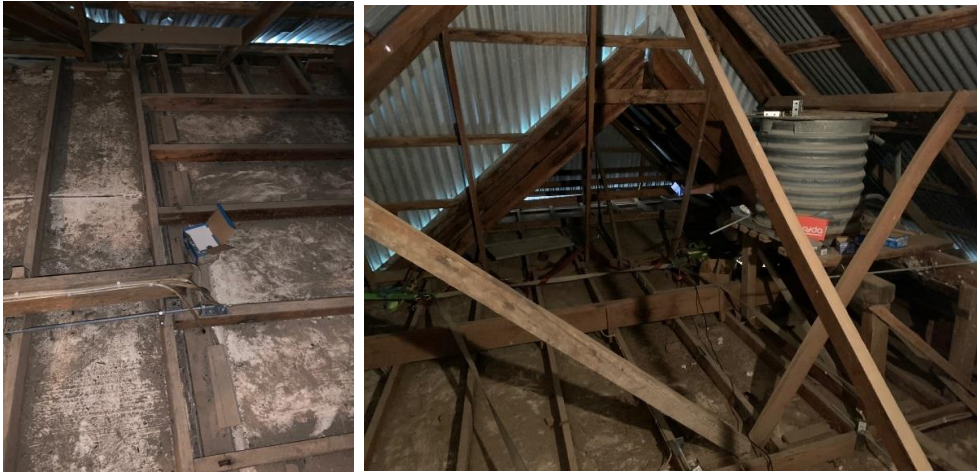
Temporary bolts and ties holding roof together – significant failure of beams with temporary supports added to support roof tin (also failing).

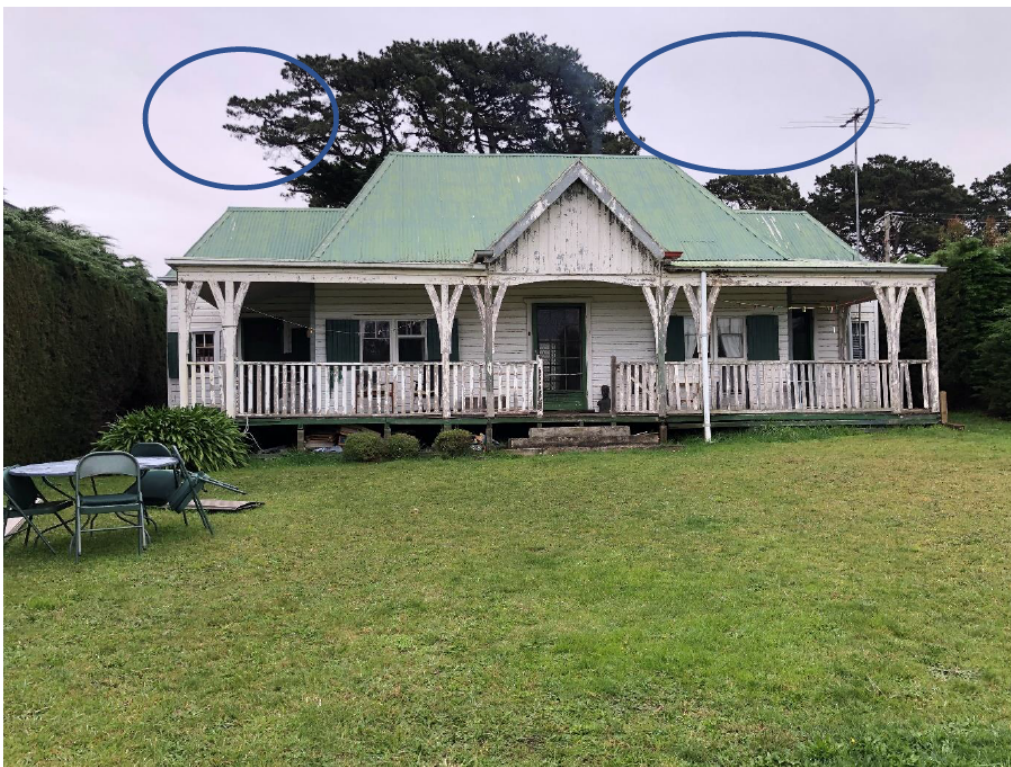
Photo taken just prior to covid lockdown. During Covid the house was painted with rust treating enamel paint to try and hold the rust – sadly the rust started reappearing through the new paint within 6 months. There are significant areas where major sections of the pine trees have fallen. One of them creating \$12k of damage.

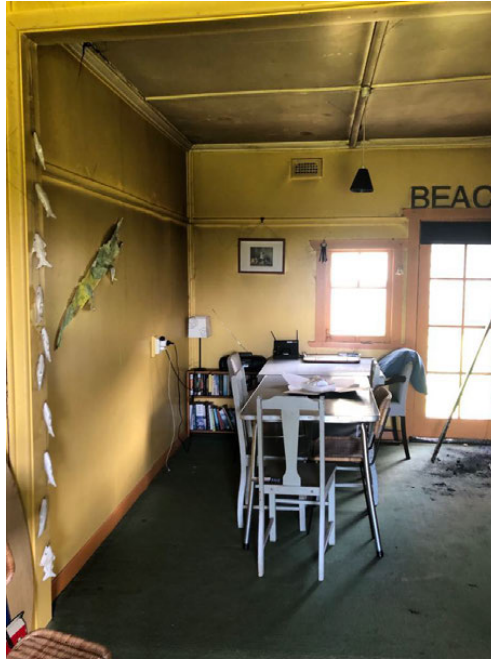
Smoke damage occurred across the entire house. All carpets, fittings and electrics were removed.

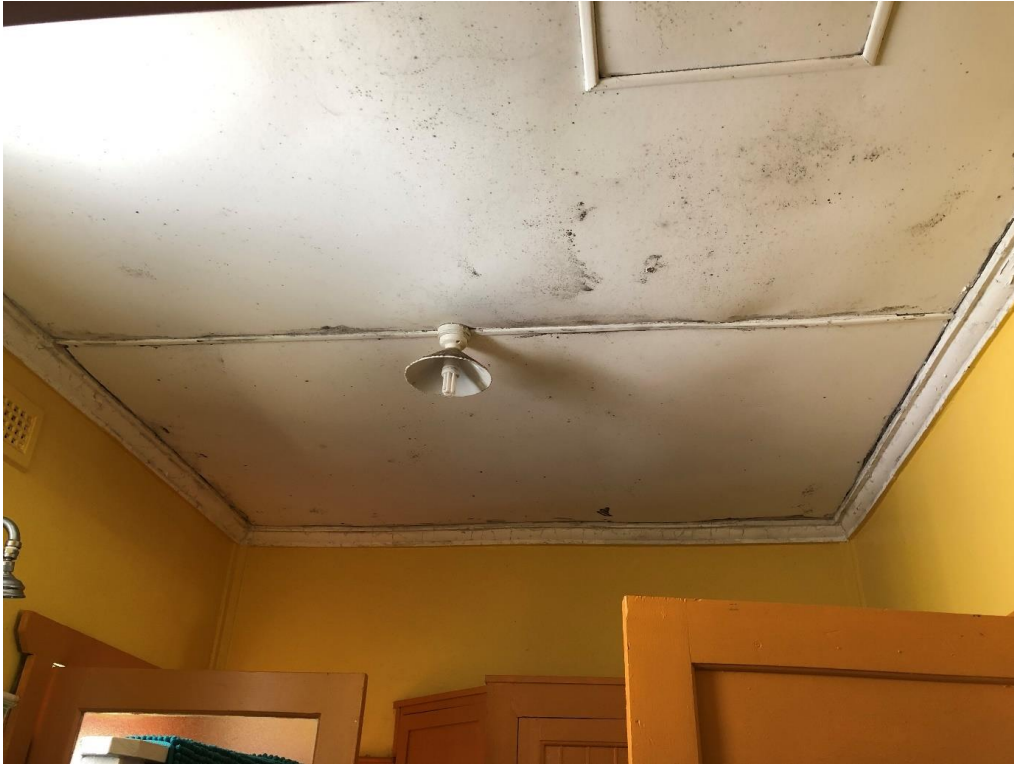
Central ceiling structure failure.

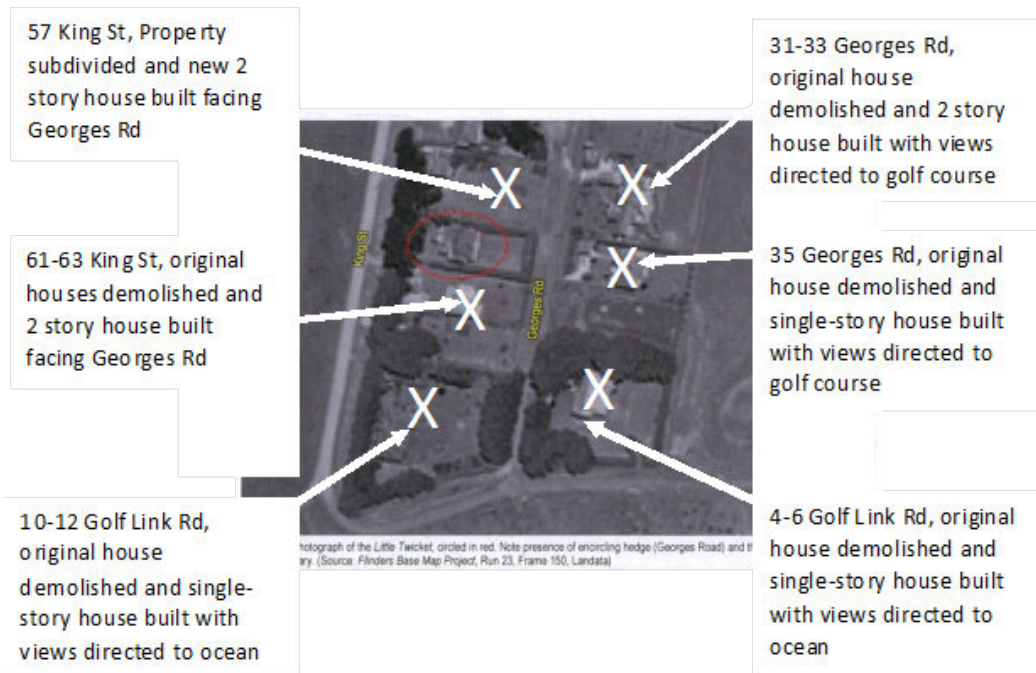
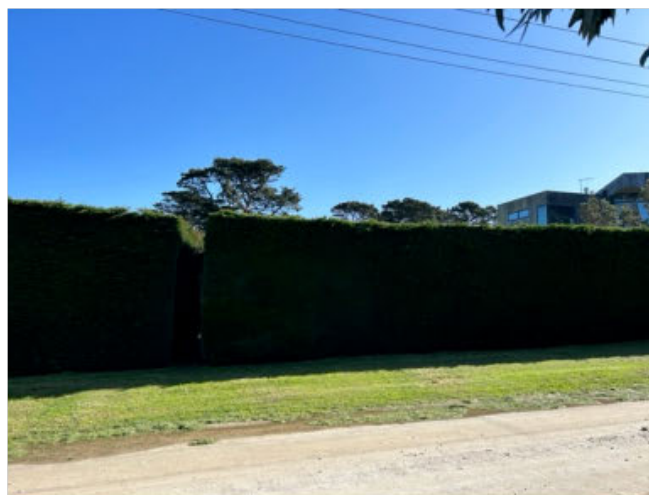
Georges Rd street view of 59 King Street property. Zero connection of the house to the streetscape. There are no views of the house from anywhere in Georges Road.

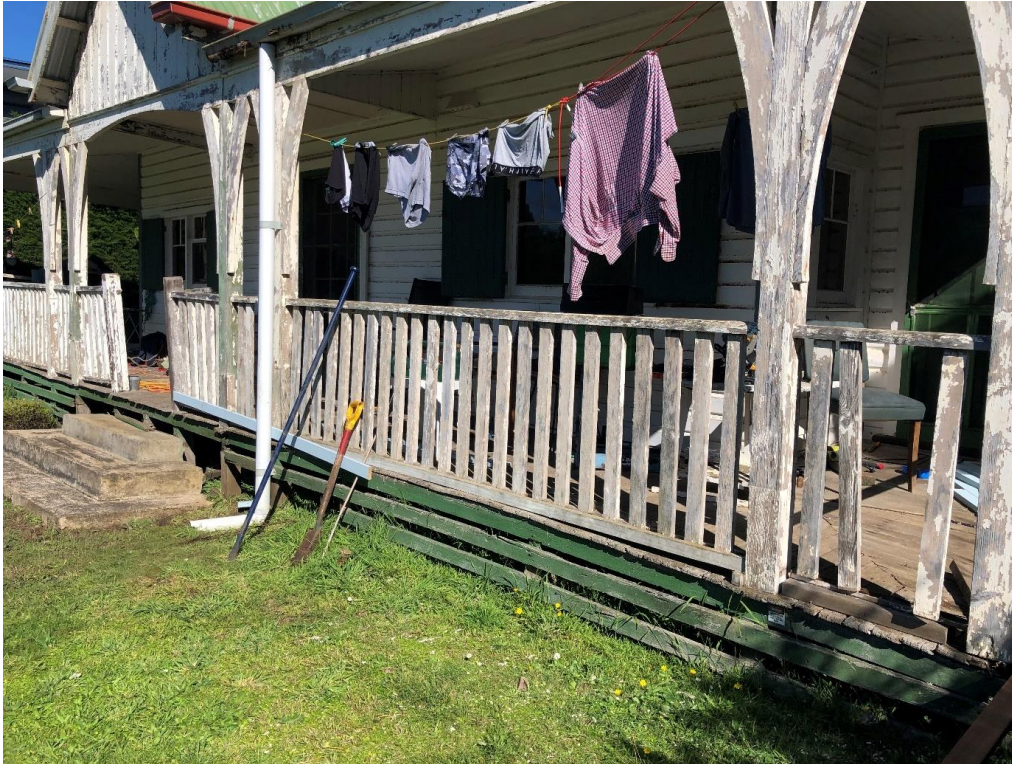
To say receiving the letter dated June 13, 2023 from the Mornington Peninsula Shire was a shock is an understatement, the house has never been listed on previous heritage assessments by the Shire or the previous Shire of Flinders. It has no heritage value and is past its useful life. All materials in the house are rusting, rotting and beyond restoration. The house is in a state of literally falling down.

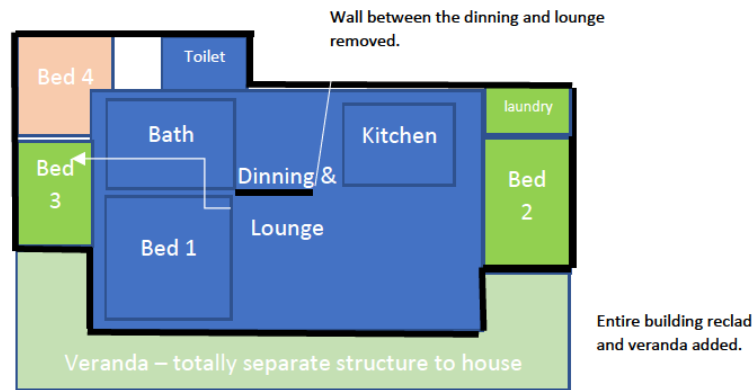
Addition Front Veranda

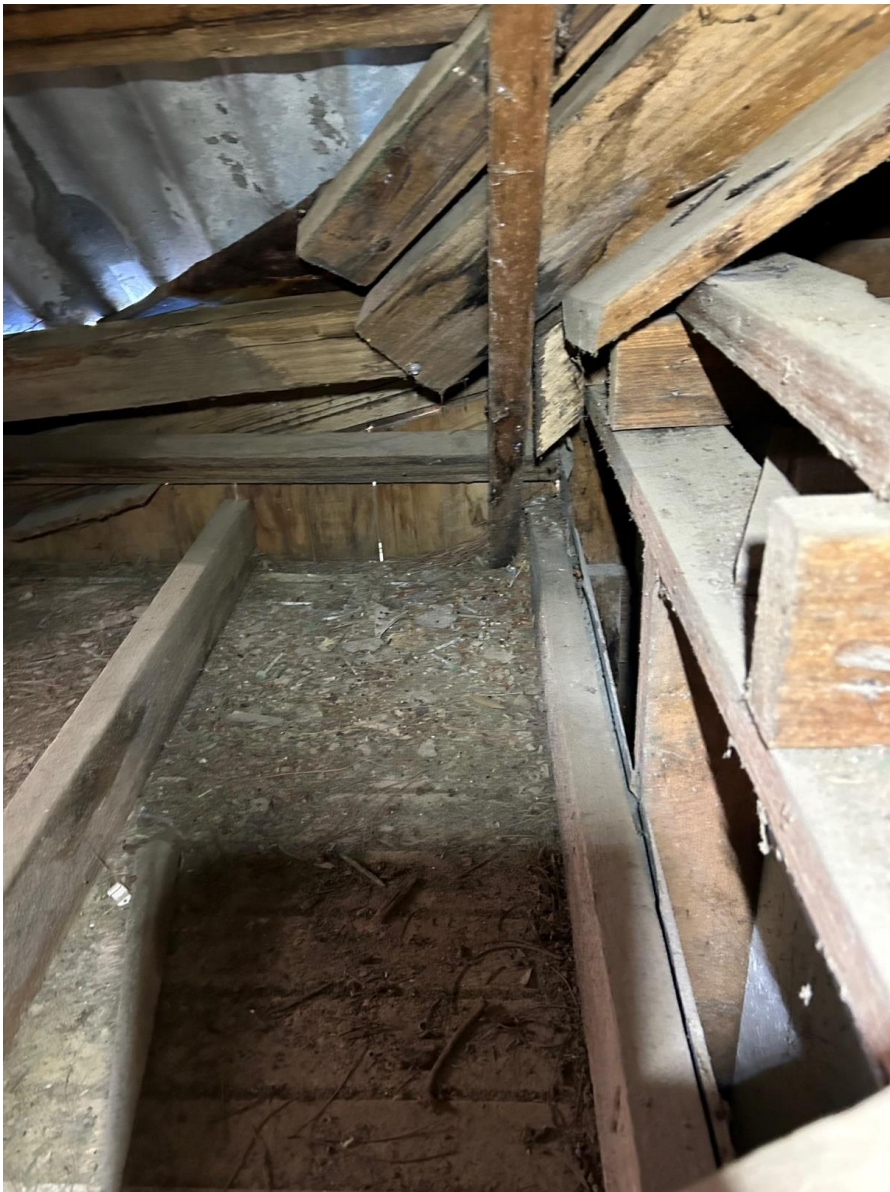
Photo looking south showing the veranda centre section connection to the original house rectangle. Significant water damage to structural timbers with roof truss members bowing 25 – 30mm. Structural timbers, joists and studs all Tasmanian hardwood.

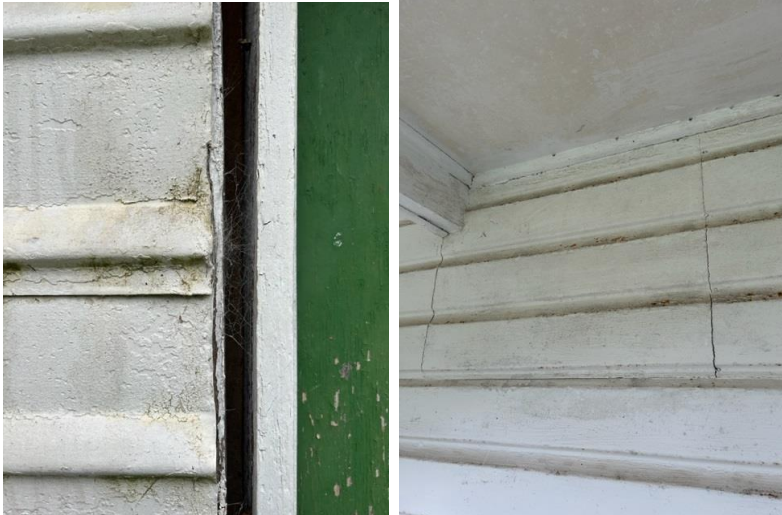
Wide Gaps are throughout the house, vertical cracks in the cladding

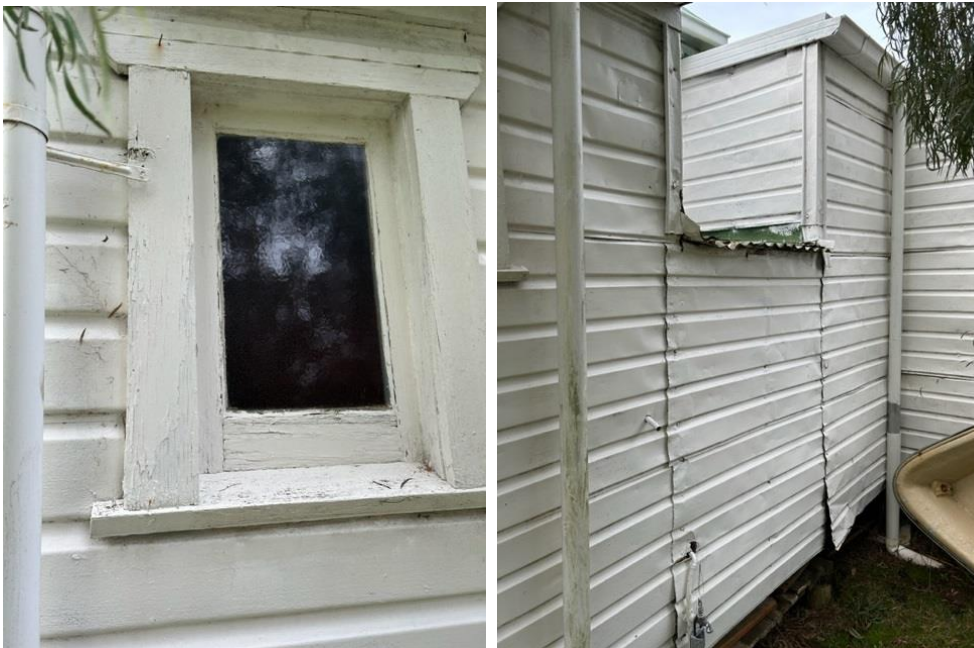
Cladding totally at the end of life. Patched extensively, rusting from both sides.

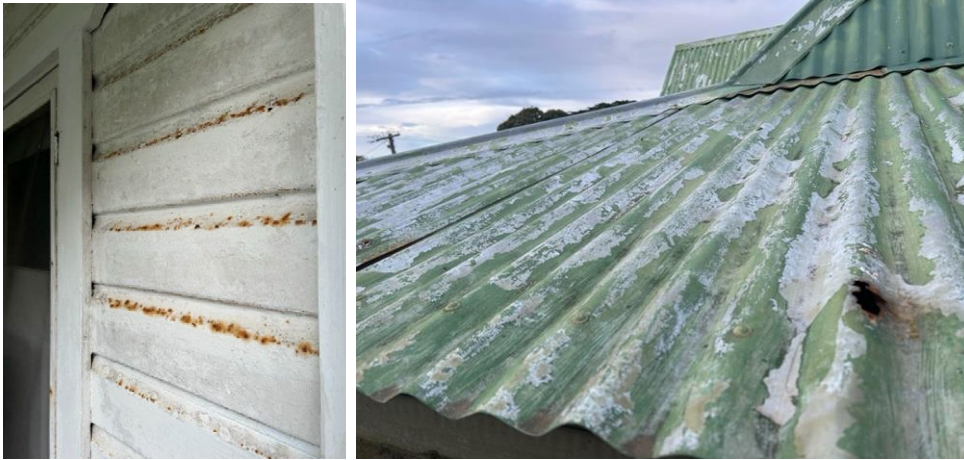
Extensive rust to all cladding. Roof leaks and has extensive holes.

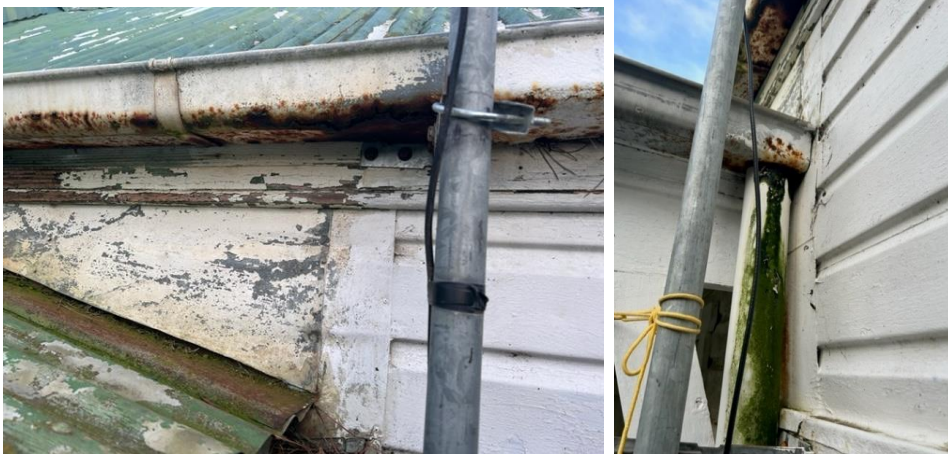
Gutters and drainage dilapidated.

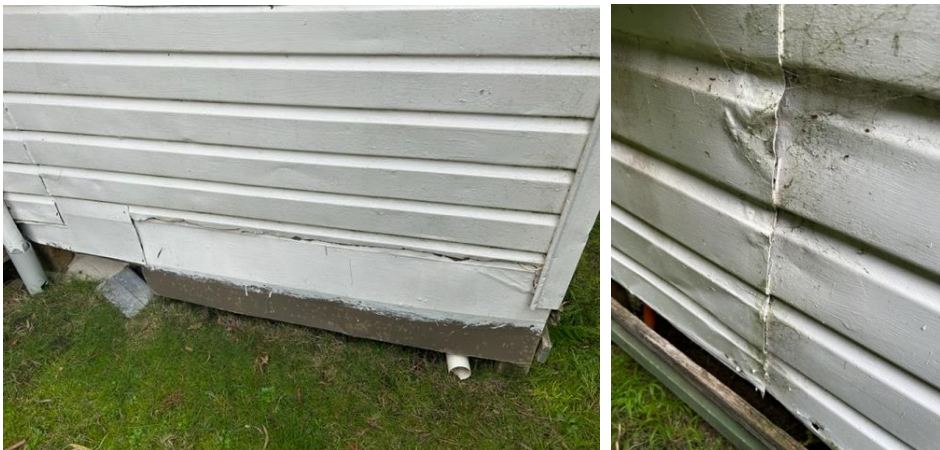
Various patching to exterior cladding to cover rusted out sections.

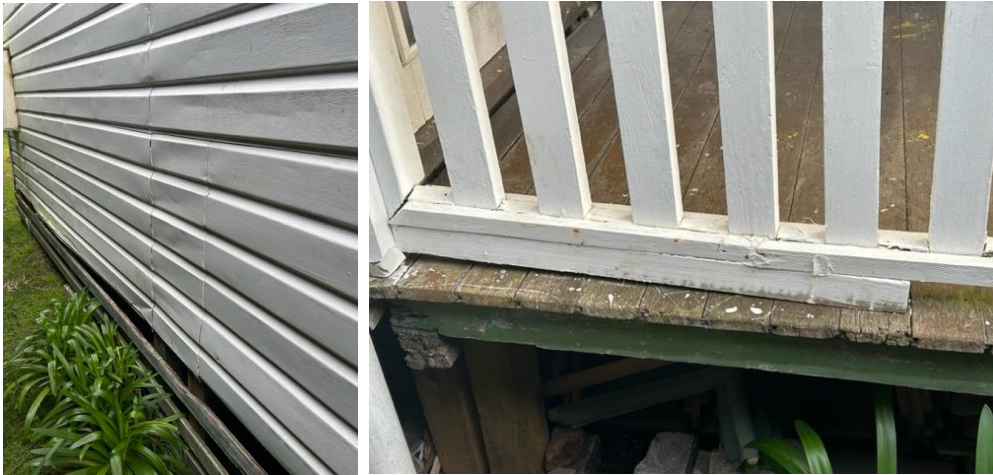
Substructure, stumps, bearers, and beams failed. Temporary concrete blocks to stabilize a 12 – 24 month proposition at best as the reactive clay soil moves up and down depending on seasonal moisture.

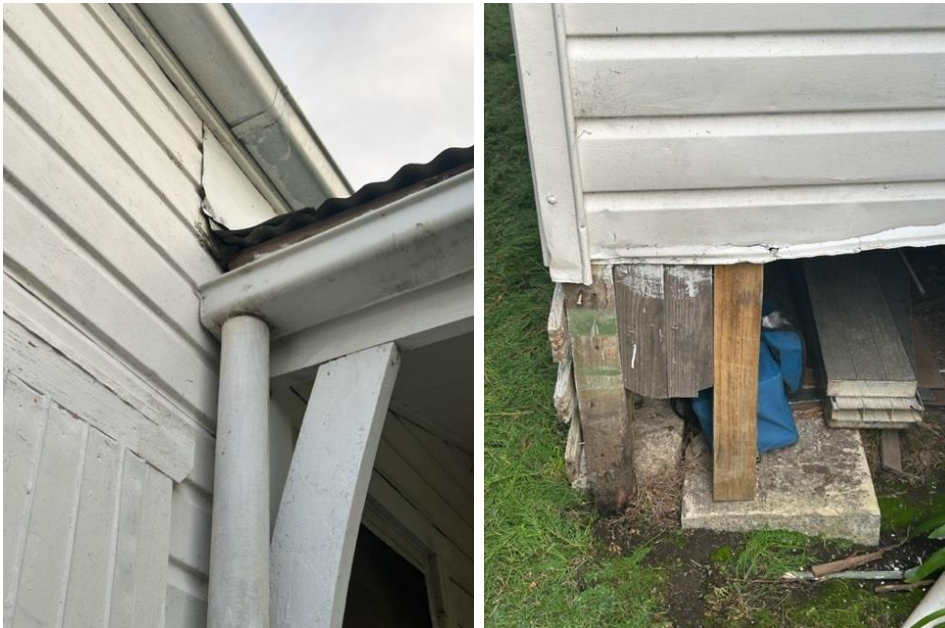
Temporary flashing to cover large rust area, 4 stumps, including latest temporary support with concrete pad sitting on surface. Extensive rust on cladding and bottom section falling off.

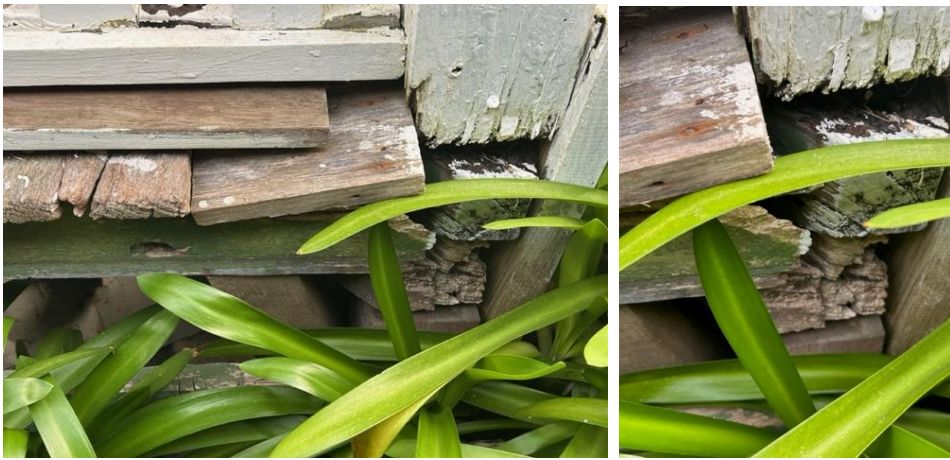
Substructure totally failed.

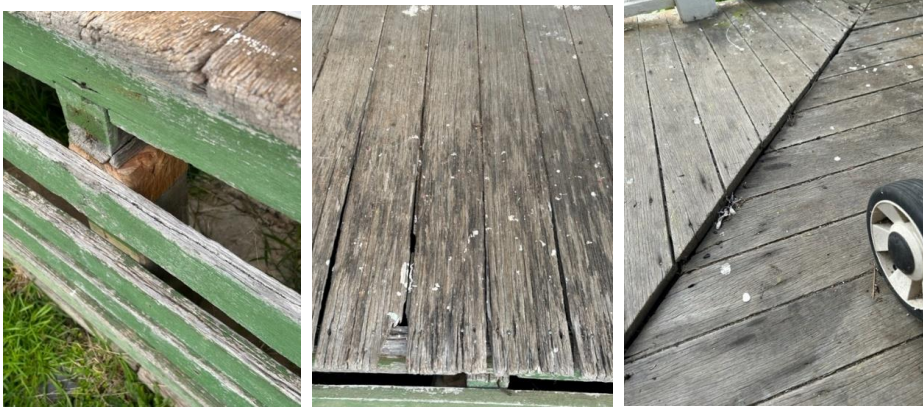
Veranda timber totally failed.

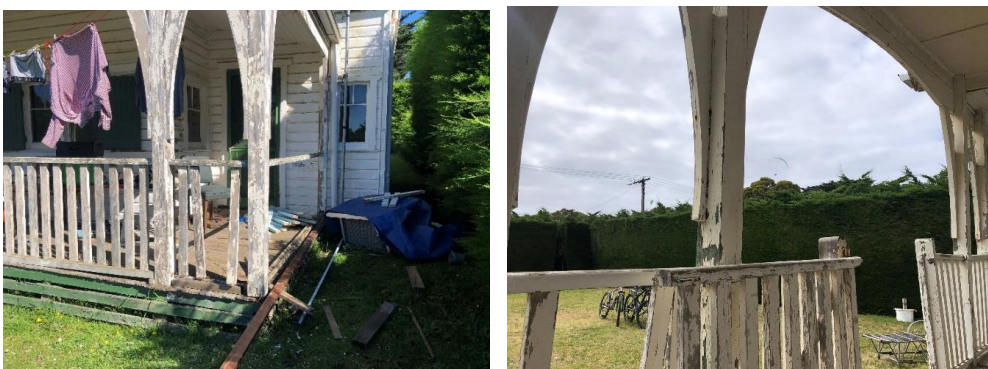
Timbers have been temporarily propped up, but you can see the condition of the timber – it has failed.

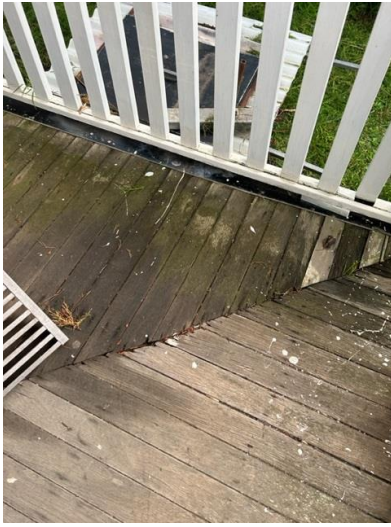
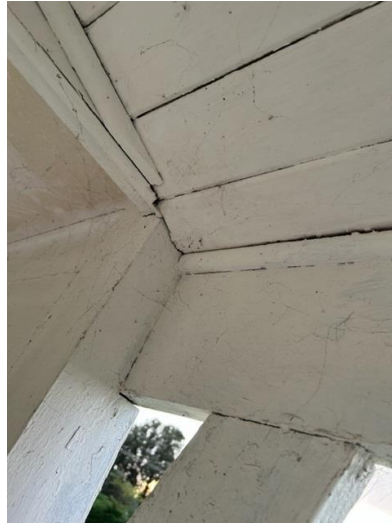
Extensive failure of structure – joints 5mm – 50mm separations. Rotting timbers, total failure.

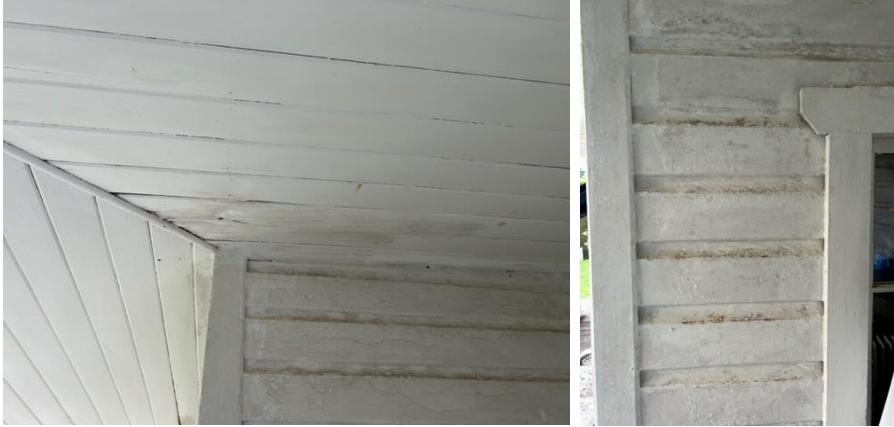
Extensive rust throughout cladding. Rotten lining boards are crumbling away under the leaking ceiling.

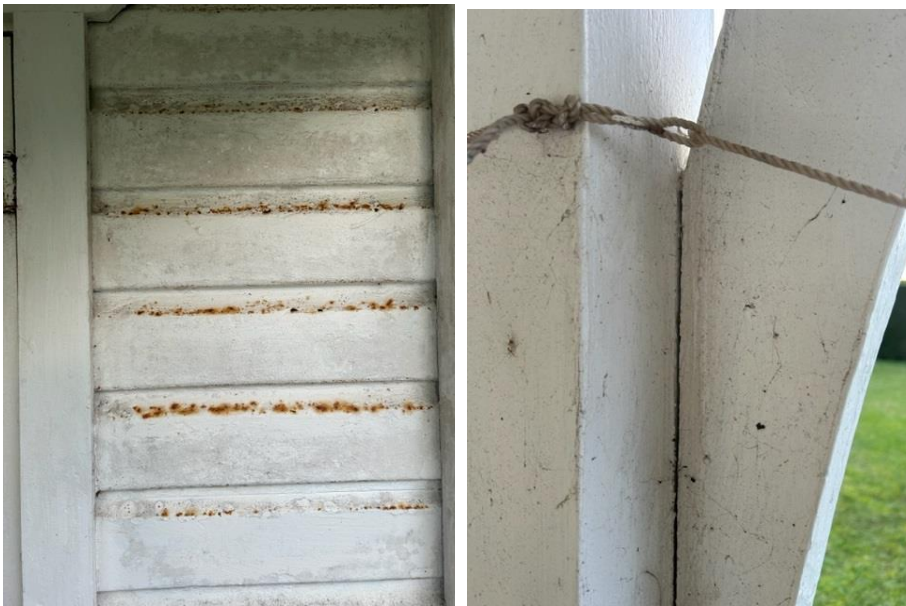
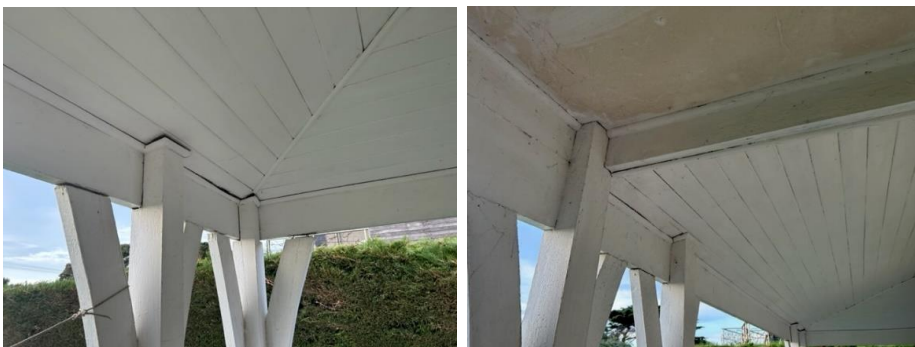
Miss aligned structure supports.

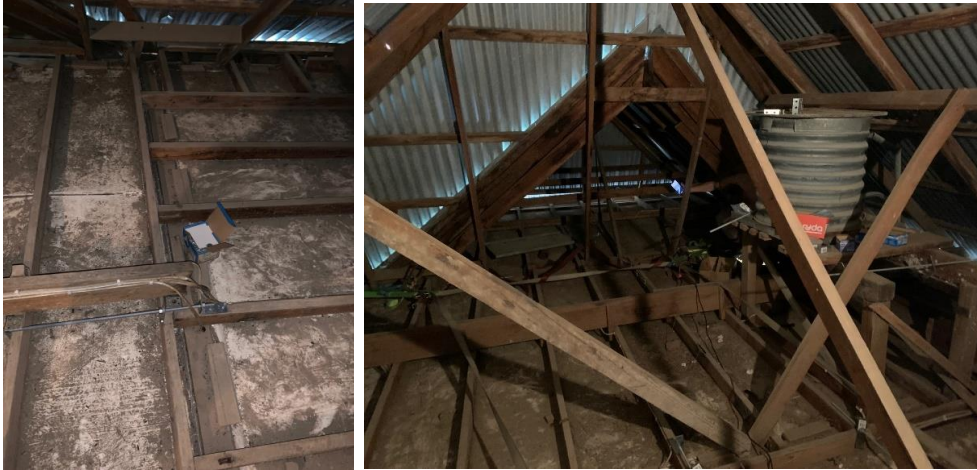
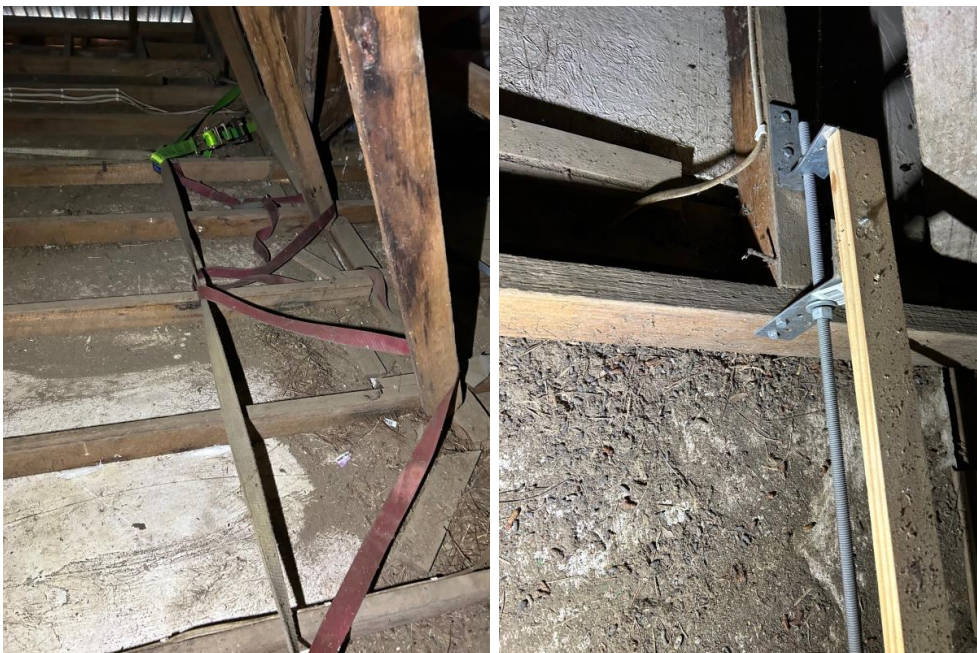
Temporary bolts and ties holding roof together – significant failure of beams with temporary supports added to support roof tin (also failing).

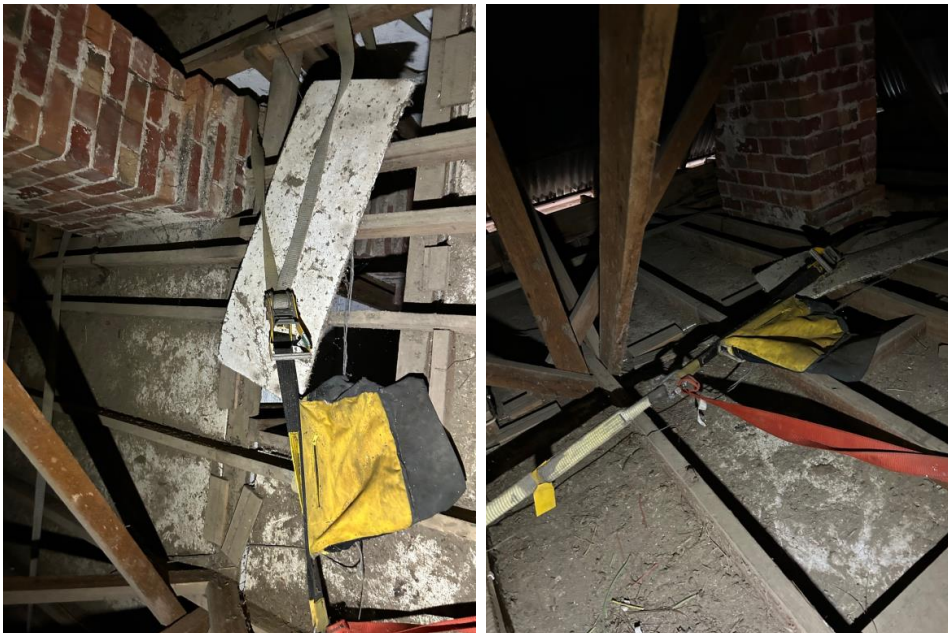
Ties and bolts were added post 2021 fire to temporarily tie the south Bed 3 addition to the central rectangle structure – these are very temporary. Significant water damage and the loss of the buildings stumps have resulted in the south addition separation from the original centre rectangle.
