**MORNINGTON
PENINSULA**
Shire

ATTACHMENTS

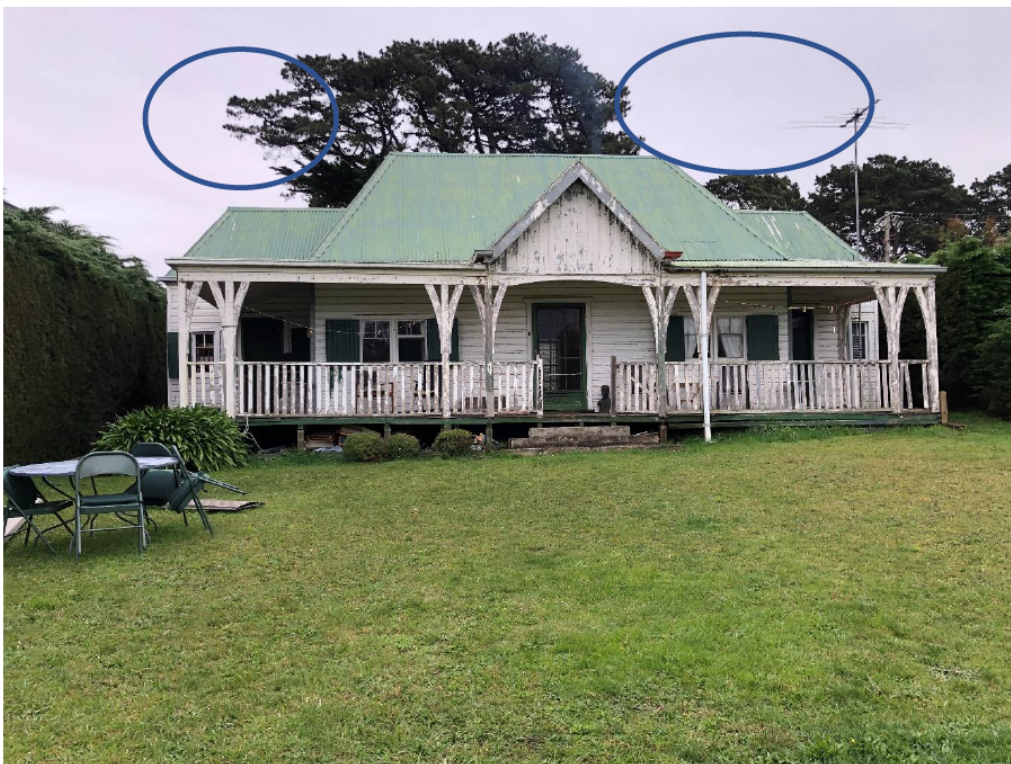
Photo taken just prior to covid lockdown. During Covid the house was painted with rust treating enamel paint to try and hold the rust – sadly the rust started reappearing through the new paint within 6 months. There are significant areas where major sections of the pine trees have fallen. One of them creating \$12k of damage.

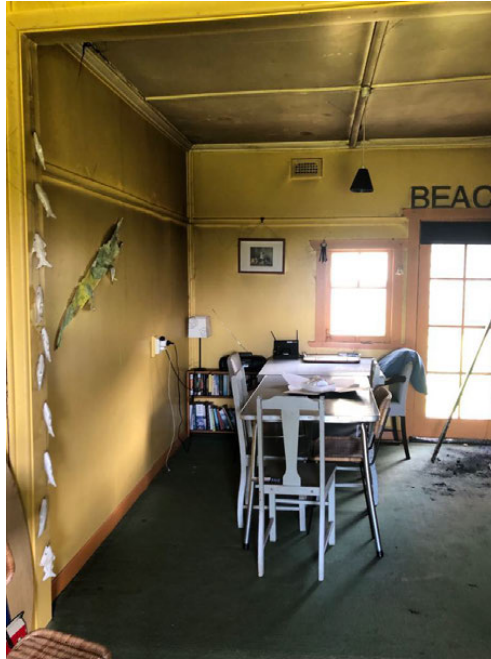
Smoke damage occurred across the entire house. All carpets, fittings and electrics were removed.

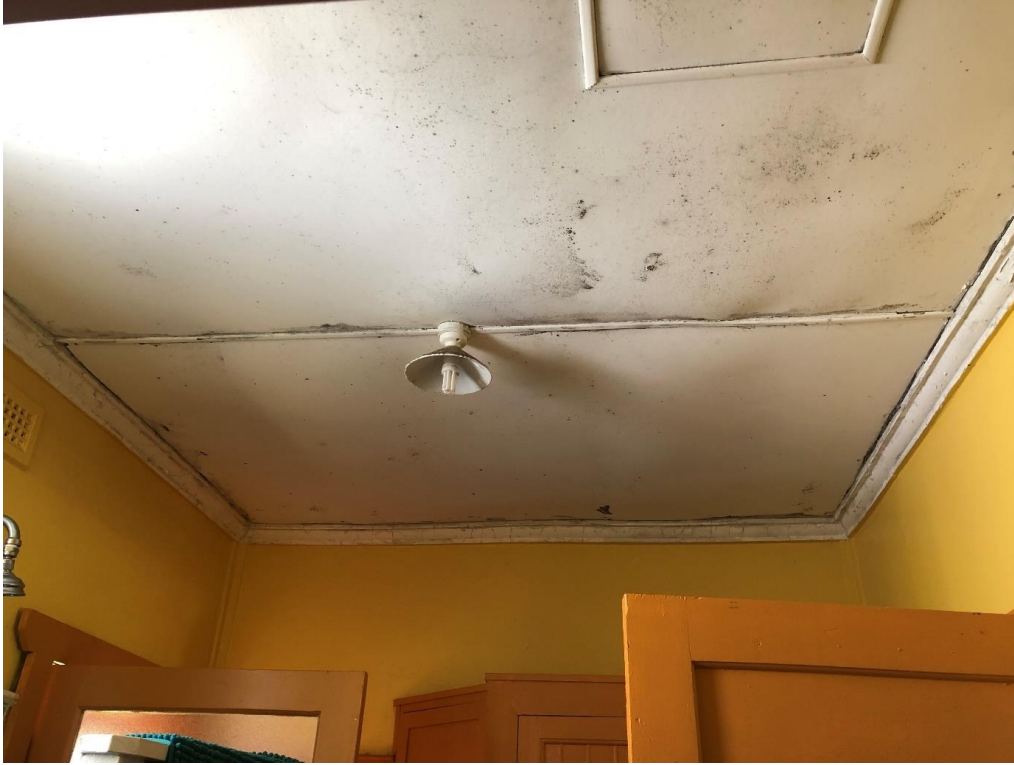
Central ceiling structure failure.

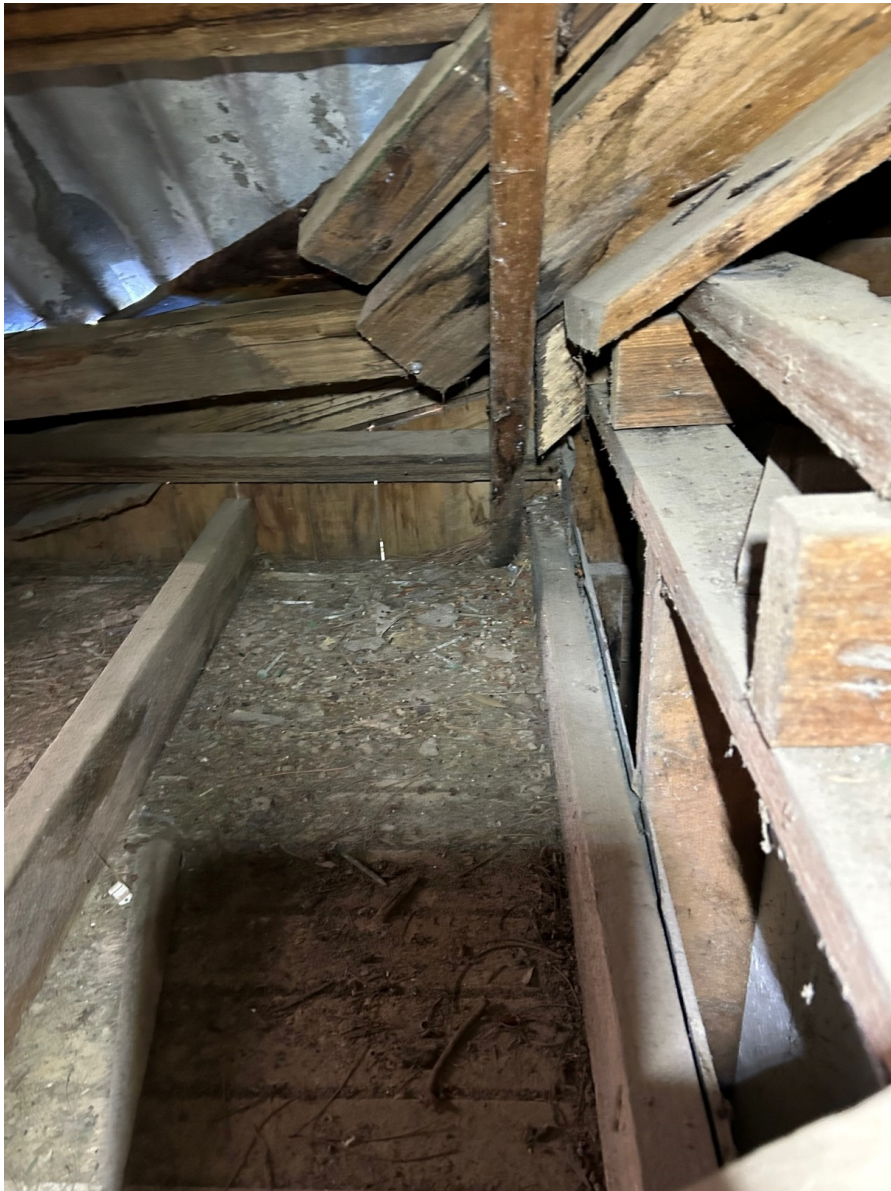
Photo looking south showing the veranda centre section connection to the original house rectangle. Significant water damage to structural timbers with roof truss members bowing 25 – 30mm. Structural timbers, joists and studs all Tasmanian hardwood.

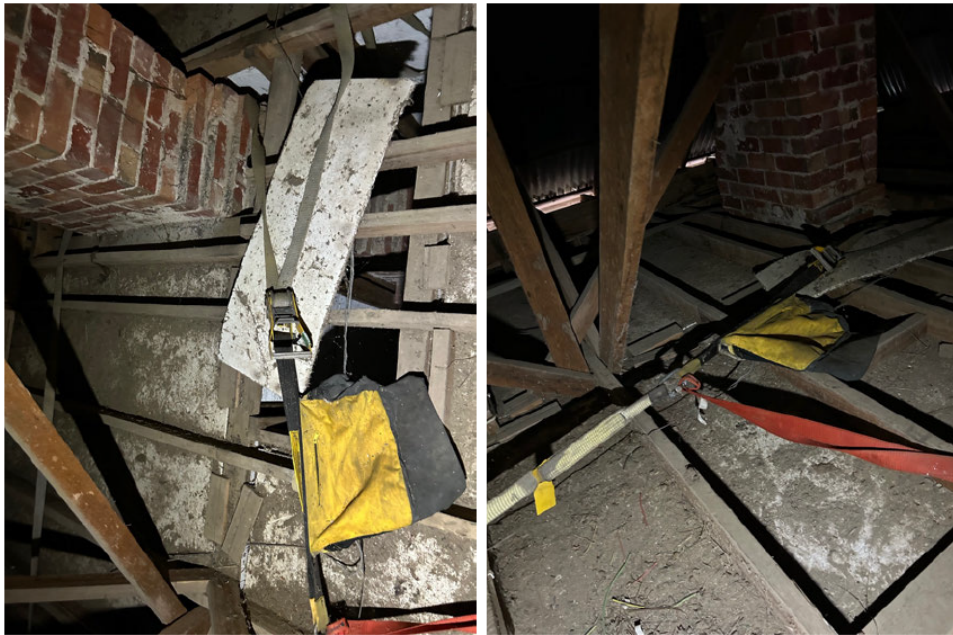
Additional bracing props to temporarily lock up the roof structure.
