Section 4

BOATSHEDS AND BATHING BOXES

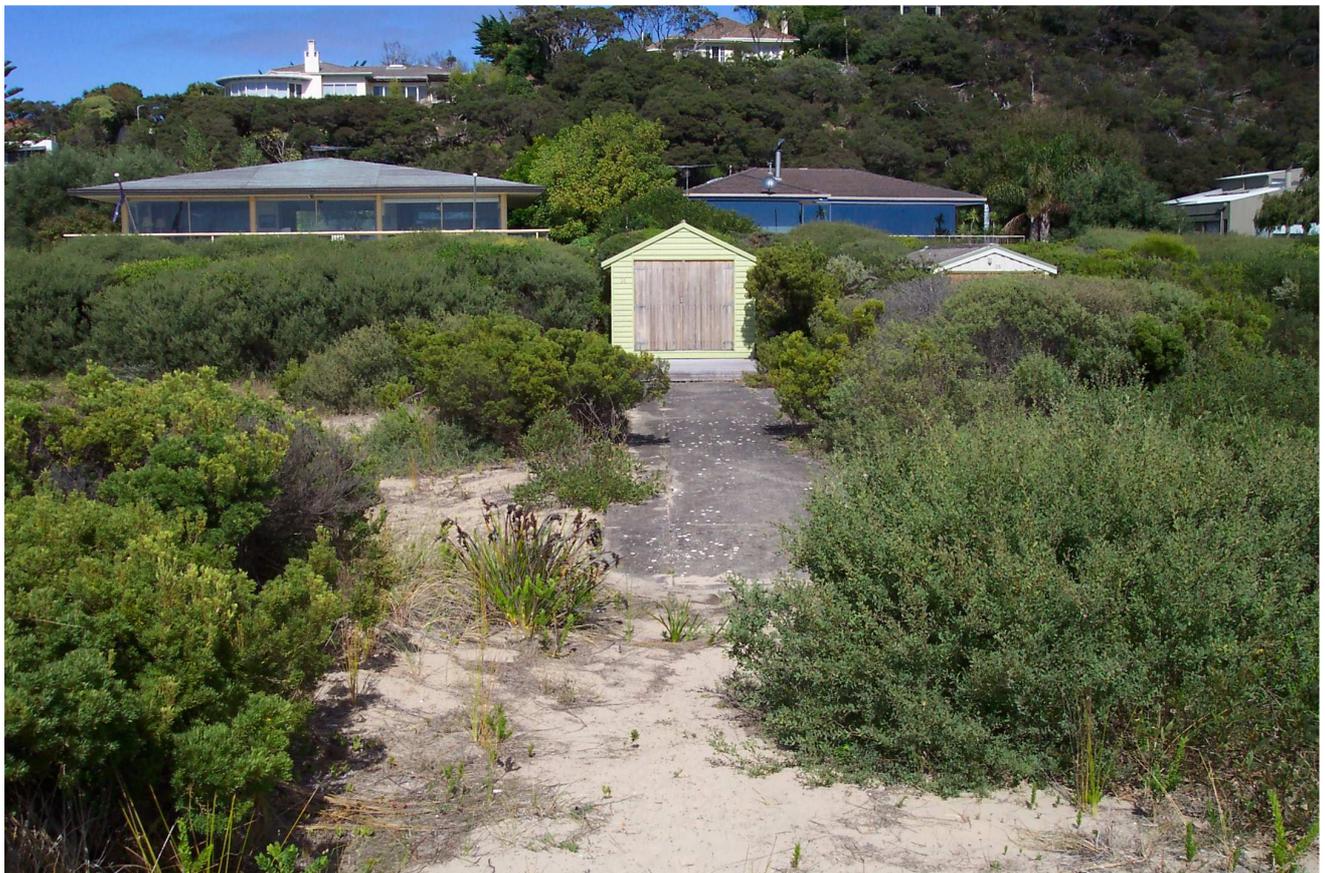
Photograph 8: Typical boat shed – eastern part of Shelley Beach

access and use. All of the Shelley Beach foreshore to the west of Campbells Road is presently vulnerable to wave attack back to the cliff line. Therefore if structures were to be relocated they would need to be located to the east of Campbells Road, or elsewhere along the bayside foreshore. Photograph 8 shows a typical view looking from the beach back to the existing boat sheds on the eastern side of Campbells Road. The boat sheds are well set back from the water line and are unlikely to be subjected to wave action over a 50 year period. The boat sheds do not form a continual line and there is space between existing boat sheds to accommodate more sheds.

However, the Ti tree vegetation between existing structures is dense (as can be seen in photograph 8) and some of this vegetation would need to be removed to make way for re-located structures.
