**MORNINGTON
PENINSULA**
Shire

ATTACHMENTS

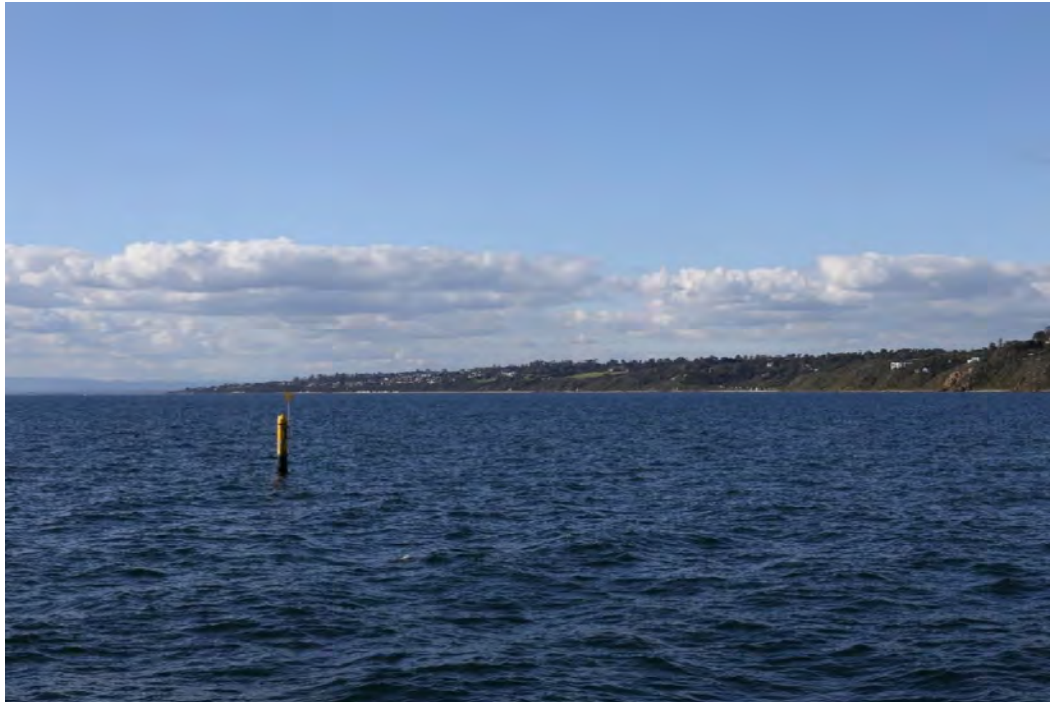
Figure 29 – View from VP1 towards the existing development from the northern end of Mornington Pier (Source: Ryman Healthcare).

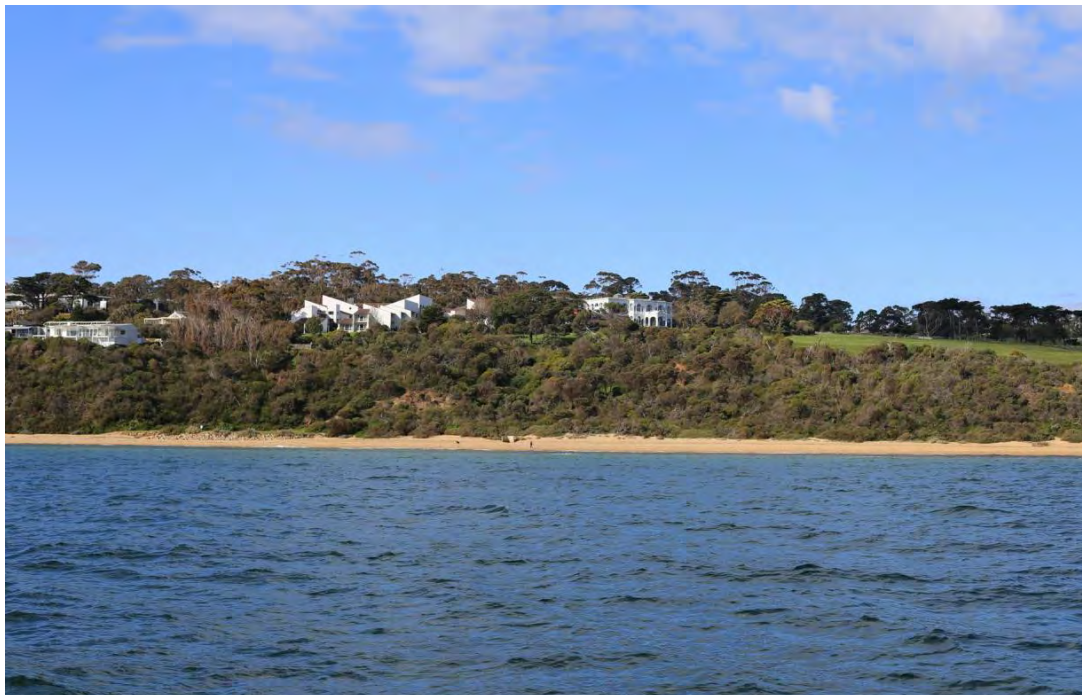
Figure 31 – View from VP2 towards the existing development from Port Phillip Bay.

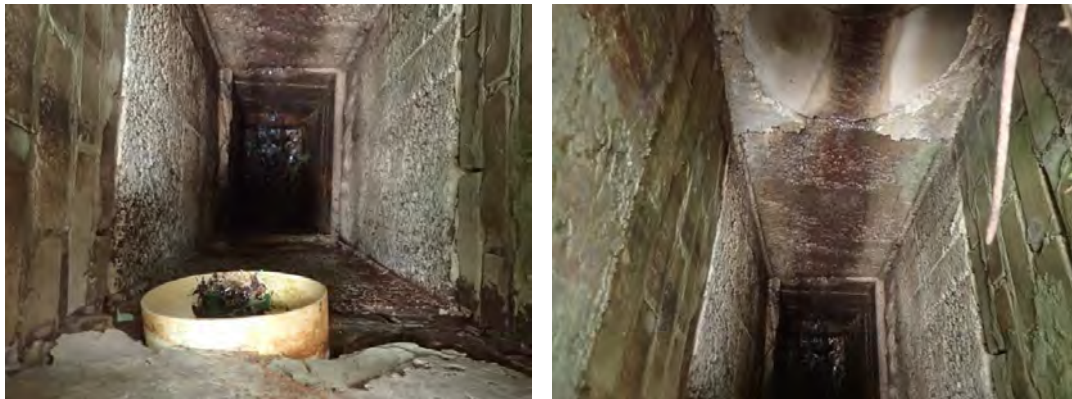
Figure 8 & 9 – Existing drainage ‘drop structure’ (November 2020)

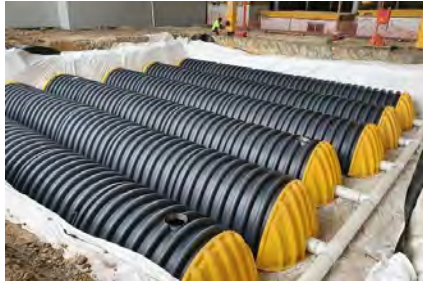
A screenshot of the MUSIC Model (as shown in figure 15 below) can be found below with the treatment train effectiveness of the whole site system displayed. Adams can provide the relevant MUSIC .sqz file if required.

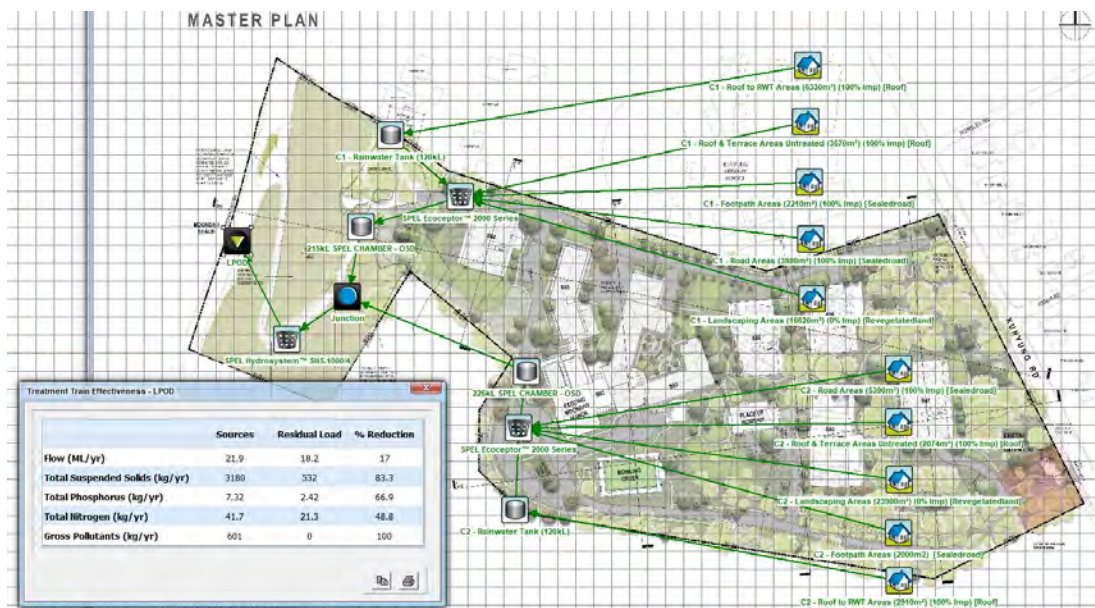
Figure 15 - MUSIC Model (November 2021)

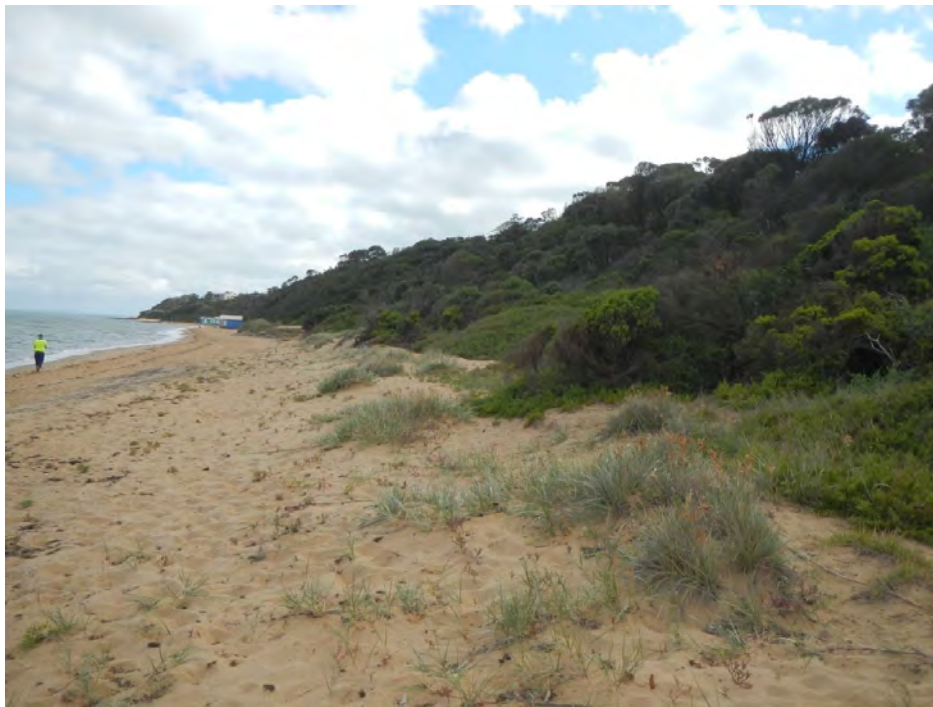
Photo 1 Beach and low dunes, north aspect from the SW boundary of activity area.
Taken by Jodie Mitchell on 10 December 2018.

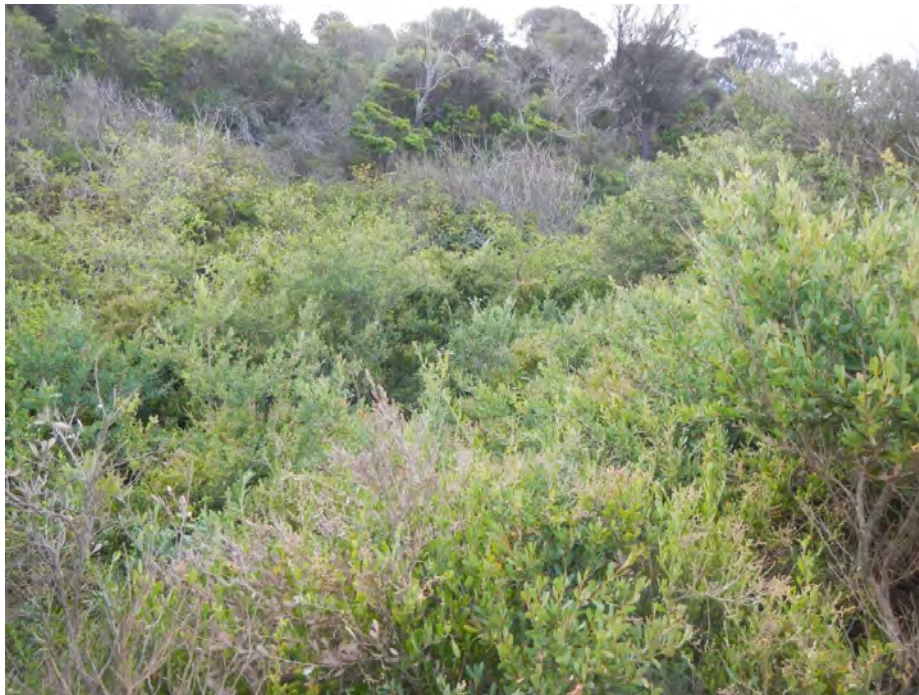
Photo 7 Looking uphill from the base of the steeply sloped area, east aspect.
Taken by Jodie Mitchell on 10 December 2018.

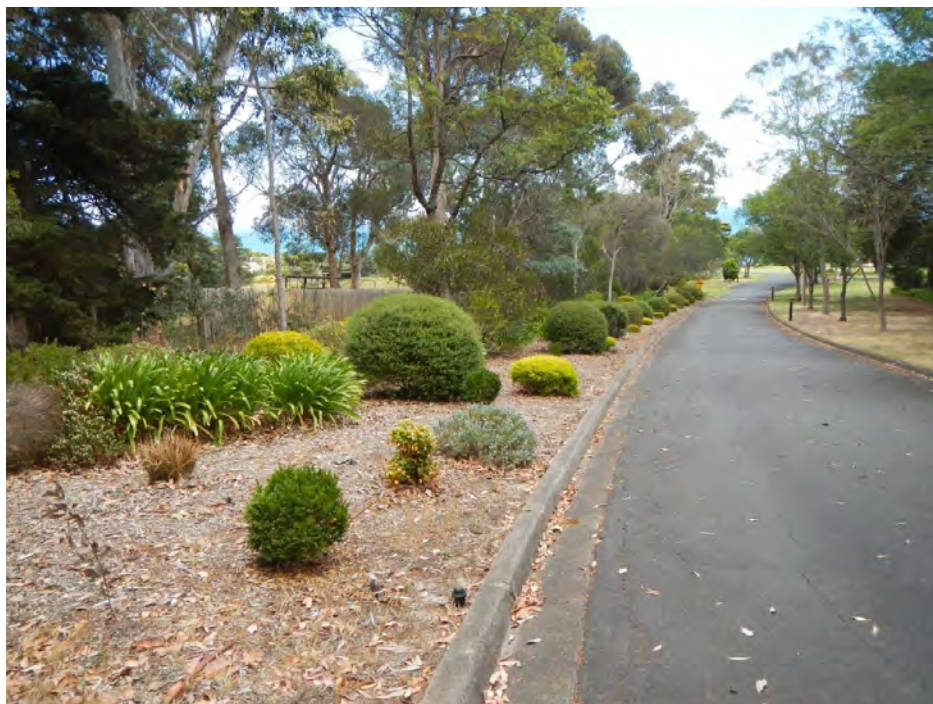
Photo 18 Drive way along south boundary, west aspect.
Taken by Jodie Mitchell on 10 December 2018.

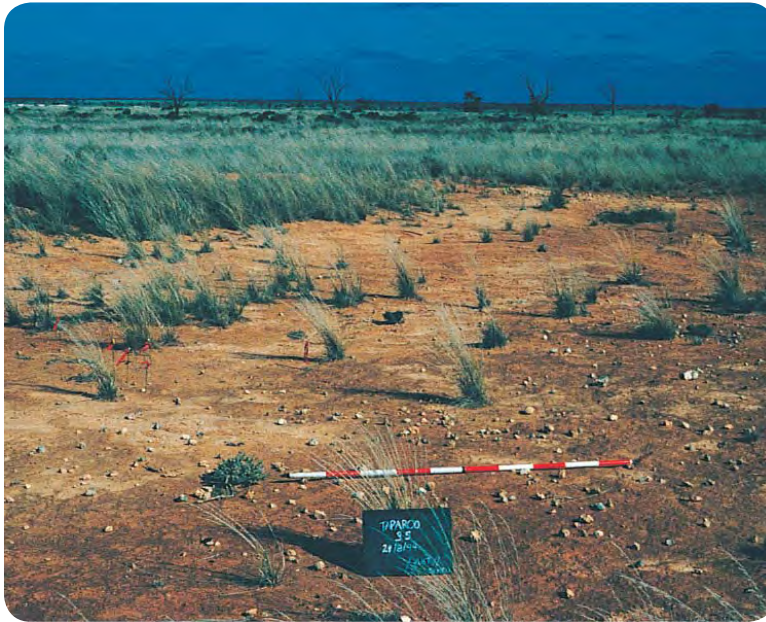
A typical surface scatter found when an older land surface has been exposed

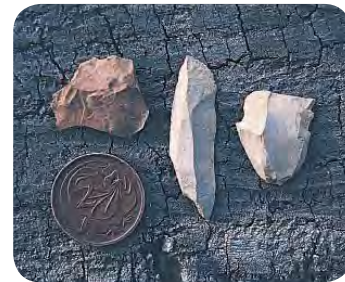
Stone Artefacts like these are commonly found in Victorian surface scatters

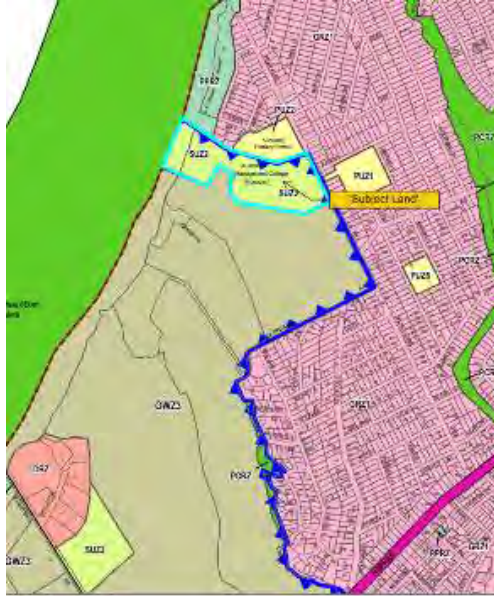
Zoning further south subject to the Design and Development Overlay (Schedule 6).

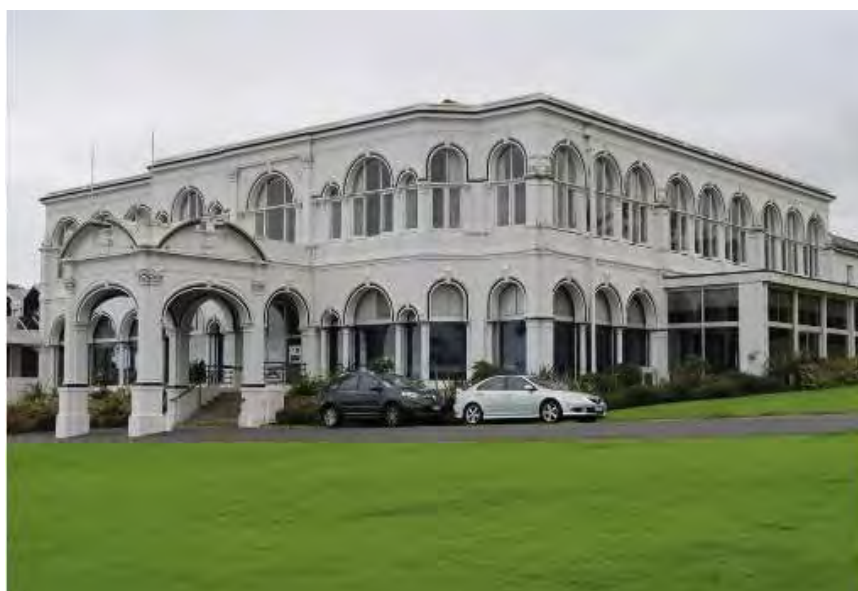
- 150 A further key positive aspect of the proposal is the extensive works proposed to restore and repair key heritage fabric. For example, the more recent structure enclosing the southern verandah of the Moondah Mansion (Copland room) would be removed to reveal the original arcaded façade.

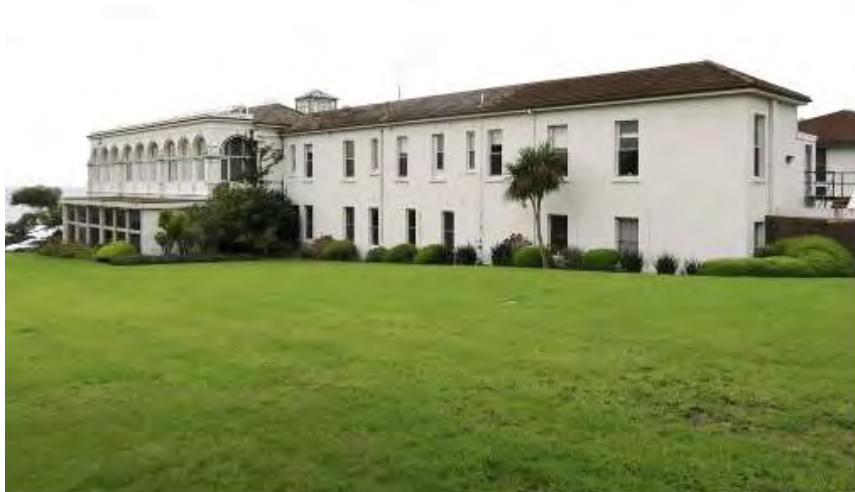
166 Mr Gard'nr confirmed that the Residential Wing (minus a small extension at its easternmost end) was constructed at the same time as the mansion and designed by the same architect. This was affirmed in the Conservation Management Plan. Mr Chessell and Ms Schemeder pointed out that the majority of the external fabric of the Residential Wing was identified of primary heritage significance in that document.³¹
