MORNINGTON
PENINSULA
Shire

Sports Capacity Plan

Volume 1 - Sports Fields

June 2019

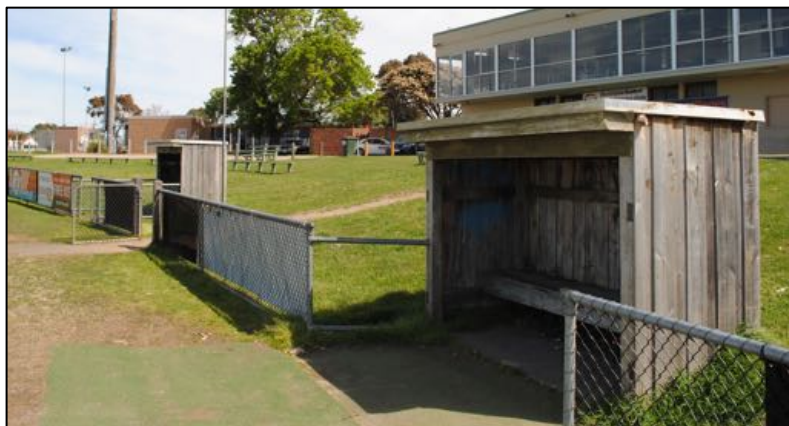
Player Bench

Scoreboard (in poor condition)

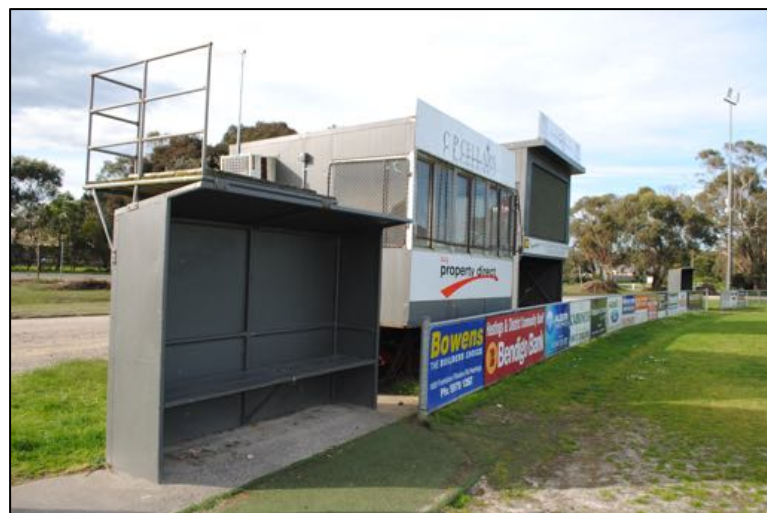
Player Bench (unsafe Coach's viewing platform)

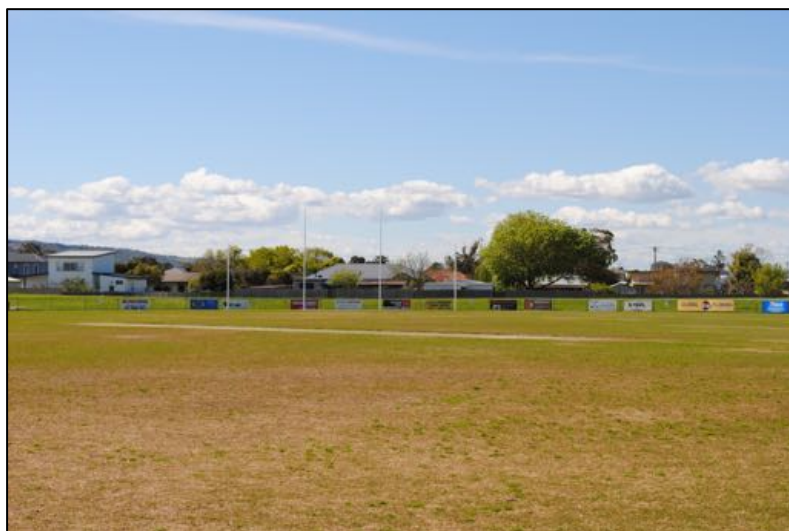
Goal Square Converted to Synthetic Surface

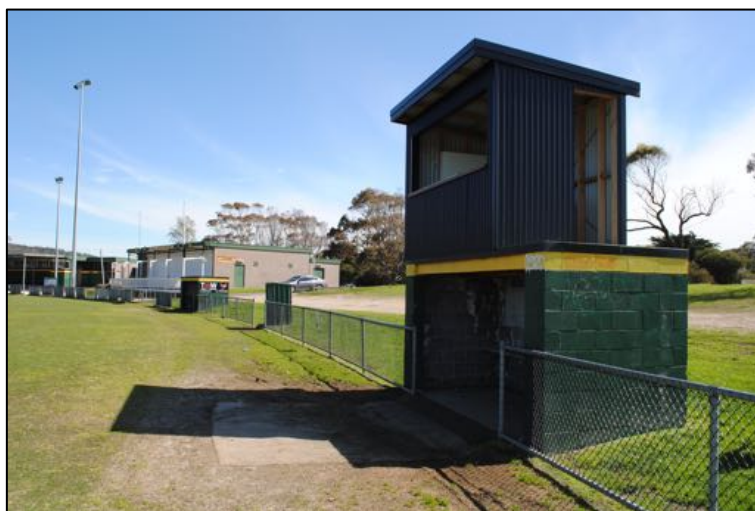
Player Bench (with unsafe Coach viewing platform)

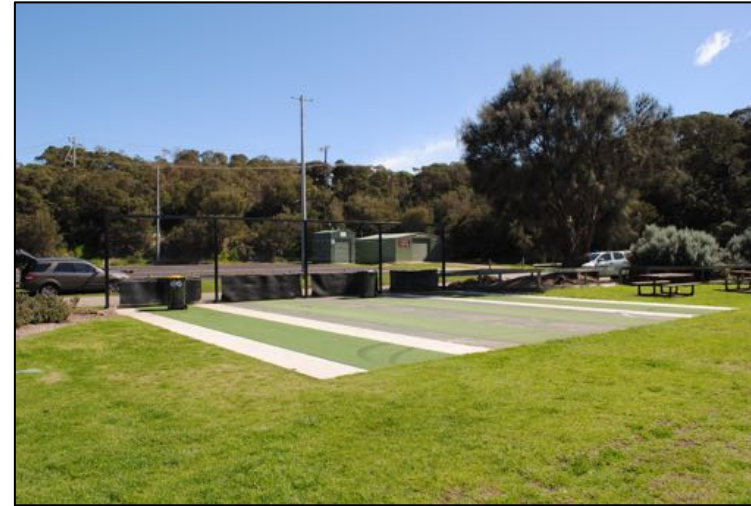
Oval
Cricket Practice Area (flexible netting used)

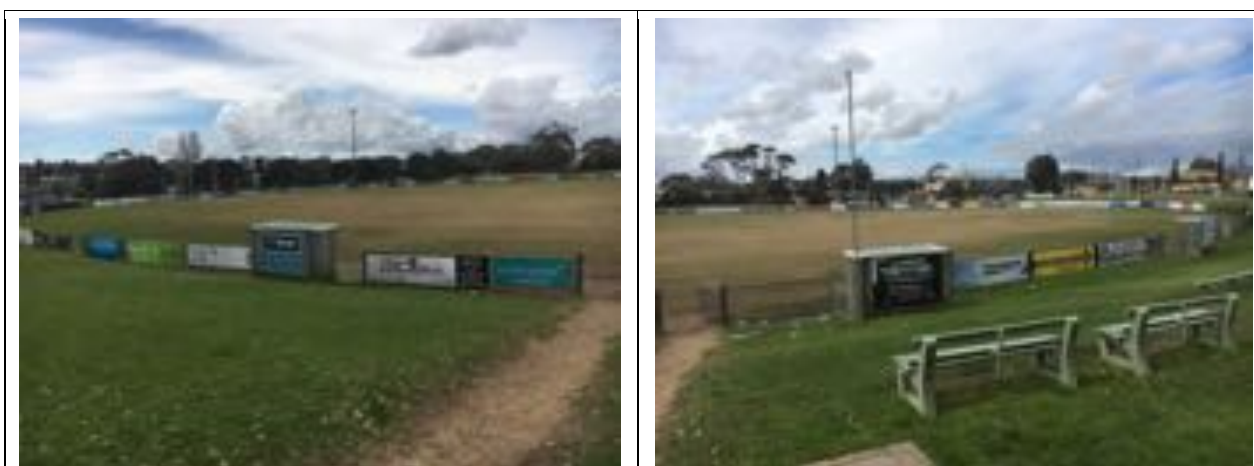
APPENDIX 1 SURFACE CONDITION ASSESSMENT - ALEXANDRA PARK

General	
Importance	High level cricket and AFL football Main oval in the municipality.
Turf ID	Maintained as monostand of couch throughout the year (including winter)
Weed Species % & Type	<5%; very few weeds present.
Surface Condition Rating	
Result	92.1%; excellent condition
Comments	Good overall condition Good turf cover, with minimal weeds Mostly smooth surface although odd hole in the surface that needs addressing. Good mowing practices evident Wear evident in north goal square and run-ups Cricket pitch surface lower than the surrounds.
Sports field Infrastructure	
Comments	Large oval surface. Contains cricket pitch. Good overall surface shape Loamy sand topsoil (200mm deep). Satisfactory automatic irrigation system. Lacks subsurface drainage. Adequate lighting surrounding oval although not new lighting.
Additional Comments	
Appears to be coping with present level of usage while being maintained as monostand of couch all year round Some attention to any weak areas will be needed to ensure that they remain safe and do not pose injury risk. Difficult to justify oversowing this ground unless usage levels alter in future.

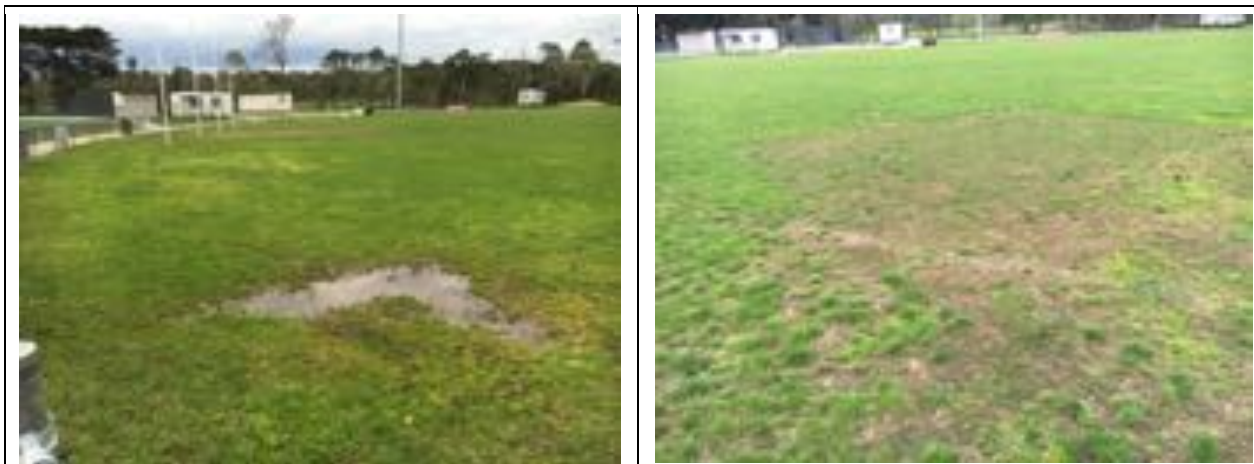
General	
Importance	Cricket and AFL football
Turf ID	Mixed sward consisting of kikuyu, Poa annua & rye
Weed Species % & Type	<5%, consisting of clover, flatweeds
Surface Condition Rating	
Result	76.8%; marginal condition
Comments	Poor turf cover with weak areas throughout Evidence of turf repair Soft surface and wet areas present Wear evident in west goal square resulting in loss of cover Cricket pitch lower than surrounds
Sports field Infrastructure	
Comments	Reasonable size oval surface Contains cricket pitch Approaches ridge to dome shape surface but undulating where damage occurred Sandy loam topsoil Lacks irrigation system. Lacks subsurface drainage confined to perimeter drain. Lighting surrounding oval
Additional Comments	
Struggling to cope with current level of usage, whether training or games. Surface susceptible to damage Needs improving or changing level of usage	
Recommendations	
Maintenance/Management	Monitor training

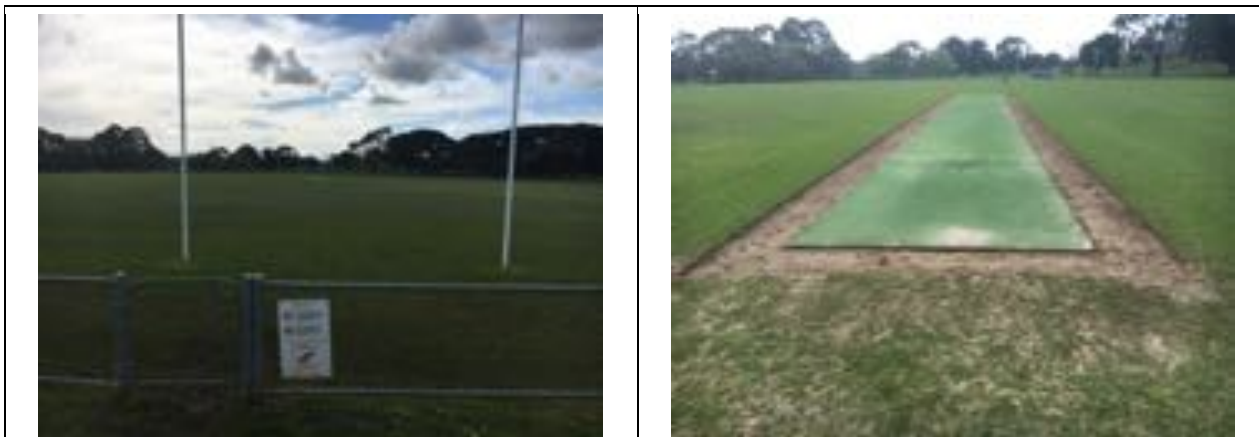
General	
Importance	Cricket and AFL football
Turf ID	Consists of kikuyu & Poa annua
Weed Species % & Type	10-15%, consisting of capeweed
Surface Condition Rating	
Result	92.1%; excellent condition
Comments	Good thick turf cover, although weeds present in surface Smooth surface Surface soft in some areas Very little wear or damage to the surface
Sports field Infrastructure	
Comments	Large oval surface Contains cricket pitch Good overall shape, ridge Heavy soil conditions, consisting of sandy loam Inadequate irrigation system. Lacks subsurface drainage No lighting
Additional Comments	
Currently in excellent condition and coping with current level of usage. Benefit from being upgraded, ie. irrigation and lighting to take some of the pressure off the No.1 Ground	
Recommendations	
Maintenance/Management	Control weeds
Capital Improvements	Install lights to spread wear especially from other ground Install irrigation

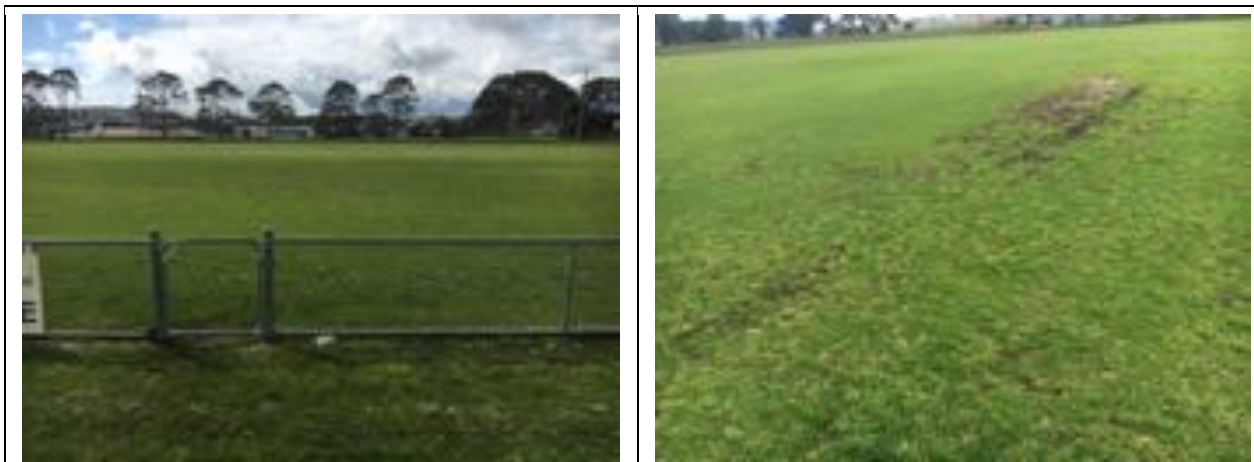
General	
Importance	Cricket & AFL football
Turf ID	Mixed sward consisting of kikuyu, rye & Poa annua
Weed Species % & Type	<5%, consisting of clover
Surface Condition Rating	
Result	70.1%; poor condition
Comments	Weak turf cover, especially east side of oval Boggy, soft, unstable areas, especially in east side of oval Poor playing conditions especially through wet weather Wheel ruts in surface, indicative of soft surface Wear evident in goal squares and most of surface especially corridor, training
Sports field Infrastructure	
Comments	Large oval surface Contains cricket pitch Verging on 1 way slope, undulations throughout, especially where damage occurred to surface. Sandy loam topsoil Satisfactory automatic irrigation system. Lacks subsurface drainage Limited lighting surrounding oval, confined to west side. Cricket pitch lower than surrounds
Additional Comments	
Not coping with current level of usage, with excessive damage to surface, especially east side. Needs to be upgraded.

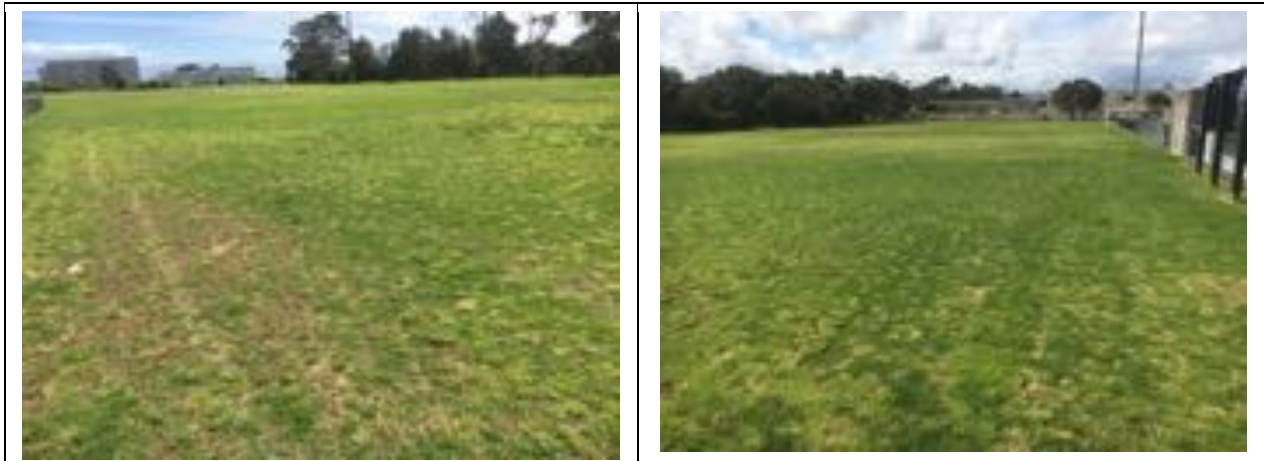
General	
Importance	Soccer & soccer training
Turf ID	Mixed sward consisting of kikuyu, rye & Poa annua
Weed Species % & Type	<5%, very few weeds
Surface Condition Rating	
Result	68.6%; poor condition
Comments	Considerable wear and damage to surface. Resulting in uneven turf cover. Boggy soft and unstable areas present in surface Surface ruts Considerable wear in goals, corridor, associated with training
Sports field Infrastructure	
Comments	Adequate size Approaching 1 way slope Sandy loam topsoil (200mm deep). Inadequate irrigation system. Lacking subsurface drainage confined to perimeter drain. Limited lighting
Struggling to cope with the current level of usage. Needs upgrading to cope with current level of usage. Also needs changes to training practices, by monitoring training to spread wear and minimise extent of damage to the surface.	
Recommendations	
Maintenance/Management	Repair surface, returf goal mouths Monitor training to minimise damage to the surface

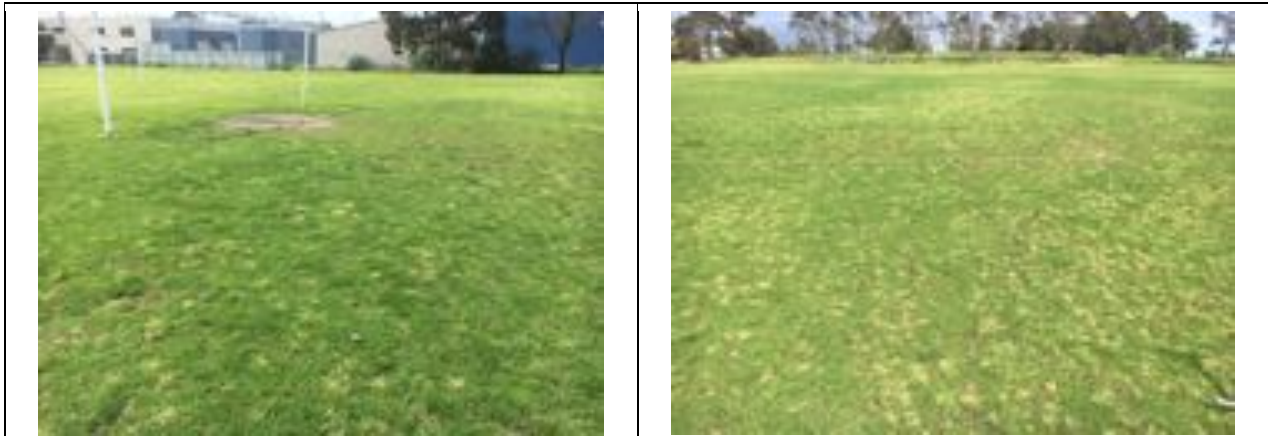
General	
Importance	Soccer & soccer training
Turf ID	Mixed sward consisting of kikuyu, rye & Poa annua
Weed Species % & Type	<5%, very few weeds
Surface Condition Rating	
Result	71.0%; poor condition
Comments	Considerable wear and damage to surface. Resulting in uneven turf cover. Boggy soft and unstable areas present in surface Surface ruts Considerable wear in goals, corridor, associated with training
Sports field Infrastructure	
Comments	Adequate size Approaching 1 way slope Sandy loam topsoil (200mm deep). Inadequate irrigation system. Lacking subsurface drainage confined to perimeter drain. Limited lighting
Additional Comments	
Struggling to cope with the current level of usage. Needs upgrading to cope with current level of usage. Also needs changes to training practices, by monitoring training to spread wear and minimise extent of damage to the surface.	
Recommendations	
Maintenance/Management	Repair surface, returf goal mouths Monitor training to minimise damage to the surface

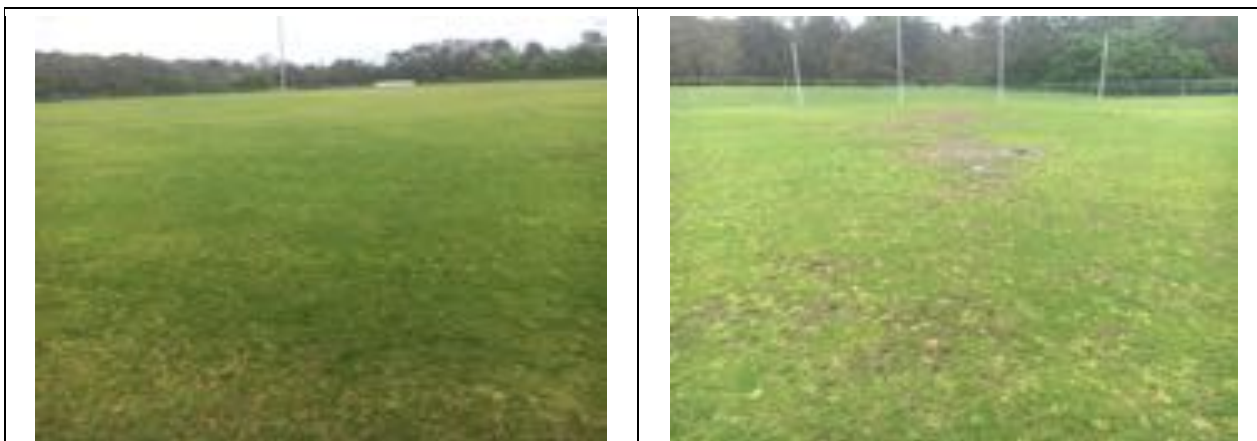
General	
Importance	Cricket and AFL football
Turf ID	Mixed sward consisting of kikuyu, Poa annua
Weed Species % & Type	<5%; very few weeds
Surface Condition Rating	
Result	75.4%; poor condition
Comments	Weak & patchy turf cover, with thin turf density. Uneven surface especially where damage to surface occurred. Soft unstable areas where loss of cover Rabbit damage to surface Considerable wear & damage in goals, corridor, pavilion
Sports field Infrastructure	
Comments	Reasonable size oval Deficiencies in surface shape, undulating surface. Heavy soil type Subsurface drainage although question performance Irrigation system Good lighting surrounds oval surface
Additional Comments	
Ground struggling to cope with current level of usage, in particular training resulting in excessive wear and damage to the surface. Changes to training and usage are needed initially to determine if these will be sufficient to improve condition of oval.

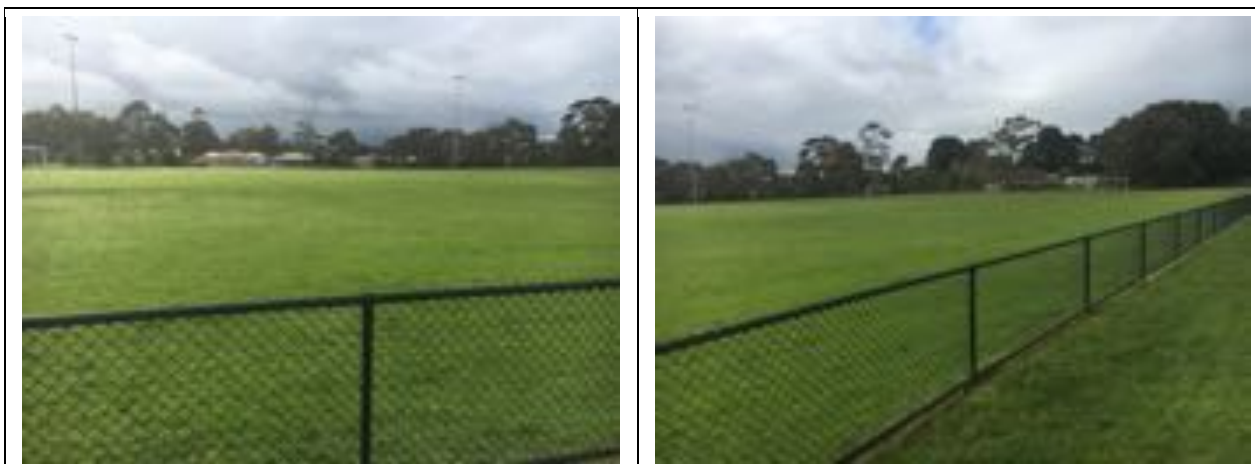
General	
Importance	Soccer & cricket
Turf ID	Mixed sward consisting of kikuyu & Poa annua
Weed Species % & Type	10%, consisting of clover flatweeds
Surface Condition Rating	
Result	84.3%; satisfactory condition
Comments	Mostly good turf cover with weaker cover in goals Minor undulations in surface Training impacting on surface Wear evident in corridor, goals and run-ups. Cricket pitch lower than surrounds, holding water in south end
Sports field Infrastructure	
Comments	Large oval surface Verging on 1 way slope with minor undulations Good lighting surrounding oval Inadequate subsurface drainage Adequate irrigation
Additional Comments	
Ground is coping with current level of usage although cricket pitch is holding water in surface highlighting that it is low and must be addressed.	
Recommendations	
Maintenance/Management	Control weeds Repair/returf weakly grassed & bare areas to restore turf cover Monitor usage & training to spread wear and minimise damage to surface

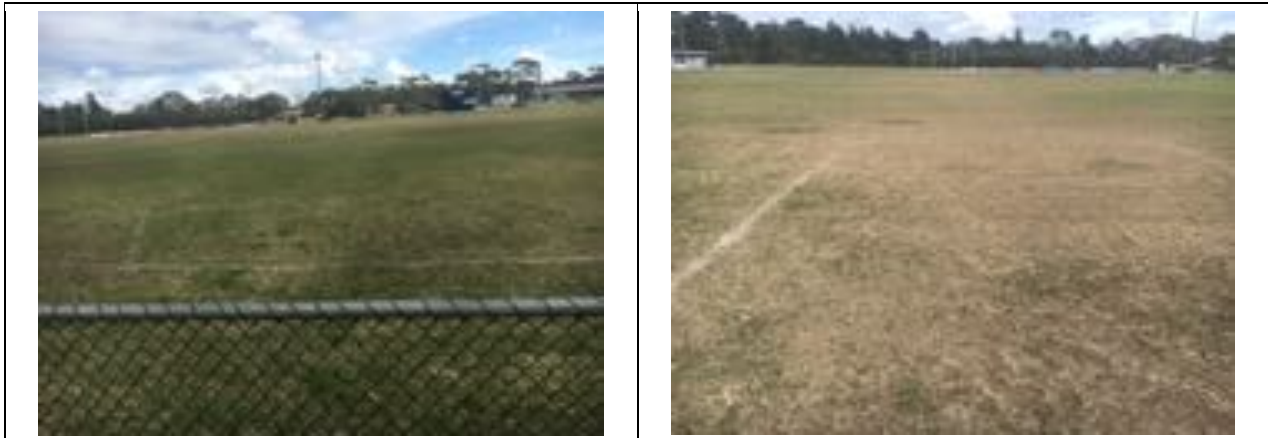
General	
Importance	Cricket & football
Turf ID	Maintained as monostand of couch
Weed Species % & Type	<5%, very few weeds
Surface Condition Rating	
Result	83.7%; satisfactory condition
Comments	Turf cover satisfactory although varies throughout Thin turf density on south side and through corridor. Surface undulating in areas, especially where previous damage to surface occurred. Considerable wear especially in corridor, goals & in front of pavilion on south side. Cricket pitch level and in good condition.
Sports field Infrastructure	
Comments	Shape approaching ridge with minor undulations Sandy loam topsoil Lacks subsurface drainage Perimeter drainage evident Irrigation adequate Good lighting surrounding oval
Additional Comments	
Ground just coping with current level of usage although evidence of excessive wear in some areas on surface. Changes to usage and training practices are needed to improve condition. Otherwise it might be necessary to oversow with rye to improve condition and durability during winter.

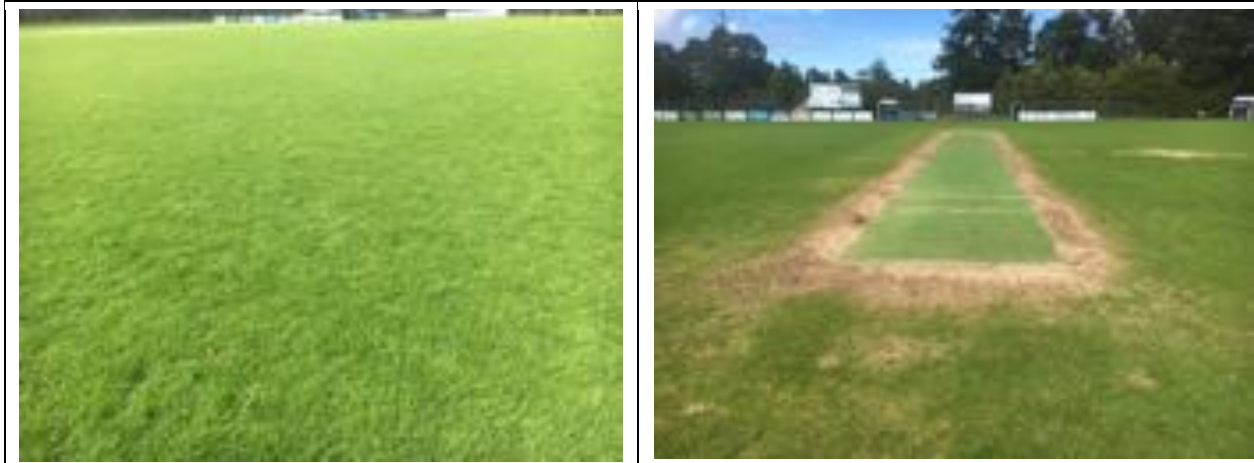
General	
Importance	Cricket & football
Turf ID	Mixed sward consisting of kikuyu, rye & Poa annua
Weed Species % & Type	20%; consisting of capeweed, clover, flatweeds
Surface Condition Rating	
Result	88.1%; satisfactory condition
Comments	Mostly good turf cover although weeds form part of cover. Soft surface in some areas. Wear evident especially in goals and centre of oval. Cricket pitch slightly lower than surrounds, although good surface
Sports field Infrastructure	
Comments	Surface shape satisfactory although minor undulations Lacks subsurface drainage Lacks irrigation Limited lighting confined to building Heavy soil type
Additional Comments	
Ground coping with current use, apart from excessive wear in goals and centre. Appears to receive limited use although could be potential to utilise more.	
Recommendations	
Maintenance/Management	Repair/returf weakly grassed & bare areas to restore turf cover Regular surface & subsurface aeration Monitor usage & training to spread wear and minimise damage to surface

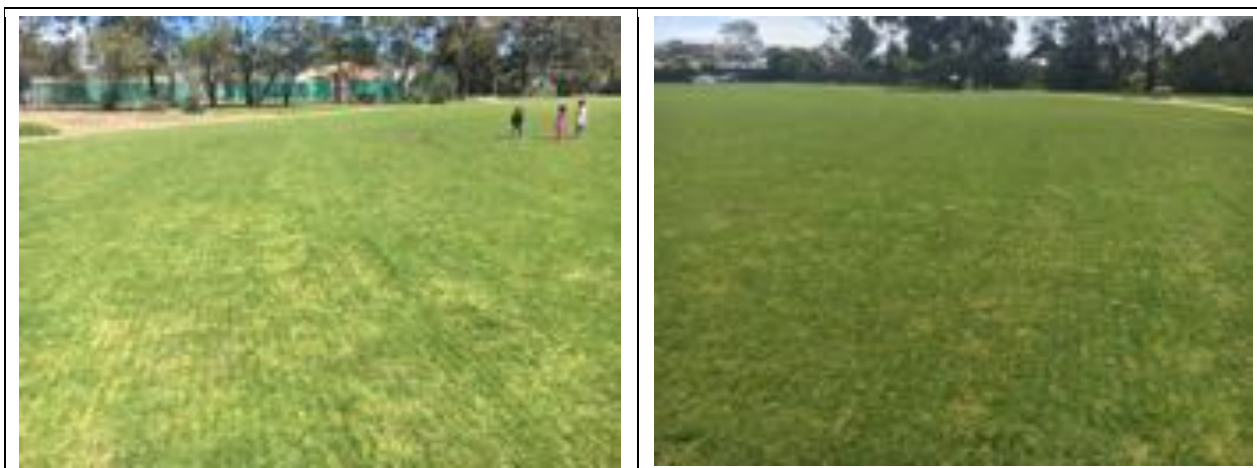
General	
Importance	
Turf ID	
Weed Species % & Type	
Surface Condition Rating	
Result	81.1%; satisfactory condition
Comments	<p>Mostly good turf cover although cover varies over surface Thin density around edge where seed drill lines still evident Evidence of wear near pavilion but very little wear or damage elsewhere Sandy loam topsoil Cricket pitch in good condition and level with surrounds Uneven surface especially west side</p>
Sports field Infrastructure	
Comments	<p>Irrigation present although effectiveness unknown Limited subsurface drainage Compacted and shallow depth of topsoil Surface verging on dome shape but undulating especially on west side near pavilion Limited lighting (in front of pavilion).</p>
Additional Comments	
Ground appears to be coping with current level of usage with very little damage to surface. Lighting is limited which could impact on surface if used more.	
Recommendations

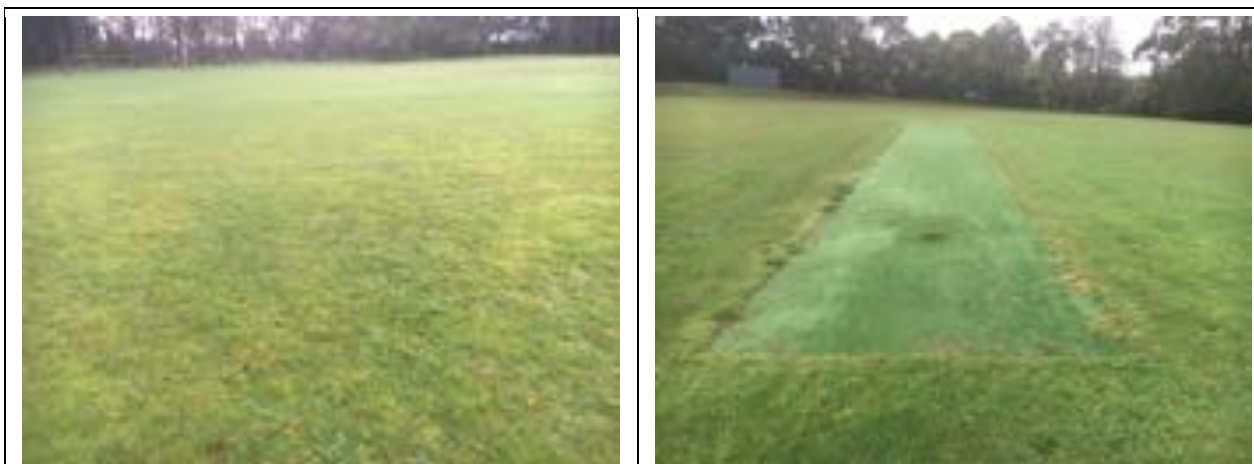
General	
Importance	Used only during summer for cricket Considered low priority ground
Turf ID	Mixed sward consisting of kikuyu, fine fescue, Poa annua
Weed Species % & Type	15%; flatweeds
Surface Condition Rating	
Result	86.7%; satisfactory condition
Comments	Good turf cover, although weeds form part of the turf cover Smooth surface Very little wear or damage to the surface Not being used during winter Cricket pitch in good condition and level with surrounds Moss and Red Thread disease present in surface
Sports field Infrastructure	
Comments	Basically a paddock being used for sport Satisfactory surface shape, approach 1 way slope Lacks irrigation or drainage Heavy soil type, susceptible to becoming saturated during wet weather No lighting
Additional Comments	
This ground is providing a satisfactory sporting surface for cricket over summer, but is unlikely to be suitable for winter use because of limited infrastructure, poor draining soil conditions, and susceptibility to damage during wet weather.

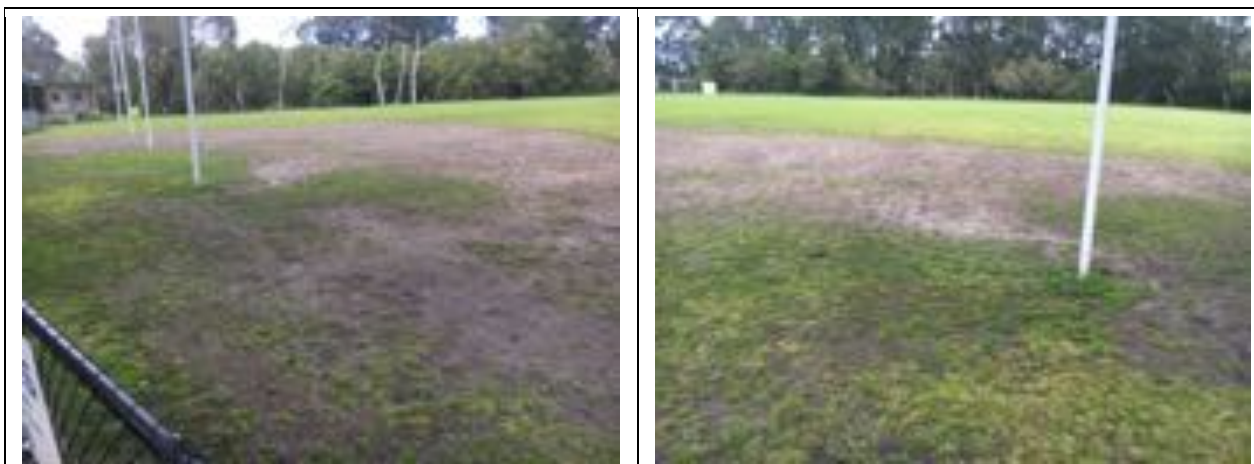
General	
Importance	Cricket & football Main oval in the municipality.
Turf ID	Mixed sward consisting of kikuyu, fine fescue, rye Poa annua
Weed Species % & Type	<5%, very few weeds
Surface Condition Rating	
Result	80.9%; satisfactory condition
Comments	Mostly satisfactory cover, except south end Weak and bare areas throughout south end Associated with training. Cricket pitch has good surface but is lower than immediate surrounds
Sports field Infrastructure	
Comments	Reasonable size oval Appears to be dome shape with minor undulations Limited lighting confined to south end Sandy loam topsoil Lacks irrigation Lacks drainage
Additional Comments	
Struggling with current level of usage, especially current training practices, resulting in considerable loss of cover in south end despite reasonable condition over rest of oval. Has the potential to be utilised more if improvements were made in the infrastructure.

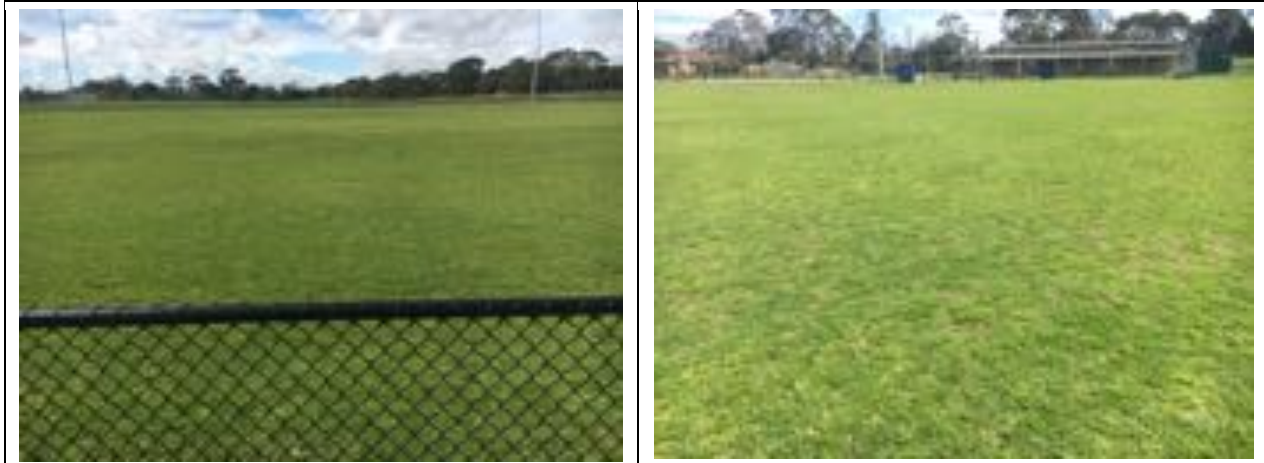
General	
Importance	High level cricket and AFL football
Turf ID	Kikuyu and Poa
Weed Species % & Type	<5%, very few weeds
Surface Condition Rating	
Result	83.1%; satisfactory condition
Comments	Good overall turf cover Evidence of wear near pavilion and goals but not excessive elsewhere Cricket pitch has good cover but is lower than immediate surrounds
Sports field Infrastructure	
Comments	Mostly good surface shape verging on dome Lighting surrounds oval Irrigation system Lacks subsurface drainage Loamy topsoil
Additional Comments	
Appears to be coping with current level of usage. Has the potential to cope with more usage providing changes occurred to current training practices.	
Recommendations	
Maintenance/Management	Surface & subsurface aeration
Capital Improvements	Re-instate cricket pitch to match surface levels

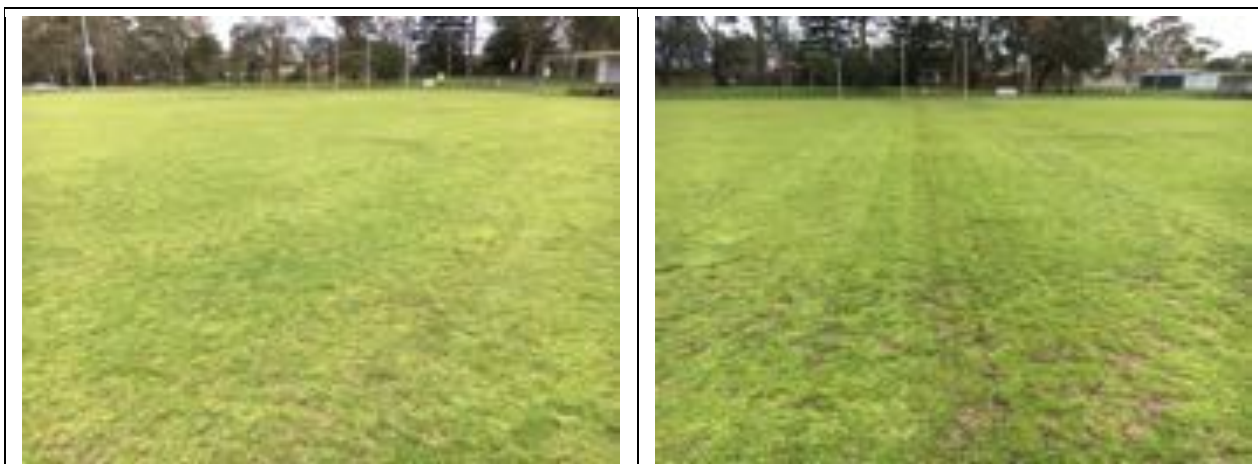
General	
Importance	Cricket & AFL football
Turf ID	Couch, rye, Poa
Weed Species % & Type	20%, weeds including clover, flatweeds
Surface Condition Rating	
Result	76.8%; marginal condition
Comments	Weak and patchy cover, uneven cover, thin turf density. Considerable wear to surface in goals, corridor and associated with training Impacting on surface Cricket pitch slightly lower than immediate surrounds
Sports field Infrastructure	
Comments	Large oval surface Approaching ridge shape Sandy loamy topsoil Lacks subsurface drainage Irrigation system Lights surround oval
Additional Comments	
Struggling to cope with current level of usage. Has irrigation but issues with surface shape and possibly soil conditions. Candidate to be reconstructed to improve usage capabilities.	
Recommendations	
Maintenance/Management	Control weeds Repair/returf weakly grassed & bare areas to restore turf cover Regular surface & subsurface aeration Monitor usage & training to spread wear and minimise damage to surface

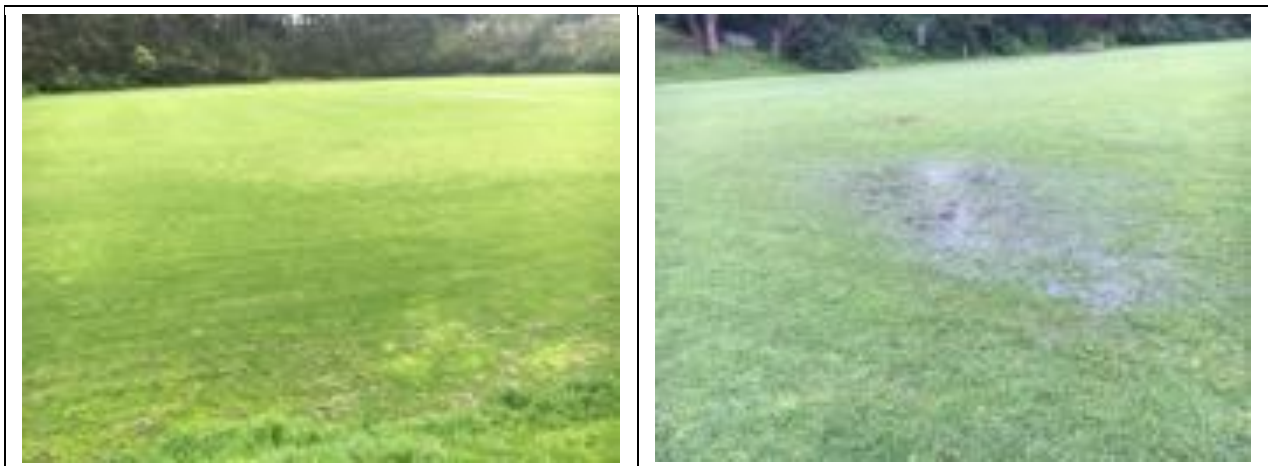
General	
Importance	Used for cricket only in summer Not used in winter
Turf ID	Mixed sward consisting of kikuyu, Poa annua
Weed Species % & Type	25%, high weed population consisting of chickweed
Surface Condition Rating	
Result	89.9%; satisfactory condition
Comments	Good turf cover, density Surface uneven, holding water in south end during wet weather despite good cover Clippings and rubbish on surface indicating difficulty to manage this oval No evidence of wear or damage to surface
Sports field Infrastructure	
Comments	Limited size although satisfactory for cricket Low lying area surrounded by batters and raised topography Acts like a retarding basin due to lack of natural and subsurface drainage Lacks irrigation system No lights
Additional Comments	
Although this ground has an excellent turf cover and appearance, it will not cope with fixture winter use because of the deficiencies with infrastructure, in particular low lying area, no surface runoff, lacking subsurface drainage etc. Unlikely to be option for winter use unless upgraded

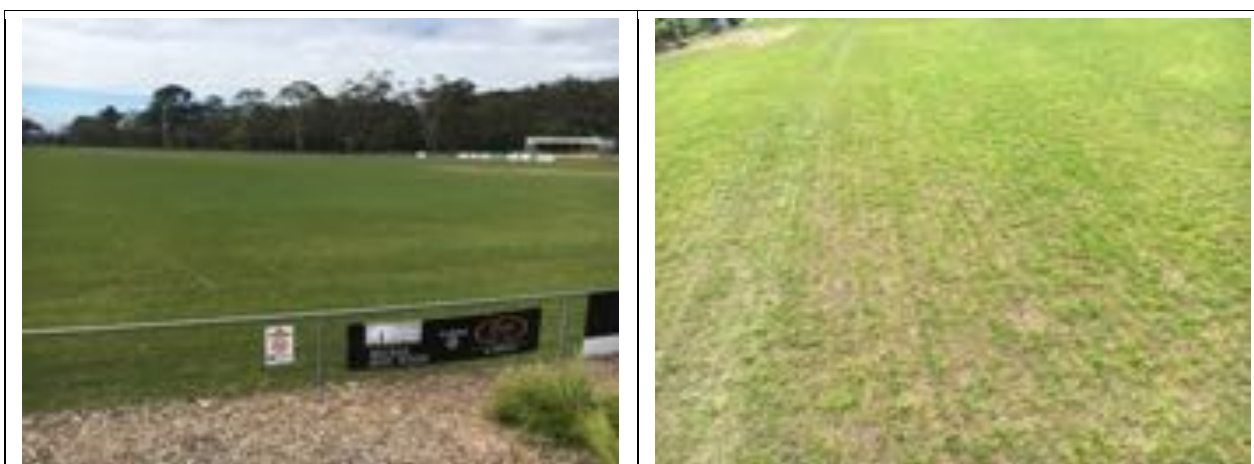
General	
Importance	Cricket & AFL football
Turf ID	Consists of couch, Poa annua & rye
Weed Species % & Type	<5%, very few weeds
Surface Condition Rating	
Result	79.6%; marginal condition
Comments	Weak and patchy turf cover Smooth surface despite imperfections in cover Considerable wear and damage in goals, corridor and near pavilion Associated with training Cricket pitch slightly lower than surrounds
Sports field Infrastructure	
Comments	Good size oval Irrigation system present Shape verging on ridge, satisfactory Lacks subsurface drainage Soil type consists of sandy loam Lights surround oval although lights quite low
Additional Comments	
Struggling to cope with current usage levels and practices. Could be associated with training practise. Need to investigate if conditions can be improved by changing training practices. Otherwise might require further capital improvement, such as installing drains, improving soil type and conditions.

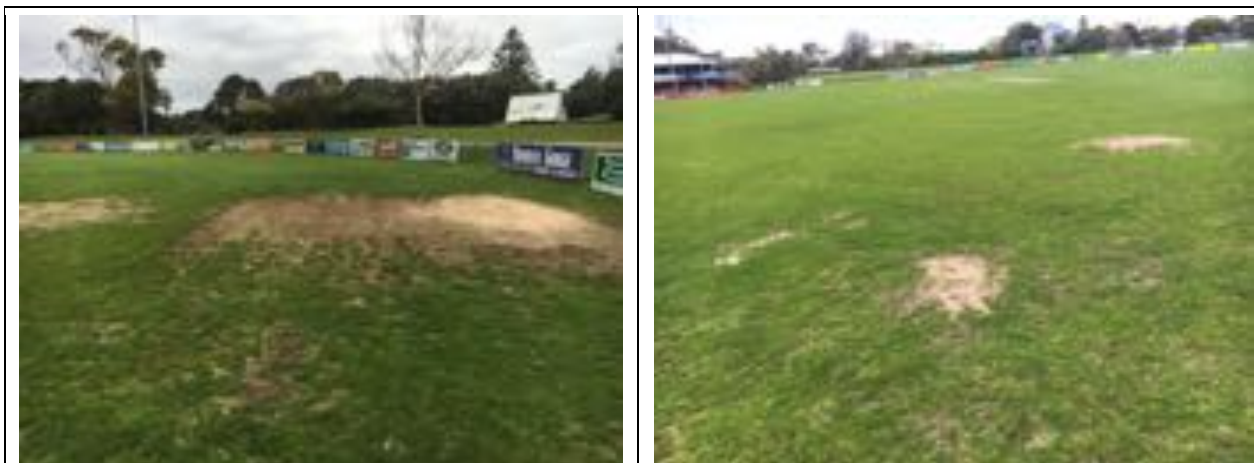
General	
Importance	Cricket & AFL football
Turf ID	Mixed sward consisting of couch, kikuyu, rye & Poa annua
Weed Species % & Type	<5%, very few weeds
Surface Condition Rating	
Result	79.6%; marginal condition
Comments	Mostly good cover although weakly grassed and bare patches existed Wear evident in goals, corridor and near pavilion, associated with training Cricket pitch lower than surrounds
Sports field Infrastructure	
Comments	Good oval size Reasonable surface shape approach ridge Lacking subsurface drainage Limited irrigation Lights surround oval
Additional Comments	
Coping with current level of usage, although training impacting on surface. Need to change training practices to reduce extent of damage to surface	
Recommendations	
Maintenance/Management	Repair/returf weakly grassed & bare areas to restore turf cover Regular surface & subsurface aeration Monitor usage & training to spread wear and minimise damage to surface Continue to oversow with rye for winter play

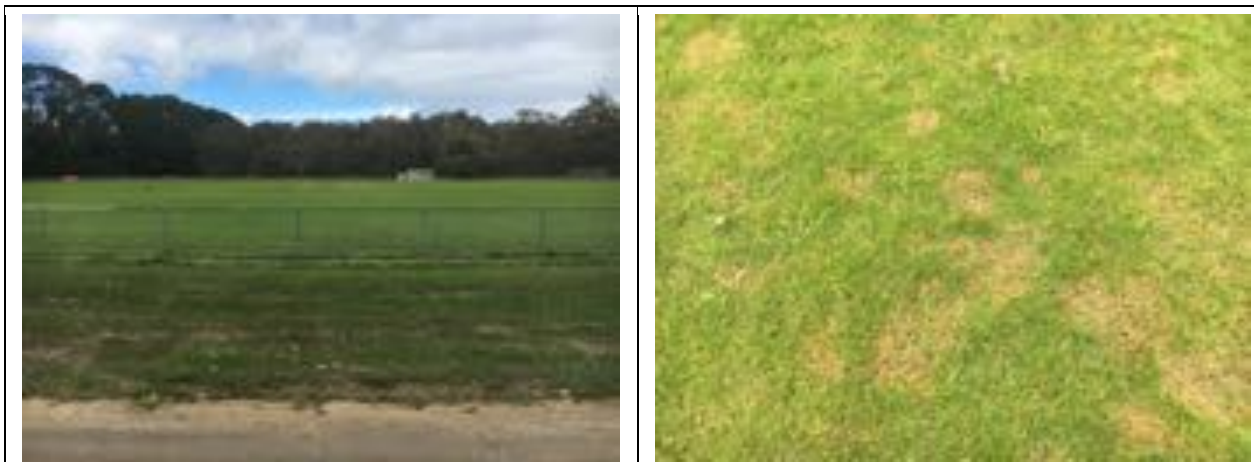
General	
Importance	Cricket & AFL football
Turf ID	Mixed sward consisting of kikuyu, bent, fine fescue, rye & Poa annua
Weed Species % & Type	20%, consisting of chickweed, clover, flatweeds
Surface Condition Rating	
Result	89.5%; satisfactory condition
Comments	Good turf cover, although weeds form part of the turf cover Disease evident in surface, Red Thread disease, also moss Smooth surface Very little wear or damage to surface Cricket pitch higher than surrounds
Sports field Infrastructure	
Comments	Good size oval Slope appears to be single slope Sandy loam topsoil Irrigation system. Limited subsurface drainage confined to perimeter drain. No lighting
Additional Comments	
Coping with current level of usage. Further investigation of infrastructure is needed to determine if could be utilised for other sporting activities.	
Recommendations	
Maintenance/Management	Control weeds Surface & subsurface aerate

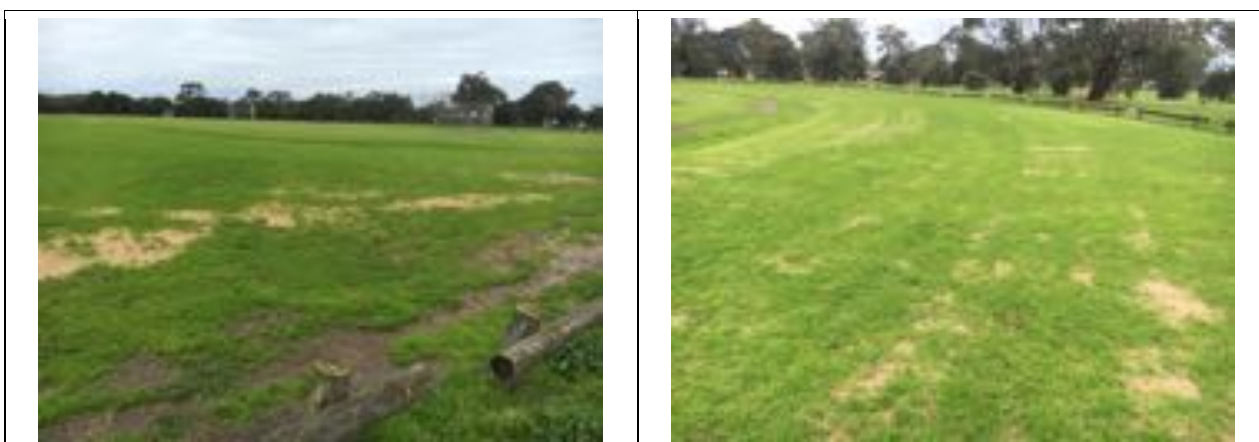
General	
Importance	Athletics
Turf ID	Mainly kikuyu
Weed Species % & Type	10%, consisting of clover & chickweed
Surface Condition Rating	
Result	85.2%; satisfactory condition
Comments	Mostly good turf cover, benefiting from recent sodding Wear evident in north goal square resulting in loss of cover Still undulating off the athletics track Minimal wear or damage evident on surface.
Sports field Infrastructure	
Comments	Situated on old tip site, contributing to uneven surface. Poor surface shape although recent work had helped to improve athletics track Sandy loam topsoil Lacks irrigation Lacks drainage No lights
Additional Comments	
Difficult to utilise infield of the track unless major improvements in shape and stability were achieved.	
Recommendations	
Maintenance/Management	Control weeds
Capital Improvements

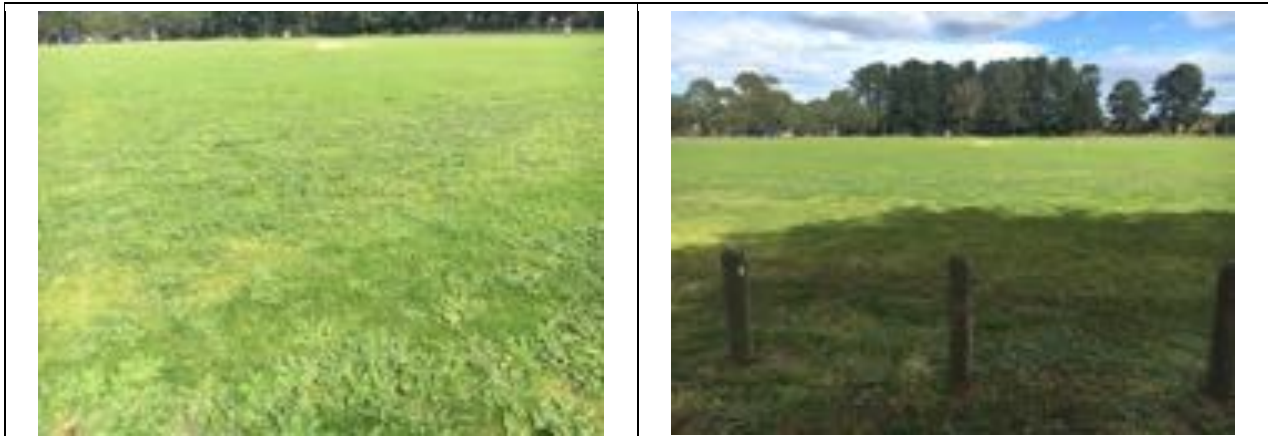
General	
Importance	Cricket and baseball
Turf ID	Mixed sward consisting of kikuyu, fine fescue, rye & Poa annua
Weed Species % & Type	30%%, consisting of flatweeds
Surface Condition Rating	
Result	88.3%; satisfactory condition
Comments	Good turf cover, although weeds form part of the turf cover Minimal wear or damage to the surface Minor issues with cricket pitch levels
Sports field Infrastructure	
Comments	Reasonable size oval Mostly smooth surface appears to be single slope Limited lighting Has irrigation Lacks drainage Poor soil conditions
Additional Comments	
Coping with current level of use, and possibly could be used for more use especially over winter. Would most likely need improved infrastructure, eg. drainage.	
Recommendations	
Maintenance/Management	Control weeds
Capital Improvements
