Flinders Township and Tanti Creek Geotechnical Information Pack

Geotechnical assessment for landslip susceptibility and investigation zoning: Flinders
Foreshore Mornington Peninsula, January 2008

GEOTECHNICAL ASSESSMENT FOR LANDSLIP SUSCEPTIBILITY AND INVESTIGATION ZONING

**FLINDERS FORESHORE
MORNINGTON PENINSULA**

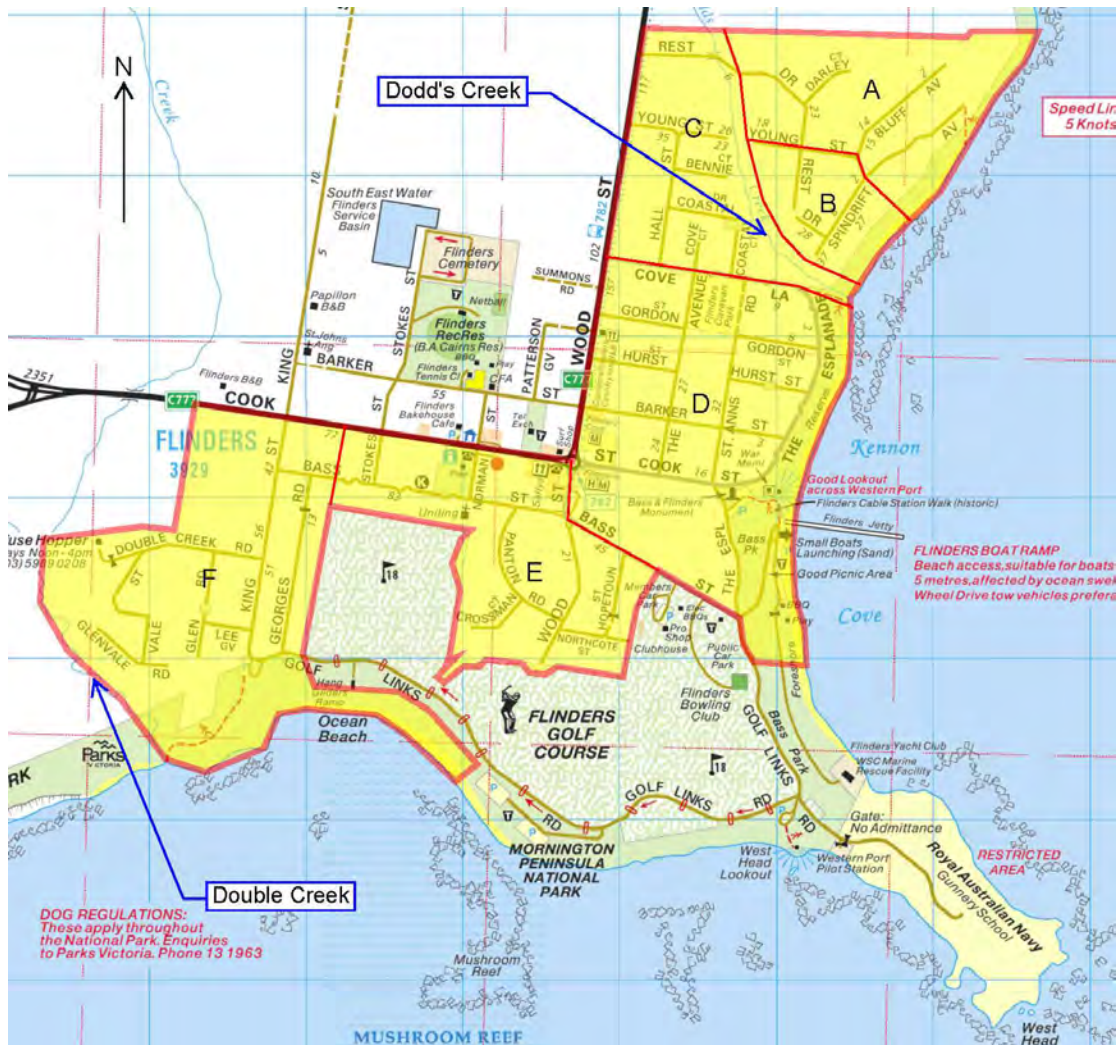
Figure 1.1: Area of the Study

The approximate location of the study is shown in Figure 1.1 together with the designated areas A – F.

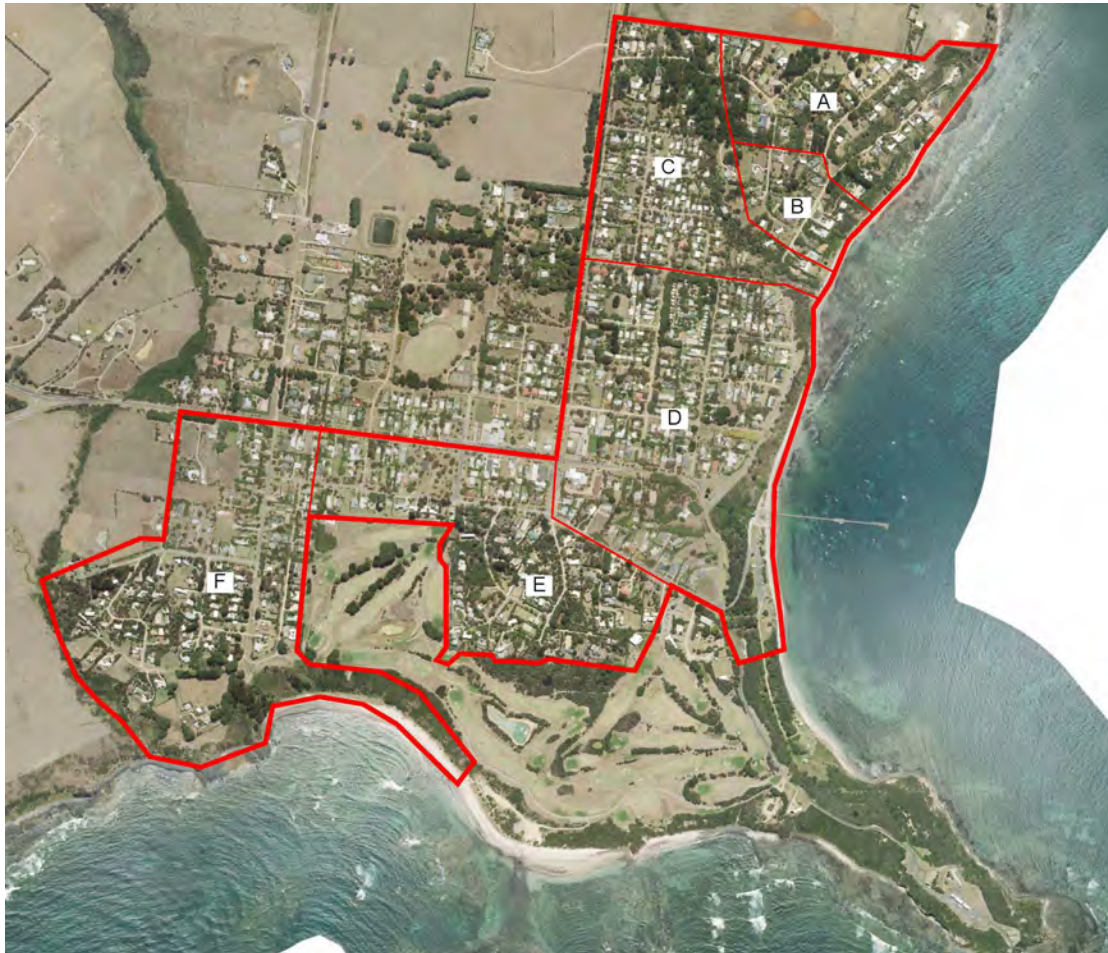
Figure 4.1: Aerial Photograph of the Site (2003)

The approximate locations of the different areas assessed are shown on the photograph.

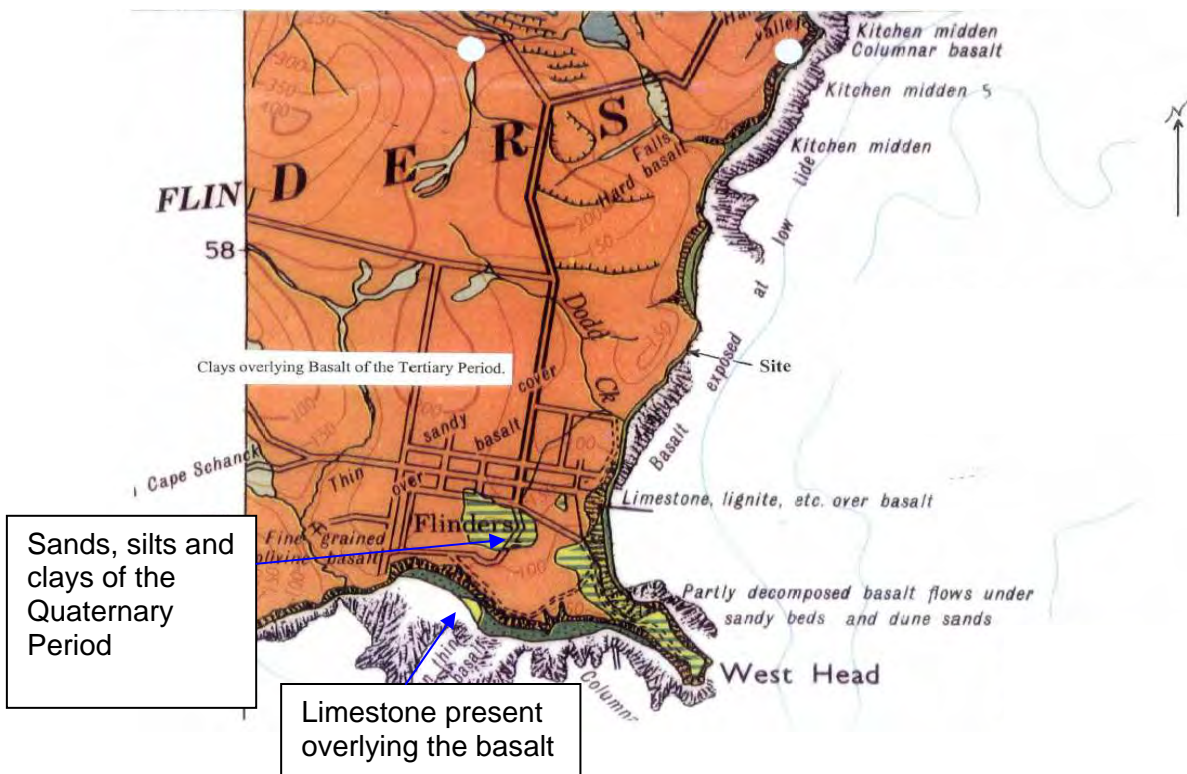
Figure 5.1: Excerpt of the Geological Map of the Area

The Western Port 1: 63 360 Geological Survey map (1967) shows basaltic materials of the Lower Tertiary *Older Volcanics* to occur both at the surface and underlying the area being studied, with the words "Thin sandy cover over basalt" recorded on the map in the Flinders township area. A narrow beach of (quartz) sand is shown fringing the basaltic coastal cliffs, with basalt below the beach exposed at low tide. Neither the map nor the related Geological Survey Memoir 17 on the Mornington Peninsula (Keble, 1950) give any data on the degree of weathering of the basalt.

Along the foreshore, there are beach and coastal dune sands overlying the Lower Tertiary *Older Volcanics*.

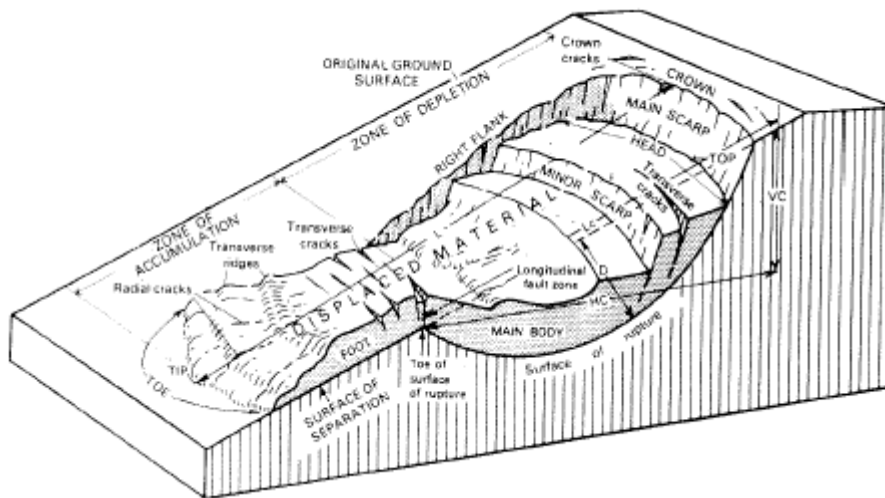
Figure 7.1: Landslide Features.

There are several steep cusped scarps rising above Spindrift Avenue with the typical appearance of elements of a *main scarp* at the head of a *landslide*. The gently undulating surface below the cusped main scarp elements is the surface of *displaced material*, which has slid by shear failure on a *surface of rupture*. The surface of rupture begins at the complex main scarp exposed above. Spindrift Avenue crosses the main scarp about 50m north-east of Young Street and continues thereafter on the surface of displaced material. There is a fairly wide but uneven *zone of accumulation* of the displaced failed material, on which houses are built, with the *toe*, marking the down slope limit of the landslide, well below the road towards the sea. The landslide is complex, and may represent several slides in combination. The nomenclature used above is from Turner and Schuster (1996), based on the IAEG Commission (1990) after Varnes (1978) and is shown below.

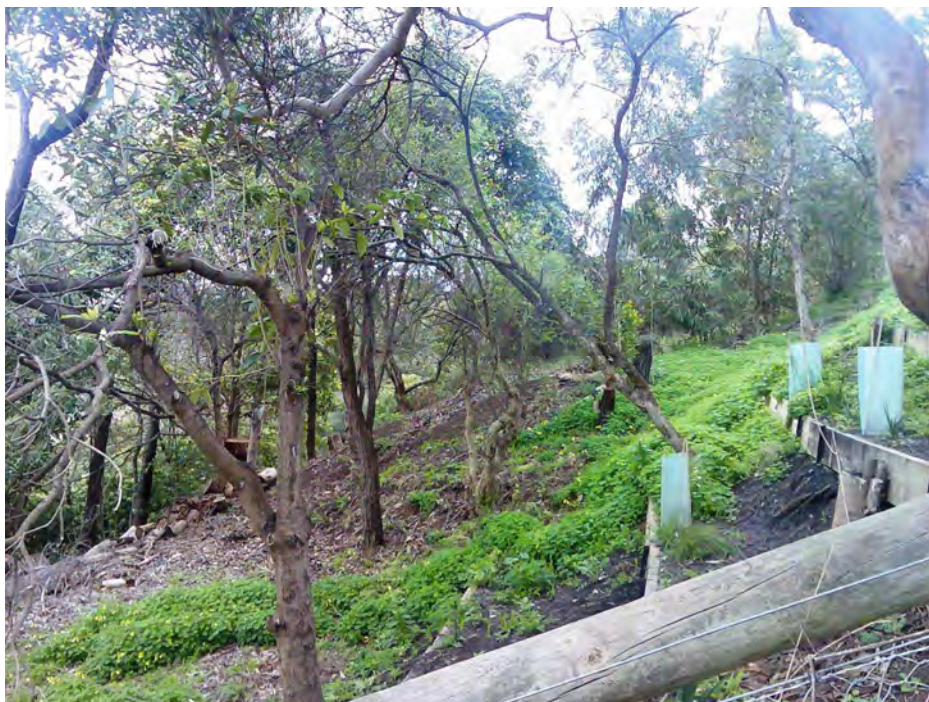
Plate 7.1: Scarp of landslide between Spindrift Avenue and Bluff Avenue

One of the four boreholes (Bore 4, Piper & Associates, 1998) was located on one of the cusped *main scarp* elements. This borehole indicated at least 9.0m of basaltic clay there, still in the unfailed material. Another borehole (Bore 5, Piper & Associates, 1998) appears to be above the main scarp (but might still be on it, because the scarp has not been accurately mapped), and likewise revealed at least 9.0m of basaltic clay. Fabric weaknesses in bore samples are possibly indications of structural weakness in these steep slopes above the failed material of the zone of accumulation.

The depth and shape of the *surface of ruptures* are also unknown, but they are likely to be deep and arcuate. Some quartz sand among the basaltic clay in parts of the lower zone of displaced material appears to have originated from near the ridge top above the head scarp and is suggestive of complex shear movements and probable flow subsequent to the initial stage of failure.

The steep slopes of the main scarp elements at the head of the landslide are probably potentially unstable. No cuts into their profiles should be made. Any cuts into slopes in the area of displaced material of the zone of accumulation would endanger their stability. The ground water conditions on the site have not been studied, but the groundwater is below 10m. To maximise ground stability, good drainage is nonetheless essential.

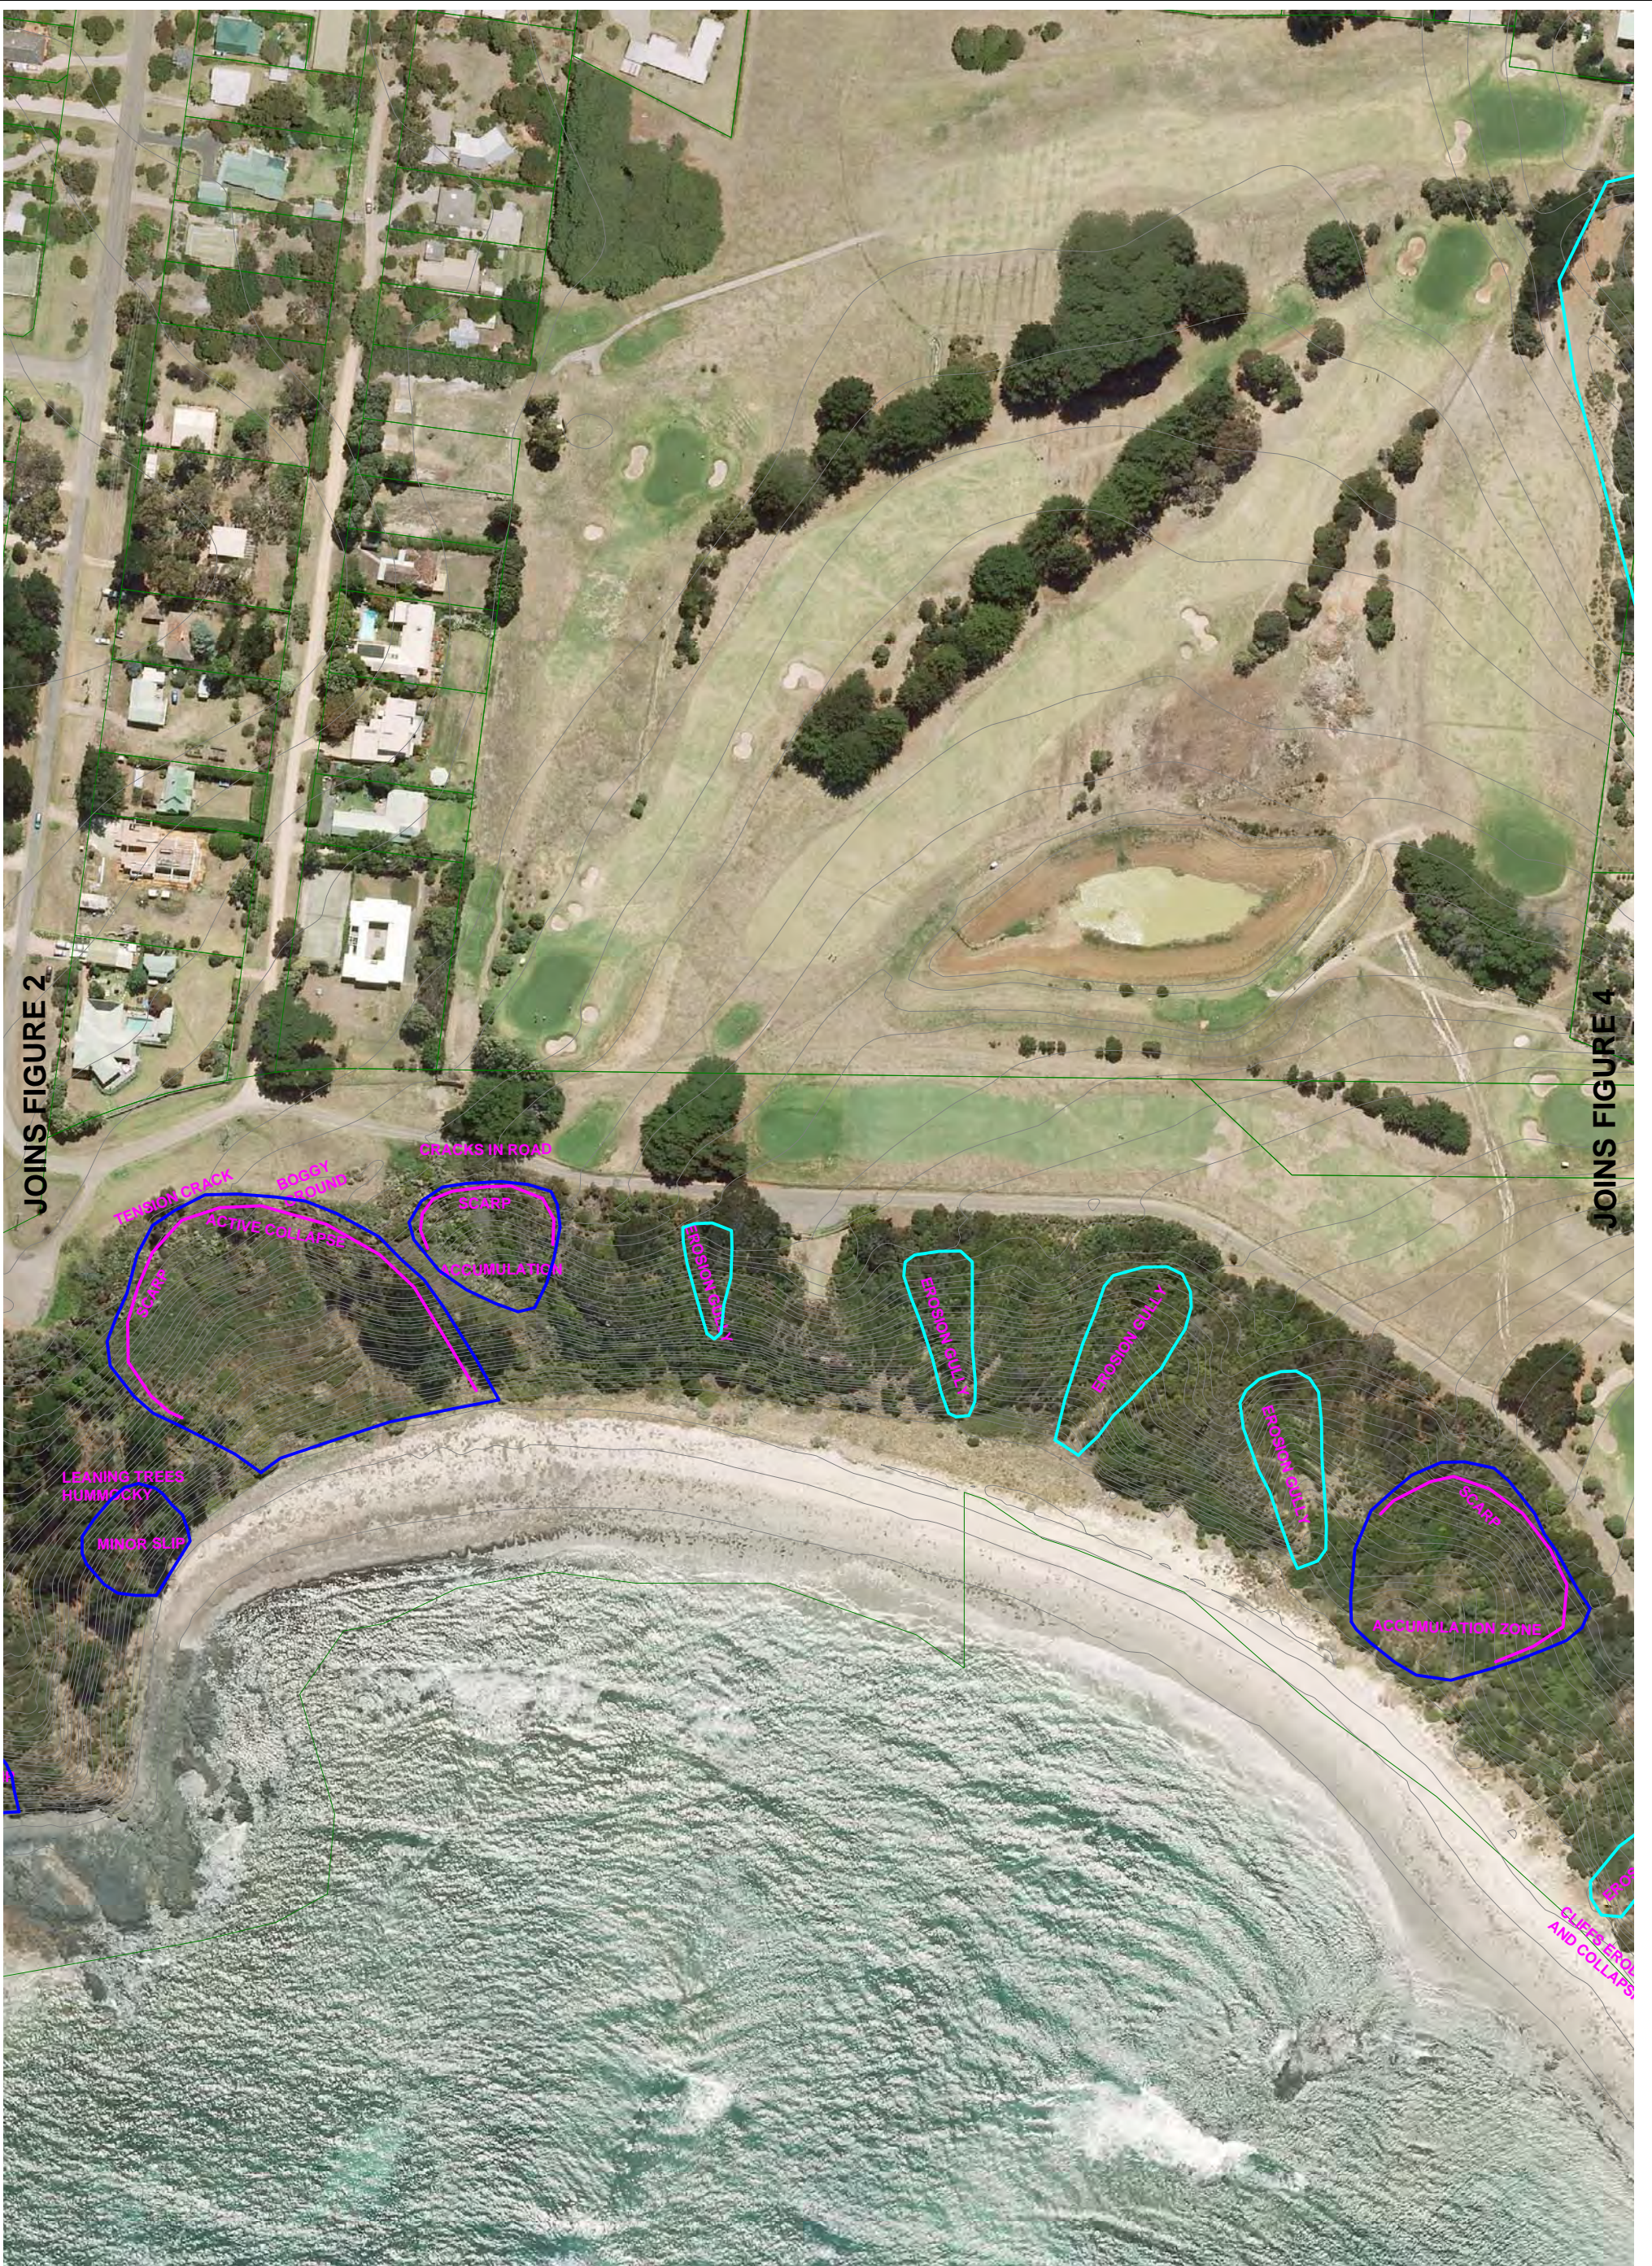
TITLE	ON SITE OBSERVATION PLAN	JOB NO.	27005	DATE	22 NOV 2007
PROJECT	FLINDERS FORESHORE LANDSLIP ASSESSMENT	SCALE (A3)	1:2,000	REV NO.	0
FILE REFERENCE	FLINDERS.WOR	DRAWN	DBS	FIG NO.	2

—	Probable Landslips
—	Potential Landslip or Area with Potential for Landslip
TEXT	On Site Observations

Details of the findings of the walkover are shown on Figures 2 to 8, Appendix A and are discussed in Sections 7 to 12.

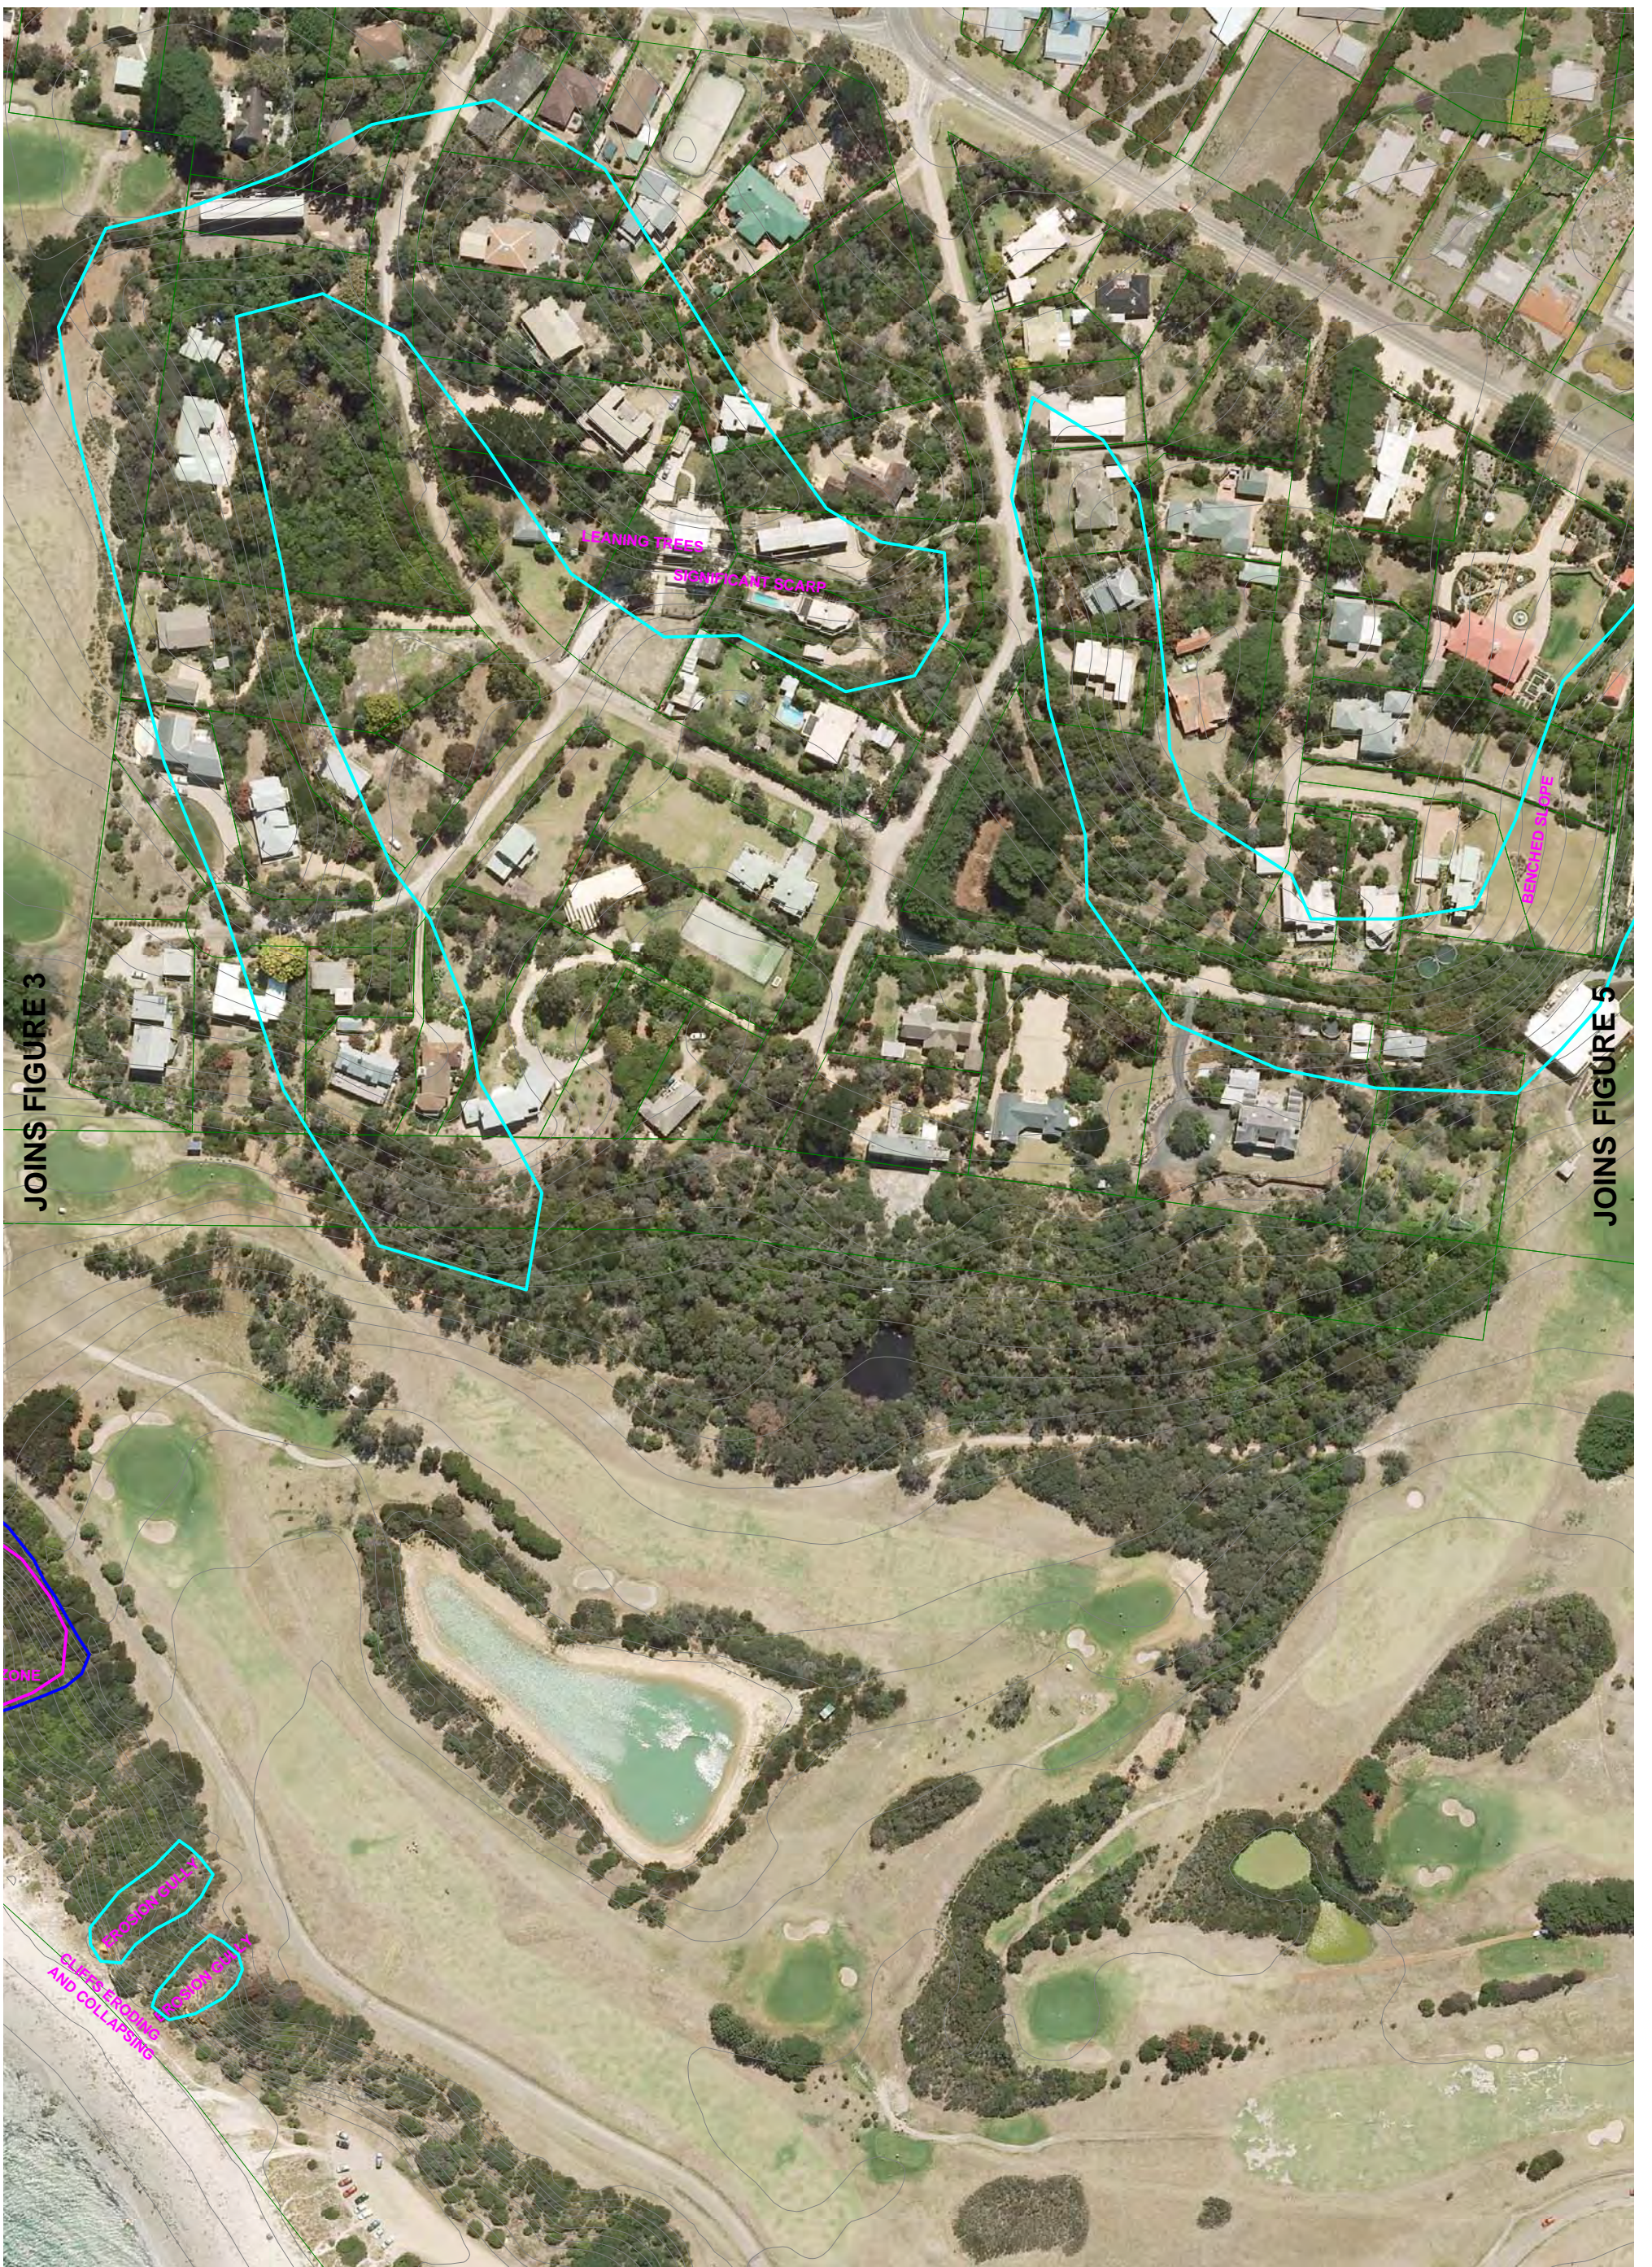
TITLE	ON SITE OBSERVATION PLAN	JOB NO.	27005	DATE	22 NOV 2007
PROJECT	FLINDERS FORESHORE LANDSLIP ASSESSMENT	SCALE (A3)	1:2,000	REV NO.	0
FILE REFERENCE	FLINDERS.WOR	DRAWN	DBS	FIG NO.	3

LEGEND	
—	Probable Landslips
—	Potential Landslip or Area with Potential for Landslip
—	On Site Observations

The section of Flinders township between southern Spindrift Avenue and the strandline is typically at a grade of 40 - 50% to the base of the cliff with some areas at a slope of 60 – 70% with a few sections up to a grade of 80 – 90%. Apart from either end of this section of Spindrift Avenue, many of the lots are graded at 10 – 30%. See Figure No. 3, Appendix B.

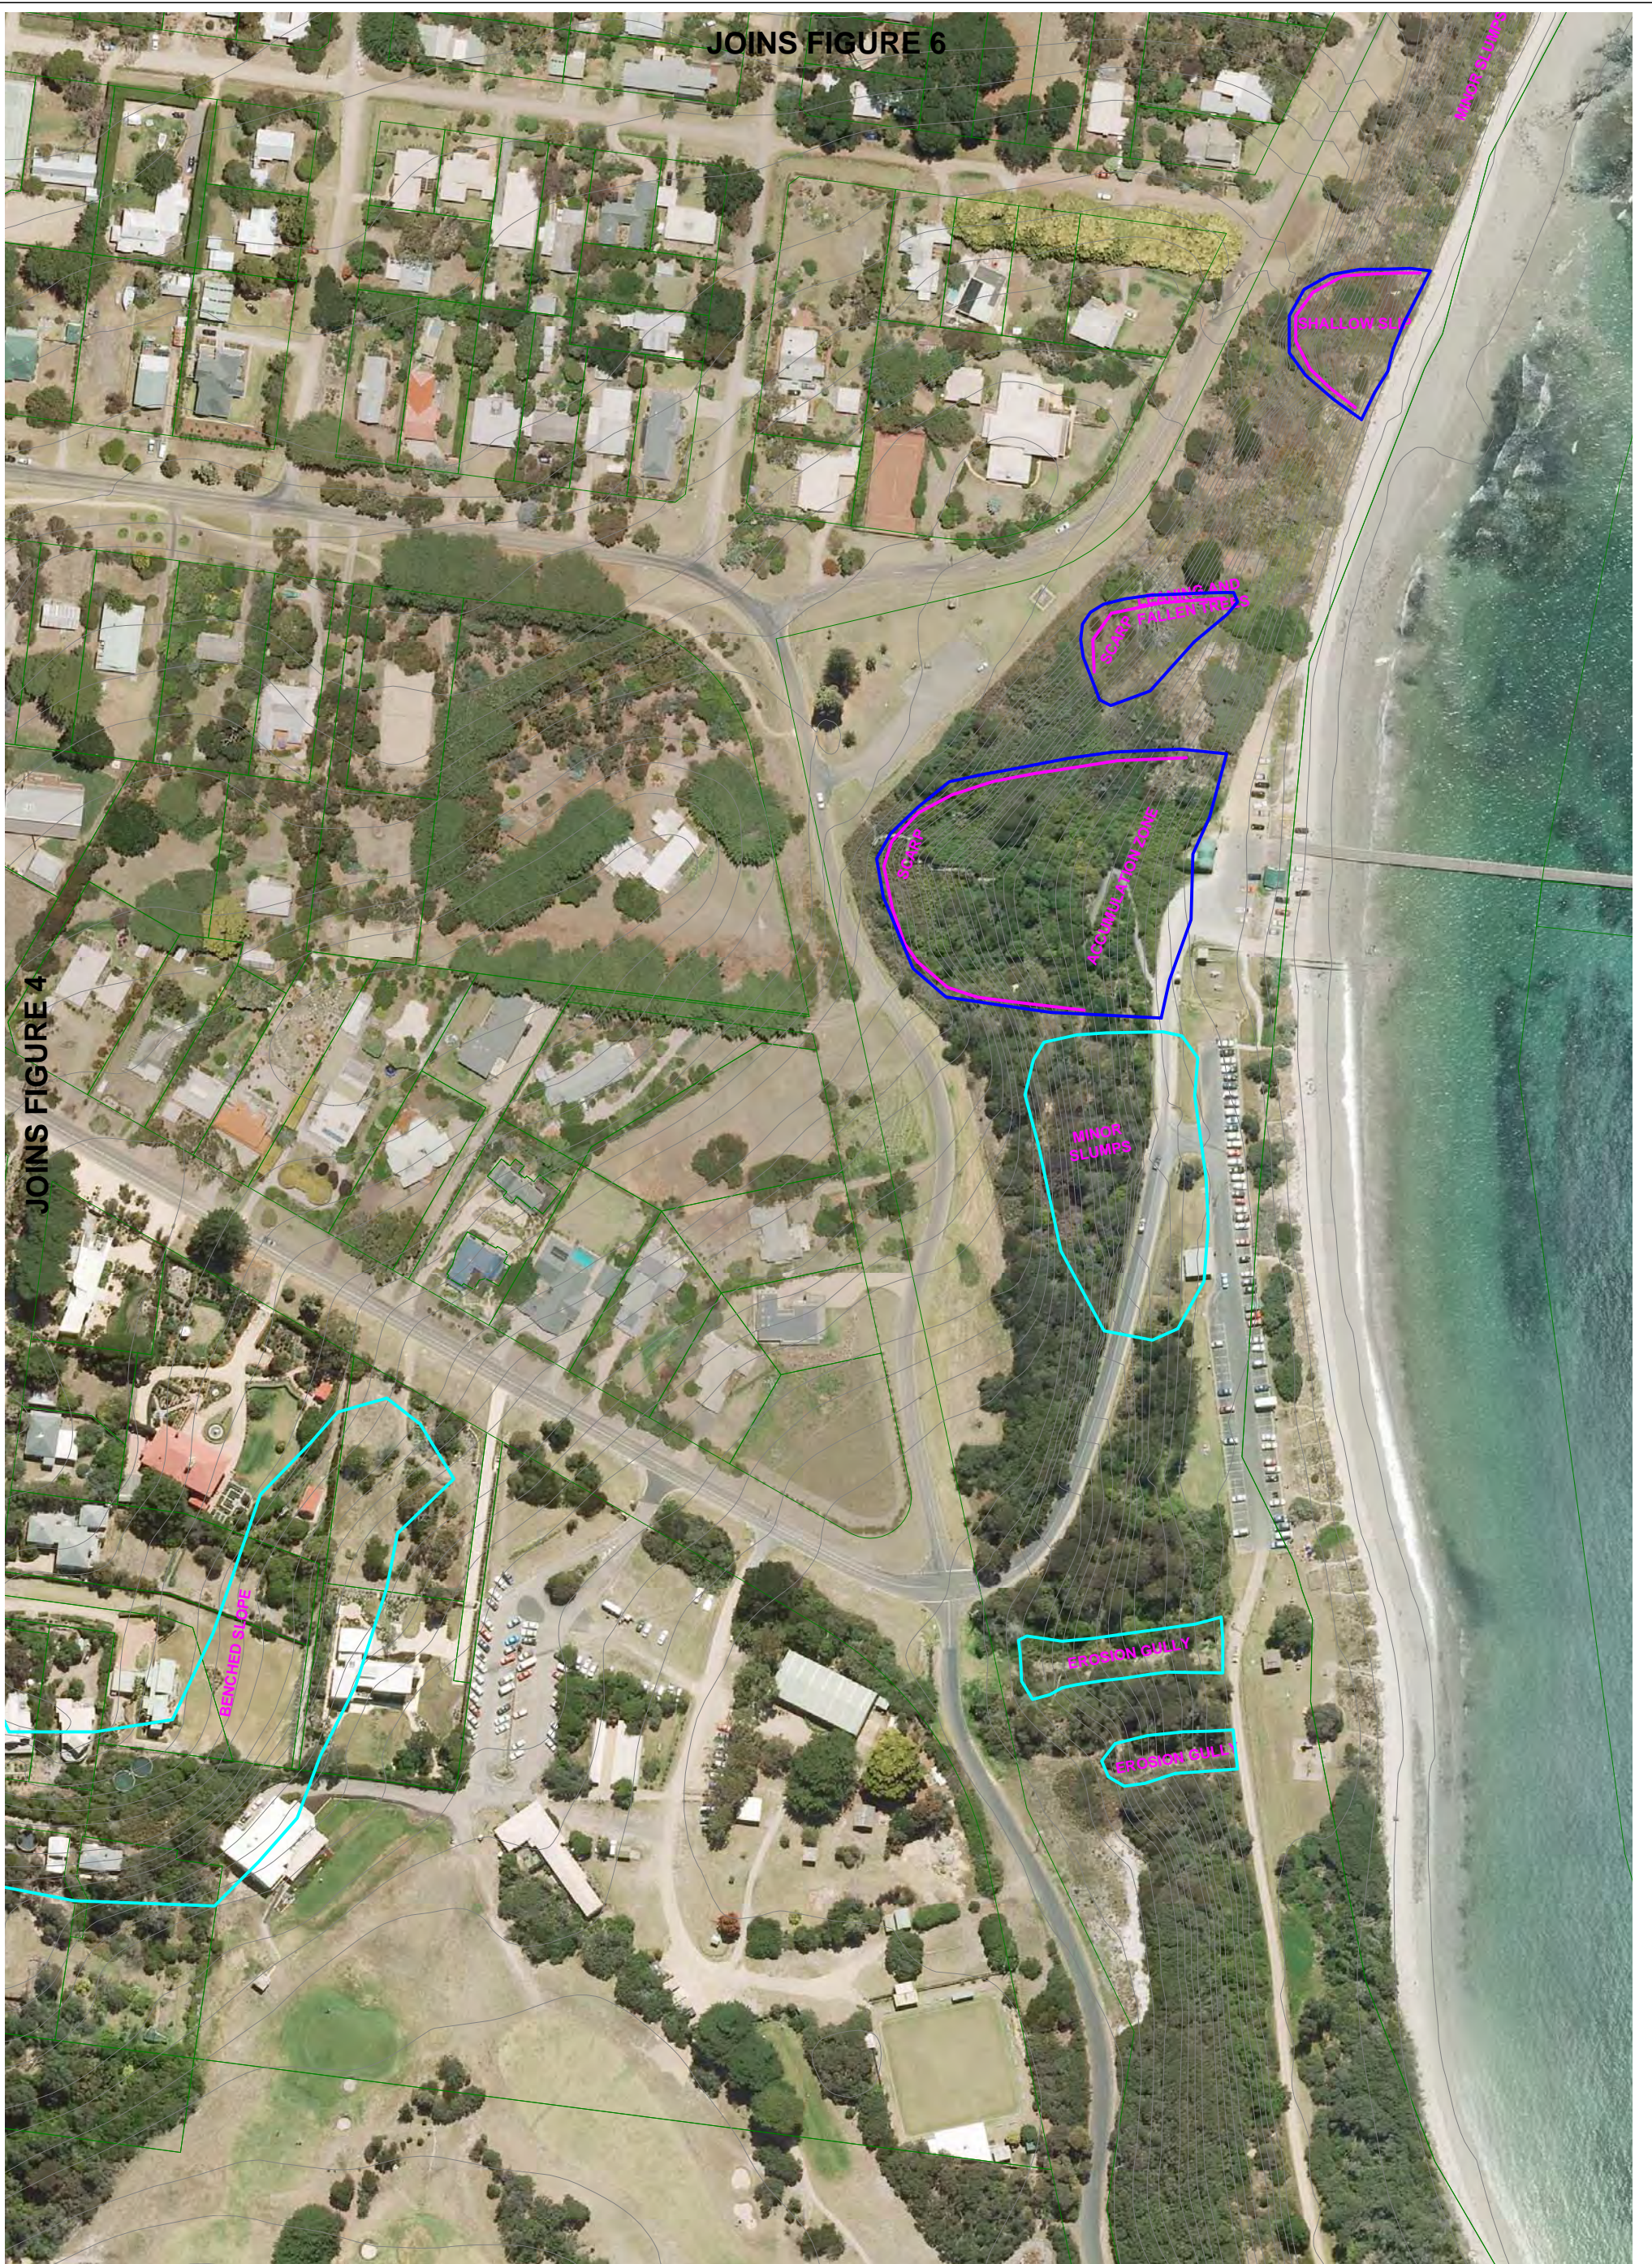
TITLE	ON SITE OBSERVATION PLAN	JOB NO.	27005	DATE	22 NOV 2007
PROJECT	FLINDERS FORESHORE LANDSLIP ASSESSMENT	SCALE (A3)	1:2,000	REV NO.	0
FILE REFERENCE	FLINDERS.WOR	DRAWN	DBS	FIG NO.	4

- Probable Landslips
- Potential Landslip or Area with Potential for Landslip
- TEXT On Site Observations

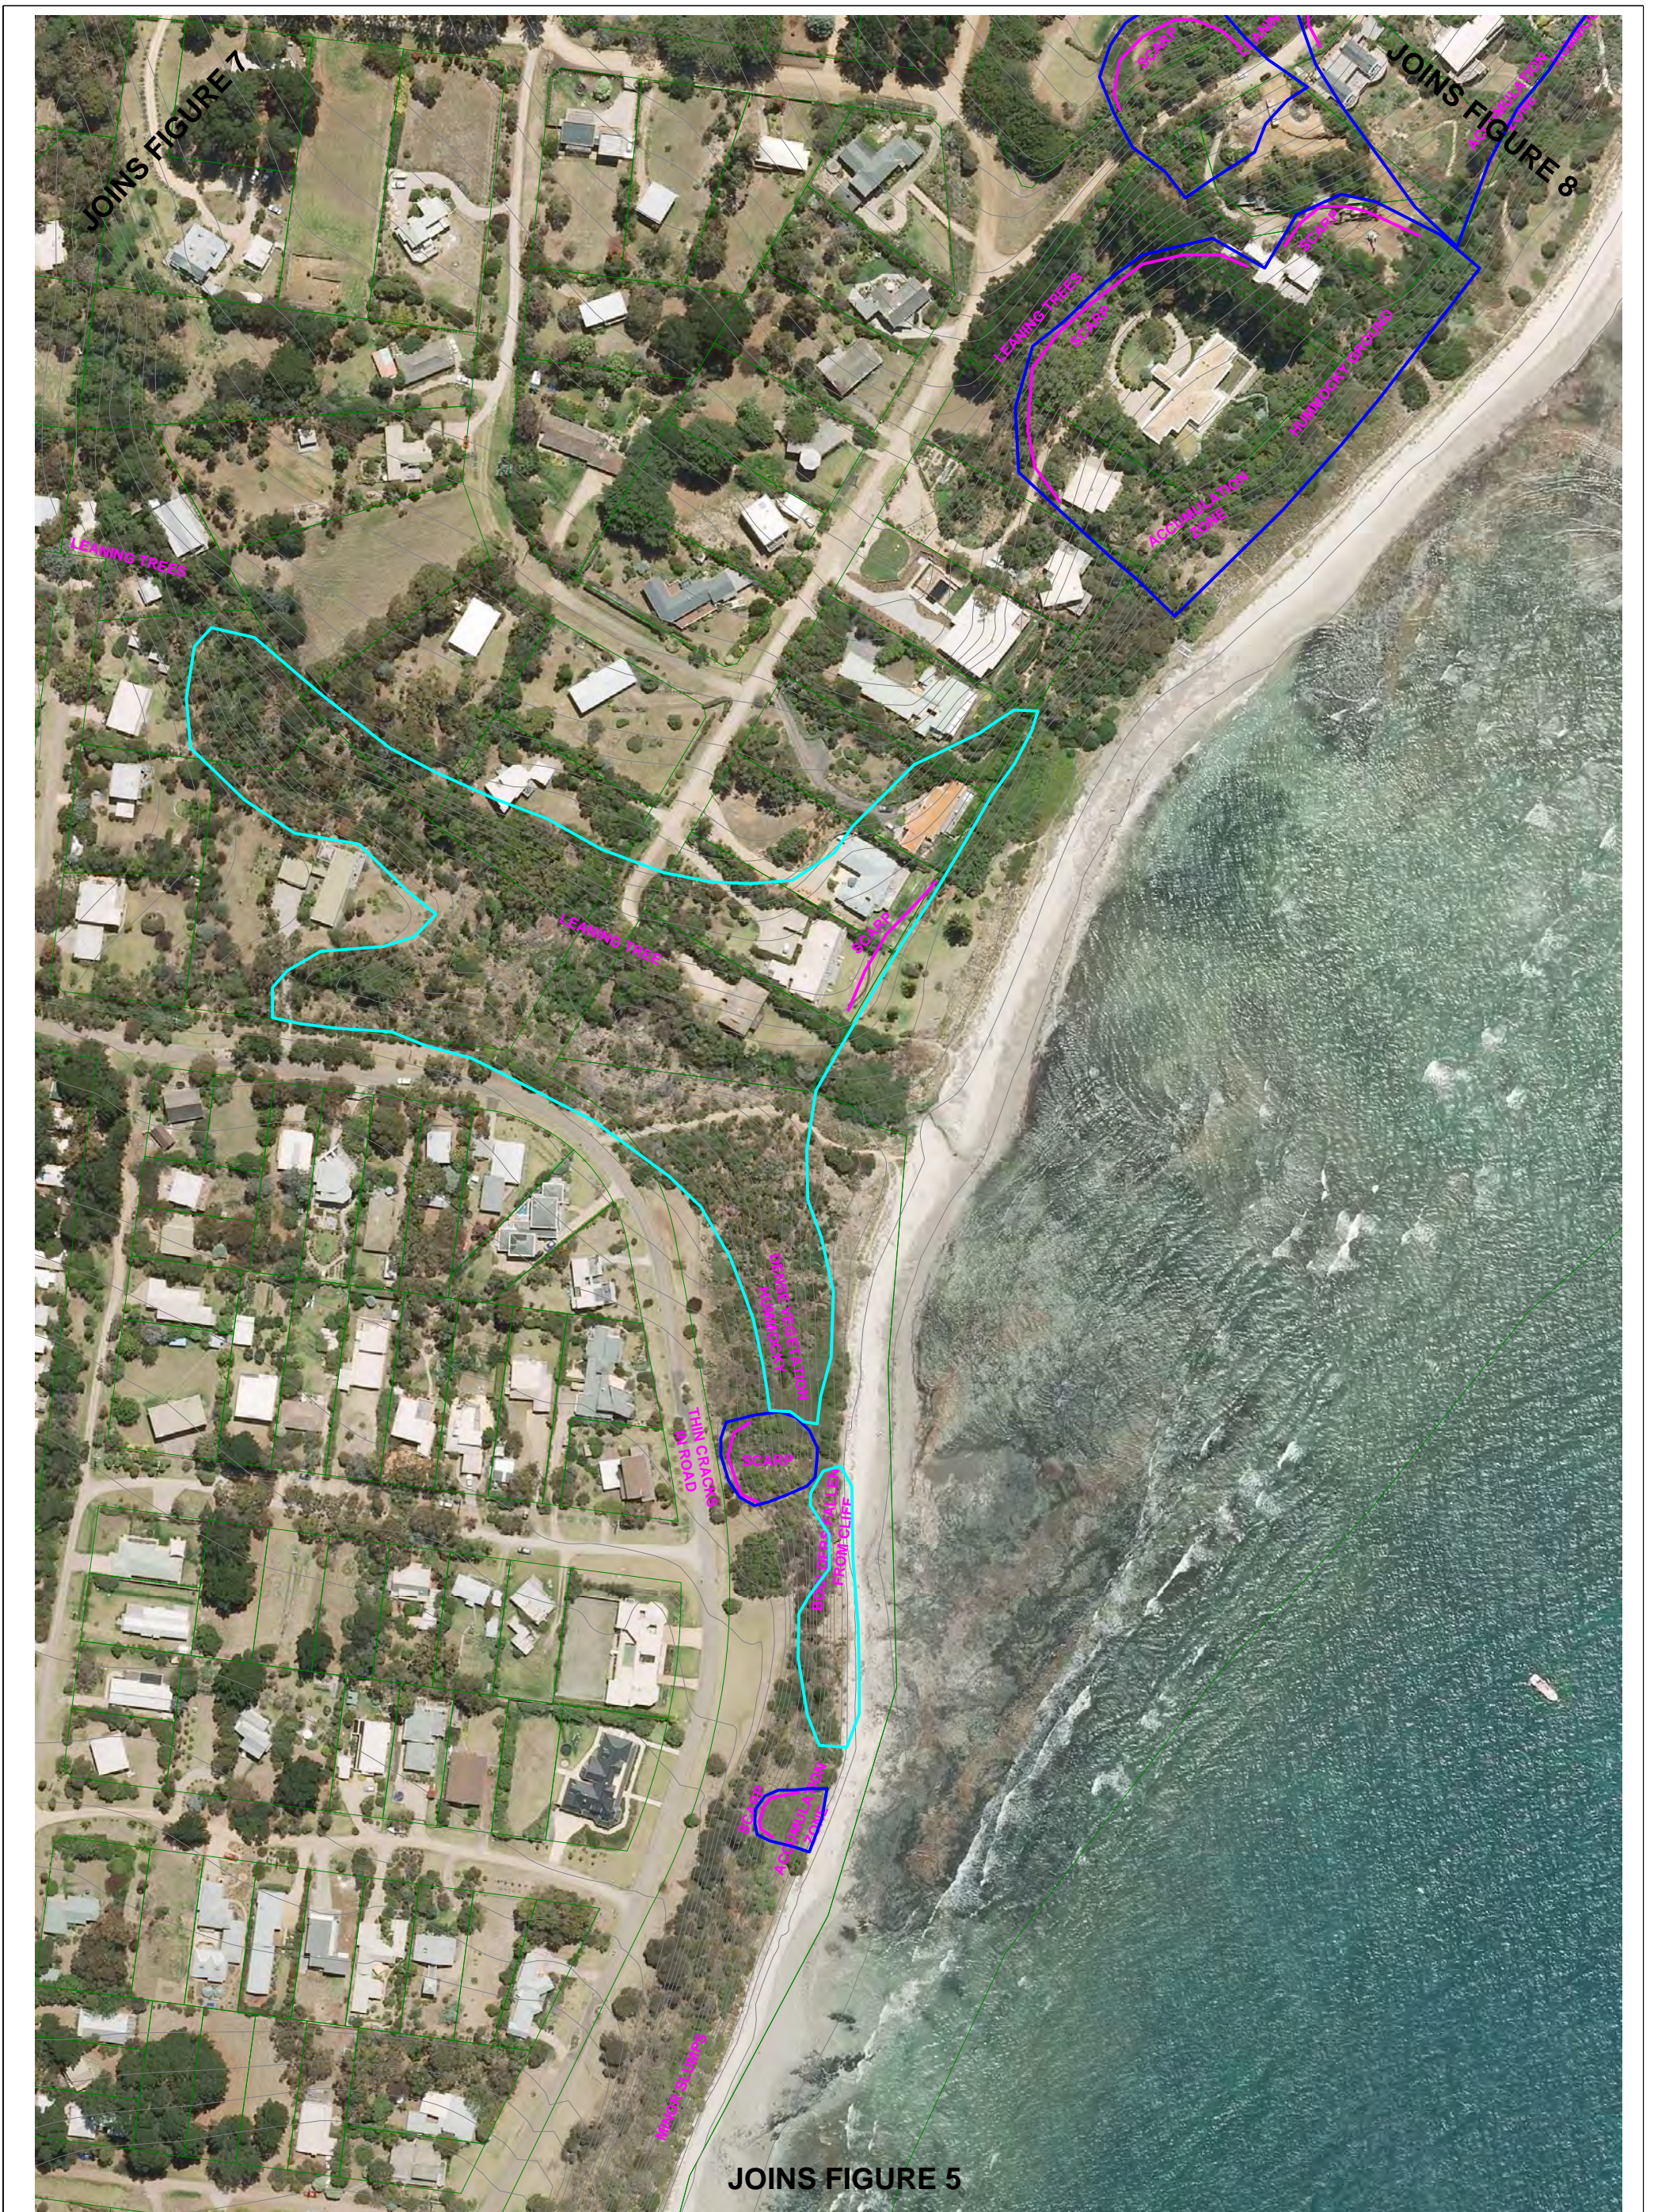
TITLE	ON SITE OBSERVATION PLAN	JOB NO.	27005	DATE	22 NOV 2007
PROJECT	FLINDERS FORESHORE LANDSLIP ASSESSMENT	SCALE (A3)	1:2,000	REV NO.	0
FILE REFERENCE	FLINDERS.WOR	DRAWN	DBS	FIG NO.	5

- Probable Landslips
- Potential Landslip or Area with Potential for Landslip
- TEXT On Site Observations
