Flinders Township and Tanti Creek Geotechnical Information Pack

Geotechnical assessment for landslip susceptibility and investigation zoning: Flinders
Foreshore Mornington Peninsula, January 2008

GEOTECHNICAL ASSESSMENT FOR LANDSLIP SUSCEPTIBILITY AND INVESTIGATION ZONING

**FLINDERS FORESHORE
MORNINGTON PENINSULA**

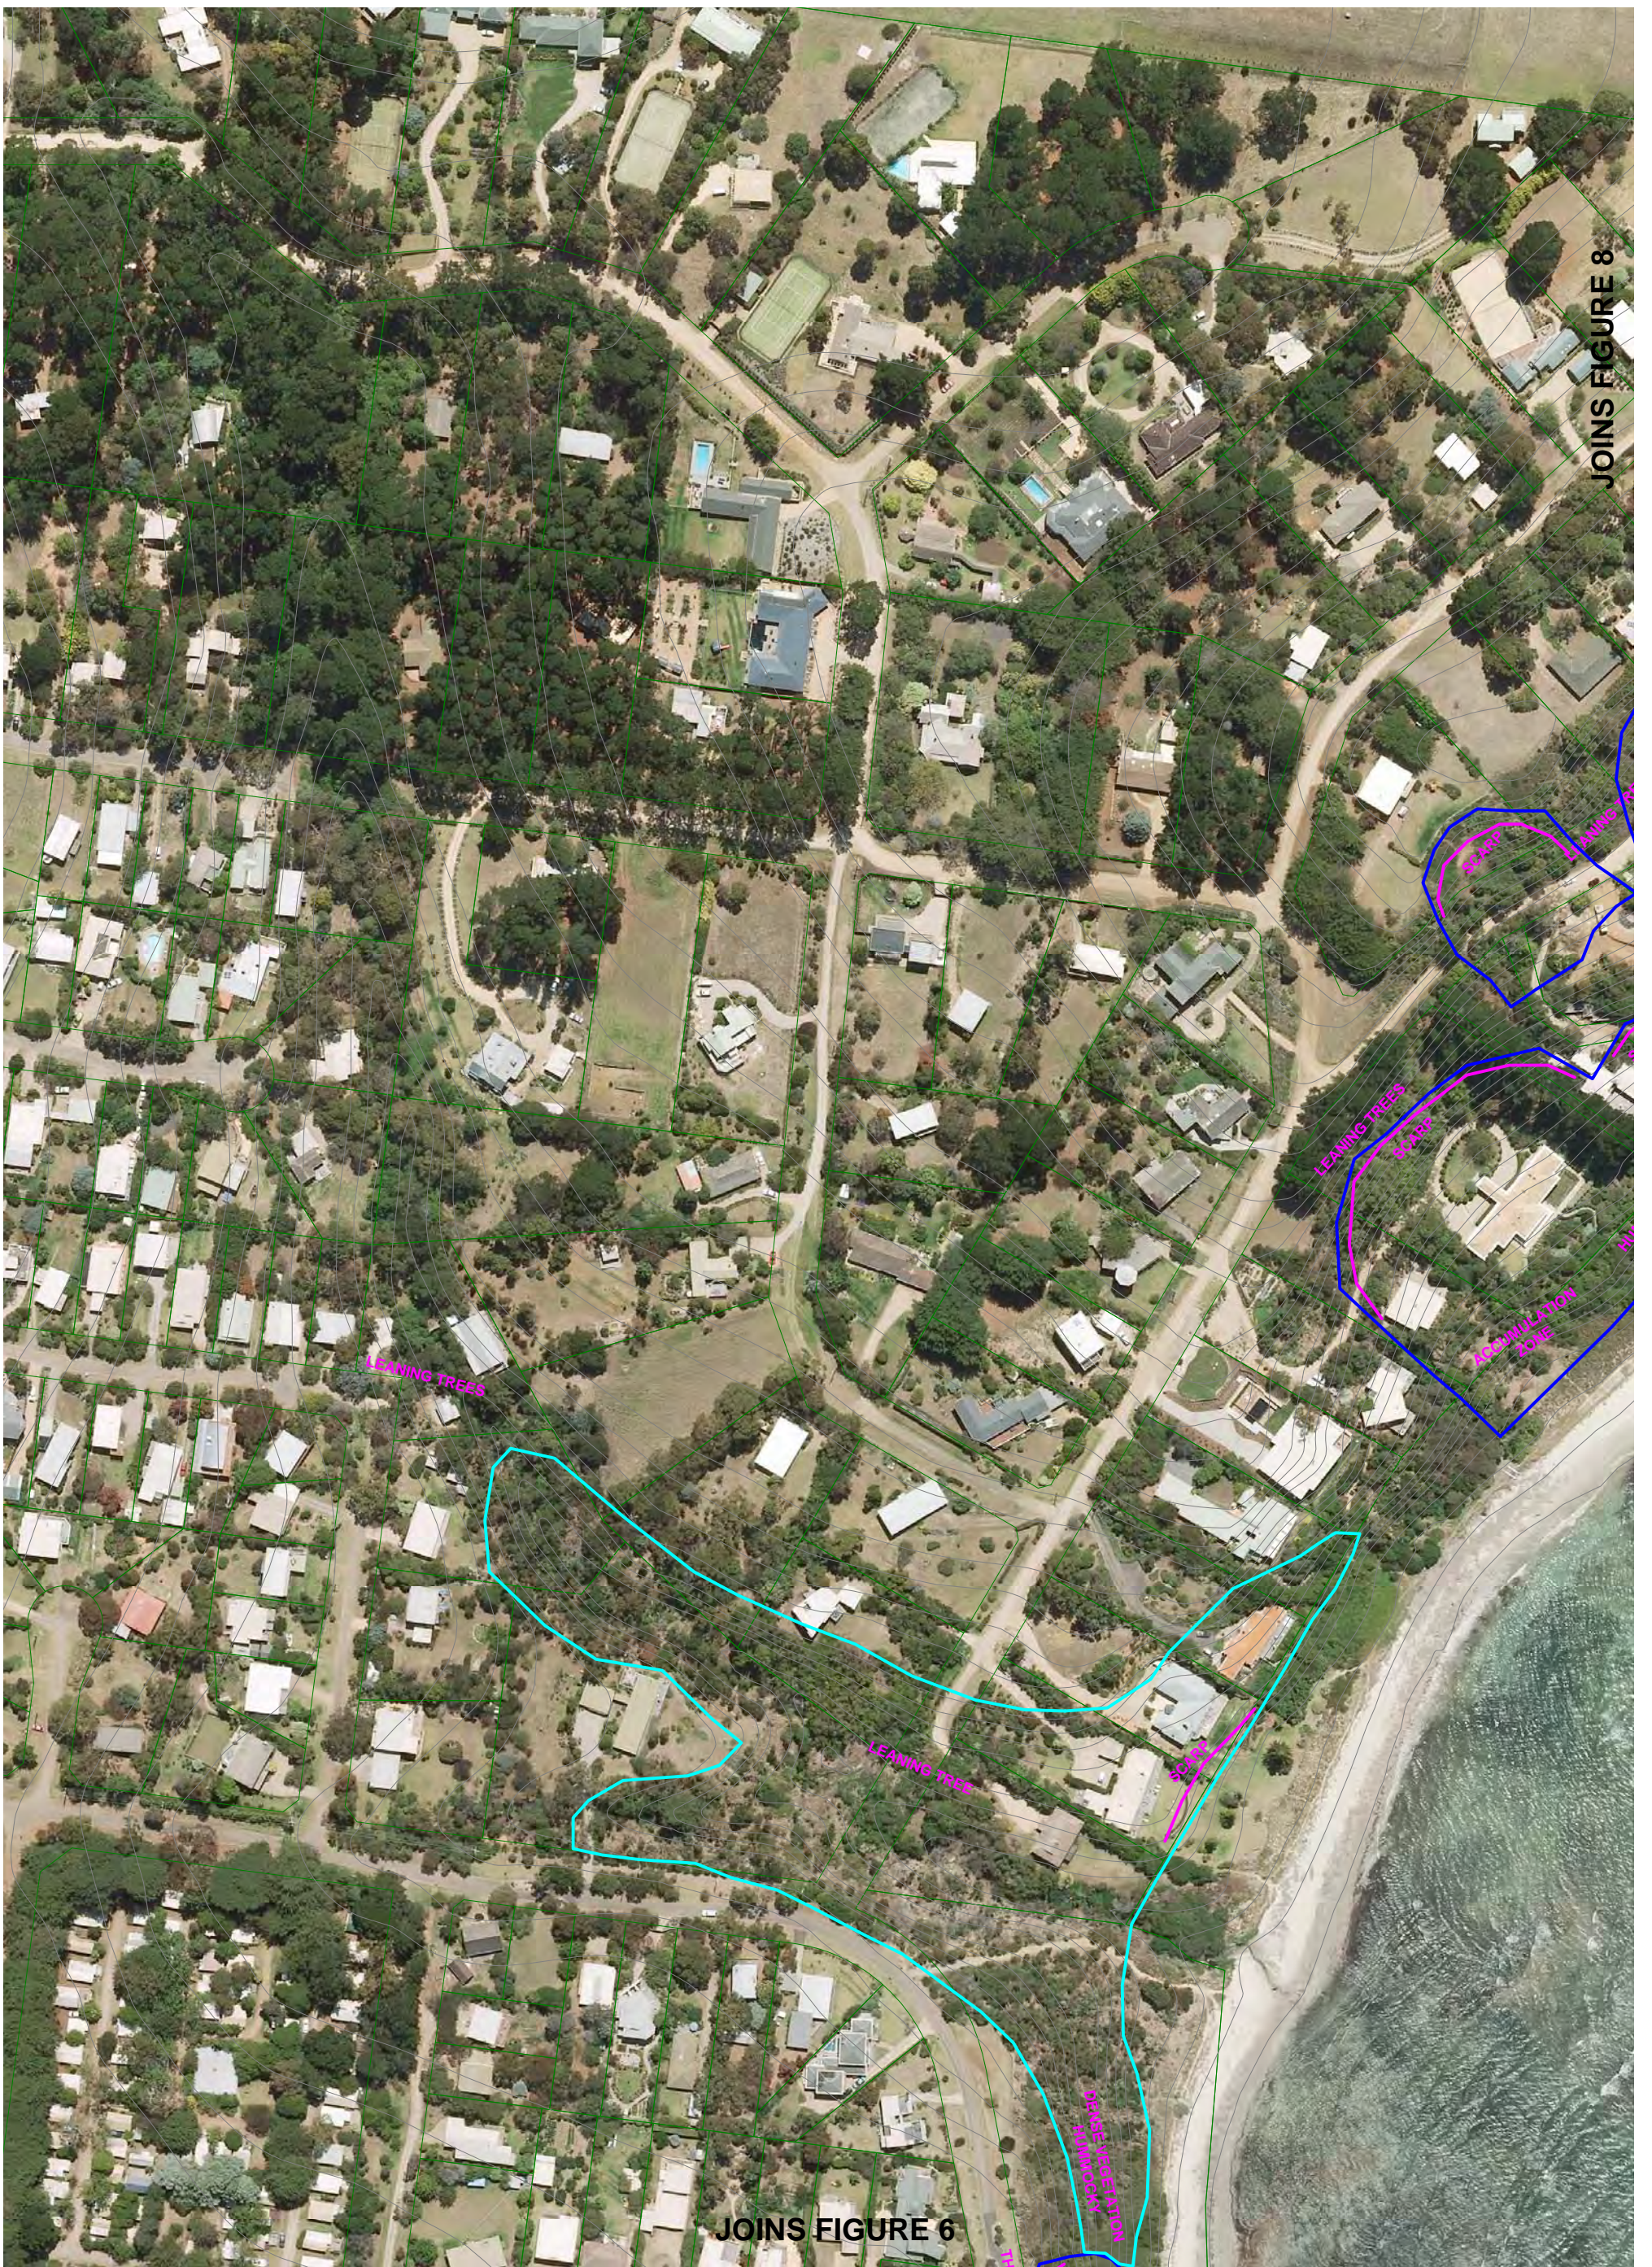
TITLE	ON SITE OBSERVATION PLAN	JOB NO.	27005	DATE	22 NOV 2007
PROJECT	FLINDERS FORESHORE LANDSLIP ASSESSMENT	SCALE (A3)	1:2,000	REV NO.	0
FILE REFERENCE	FLINDERS.WOR	DRAWN	DBS	FIG NO.	7

The Figure No. 8, Appendix A shows the extents of the landslips in the area. No attempt has been made to show the extent of the down slope limit of the failure or debris flow, but often this has been removed by sea erosion. Boundaries are shown as approximations only, based on field notes and examination of aerial photographs. The failures are generally arcuate type of failures with a zone of accumulation on the slopes below.

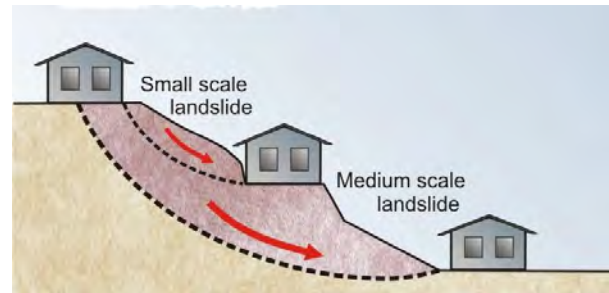
Figure 1

Rotational or circular slip failures (Figure 1) - can occur on moderate to very steep soil and weathered rock slopes (Table 1). The sliding surface of the moving mass tends to be deep seated. Tension cracks may open at the top of the slope and bulging may occur at the toe. The ground may move in discrete "steps" separated by long periods without movement. More rapid movement may occur after heavy rain.

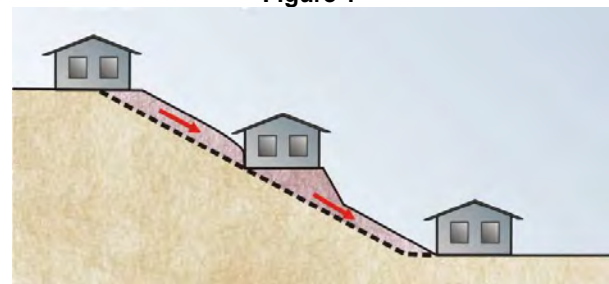
Figure 2

Translational slip failures (Figure 2) - tend to occur on moderate to very steep slopes (Table 1) where soil, or weak rock, overlies stronger strata. The sliding mass is often relatively shallow. It can move, or deform slowly (creep) over long periods of time. Extensive linear cracks and hummocks sometimes form along the contours. The sliding mass may accelerate after heavy rain.

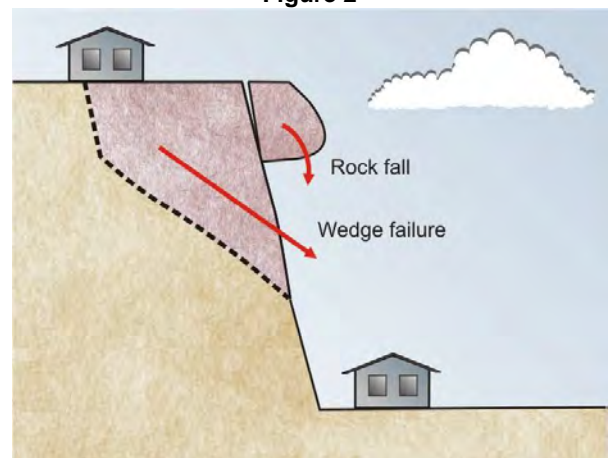
Figure 3

Wedge failures (Figure 3) - normally only occur on extreme slopes, or cliffs (Table 1), where discontinuities in the rock are inclined steeply downwards out of the face.

Cliffs may remain apparently unchanged for hundreds of years. Collections of boulders at the foot of a cliff may indicate that rock falls are ongoing. Wedge failures and rock falls do not "creep". Familiarity with a particular local situation can instil a false sense of security since failure, when it occurs, is usually sudden and catastrophic.

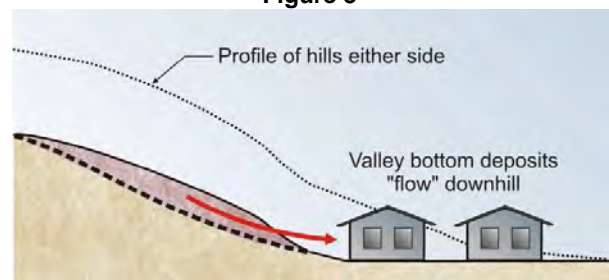
Figure 4

Debris flows and mud slides (Figure 4) - may occur in the foothills of ranges, where erosion has formed valleys which slope down to the plains below. The valley bottoms are often lined with loose eroded material (debris) which can "flow" if it becomes saturated during and after heavy rain. Debris flows are likely to occur with little warning; they travel a long way and often involve large volumes of soil. The consequences can be devastating.

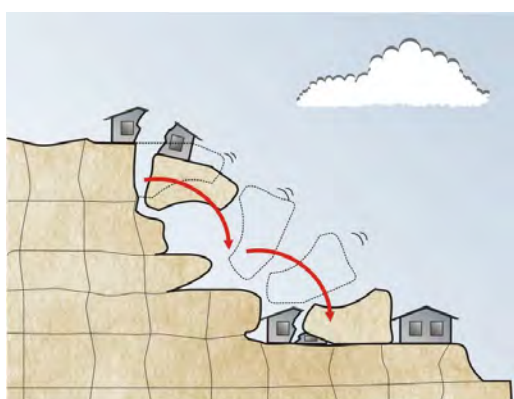
Figure 1 - Failure of an undercut block

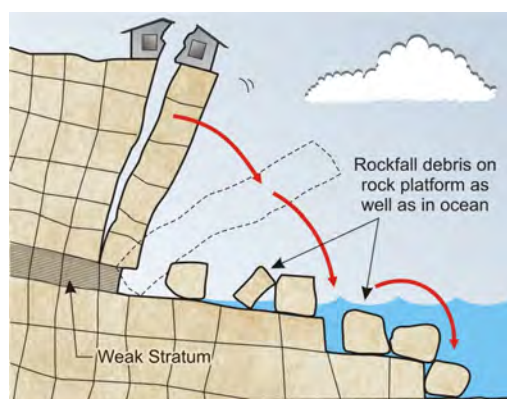
Figure 2 - Toppling failure

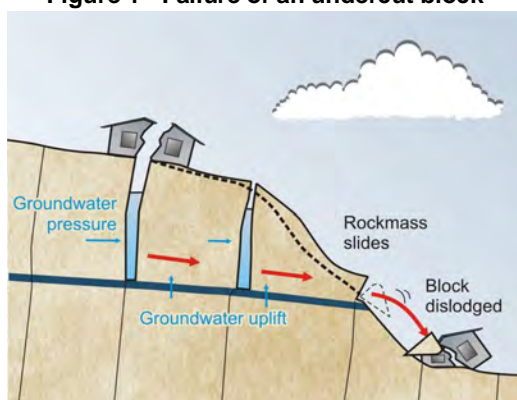
Figure 3 - Block slide on weak layer

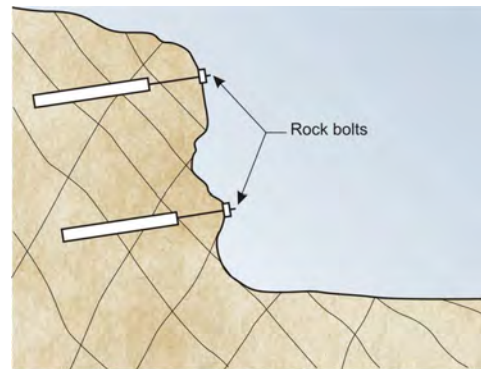
Figure 5

Rock bolts and rock anchors (Figure 5) - can be installed in the ground to improve its strength and prevent individual blocks from falling. Rock bolts are usually tightened using a torque wrench, whilst rock anchors carry higher loads and require jacking. Both can be designed to be "permanent" using stainless steel, or sheathing, to inhibit corrosion, but the cost can be up to 10 times that of the "temporary" alternative. You should inspect rock bolts and rock anchors for signs of water seepage, rusting and deterioration around the heads at least once every 5 years. If you notice any of these warning signs, have them checked by a geotechnical practitioner. It is recommended that you keep copies of design drawings and maintenance records (GeoGuide LR11) for the anchors on your site and pass them on to the new owner should you sell.

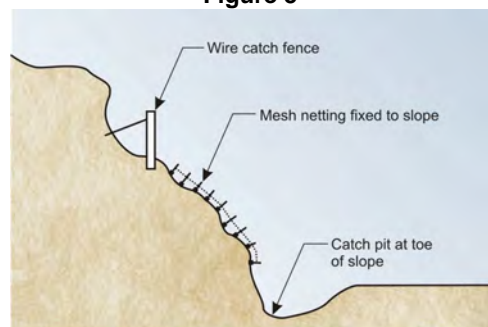
Figure 6

Rock fall netting, catch fences and catch pits (Figure 6) - are designed to catch or control falling rocks and prevent them from damaging nearby property. You should inspect them at least once every 5 years, and after major falls, and arrange for fallen and trapped rocks to be removed if they appear to be filling up. Check for signs of corrosion and replace steel elements and fixings before they lose significant strength.

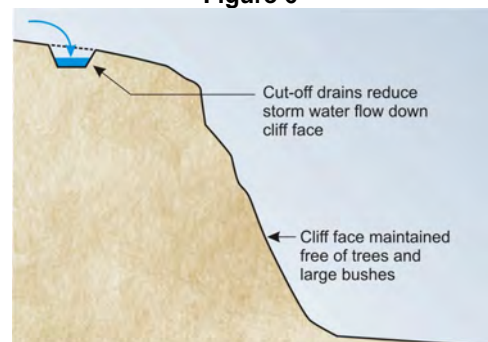
Figure 7

Cut-off drains (Figure 7) - can be used to intercept surface water run-off and reduce flows down the cliff face. Suitable drains are often excavated into the rock, or constructed from mounds of concrete, or stabilised soil, depending on conditions. Drains must be laid to a fall of at least 1% so they drain adequately. Frequent inspection is needed to ensure they are not blocked and continue to function as intended.

Clear trees and large bushes (Figure 7) - from slopes since roots can prize boulders from the face increasing the landslide hazard.

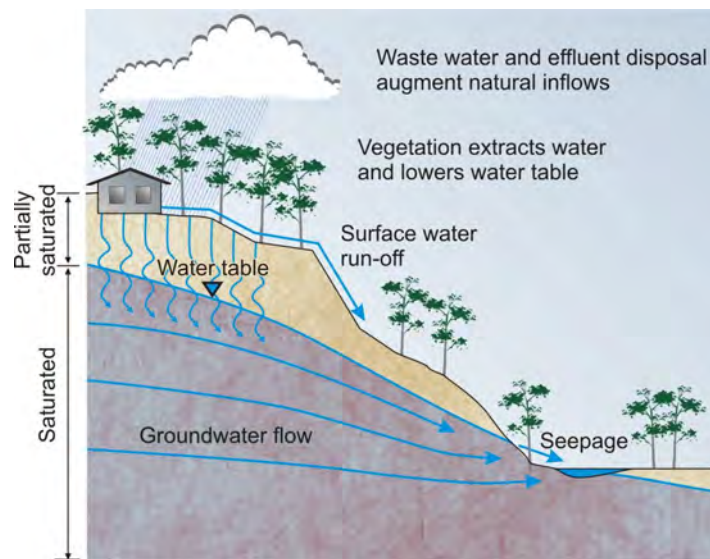
The ground is permeable and water flows through it as illustrated in Figure 1. When rain falls on the ground, some of it runs along the surface ("surface water run-off") and some soaks in, becoming groundwater. Groundwater seeps downwards along any path it can find until it meets the water table: the local level below which the ground is saturated. If it reaches the water table, groundwater either comes to a halt in what is effectively underground storage, or it continues to flow downwards, often towards a spring where it can seep out and become surface water again. Above the water table the ground is said to be "partially saturated", because it contains both water and air. Suctions can develop in the partially saturated zone which have the effect of holding the ground together and reducing the risk of a landslide. Vegetation and trees in particular draw large quantities of water out of the ground on a daily basis from the partially saturated zone. This lowers the water table and increases suctions, both of which reduce the likelihood of a landslide occurring.

Figure 1 - Groundwater flow

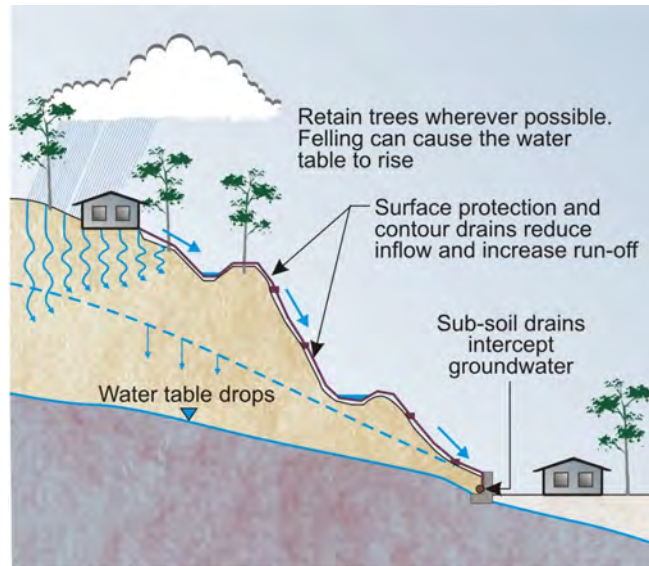
Figure 2 - Techniques used to control groundwater flow

Surface water drains (dish drains, or table drains) - are often used to prevent scour and limit inflow to a slope. Other than in rock, they are relatively ineffective unless they have an impermeable lining. You should clear them regularly, and as required, and not less than once a year. If you live in an area with seasonal rainfall, it is best to do this near the end of the dry season. If you notice that soil or rock debris is falling from the slope above, determine the source and take appropriate action. This may mean you have to seek advice from a geotechnical practitioner.

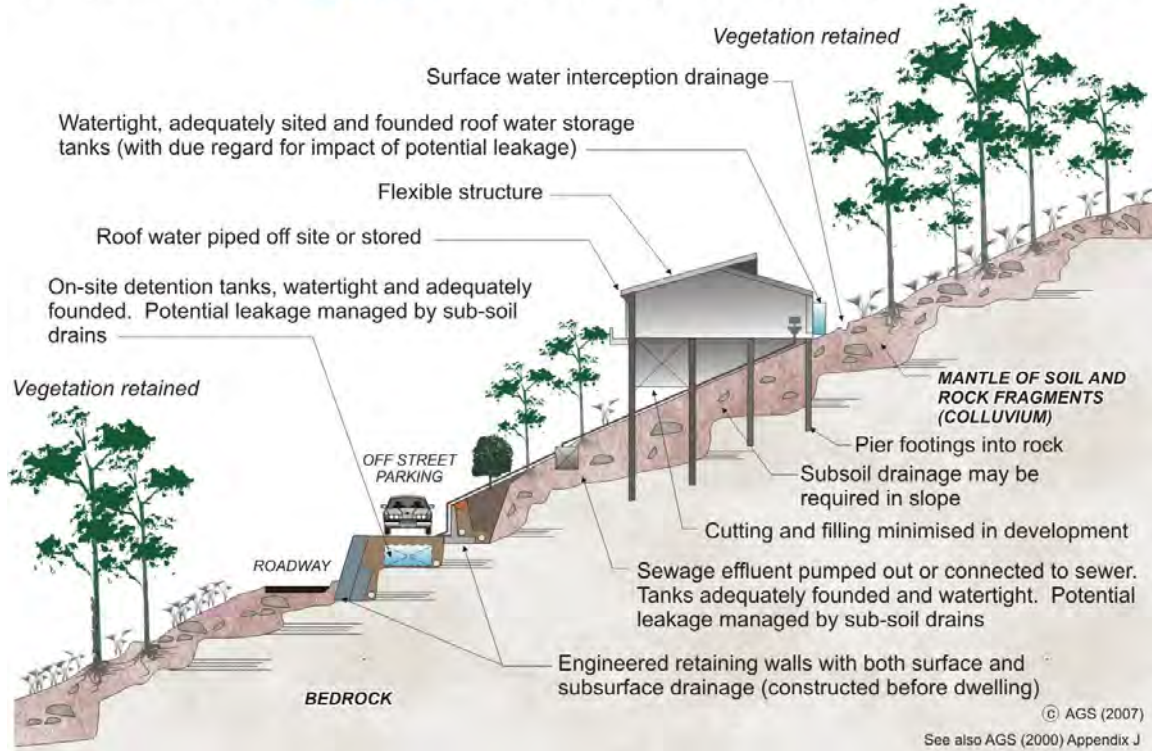
EXAMPLES OF GOOD HILLSIDE CONSTRUCTION PRACTICE

Roadways and parking areas - are paved and incorporate kerbs which prevent water discharging straight into the hillside (GeoGuide LR5).

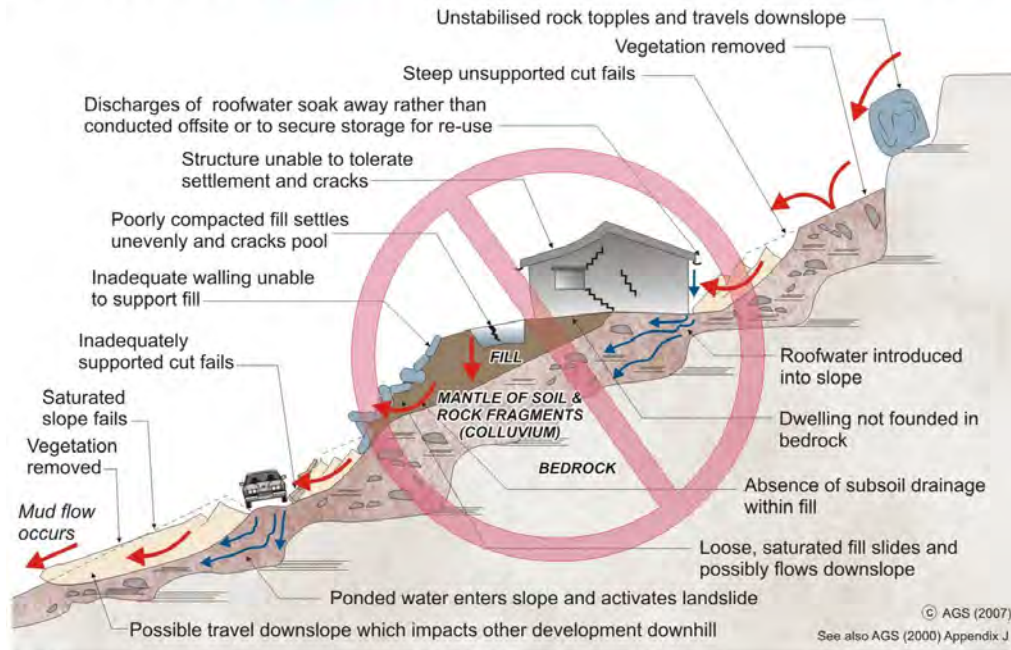
EXAMPLES OF **POOR** HILLSIDE CONSTRUCTION PRACTICE

Roadways and parking areas - are unsurfaced and lack proper table drains (gutters) causing surface water to pond and soak into the ground.

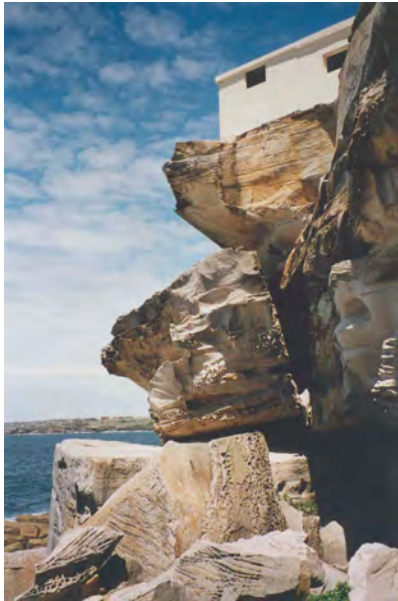
The coast presents a particularly dynamic environment where change is often the norm. Hazards exist in relation to both cliffs and sand dunes. The coast is also the most heavily populated part of Australia and always regarded as "prime" real estate, because of the views and access to waterways and beaches.

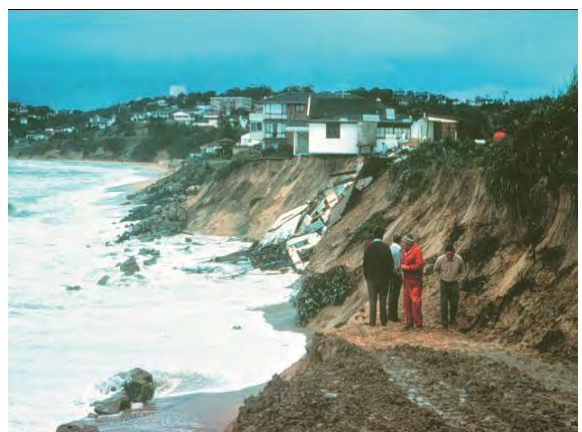
An understanding of coastal processes is essential when determining beach erosion potential. Waves produced by large oceanic storms can erode beaches and cut escarpments into dunes. These may be of relatively short duration, when beach rebuilding happens after the storm, but can be a permanent feature where long term beach recession is taking place. In many locations, houses and infrastructure are sited on or immediately behind coastal dunes. After an escarpment has eroded, those assets may be lost or damaged by subsequent slumping of the dune. It is important that, on erodible coastal soils, the potential for landward incursion of an erosion escarpment is determined. Having done this, the likelihood of slope instability can be established as part of the landslide risk management process. Injury, death and structural damage have occurred around the Australian coast from collapsing sand escarpments.

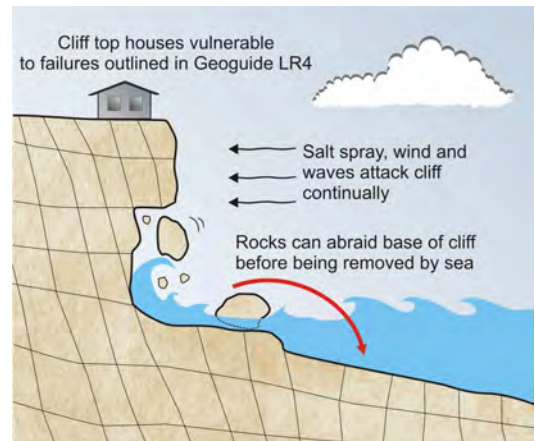
Figure 1

Coastal cliffs and headlands exist because the rock that they are made from is able to resist erosion. Even so, cliff-faces are not immune and will continue to collapse (Figure 1) by one or other of the mechanisms shown on GeoGuide LR4. If you live on a coastal cliff, you should undertake inspection and maintenance as recommended in LR4 and the other GeoGuides, as appropriate. The top of the cliff, its face, and its base should be inspected frequently for signs of recent rock falls, opening of cracks, and heavy seepage which might indicate imminent failure. Since the sea can remove fallen rocks rapidly, inspections should be made shortly after every major storm as a matter of course. **If collapses are occurring seek advice from an appropriately experienced geotechnical practitioner. Advise you local council if you believe erosion is rapid or accelerating.**

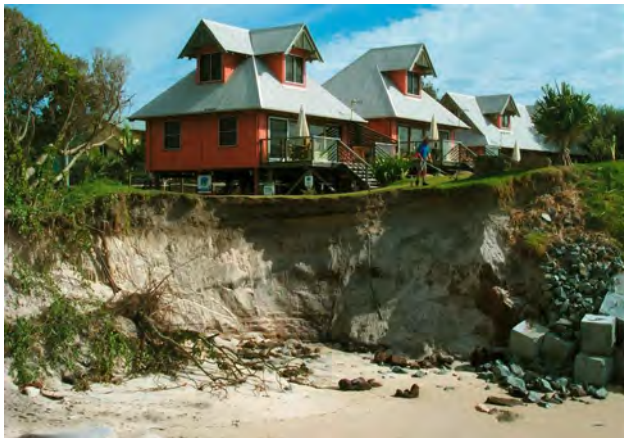
Any excavation in a natural dune slope is inherently unstable and must be supported and maintained (GeoGuide LR6). Dunes are particularly susceptible to ongoing erosion by wind and wave action and extreme changes can occur in a single storm. Whilst vegetation can help to stabilise dunes in the right circumstances, unfortunately a single storm has the potential to cut well into dunes and, in some cases, remove an entire low lying dune system or shift the mouth of a river. **As for cliffs, it is appropriate to observe the effects of major storms on the coastline. If erosion is causing the coastline to recede at an appreciable rate, seek advice from suitably experienced geotechnical and coastal engineering practitioners and bring it to the attention of the local council.**
