Landslide Risk Assessment

Beleura Cliff Path, Caraar Creek Road to Mills Beach, Mornington

PREPARED FOR:
Mornington Peninsula Shire

December 11, 2023
RFP: V220152Report02.3

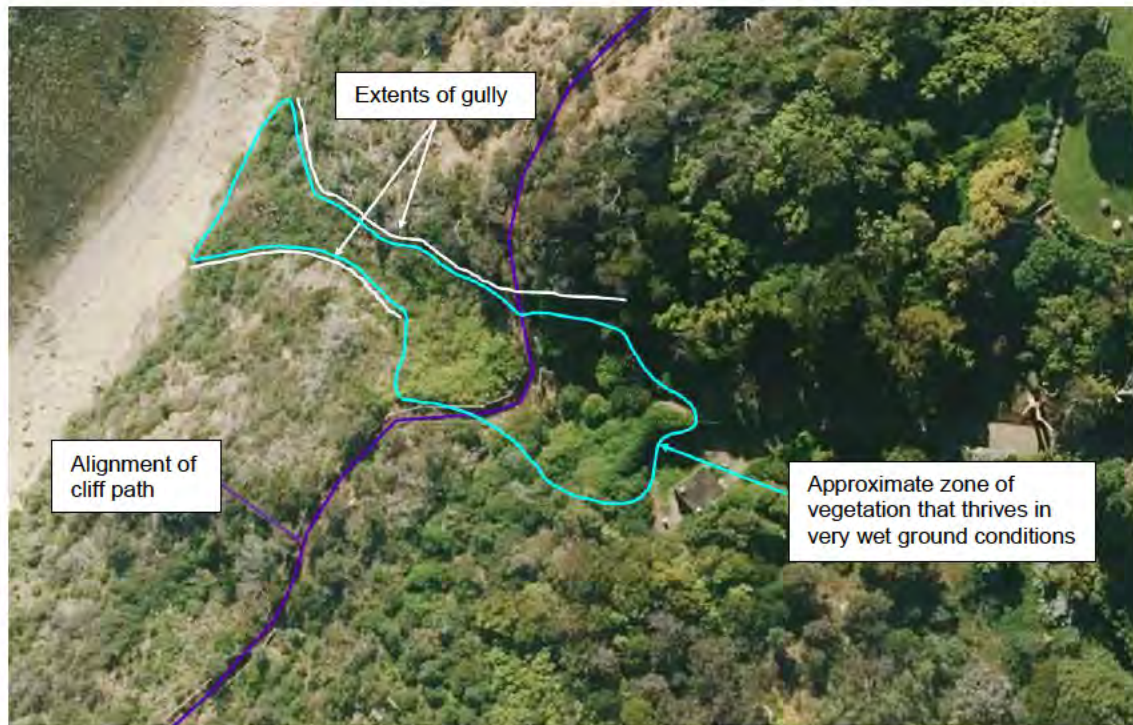
The aerial imagery also provides an indication of the level of saturation of the ground in the gully locations. The type and distribution of vegetation is a reflection of the moisture condition of the soils in which they are growing. Figure 3-7 presents an extract from the aerial imagery of one of the gullies located in the mid-section of the path. This shows that dense, lush, green vegetation that is indicative of high soil moisture levels is growing within the identified gully.

Figure 3-7 – Aerial image of a historic natural drainage gully in the mid-section of the path

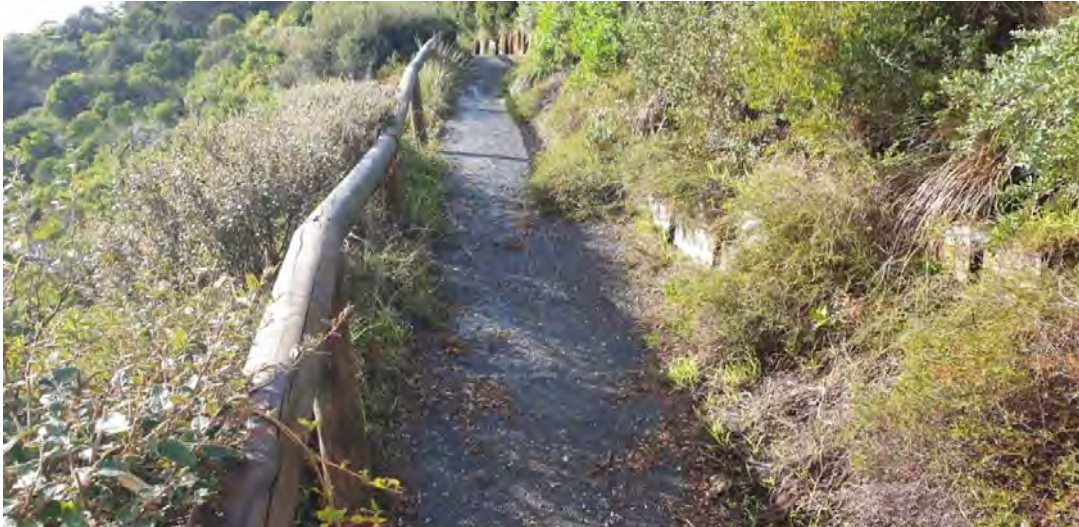
- The construction of the path has resulted on some sections of the path being built on a fill embankment, meaning material has been placed here, while other sections have been cut into the cliff. An example of the path built on a fill embankment is shown in Figure 4-4 and an example of the path cut into the cliff is shown in Figure 4-5.

Figure 4-4 – Example of path built on fill embankment (Section 9)

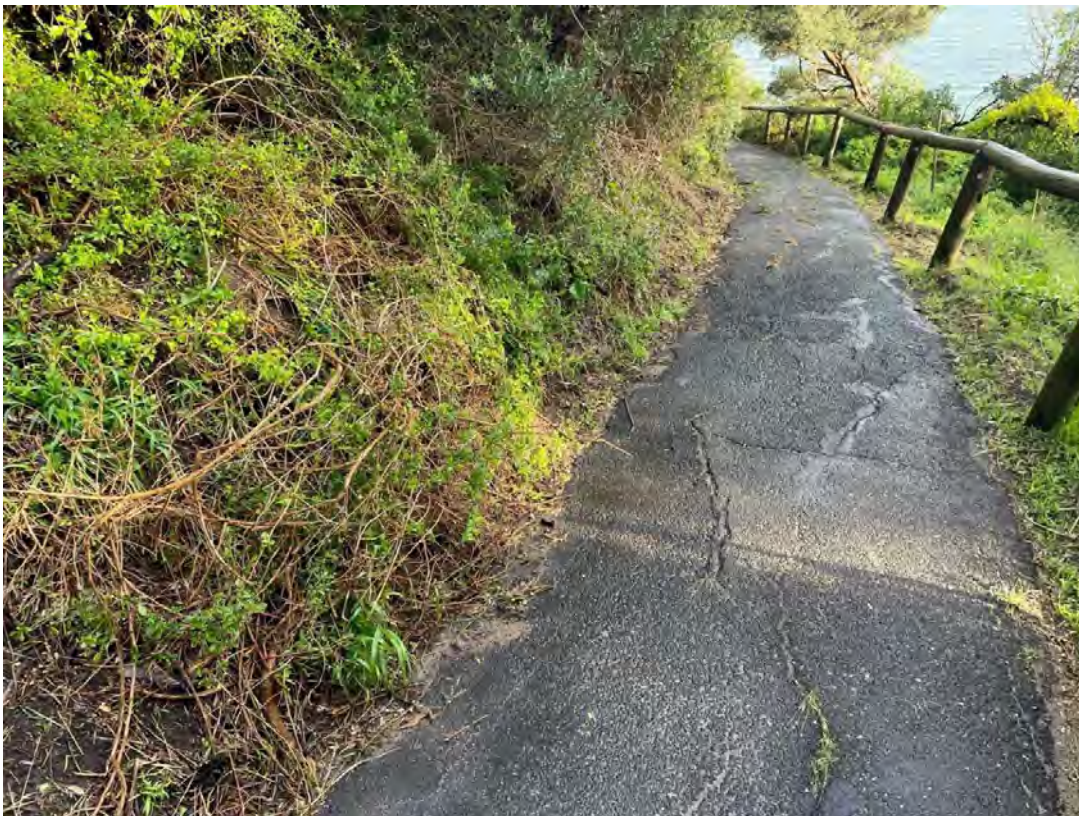
Figure 4-5 – Example of path cut into the cliff (Section 4)

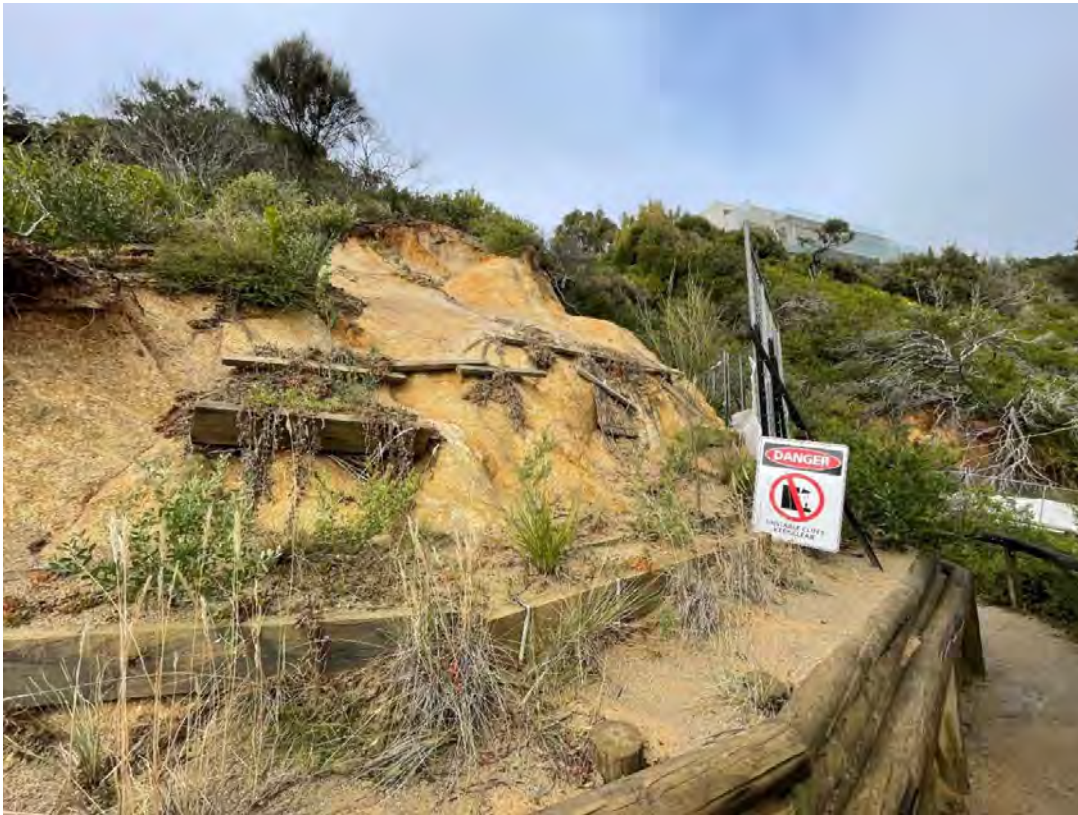
- In multiple locations informal retaining walls were observed adjacent to the path. An example of these retaining walls is presented in Figure 4-9. In some instances, walls that were originally built to catch debris from minor upslope slips are full and have been planted. An example of overflowing catch walls is presented in Figure 4-10.

Figure 4-10 – Full and planted catch walls (Section 19)

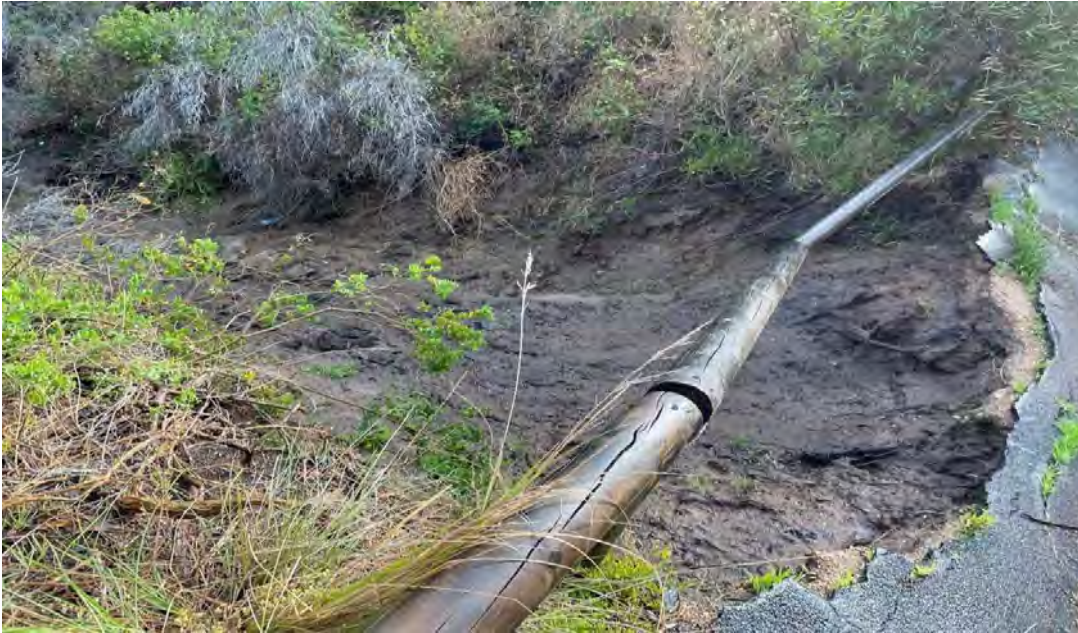
- There are 2 active landslides that have impacted on the path in recent times:
 - a. Section 7, where a debris flow has been reactivated. This is shown in Figure 4-11.
 - b. Section 20, downslope of the property at 23 Kalimna Drive. This landslide is a smaller part of a larger historic landslide in this area. This is shown in Figure 4-12.

Figure 4-11 - Section 7: Recent Landslide, 2022

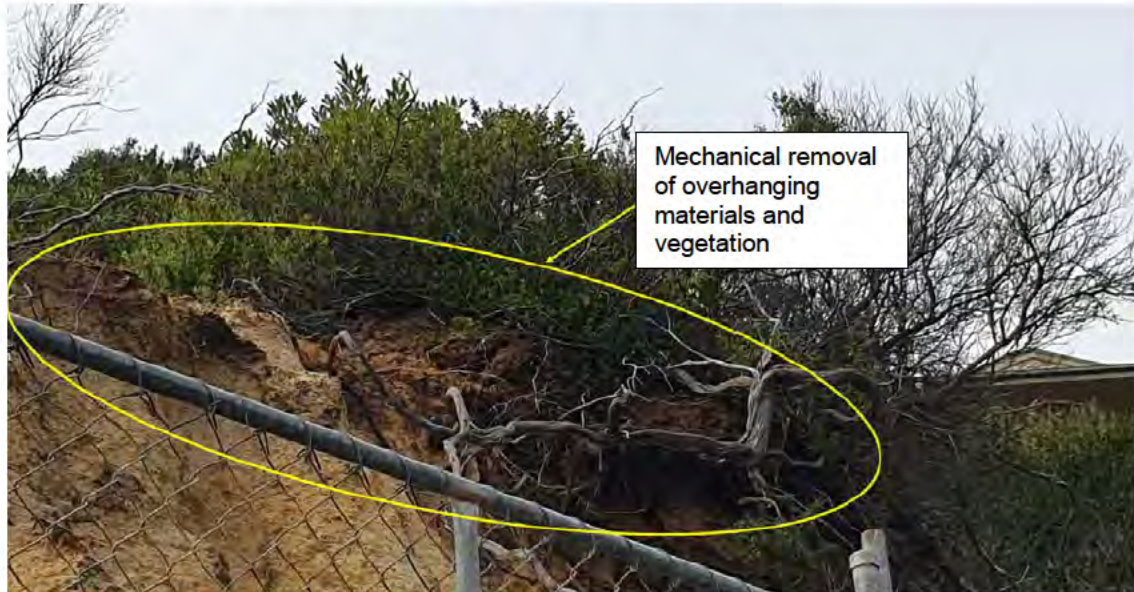
Figure 6-6 – Section 19: zone of overhanging material to be mechanically removed

Section 19 includes the areas where overhanging material was observed. It is recommended that the overhanging material is removed via mechanical means, and the section of the cliff upslope of the path be battered back to a shallower angle. The current catch wall needs to be emptied of material, such that any future soil material transported by surface run off is prevented from being deposited onto the path. This is illustrated in Figure 6-6 and Figure 6-7 below.
