**GEOTECHNICAL
ASSESSMENT OF SLOPE
STABILITY, TANTI CREEK,
MORNINGTON**

**Mornington Peninsula Shire
Council**

March 2010

Doc Ref: 23019report01.7

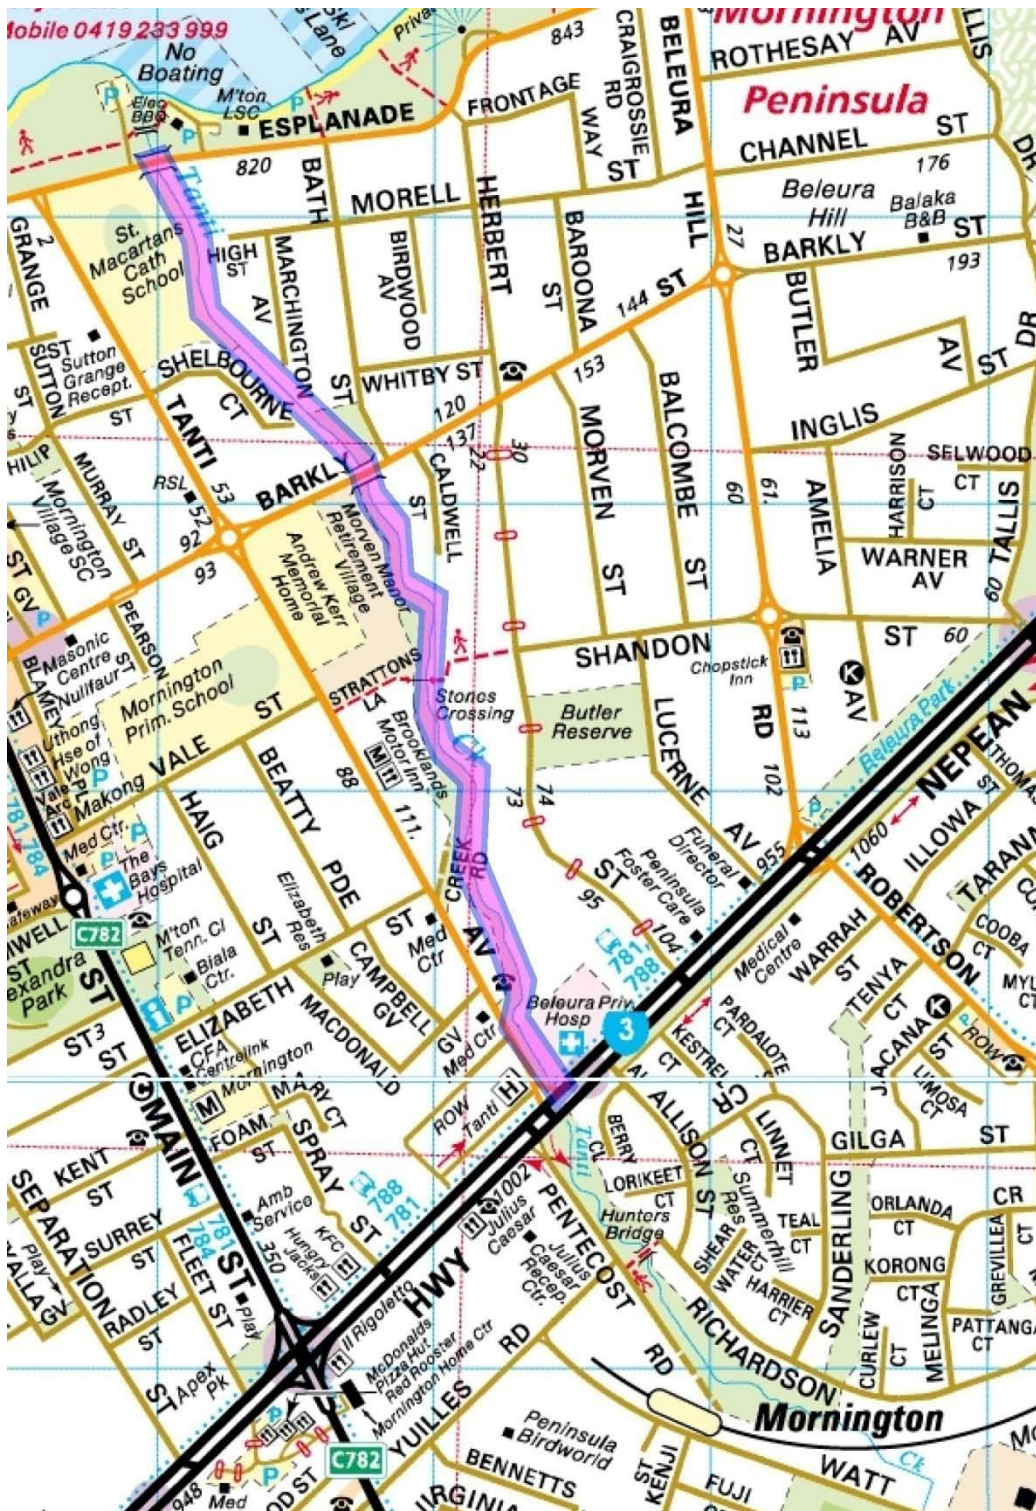
Figure 4-1: Location of Tanti Creek indicating study area

Tanti Creek flows in a north-westerly direction from south of the Mornington Tourist Railway near Watt Street until discharging into Port Phillip Bay in the vicinity of Mills Beach. The section of the creek covered by the current study area is the length of the creek between the Nepean Highway and The Esplanade and is about 1.5km, as indicated in Figure 4-1 overleaf.

The gully extends past Barkly Street at approximately 5 to 6m depth to the area in the vicinity of 17 Shelbourne Court, where the base of the gully broadens out to a wider valley. The creek is incised approximately 2-3m into the valley while the sides of the valley are approximately 5-6m high. The creek then flows along the western side of the valley with the eastern side some 30-50m distant. In this area the grade of the creek begins to flatten out as well. The creek continues in this form until The Esplanade.

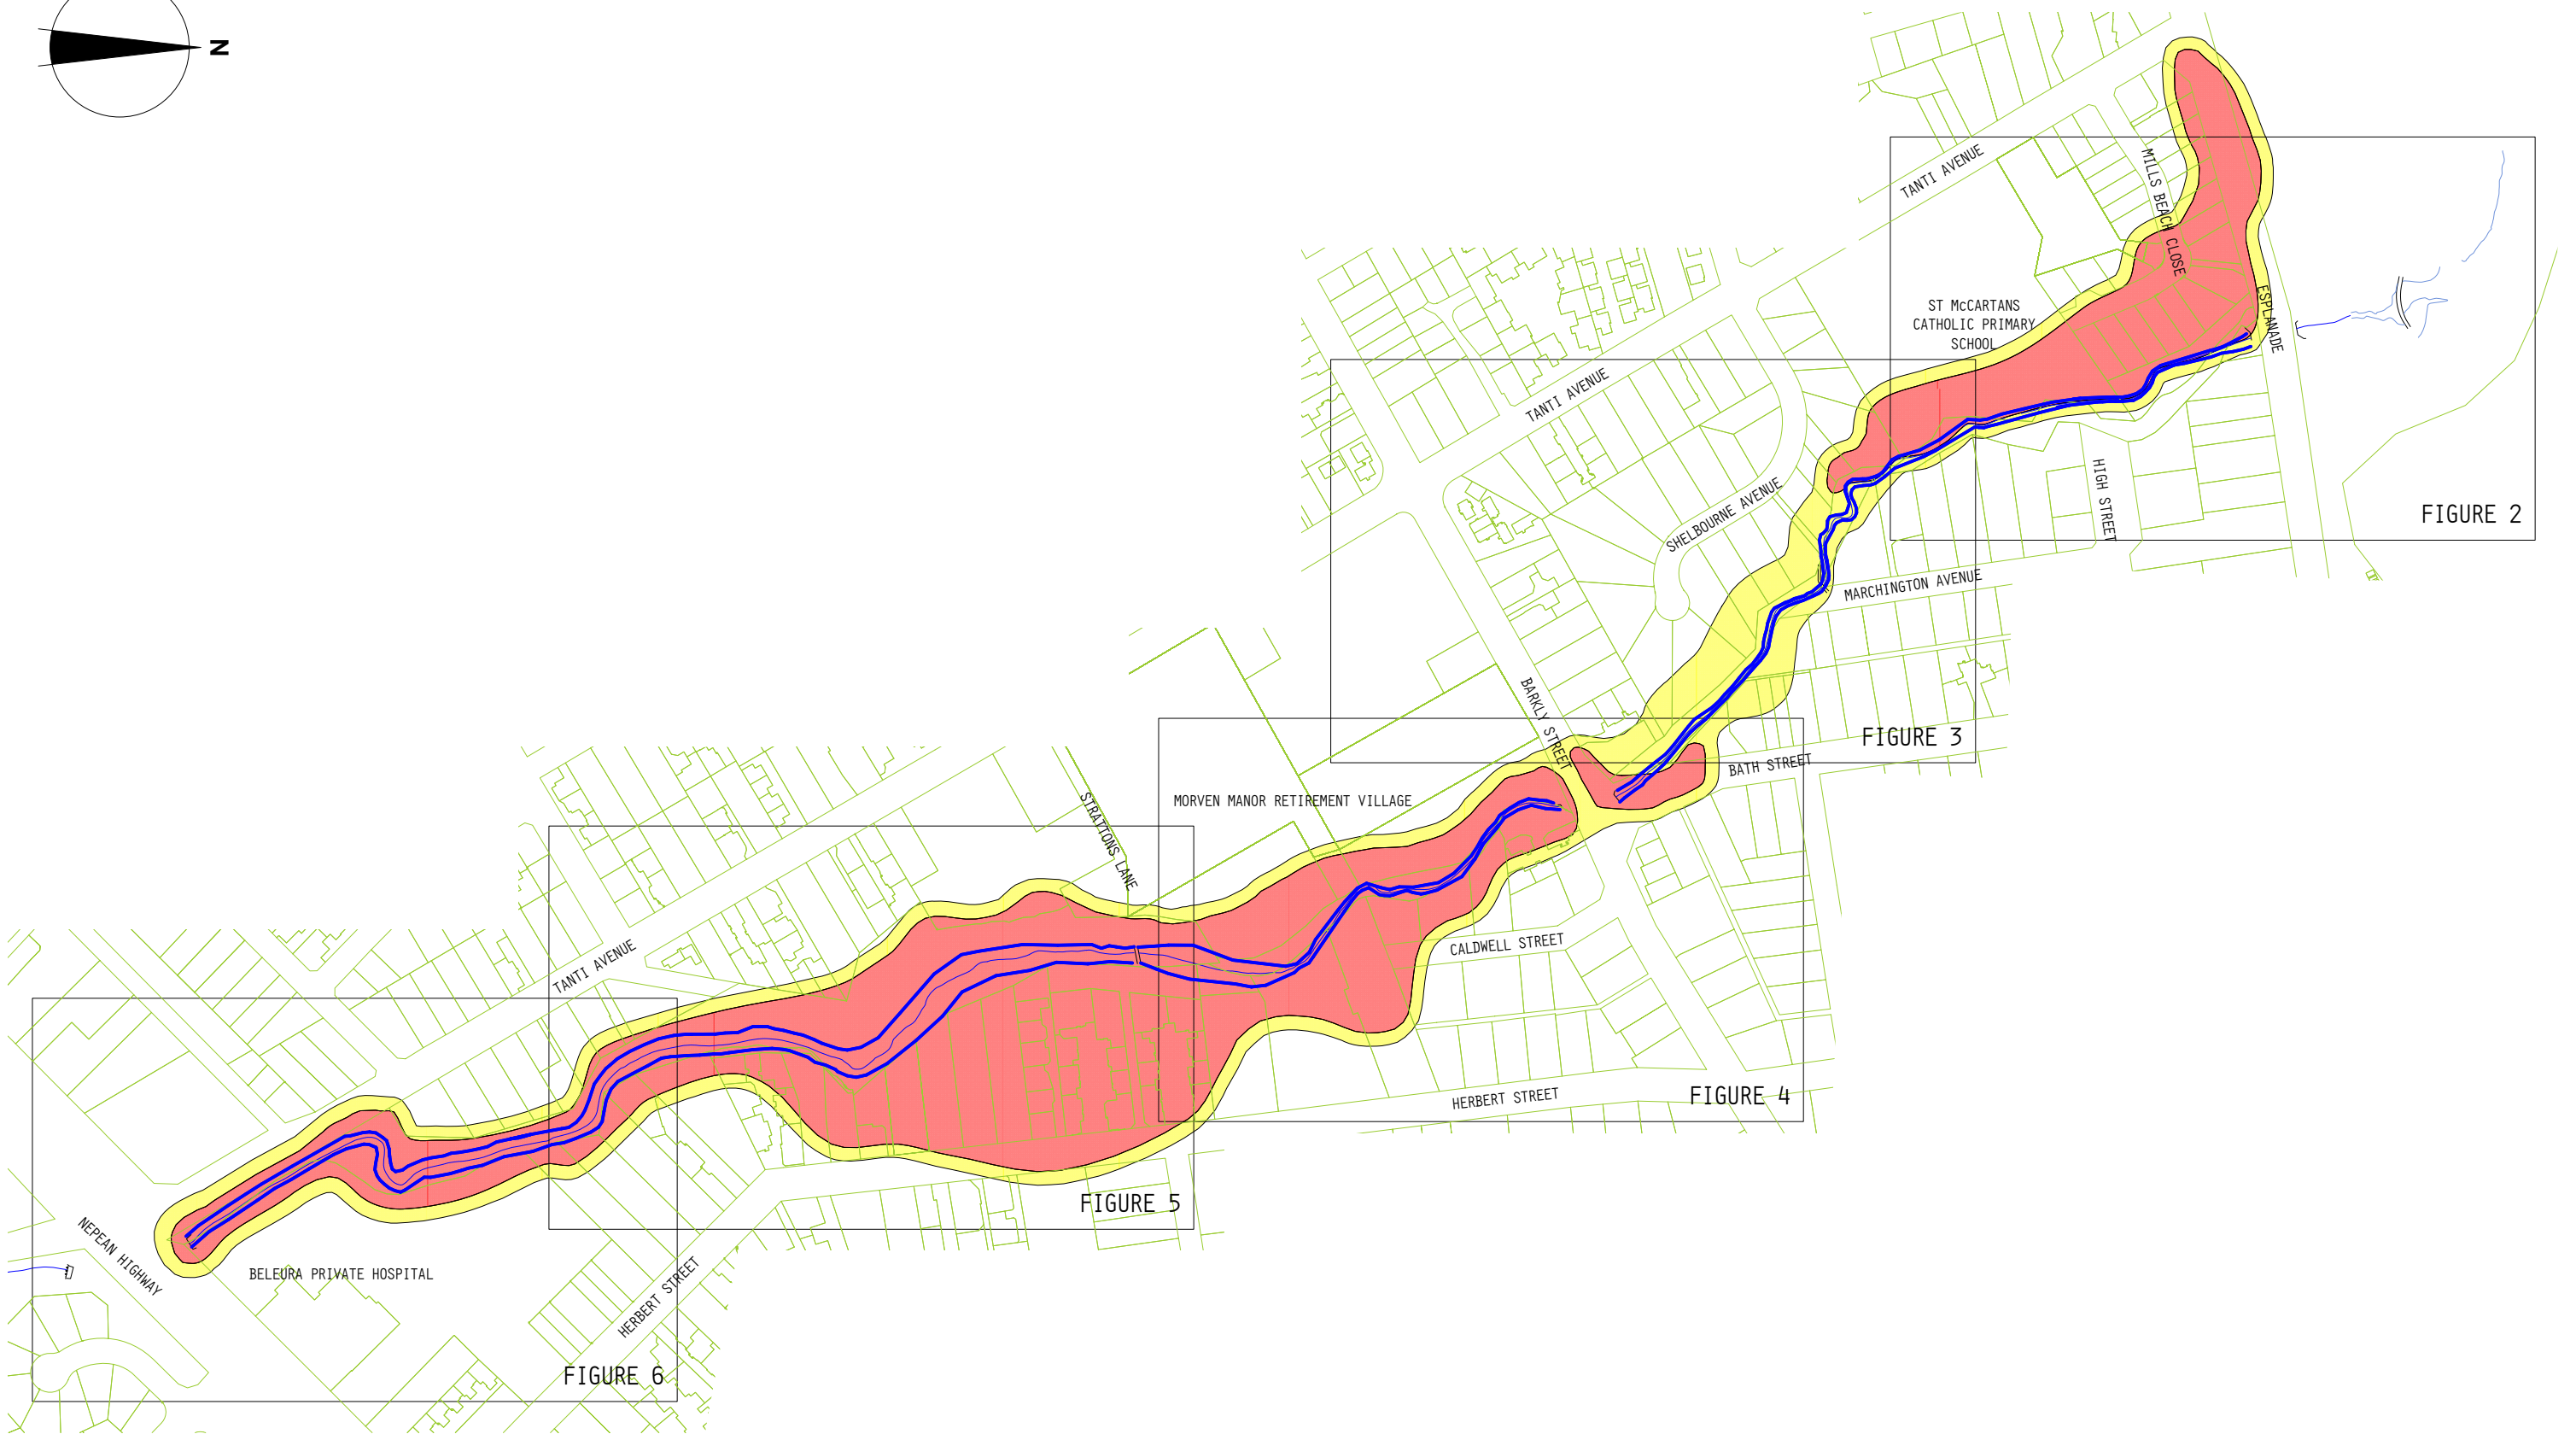
SCALE (A3)	1:3750	DATE	29 MAR 2010
DRAWN	DBS	JOB NO.	23019
		REV. NO.	1
		FIG. NO.	1

The following observations are identified on the site plans Figures No. 2 – 6, Appendix A with Figure 1, Appendix A showing the overall study area.

Although in general, along a large portion of the creek, the creek banks are stable, the creek banks have undergone mass wastage and bank slippage at numerous locations. This has resulted in loss of usable space for the properties adjacent to the affected areas and in some locations resulted in damage to structures.

The areas that are recommended to be included in the management overlays with regards to slope stability are shown on Figure Nos. 2 – 6, Appendix A with an overall layout plan as Figure No. 1. It should be noted that these management overlays are not to prohibit construction in these areas, but to highlight the need for a detailed geotechnical investigation in these areas with appropriate evaluation of the underlying pressurised aquifers and/or steep creek banks.

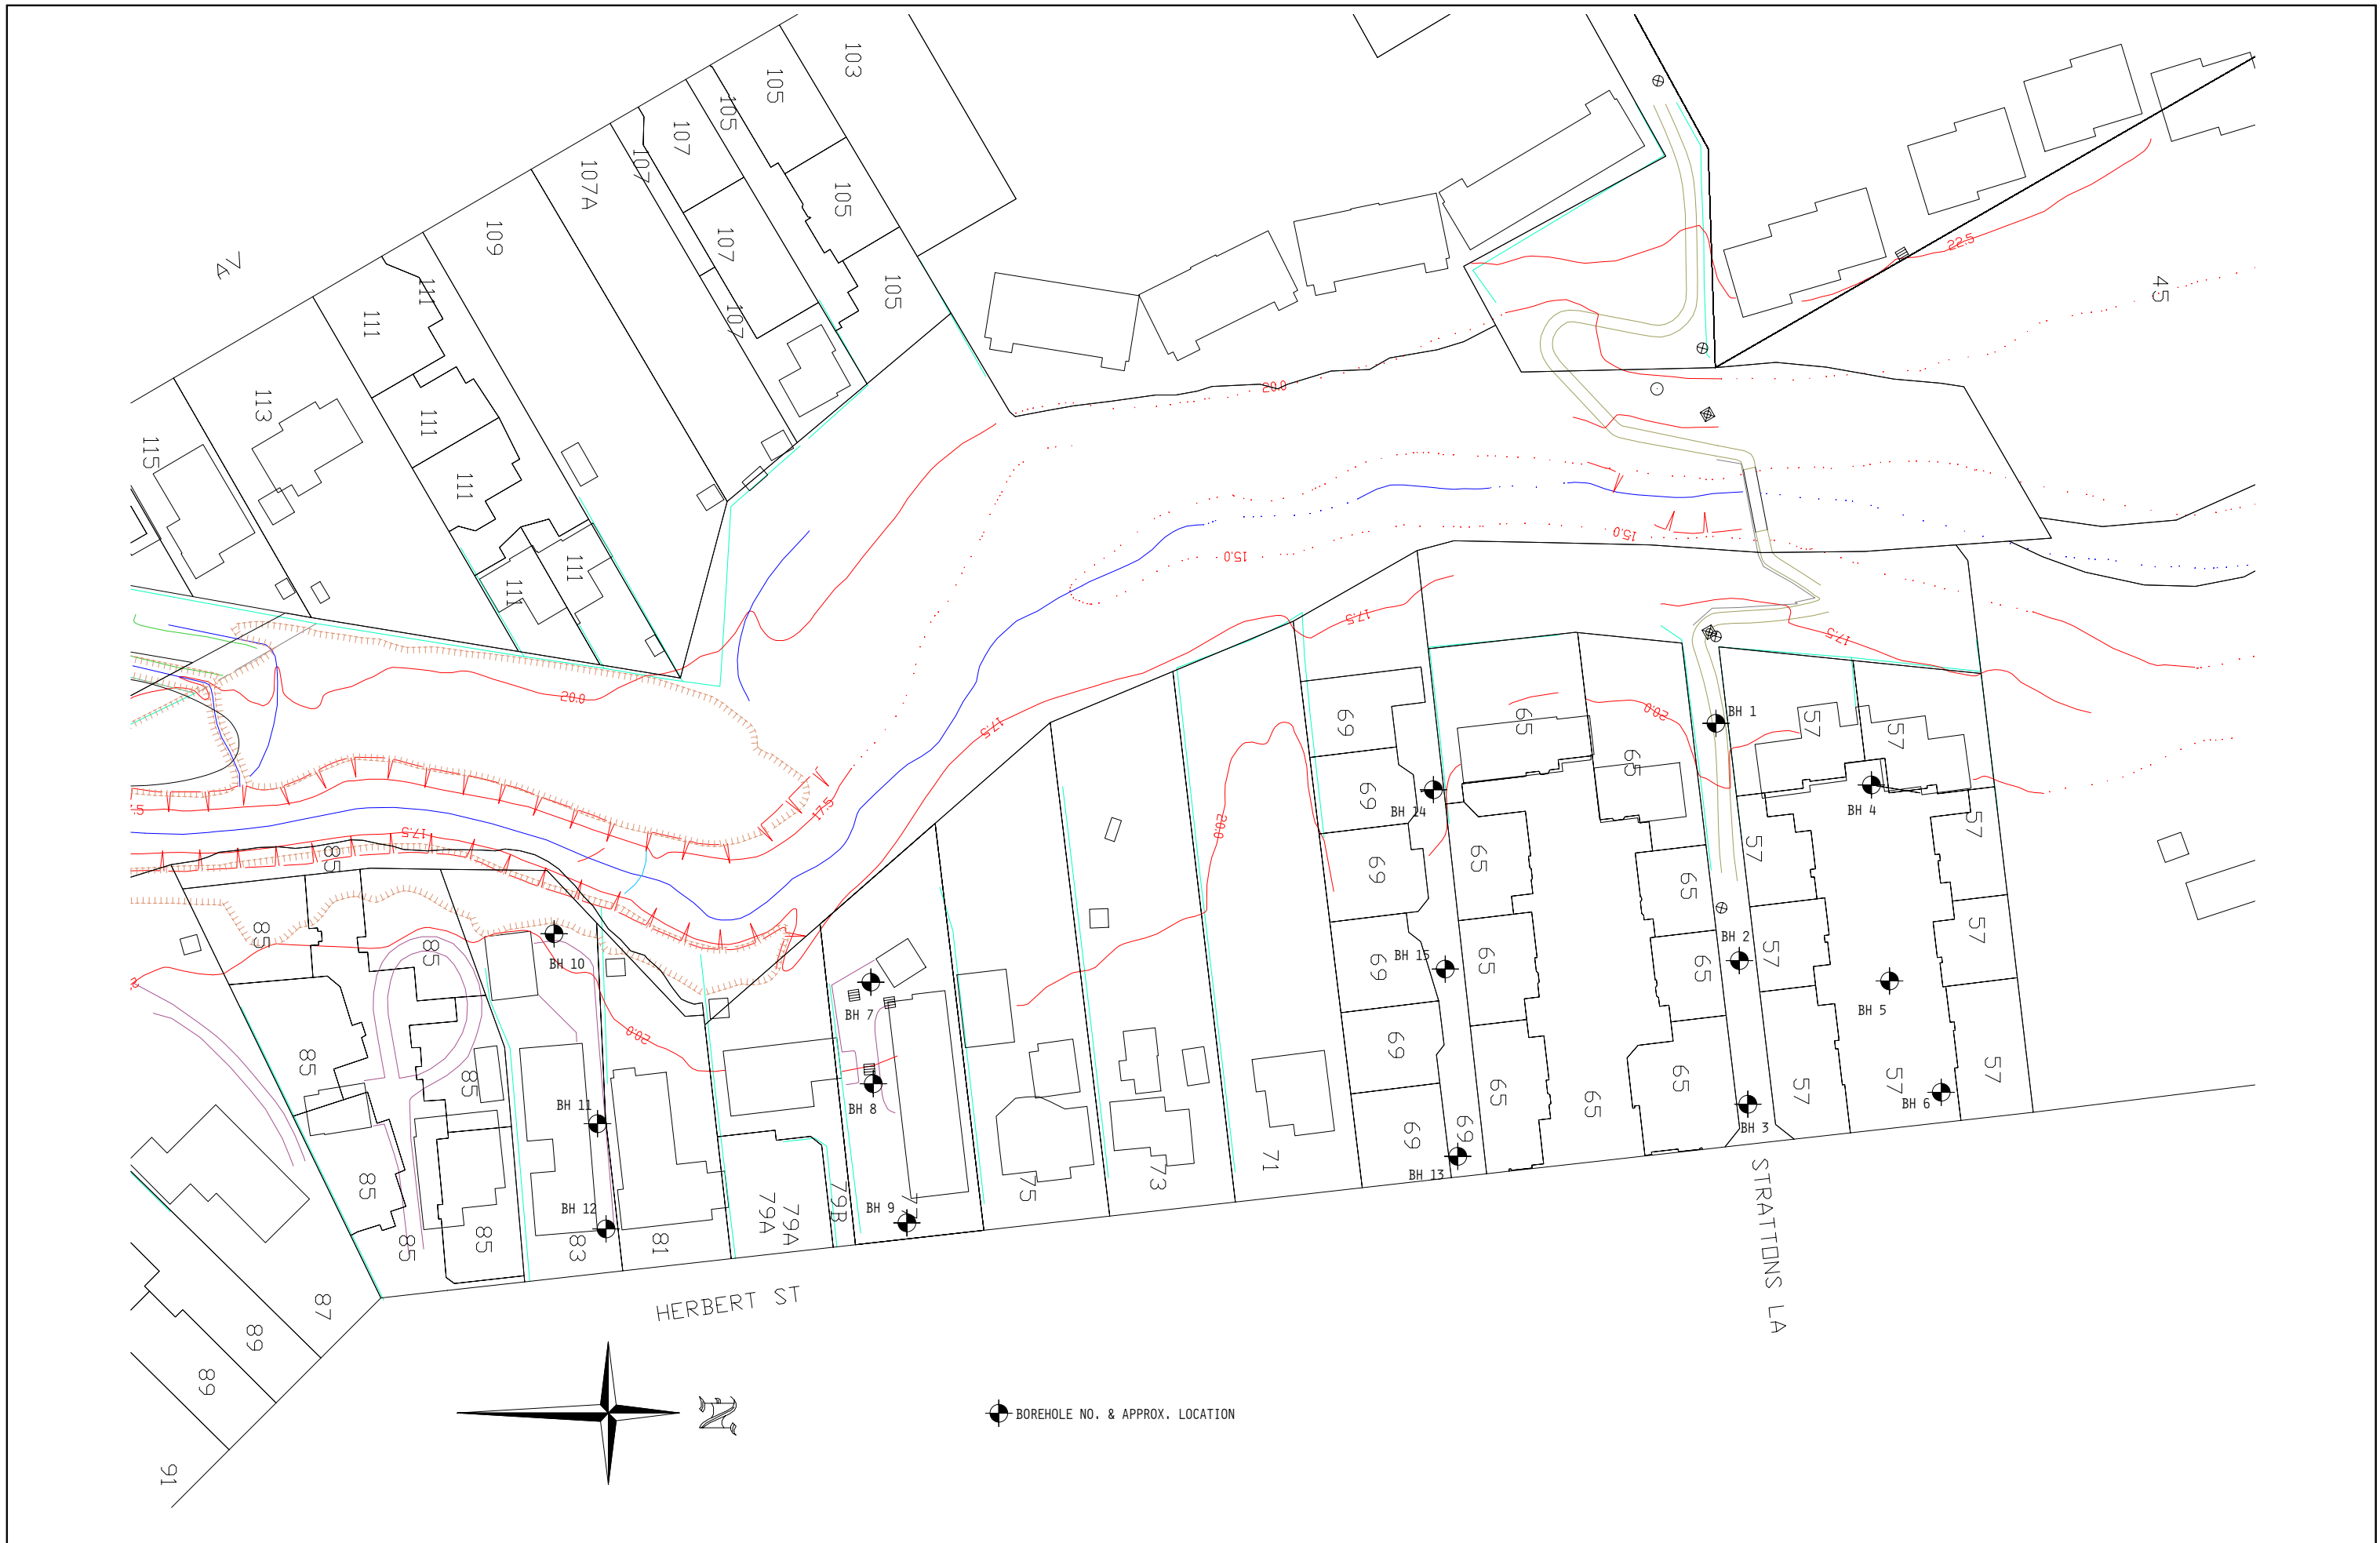
JOB NO.	23019	DATE	9 OCT 2003
SIZE	A3	SCALE	1:1000
		FIGURE NO.	1

The locations of the boreholes are shown on the Site Plan, Figure No. 1, Appendix B. The records of the boreholes are appended as Figures No. 2 – 21, Appendix B, together with the Unified Classification System as Figure No. 22.
