# **Board of Inquiry** into the McCrae landslide Report

September 2025

On 18 March 2025, the Board of Inquiry was established to inquire into, report on, and make recommendations in relation to, amongst other things, the cause of the landslide that occurred on 14 January 2025 in McCrae on the Mornington Peninsula (**McCrae Landslide**), the adequacy of measures taken to prevent and minimise landslides in McCrae, and measures to be taken for the prevention or mitigation of the risk of similar landslide events occurring again in McCrae.

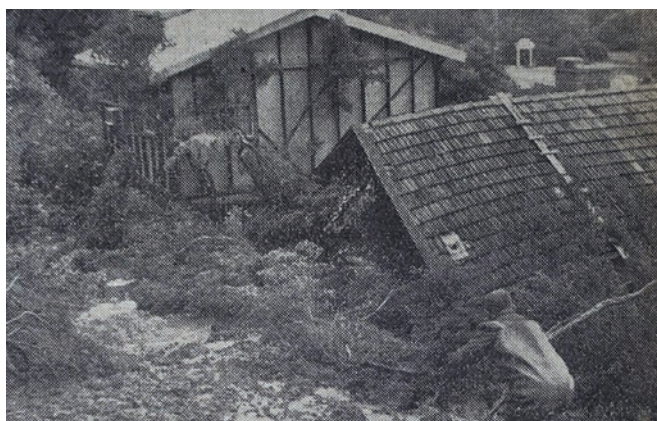
**FIGURE 3.1: VIEW LOOKING WEST AT 565 POINT NEPEAN ROAD SHOWING DAMAGE TO DWELLINGS FROM LANDSLIDE DEBRIS.<sup>5</sup>**

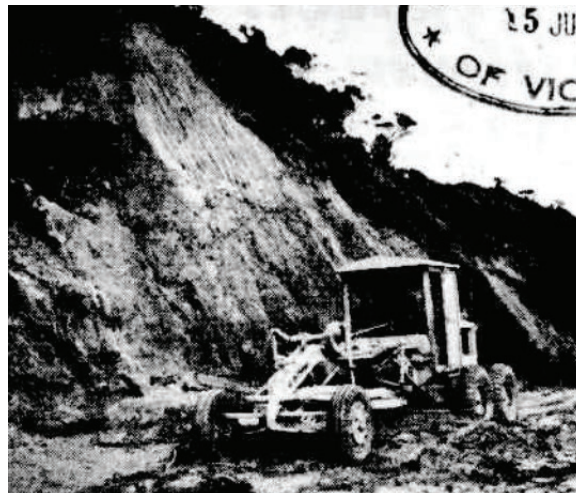
FIGURE 3.3: CLEAN-UP OF A CUTTING FAILURE ON POINT NEPEAN ROAD NEAR ANTHONY'S NOSE.<sup>7</sup>

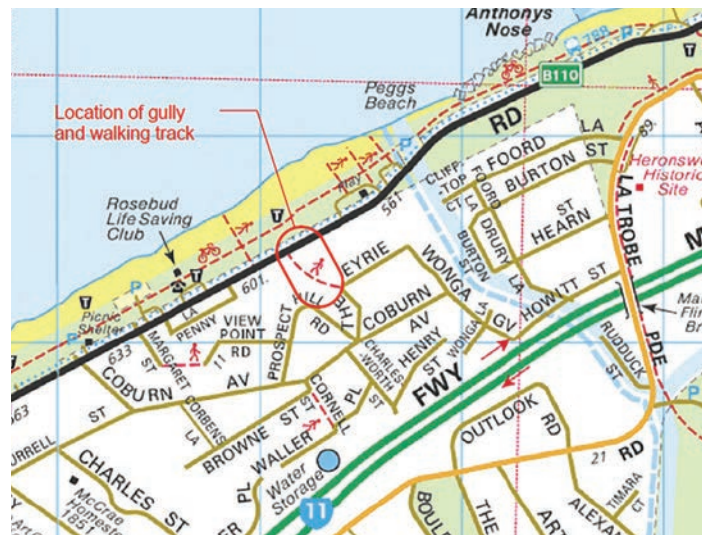
**FIGURE 3.4: ANNOTATED MAP DEPICTING THE LOCATION OF THE GULLY SUBJECT TO LANE PIPER'S INVESTIGATIONS.**<sup>44</sup>

- 32 In September 2007, after conducting geotechnical investigations and fieldwork, Lane Piper observed that the deepening of the valley and increased erosion of the escarpment were driven by two key factors:

- 34 To address this, Lane Piper made several recommendations to the Shire to stabilise the gully.<sup>47</sup> The principal recommendation was to “*partially pipe the gully to resist further erosion combined with the placement of fill around and above the pipeline to improve the stability of the gully banks*”.<sup>48</sup> The associated recommendations included using “*sandy clay or impermeable backfill*” and concrete cut-off collars to prevent high velocity water flow through the backfill.<sup>49</sup>

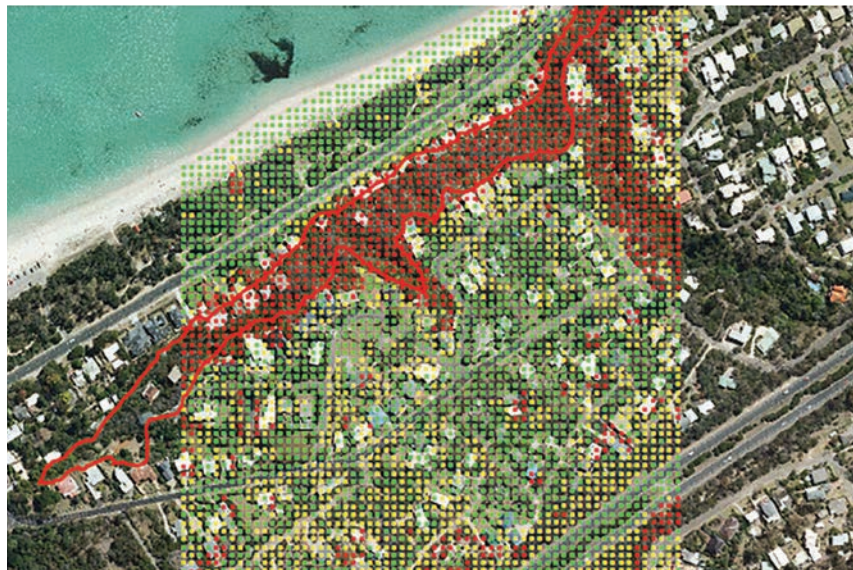
FIGURE 3.6: ZONING OF THE MCCRAE ESCARPMENT IN 2012 CARDNO REPORT.<sup>71</sup>

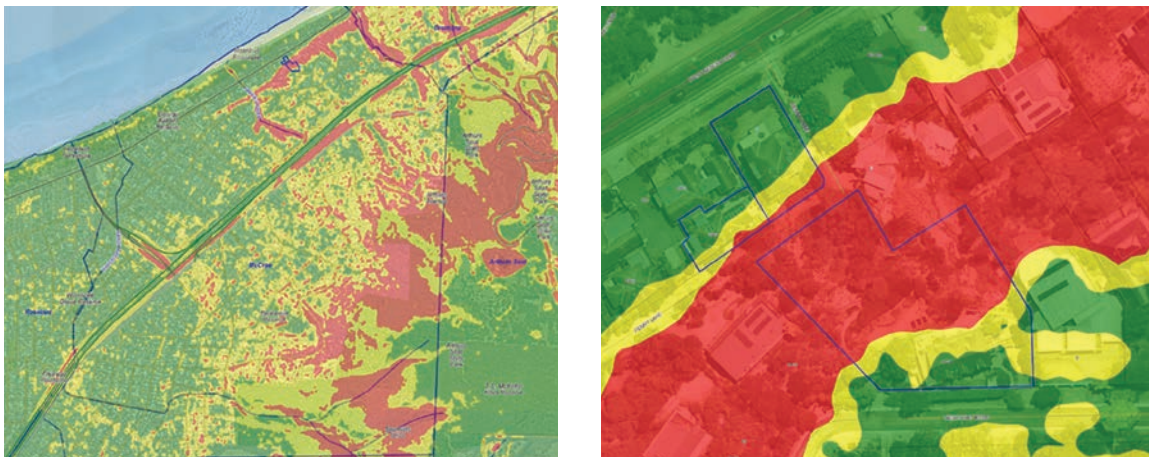
FIGURE 3.7: ZONING OF MCCRAE AREA GENERALLY AND THE SITE OF THE NOVEMBER 2022 LANDSLIDES AND THE JANUARY 2025 LANDSLIDES AT 10–12 VIEW POINT ROAD.<sup>72</sup>

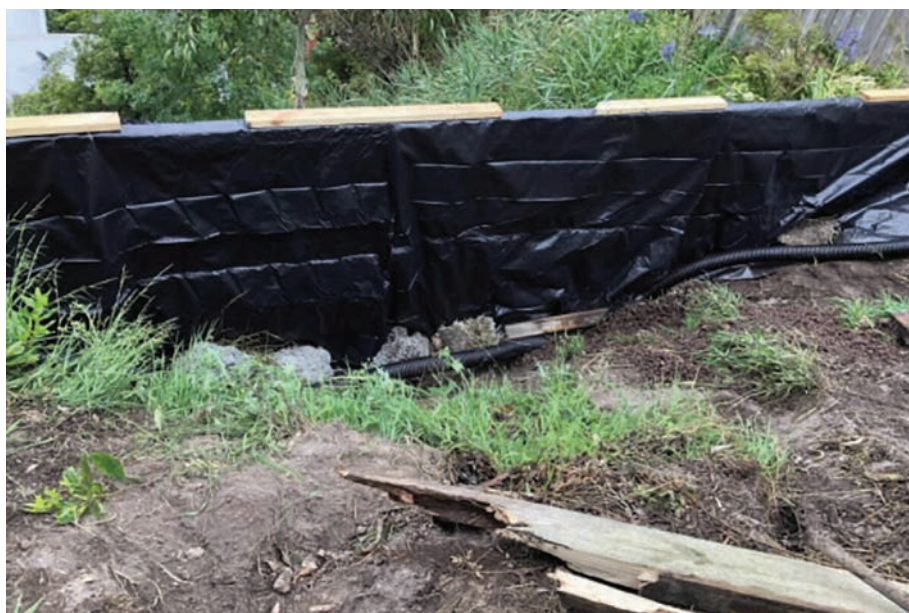
**FIGURE 3.8: CONSTRUCTION OF ORIGINAL RETAINING WALL INSTALLED BY THE BORGHESI.**<sup>96</sup>

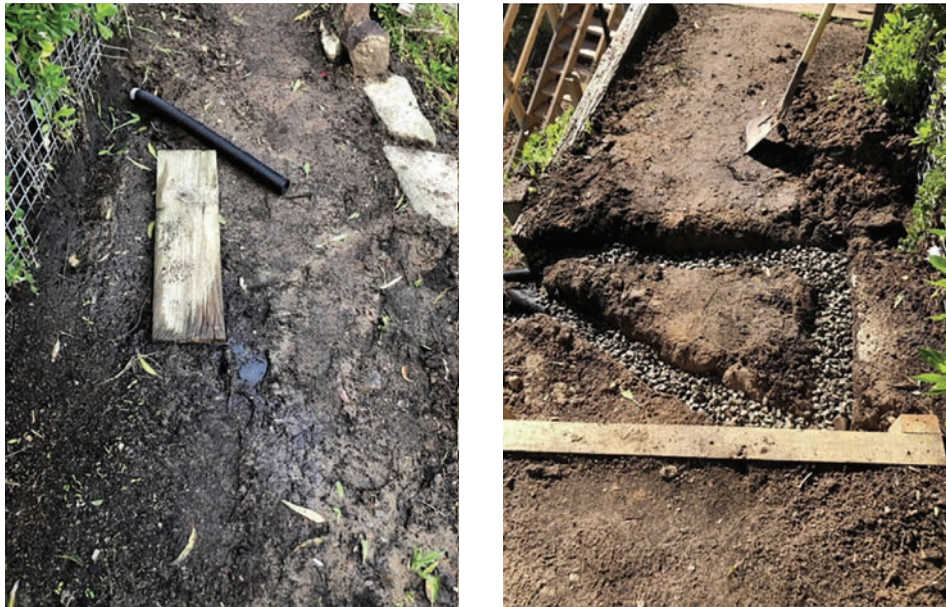
- 68 In addition to the above works, Mr Borghesi told the Board of Inquiry that, due to increased saturation of the hillside towards the western boundary of the property,<sup>97</sup> he installed agricultural (agi) drains in July 2021 in an effort “to control erosion and make the pathway down to Penny Lane trafficable”.<sup>98</sup>

**FIGURE 3.9: COMPARISON BETWEEN THE HILLSIDE PATH PRE AND POST INSTALLATION OF THE AGRICULTURAL DRAINS.<sup>99</sup>**

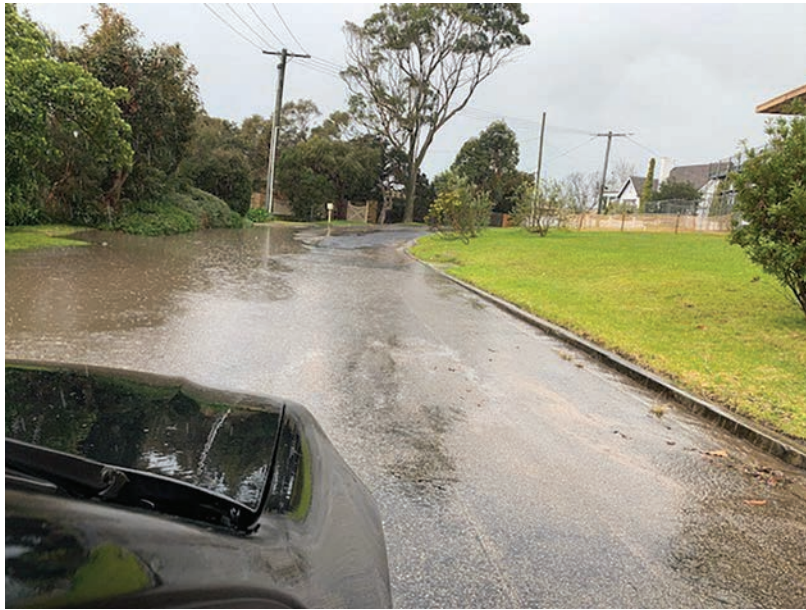
**FIGURE 3.10: FLOODING IN FRONT OF 11 PROSPECT HILL ROAD.<sup>103</sup>**

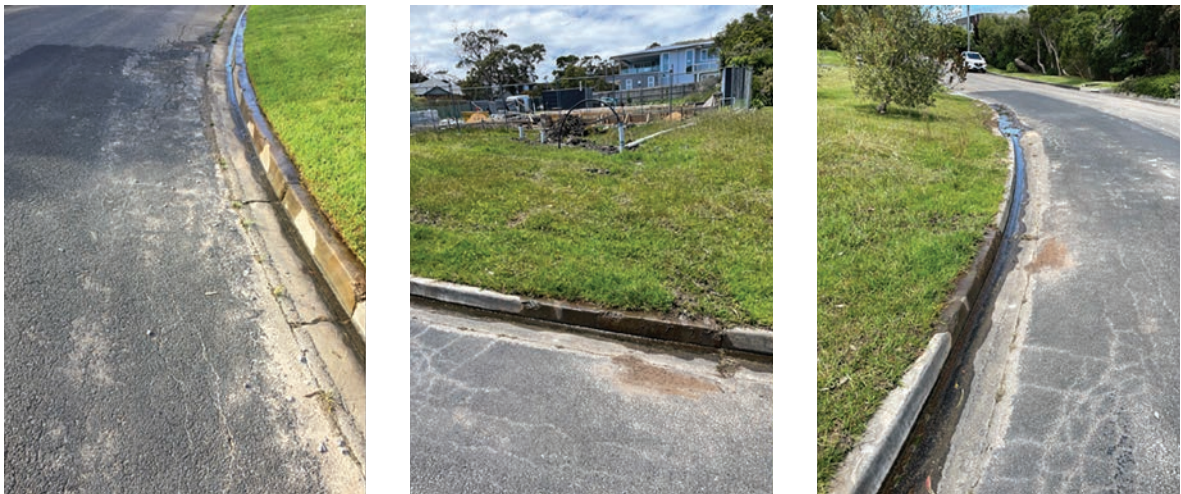
- 73 The resident also reported an increase in water along the kerbs near 5 and 7 Prospect Hill Road during the construction of both dwellings in 2020 and 2021.<sup>104</sup> This observation was also made by a longtime resident of McCrae, whose family has owned a property on Prospect Hill Road for over 50 years.<sup>105</sup> The resident added that the “*lower ... northern end, of [7 Prospect Hill Road], including the nature strip, resembled a sodden marsh up until ... [the] new house was built replacing the old one*”.<sup>106</sup>

**FIGURE 3.11: PHOTOS OF THE KERBS DURING THE DEVELOPMENT OF 7 PROSPECT HILL ROAD BETWEEN 5 MAY 2021 AND 11 NOVEMBER 2021.<sup>107</sup>**

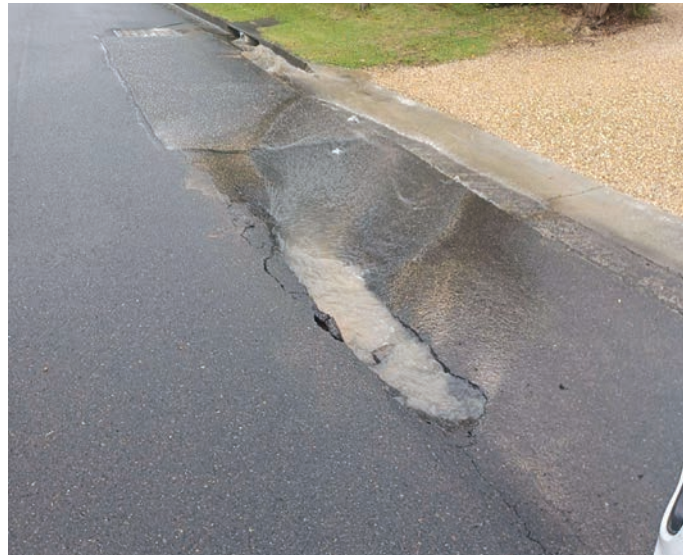
- 77 After receiving these complaints, at some stage in the morning of 14 November 2022, employees of the Shire’s contractor, DM Roads, attended the area near 23 Coburn Avenue. The contractor determined that the issue was due to SEW’s assets.<sup>113</sup> The contractor took a photo of the road surface (Figure 3.12 below) and made the site safe.<sup>114</sup> The photo was subsequently emailed to Michelle Twaites, Customer Service Officer at DM Roads, at 11.58am.<sup>115</sup>

FIGURE 3.12: PHOTO OF DEFECT IN TARMAC AND WATER FLOW ON COBURN AVENUE.<sup>117</sup>

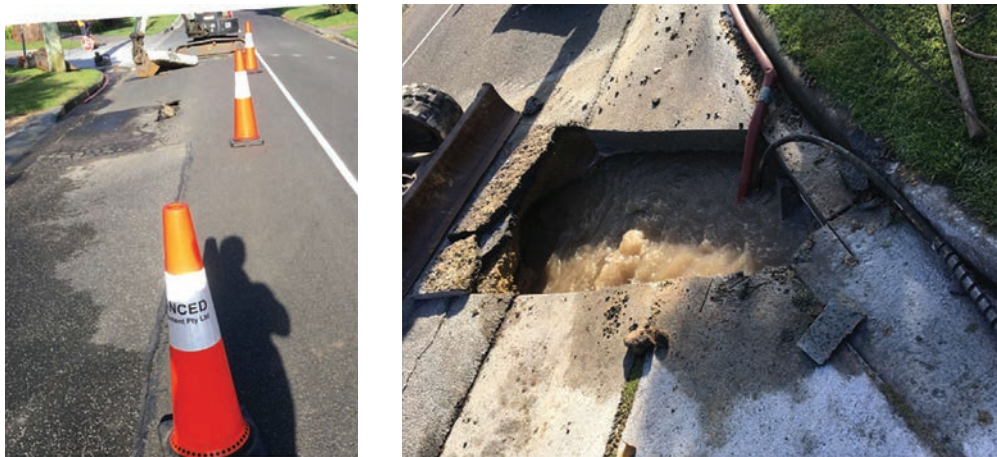
FIGURE 3.13: IMAGES OF THE CUT TO THE ROAD SURFACE AT COBURN AVENUE.<sup>124</sup>

- 79 Minutes later, SEW created a job in its Montage system and allocated it to Service Stream Ltd (**Service Stream**).<sup>118</sup> Service Stream was and remains contracted by SEW to provide water and sewer repair and maintenance services.<sup>119</sup>
- 80 Service Stream attended the site at around 3.20pm.<sup>120</sup> They remained there for several hours, until around 8.05pm.<sup>121</sup> During that timeframe, extensive works were undertaken to repair the pipe.<sup>122</sup> Those works involved drilling several holes to locate the burst, cutting and removing concrete to expose the water main, shutting off the supply of water, removing and replacing the broken pipe, filling the area around the pipe with sand/rock embedding material and repairing areas of the road that had been undermined by the water.<sup>123</sup>

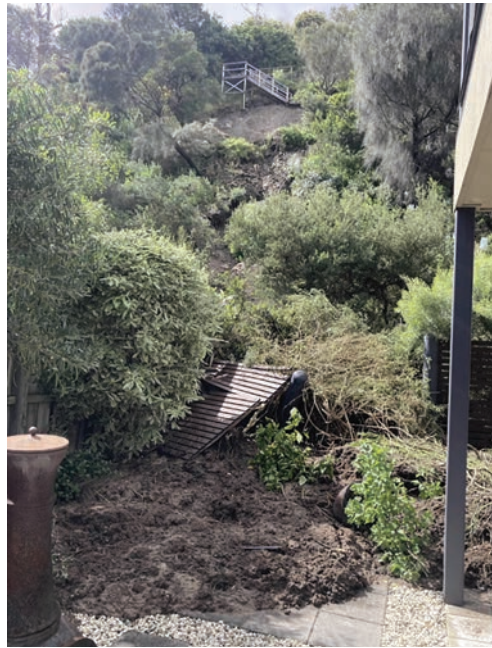
**FIGURE 3.16: THE IMPACT OF THE 15 NOVEMBER 2022 LANDSLIDE ON 3/613 POINT NEPEAN ROAD.<sup>137</sup>**

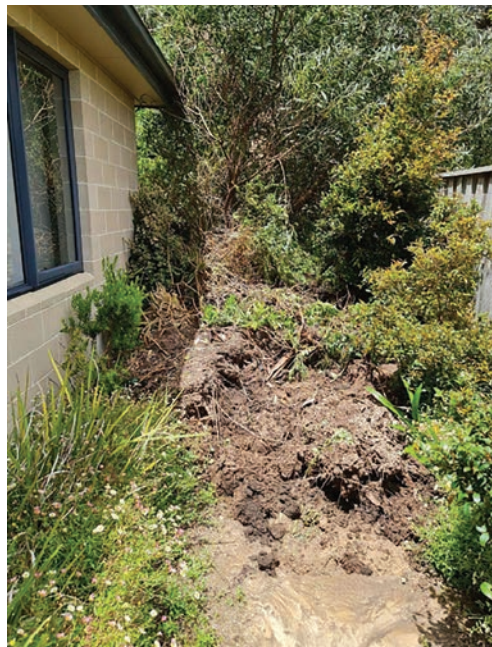
- 89 The Willigenburgs' property was not the only property damaged by the landslide on 15 November 2022.
- 90 Damage was also caused to the property at 2 Penny Lane.<sup>138</sup> Soil and debris from the landslide similarly crashed through the rear fence of 2 Penny Lane, stopping just short of the back door.<sup>139</sup> One side of the property was left covered in mud and debris which had flowed off the escarpment.

**FIGURE 3.17: THE IMPACT OF THE 15 NOVEMBER 2022 LANDSLIDE ON 2 PENNY LANE.<sup>140</sup>**

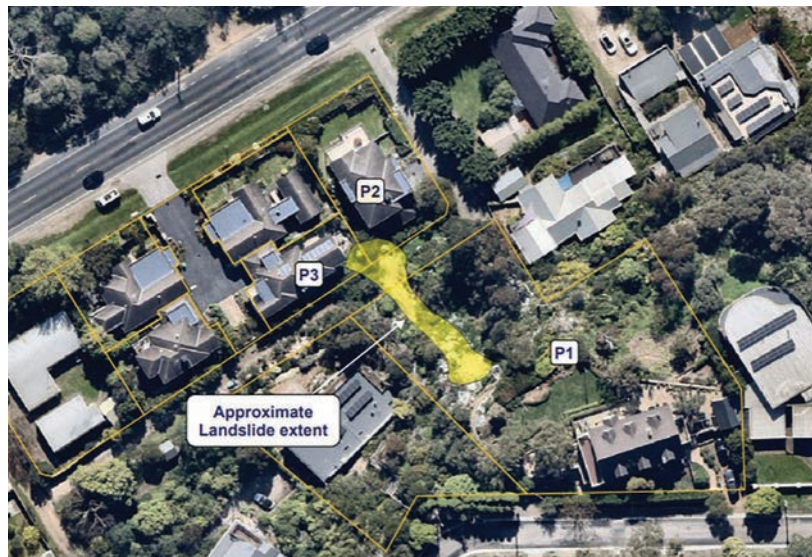
**FIGURE 3.18: AERIAL IMAGE DEPICTING THE LOCATION OF THE 15 NOVEMBER 2022 LANDSLIDE RELATIVE TO 10–12 VIEW POINT ROAD (P1), 3/613 POINT NEPEAN ROAD (P2) AND 2 PENNY LANE (P3).<sup>141</sup>**

- 91 The landslide on 15 November 2022 involved at least 20 tonnes of soil and debris flowing to the bottom of the escarpment.<sup>142</sup>
- 92 Water was observed seeping out of several locations on the escarpment throughout the landslide area,<sup>143</sup> including from a displaced irrigation system at 10–12 View Point Road.<sup>144</sup>

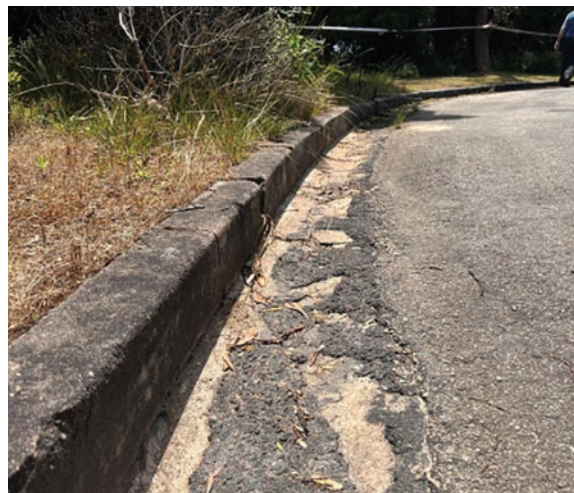
FIGURE 3.20: CRACKS AND PATCHING ALONG THE KERB OF VIEW POINT ROAD.<sup>216</sup>

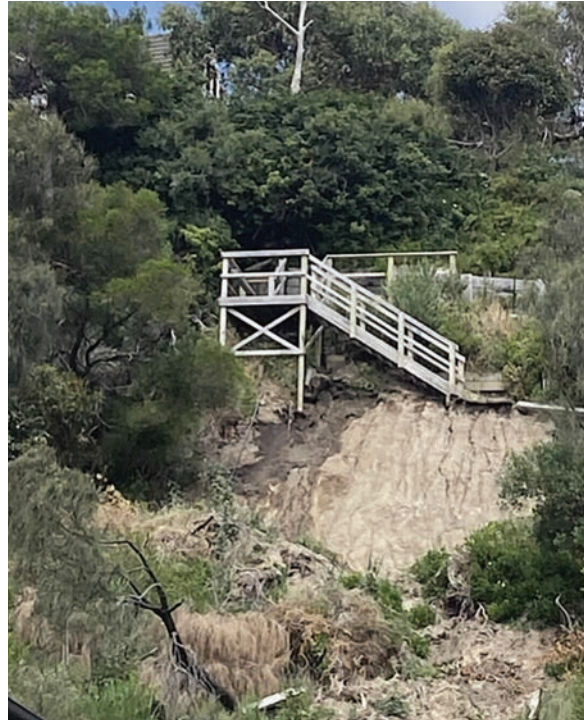
150 In early to mid-February 2023, Mr Willigenburg noticed a large wet patch forming underneath a platform located around 75% of the way up the escarpment toward 10–12 View Point Road. The remaining area had started to dry out after the landslides, but that particular patch of land remained very wet. He was concerned it was related to the drainage issues other residents had identified in late 2022.<sup>250</sup> On 13 February 2023, he sent photographs of the wet patch to Mr Flores by email and told Mr Flores the wet patch had “*been there for a while now*”.<sup>251</sup>

**FIGURE 3.22: WET PATCH UNDER STAIRCASE ON 10–12 VIEW POINT ROAD.**<sup>252</sup>

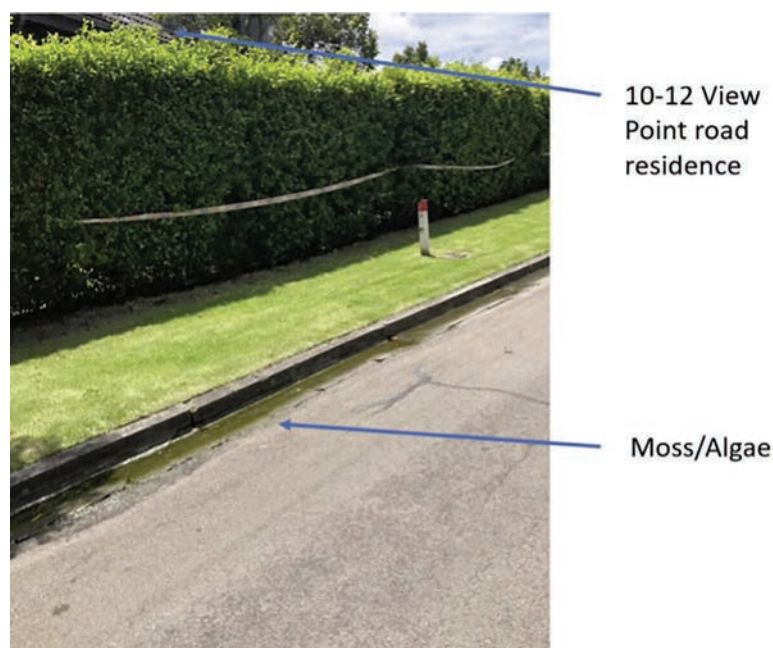
- 154 Mr Borghesi similarly told the Board of Inquiry that from the time he purchased his property in May 2014, and particularly in the period between December 2020 and May 2023, he observed a flow of water that appeared to emanate from two properties located at 1 and 5 Prospect Hill Road, directly uphill from his property.<sup>258</sup> That flow of water was intercepted and diverted down a stormwater drain on Prospect Hill Road and into a culvert at the top of View Point Road. The culvert was constantly overflowing, causing water to flow down the fractured and cracked kerb on View Point Road.<sup>259</sup> Mr Borghesi told the Board of Inquiry that he “*never saw it dry*” and that the flow of water was such that it caused moss and algae to build up from time to time.<sup>260</sup>

**FIGURE 3.23: MOSS AND ALGAE ON VIEW POINT ROAD.**<sup>261</sup>

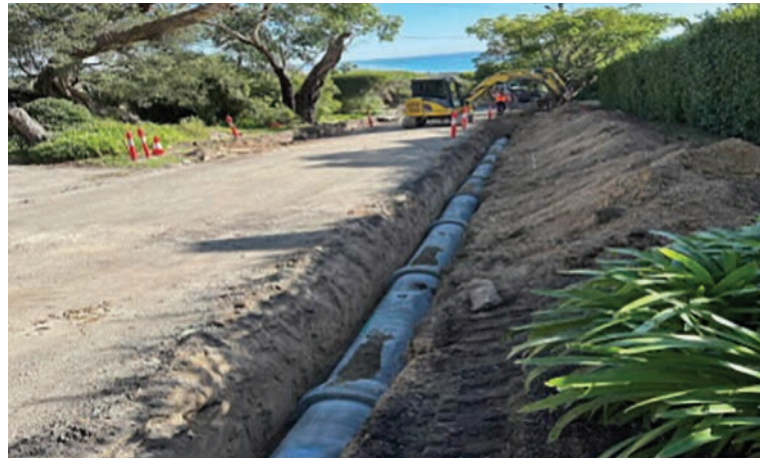
**FIGURE 3.24: SHIRE'S STORM WATER UPGRADE ON VIEW POINT ROAD.<sup>299</sup>**

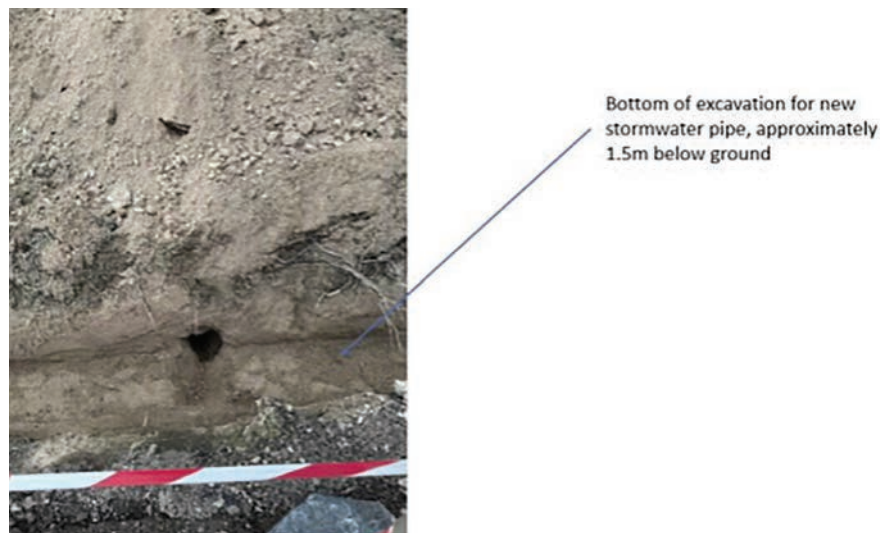
180 Mr Borghesi told the Board of Inquiry that, during the excavation process for the installation of the stormwater drain, a void was discovered directly above the location of the November 2022 landslides.<sup>300</sup>

**FIGURE 3.25: VOID LOCATED DURING THE SHIRE'S STORMWATER UPGRADE ON VIEW POINT ROAD.<sup>301</sup>**

It is now clear the cracked kerb and channel coupled with the continuous flow of water has been a key contributor to the landslip of November 2022.

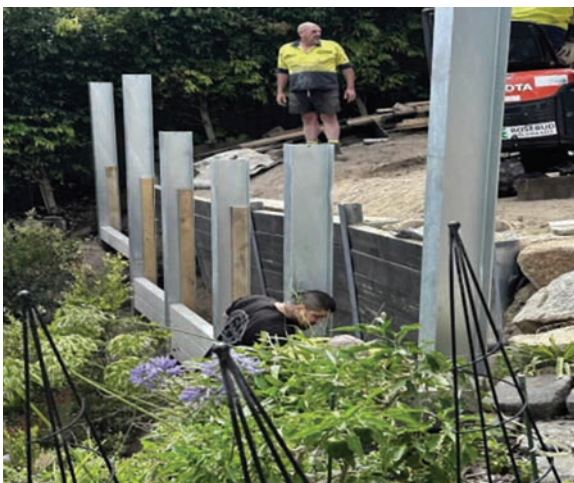
203 The construction of the reinforcement wall was undertaken by Maw Civil in January 2024.<sup>339</sup>

FIGURE 3.26: CONSTRUCTION OF THE REINFORCEMENT WALL AT 10–12 VIEW POINT ROAD.<sup>340</sup>

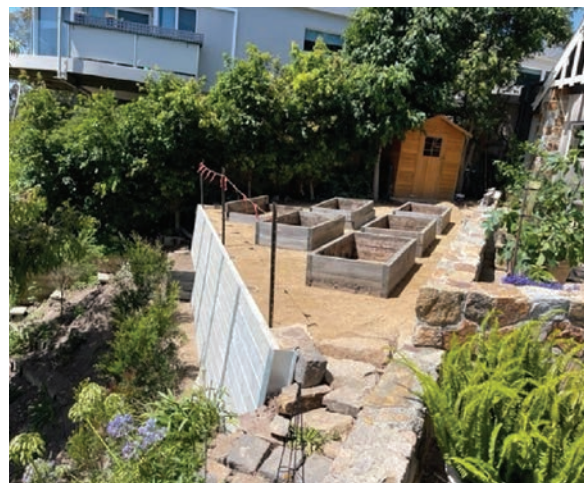
FIGURE 3.27: COMPLETED REINFORCEMENT WALL AT 10–12 VIEW POINT ROAD.<sup>341</sup>

204 Mr Borghesi described the reinforcement wall as being just under two metres at its highest point if measured from the base to the top.<sup>342</sup> He did not seek a building permit to construct the reinforcement wall.<sup>343</sup> Consequently, the Shire was not made aware of its proposed construction.<sup>344</sup>

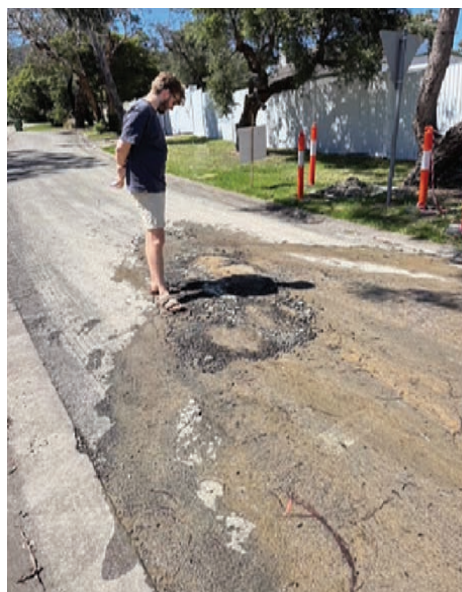
FIGURE 3.29: WATER SURFACING OUTSIDE 3 CHARLESWORTH STREET.<sup>385</sup>

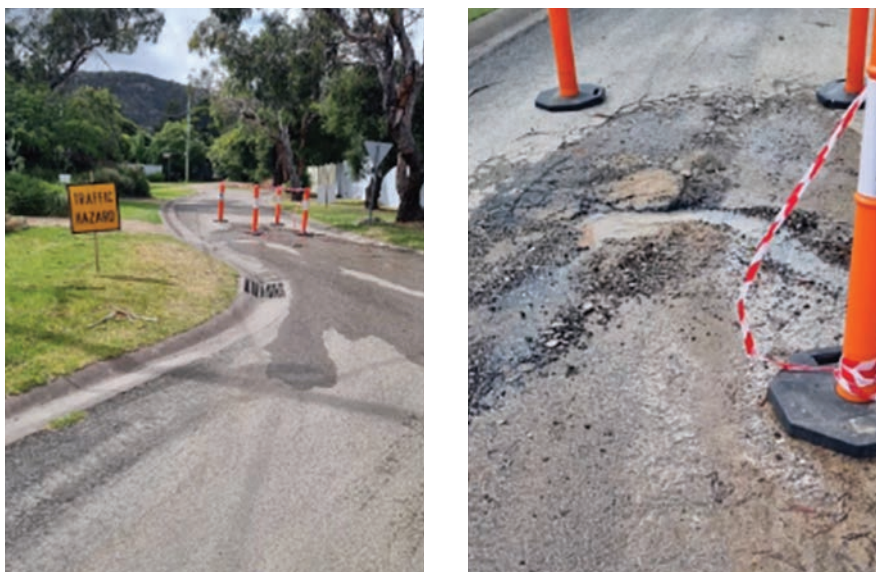
**FIGURE 3.30: PHOTOGRAPH AND VIDEO FOOTAGE OF WATER ON CHARLESWORTH STREET.**<sup>423</sup>

270 The post stated “Charlesworth Street water leak. Just posting this to see how long it takes to get repaired. Water coming out of the road for about 3 weeks now, waiting for the massive washout”.<sup>424</sup>

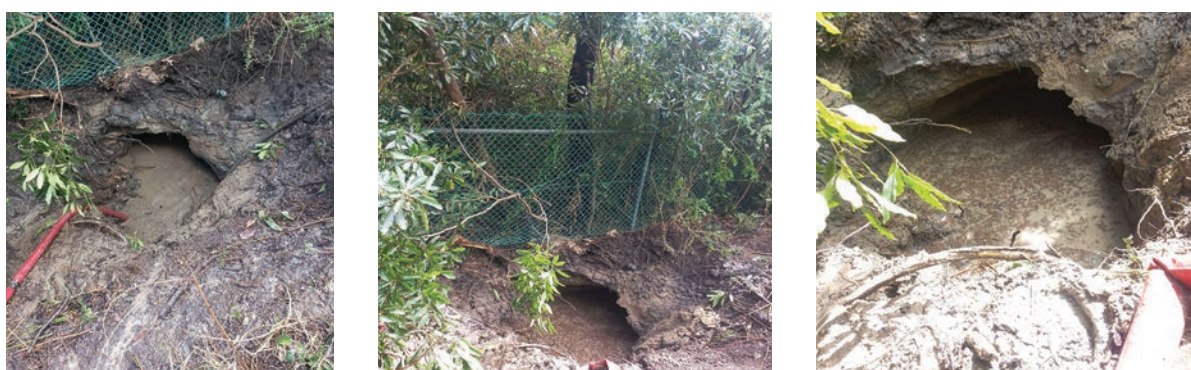
FIGURE 3.31: PHOTOGRAPHS OF BURST WATER MAIN SITE ON 31 DECEMBER 2024.<sup>470</sup>

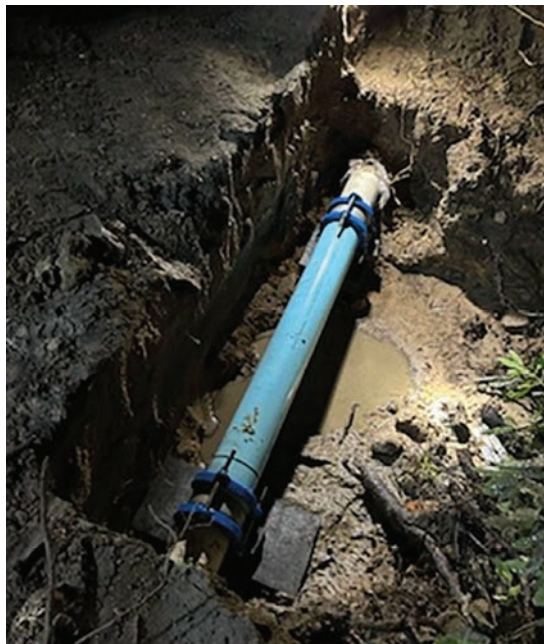
safe, the Service Stream personnel then excavated around the main, located the split on the 150 millimetre PVC water main, cut out the damaged section and replaced it with a new section of pipe.<sup>475</sup>

**FIGURE 3.32: PHOTOGRAPH OF REPAIRED SECTION OF THE BURST WATER MAIN.<sup>476</sup>**

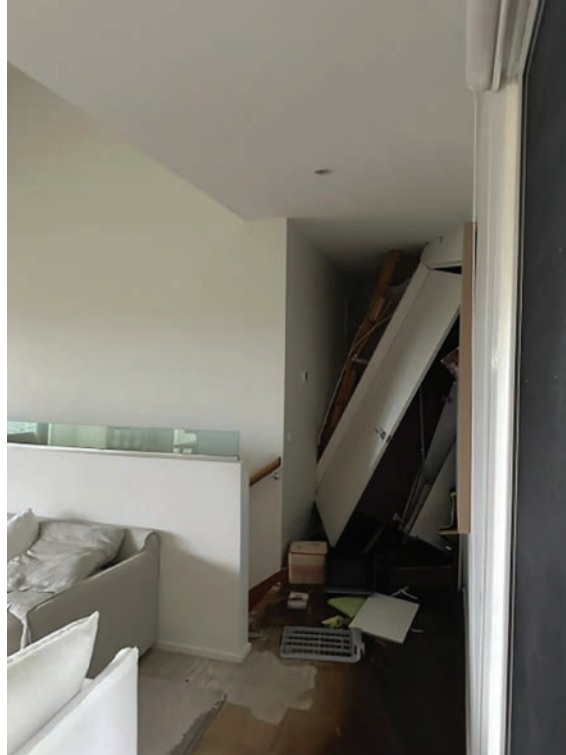
**FIGURE 3.33: PHOTOGRAPH TAKEN BY MR MORAN DEPICTING THE LAUNDRY DOOR AND CUPBOARDS ON THE SECOND FLOOR OF 3 PENNY LANE PROTRUDING INTO THE HALLWAY ON THE EVENING OF 5 JANUARY 2025.**<sup>492</sup>

313 What Mrs Moran and her daughter had experienced was a landslide that brought between 20–25 tonnes of debris crashing into their house.<sup>493</sup> It had a sub-vertical headscarp of up to 1.5 metres high and had evacuated materials, down to natural granitic soils, to its base.<sup>494</sup>

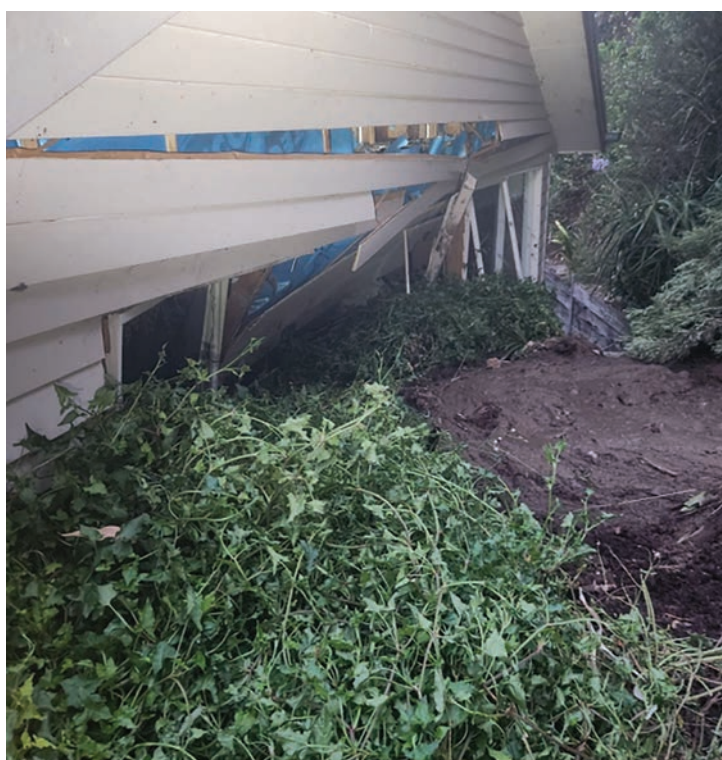
**FIGURE 3.34: PHOTOGRAPH OF THE REAR OF 3 PENNY LANE FOLLOWING THE 5 JANUARY 2025 LANDSLIDE.**<sup>548</sup>

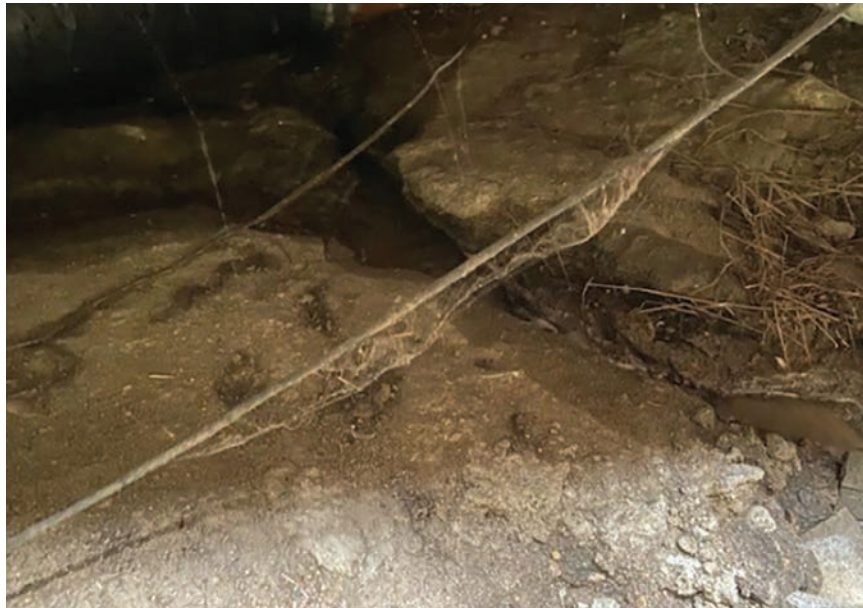
FIGURE 3.35: PHOTOGRAPH OF SCOUR LINES UNDERNEATH 3 PENNY LANE.<sup>557</sup>

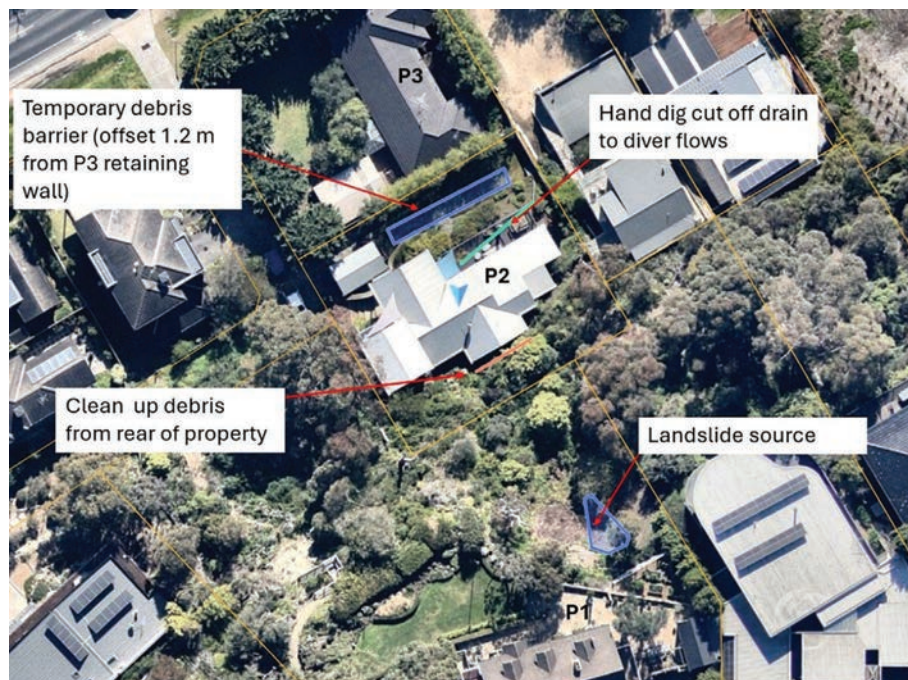
**FIGURE 3.36: AERIAL PHOTOGRAPH ON WHICH MR POPE MARKED WHERE CERTAIN ACTIONS WERE TO BE TAKEN BY THE BORGHESES AND THE MORANS.**<sup>608</sup>

382 Mr Pope noted that each property owner should take the recommended steps with “*the support of Geotechnical Engineers who are experienced in mitigation of landslide hazards*”.<sup>607</sup> Mr Pope included the following image showing his recommendations:

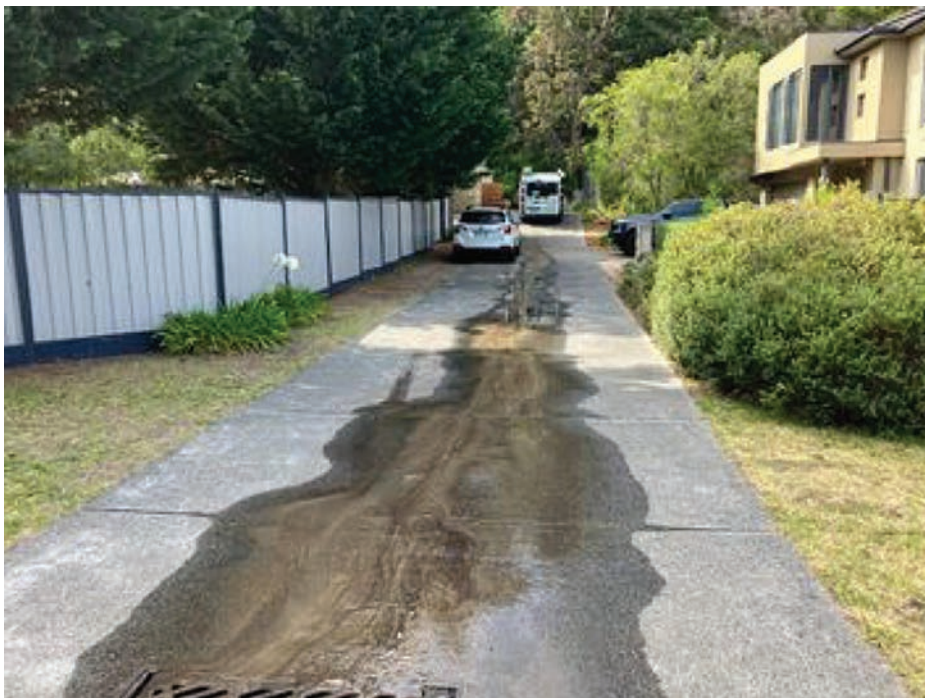
**FIGURE 3.37: PHOTOGRAPH TAKEN OF THE WATER FLOWING FROM 3 PENNY LANE DOWN PENNY LANE BY MS SCOBLE ON 9 JANUARY 2025.**<sup>633</sup>

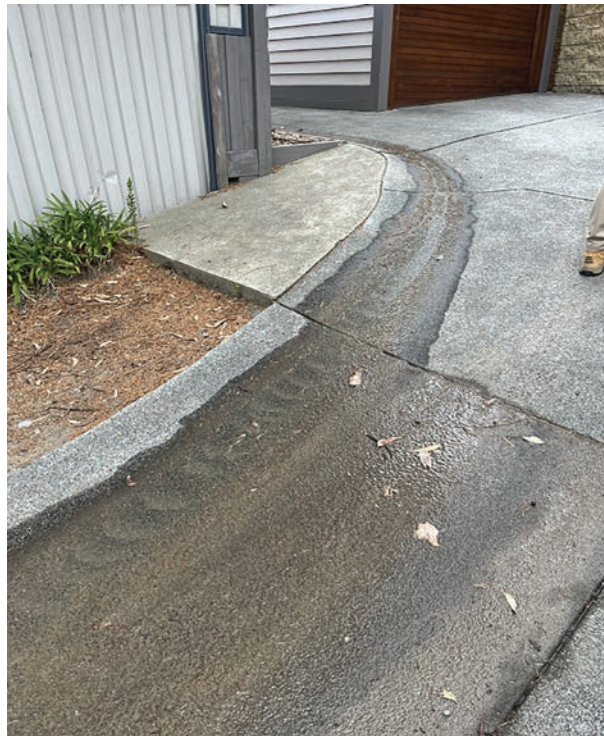
408 He included the following photograph of the flow of water and silt travelling out of the driveway of the Morans' property and onto Penny Lane:

**FIGURE 3.38: PHOTOGRAPH TAKEN BY MR ROTTER OF THE WATER FLOWING FROM THE DRIVEWAY OF 3 PENNY LANE DOWN PENNY LANE ON 9 JANUARY 2025.**<sup>635</sup>

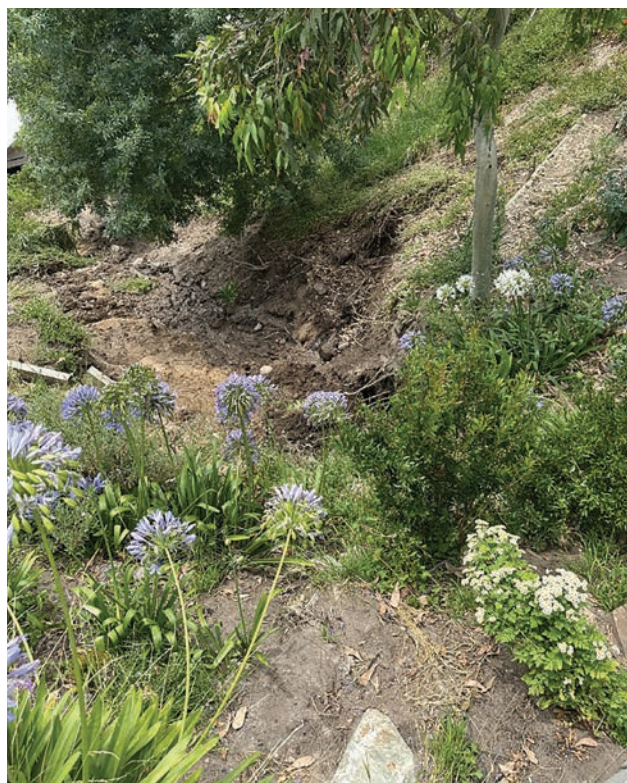
FIGURE 3.39: PHOTOGRAPH TAKEN BY MR BORGHESI SHOWING THE COMPROMISED TREE ON 9 JANUARY 2025.<sup>664</sup>

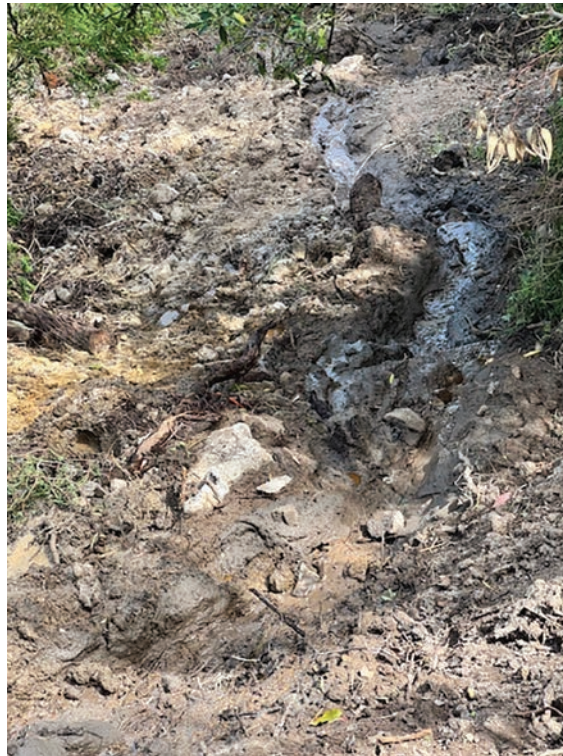
439 Around lunchtime, Mr Glover sent photographs of the landslide site to Mr Pope.<sup>679</sup> The flow of water down the escarpment was clearly visible.

**FIGURE 3.40: PHOTOGRAPH TAKEN BY MR GLOVER SHOWING THE FLOW OF WATER ON THE ESCARPMENT ON 10 JANUARY 2025.<sup>680</sup>**

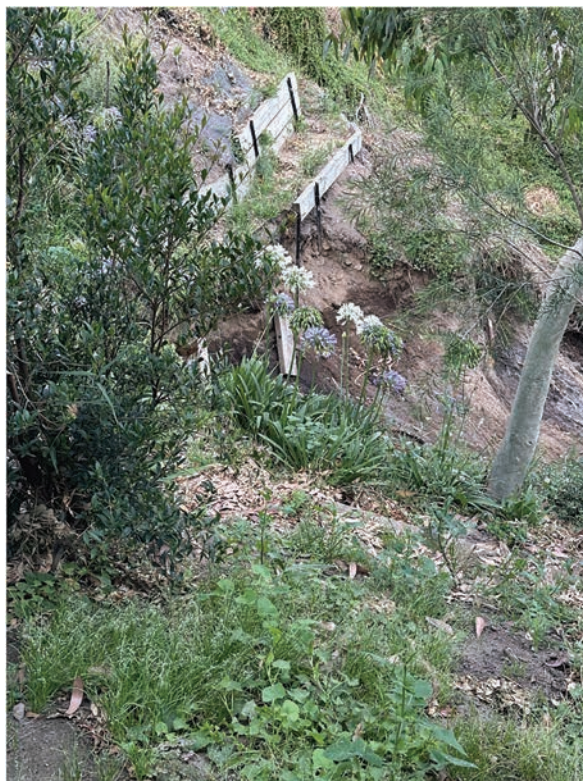
**FIGURE 3.41: PHOTOGRAPH TAKEN BY MR BORGHESI OF THE RETAINING WALL FAILING ON 12 JANUARY 2025.<sup>705</sup>**

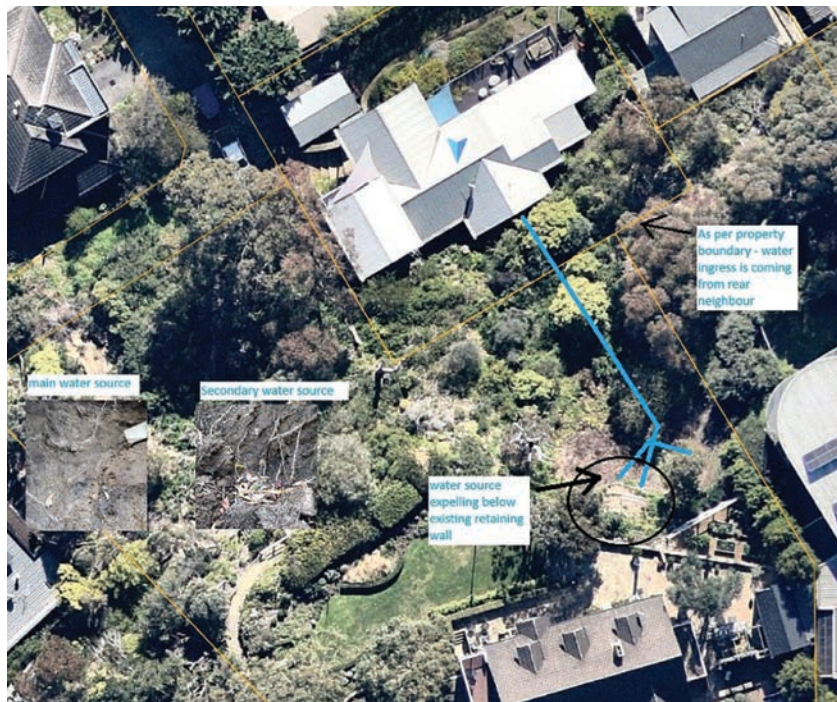
FIGURE 3.42: AERIAL IMAGE OF 3 PENNY LANE AND 10–12 VIEW POINT ROAD WITH ANNOTATIONS SHOWING LOCATION OF THE BROKEN PIPE UNDERNEATH THE RETAINING WALL AT 10–12 VIEW POINT ROAD.<sup>717</sup>

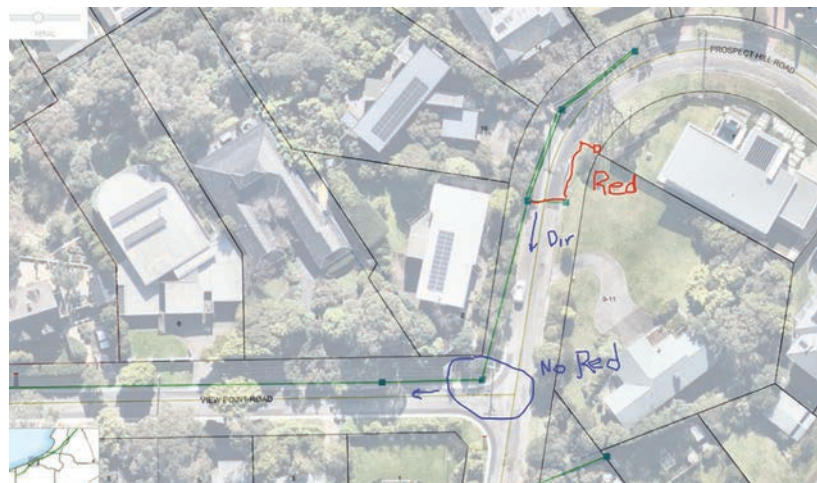
**FIGURE 3.43: DIAGRAM PREPARED BY MR GLOVER ON 10 JANUARY 2025.<sup>728</sup>**

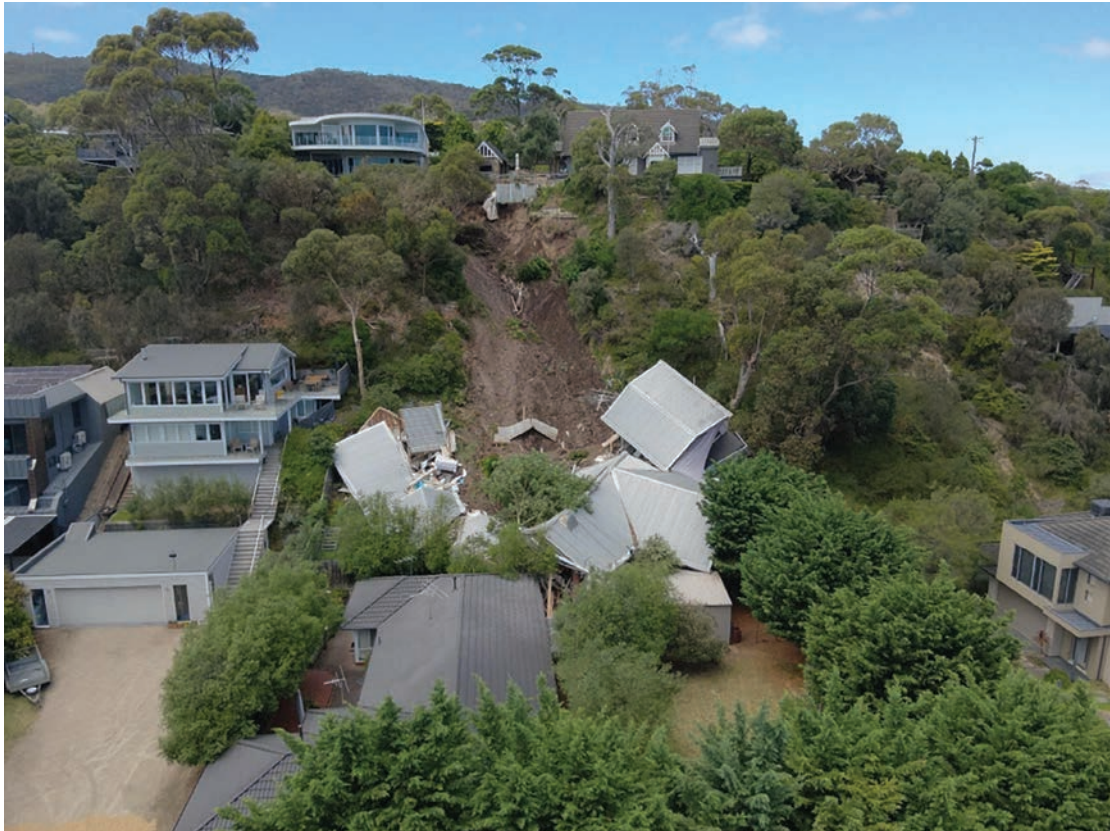
**FIGURE 3.44: AERIAL PHOTOGRAPH OF 3 PENNY LANE TAKEN FOR THE VICSES ON 14 JANUARY 2025.<sup>740</sup>**

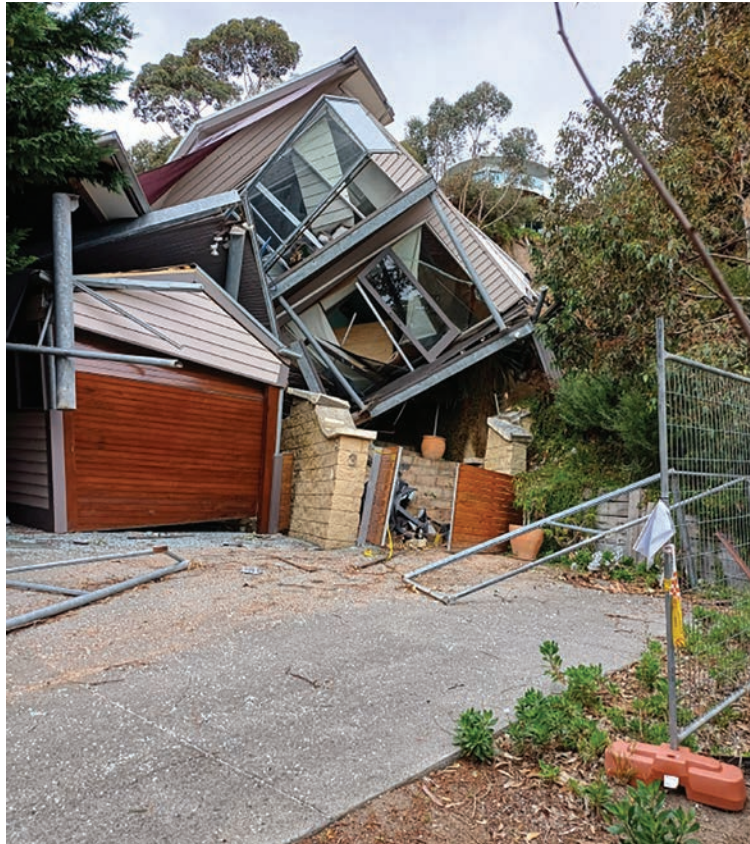
**FIGURE 3.45: PHOTOGRAPH OF 3 PENNY LANE FOLLOWING LANDSLIDE ON 14 JANUARY 2025.<sup>745</sup>**

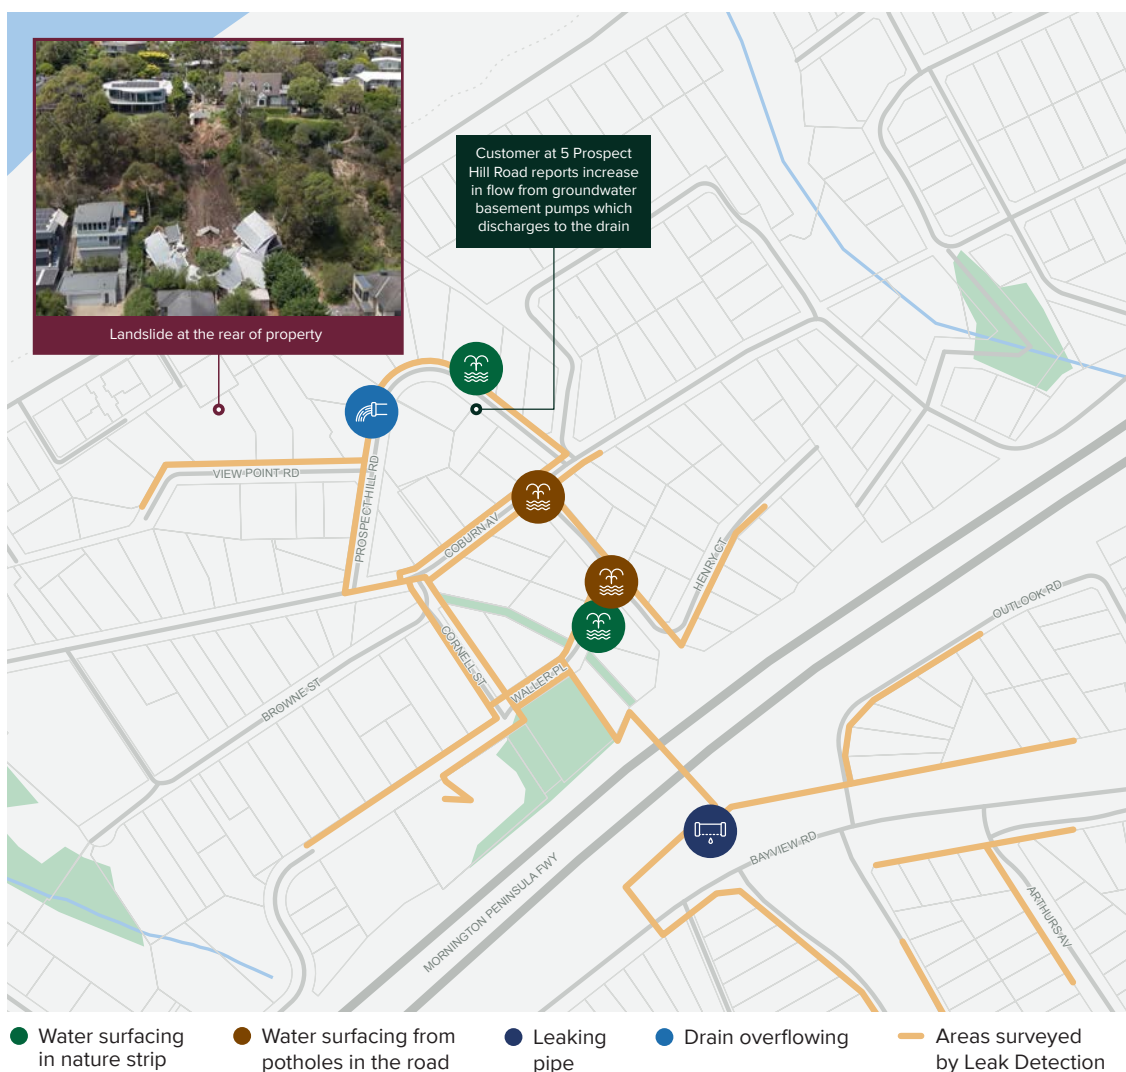
FIGURE 3.46: SCHEMATIC OF THE WATER NETWORK IN THE MCCRAE AREA ANNOTATED BY MR SWAIN. 781

The water main in Viewpoint Rd is AC [asbestos cement]. In terms of the sewer network, see GIS snapshot ... I don't believe that our sewers are impacted or have contributed in any way. I want to check the maintenance holes to the west of no. 10 when things quiet down. These are 25 metres deep and would be sensitive to any land movement.<sup>782</sup>

513 Mr Lloyd responded to that email, stating “*The burst info is interesting*”.<sup>783</sup> He told the Board of Inquiry that he understood the red symbols on the schematic to indicate burst pipes, and that in circumstances where there had been a landslide, water was emerging from the face of the landslide, and there was evidence of water surfacing, his genuine concern was “*have we got an issue with one of our pipes in that vicinity*”. He confirmed he had not yet connected the burst which had been repaired some two to three weeks earlier, with the landslide.<sup>784</sup>

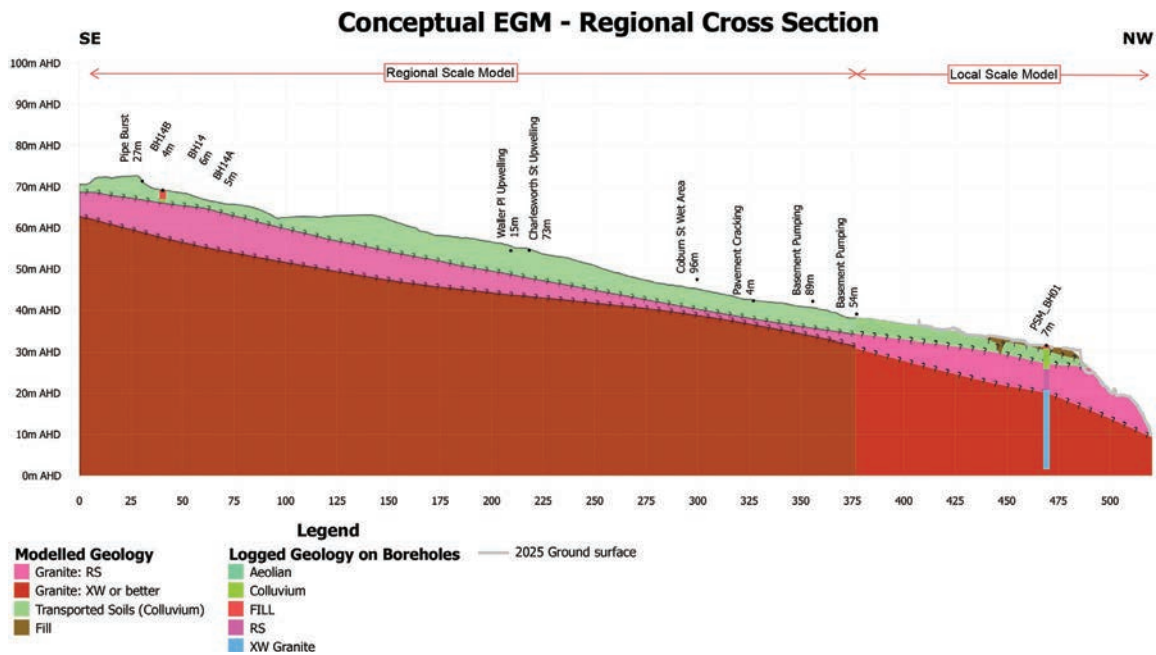
29 The geotechnical experts produced effectively identical regional cross sections.<sup>21</sup> However, the local cross sections gave rise to one area of dispute: the volume of fill on the slope above 3 Penny Lane.<sup>22</sup> This dispute will be returned to later in this Chapter.

FIGURE 4.3: REGIONAL CROSS SECTION OF PSM'S CONCEPTUAL ENGINEERING GEOLOGICAL MODEL – THE BOULEVARD TO 3 PENNY LANE.<sup>23</sup>
