# **Board of Inquiry** into the McCrae landslide Report

September 2025

On 18 March 2025, the Board of Inquiry was established to inquire into, report on, and make recommendations in relation to, amongst other things, the cause of the landslide that occurred on 14 January 2025 in McCrae on the Mornington Peninsula (**McCrae Landslide**), the adequacy of measures taken to prevent and minimise landslides in McCrae, and measures to be taken for the prevention or mitigation of the risk of similar landslide events occurring again in McCrae.

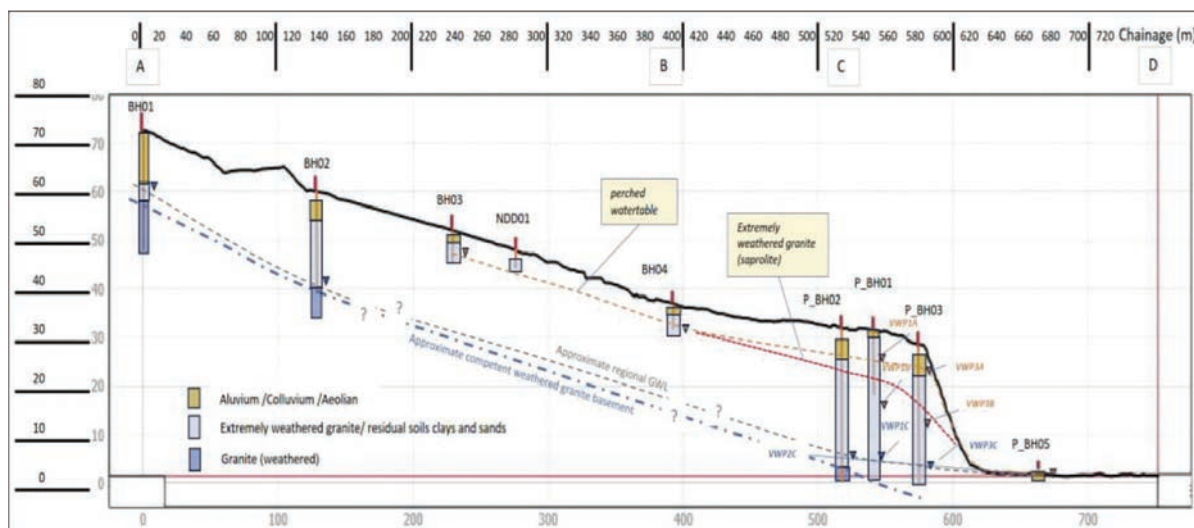
FIGURE 4.5: INTERPRETATIVE HYDROGEOLOGICAL CROSS SECTION.<sup>32</sup>

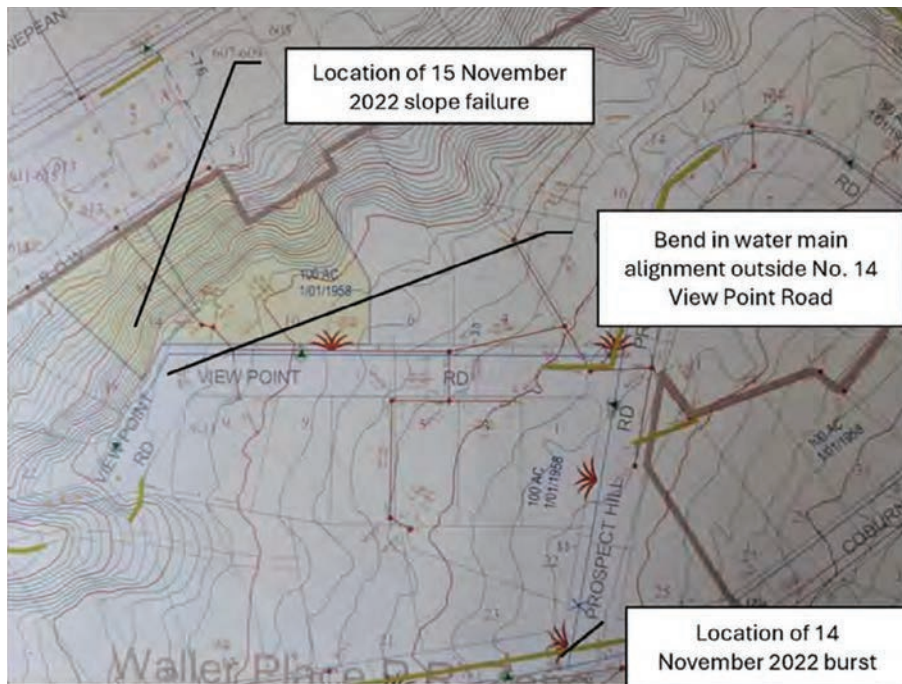
- 57 At about 5.40am on 14 November 2022, a water main failed at the corner of Prospect Hill Road and Coburn Avenue,<sup>56</sup> at approximately 23 Coburn Avenue.
- 58 The asbestos cement pipe suffered two circumferential breaks along its length,<sup>57</sup> allowing approximately 900,000 litres of water to be released prior to the main being turned off at 6.50pm.<sup>58</sup> The water from the burst water main significantly compromised the road surface and nature strip. A large sinkhole appeared on Coburn Avenue to the great concern of multiple residents.<sup>59</sup>
- 59 The failure occurred upslope of the site of the November 2022 landslides, as can be seen in the diagrams below.

**FIGURE 4.7: LOCATION OF WATER MAIN BURST RELATIVE TO THE NOVEMBER 2022 LANDSLIDES.<sup>60</sup>**

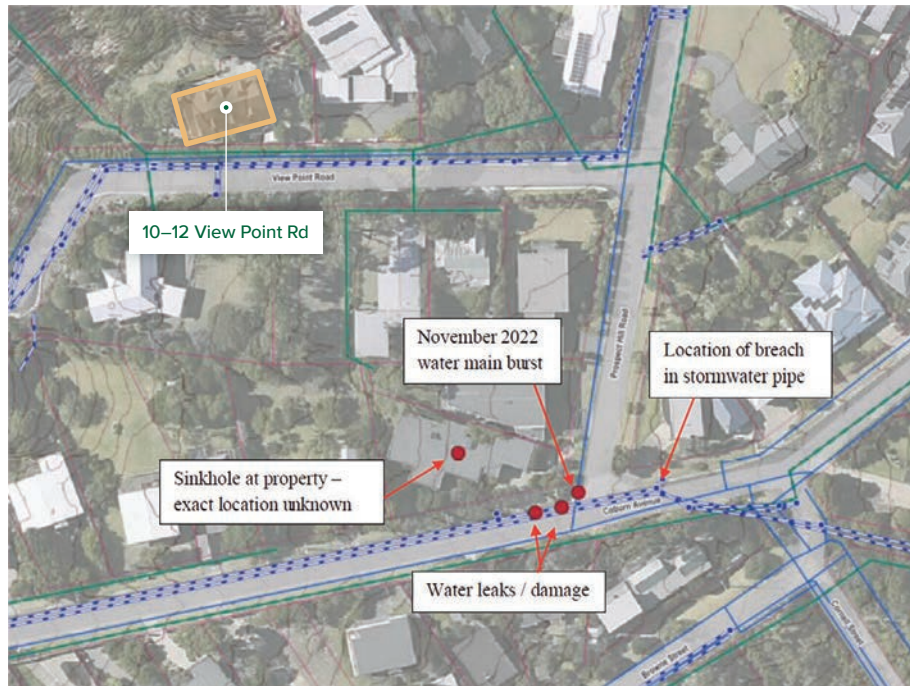
FIGURE 4.8: LOCATION OF WATER MAIN BURST AND OTHER OBSERVATIONS IN ITS VICINITY.<sup>61</sup>

60 The distance between the burst water main and the landslide site was greater than 120 metres.<sup>62</sup> Could water from the burst have travelled downslope and triggered the landslides?

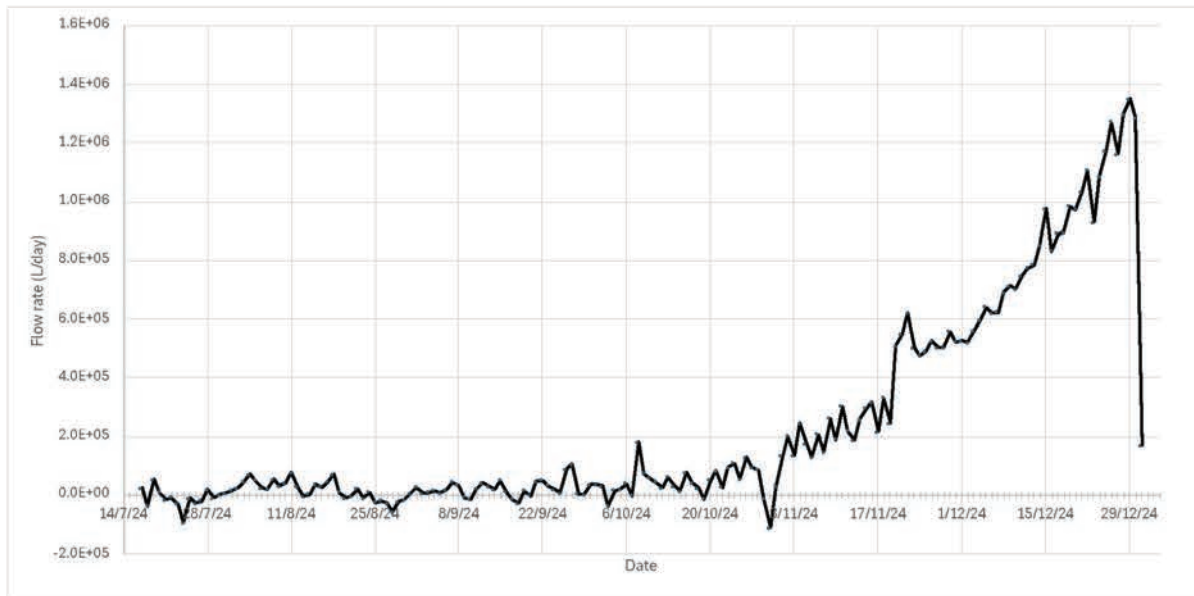
FIGURE 4.9: PROFESSOR VAN ZYL'S FLOW RATE ANALYSIS.<sup>113</sup>

- 116 Professor van Zyl modelled leakage volume per day between 11 August and 31 December 2024. On that model:
- from 11 August until sometime in mid-October, around 11,000 litres per day was lost;
  - from mid-October, that loss increased to around 50,000 litres per day;
  - by November, it had risen to 160,000 litres per day;
  - by the end of November the volume reached 560,000 litres per day;
  - by mid-December, about 1 million litres per day was escaping the pipe; and
  - finally, by the end of December, the leakage had risen to approximately 1.4 million litres per day.
- 117 The Board of Inquiry has assumed the correctness of Professor van Zyl's conclusions as to the total water loss and maximum daily flows in its consideration of the cause of the January 2025 landslides.
- 118 The next question is: where did that water go?

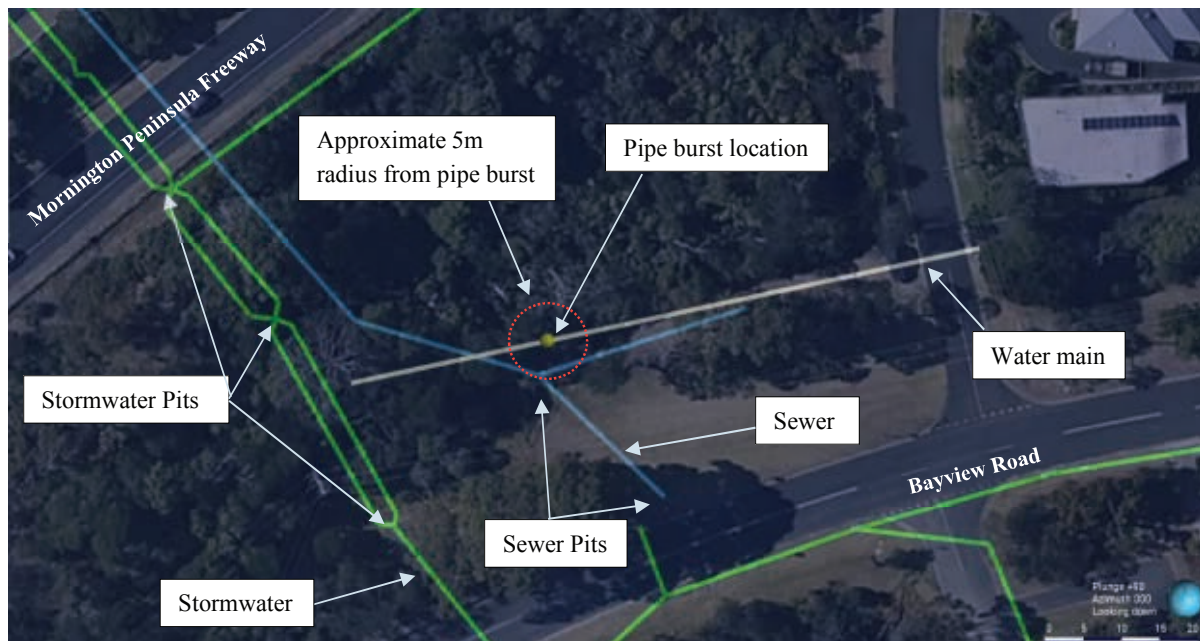
124 The image below is an overhead photograph of the burst location, annotated to identify key features of relevance. In particular, it shows the position of the burst in relation to nearby mains water, stormwater and sewer infrastructure. The annotations show that the burst occurred several metres from a sewer trench and stormwater pipes, which run downslope under the Mornington Peninsula Freeway toward the escarpment on which the January 2025 landslides occurred.

FIGURE 4.10: OVERVIEW OF THE BURST SITE SHOWING THE APPROXIMATE LOCATION OF WATER SERVICES.<sup>124</sup>

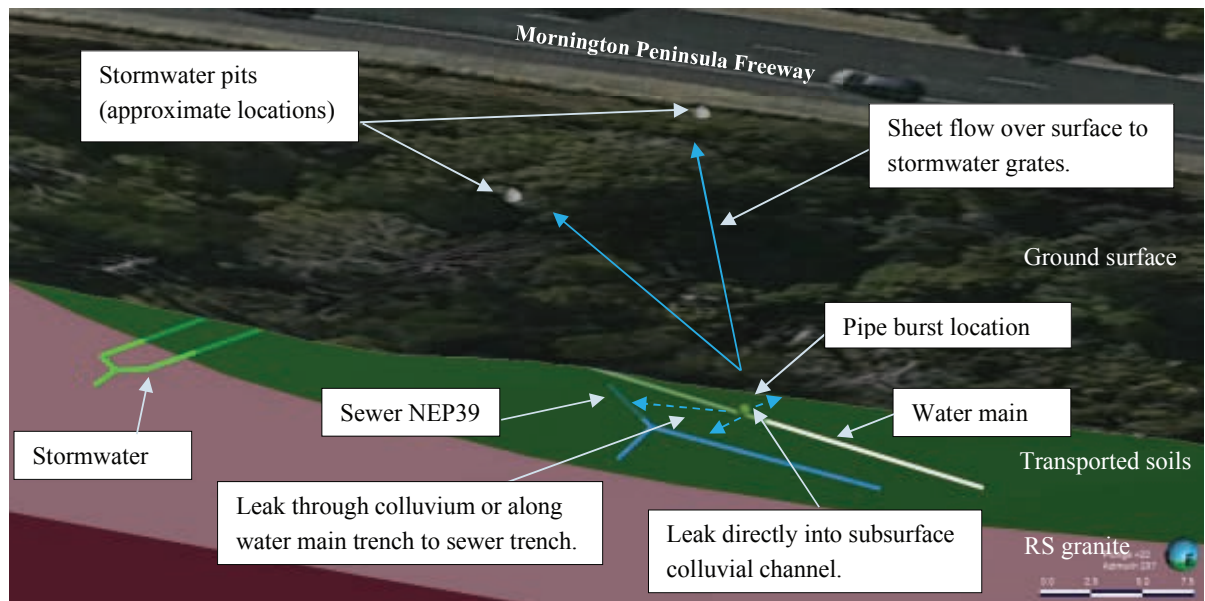
FIGURE 4.11: ISOMETRIC VIEW OF THE BURST SITE SHOWING THE APPROXIMATE LOCATION OF WATER SERVICES.<sup>125</sup>

126 The subsurface geological units in which the infrastructure is found are represented in different colours. The water main and sewer pipes are in the relatively permeable transported soils (green), which sit on top of residual granites (mauve). The implications of this for the extent and velocity of water flow will become apparent.

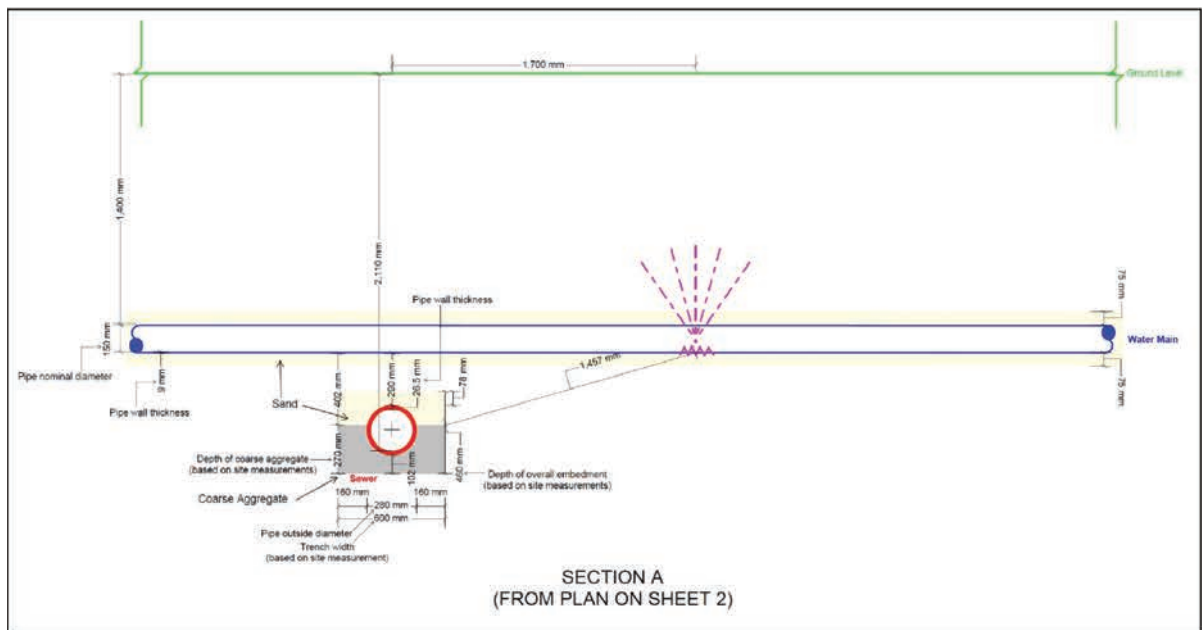
- 137 Turning to the first stage, at its simplest, the water, on immediately escaping from the burst water main, had two possible directional paths: upward to the surface or downward into the ground. That proposition requires some unpacking.
- 138 As can be seen from earlier diagrams of the burst site (Figures 4.10 and 4.11), close-by to the water main, is sewer main NEP39. That sewer main sits approximately 1.5 metres below and to the side of the water mains trench in which the burst main was located. The following cross-sectional diagram illustrates the point:

**FIGURE 4.12: SUBTERRANEAN CROSS SECTION OF THE BURST SITE.<sup>134</sup>**

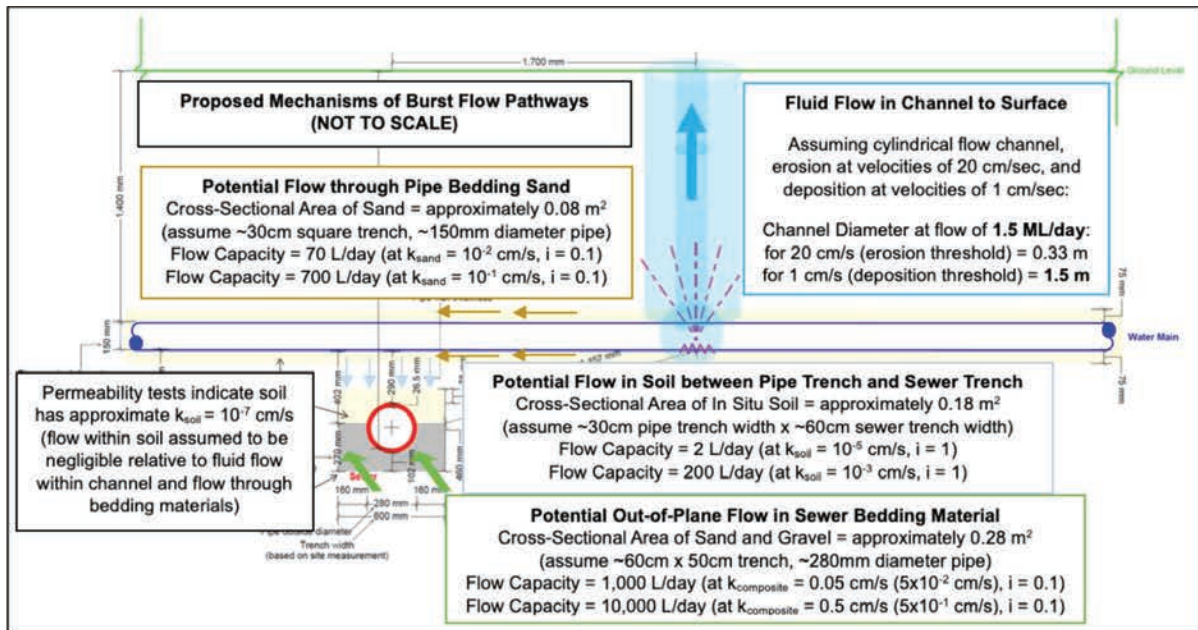
FIGURE 4.13: ANNOTATED DIAGRAM ILLUSTRATING PROF VAN ZYL'S OPINION REGARDING FLOW PATHS NEAR THE BURST SITE.<sup>135</sup>

140 As the diagram depicts, Professor van Zyl identified four flow pathways, one of which is vertical and three of which are lateral. As to the former, water from the burst could have travelled vertically upwards through a “Fluid Flow Channel” to the surface (**Vertical Burst Channel**). As to the latter, water from the burst could have travelled through the:

- bedding material of the water main, which was assumed to consist of sand;
- soil between the water main and sewer trench; or
- sewer bedding material, which was assumed to consist of gravel below the pipe and sand above the pipe.<sup>136</sup>

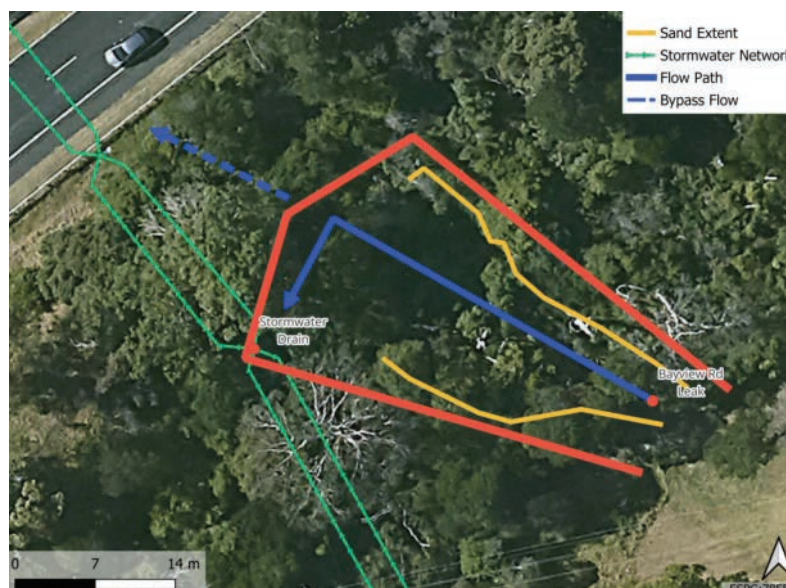
153 The diagram below illustrates the observed sand flow (delineated by the red lines) fanning out from the burst location towards the stormwater drain, and inferred to have been transported there by the surface water flow.<sup>150</sup>

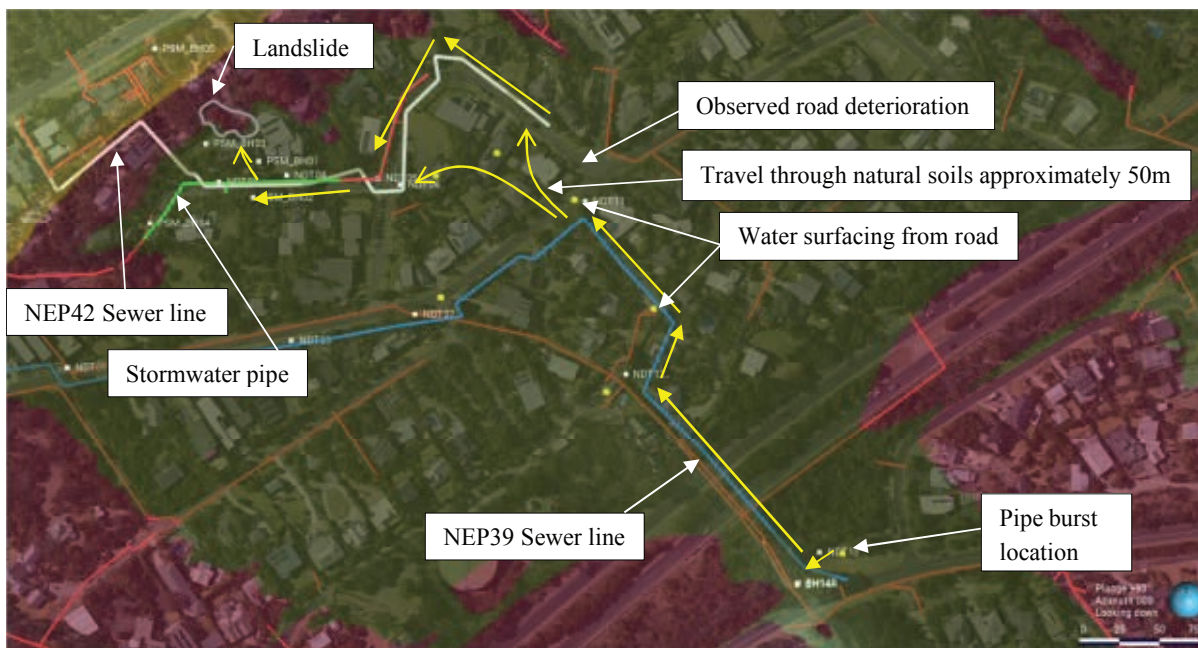
FIGURE 4.14: MR PAUL'S DEPICTION OF THE SERVICE TRENCH FLOW PATH.<sup>158</sup>

166 As can be seen from the above, the sewer service trench flow path follows the blue NEP39 sewer line downhill under the Mornington Peninsula Freeway, to Waller Place, to Charlesworth Street, then down to Coburn Avenue. The service trench flow path then follows the sewer *and* water infrastructure downhill to the site of the January 2025 landslides.

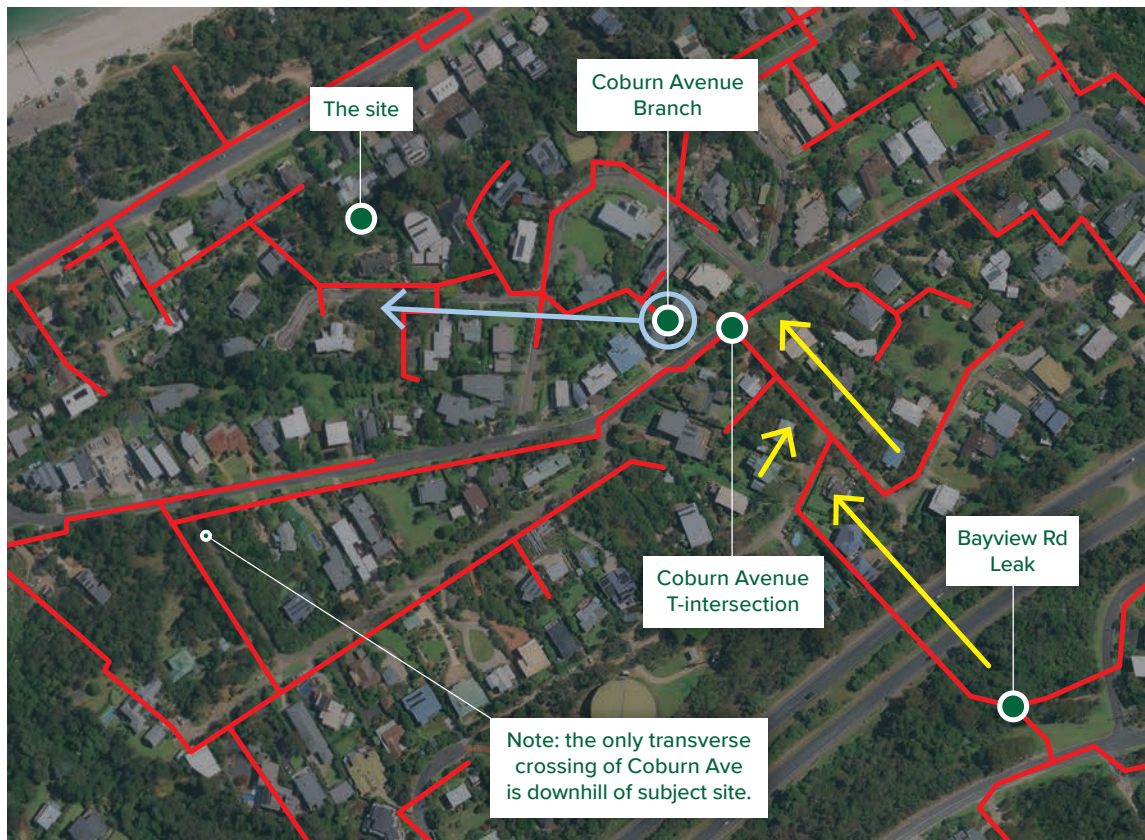
FIGURE 4.15: SEWER NETWORK (INCLUDING DEPICTION OF POTENTIAL FLOW PATH).<sup>159</sup>

167 A simplified version of the sewer service trench flow path is depicted below. As overlaid in yellow over the SEW sewer map, the flow path follows the sewer main that runs under the Mornington Peninsula Freeway from Bayview Road, turns right at Waller Place, then runs down Charlesworth Street, before turning down Coburn Avenue:

168 As can be seen from the above, there is a constant run of sewer mains between the burst site and the corner of Charlesworth Street and Coburn Avenue (**Coburn Avenue T-Intersection**).

169 A new branch of another sewer (between 31 and 31A Coburn Avenue, circled in blue (**Coburn Avenue Branch**)) picks up across Coburn Avenue and then runs from under the homes directly opposite the Coburn Avenue T-Intersection downhill to View Point Road (blue arrow). The distance between the Coburn Avenue Branch and the sewer main that runs down Coburn Avenue is approximately 10 metres.<sup>160</sup>

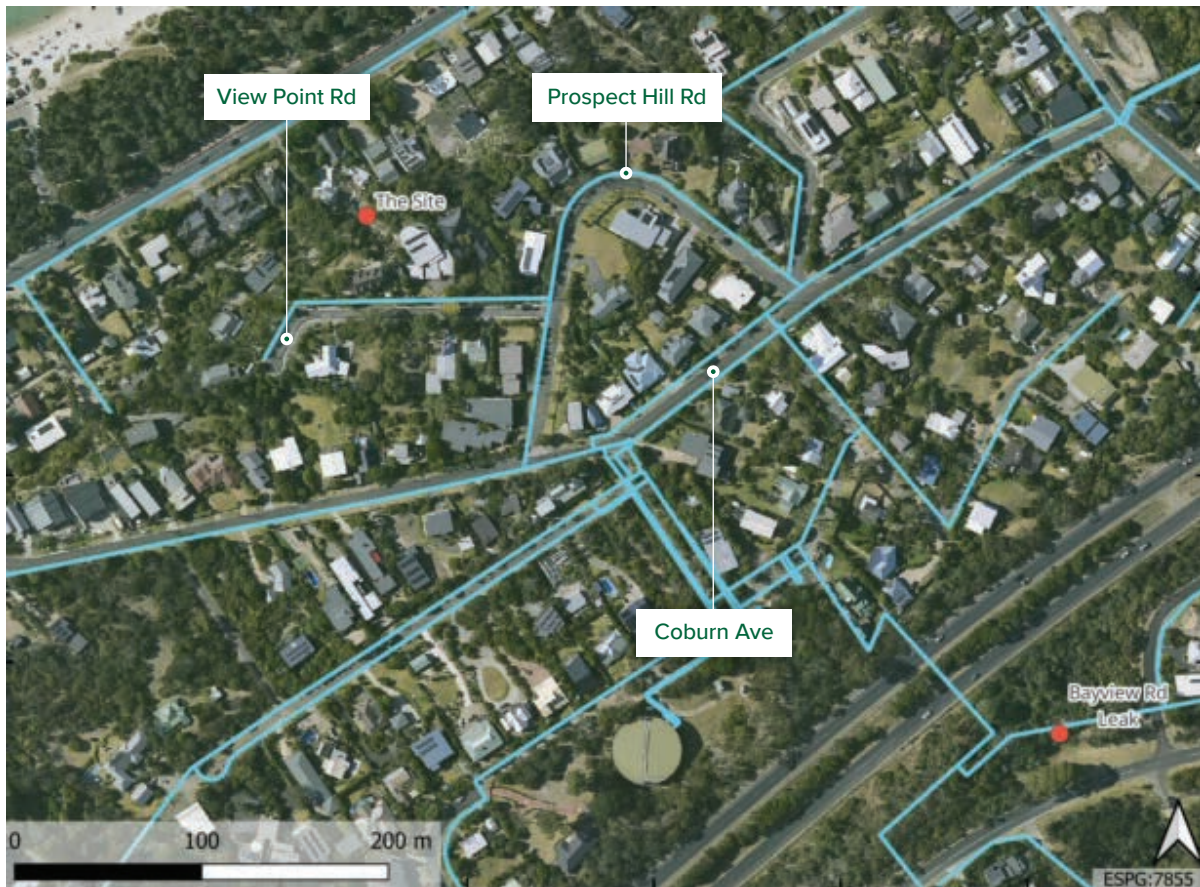
FIGURE 4.16: WATER MAINS NETWORK.<sup>161</sup>

- 172 All of that demonstrates that water mains run directly from the Coburn Avenue T-Intersection down to View Point Road.
- 173 There is only a relatively small distance of unconnected mains between the Coburn Avenue T-Intersection (where the sewer main diverts) and the Coburn Avenue Branch (which also runs down View Point Road).
- 174 Put another way, mains or sewer infrastructure effectively runs the entire way from the burst site to View Point Road, with one gap across Coburn Avenue for sewer only.

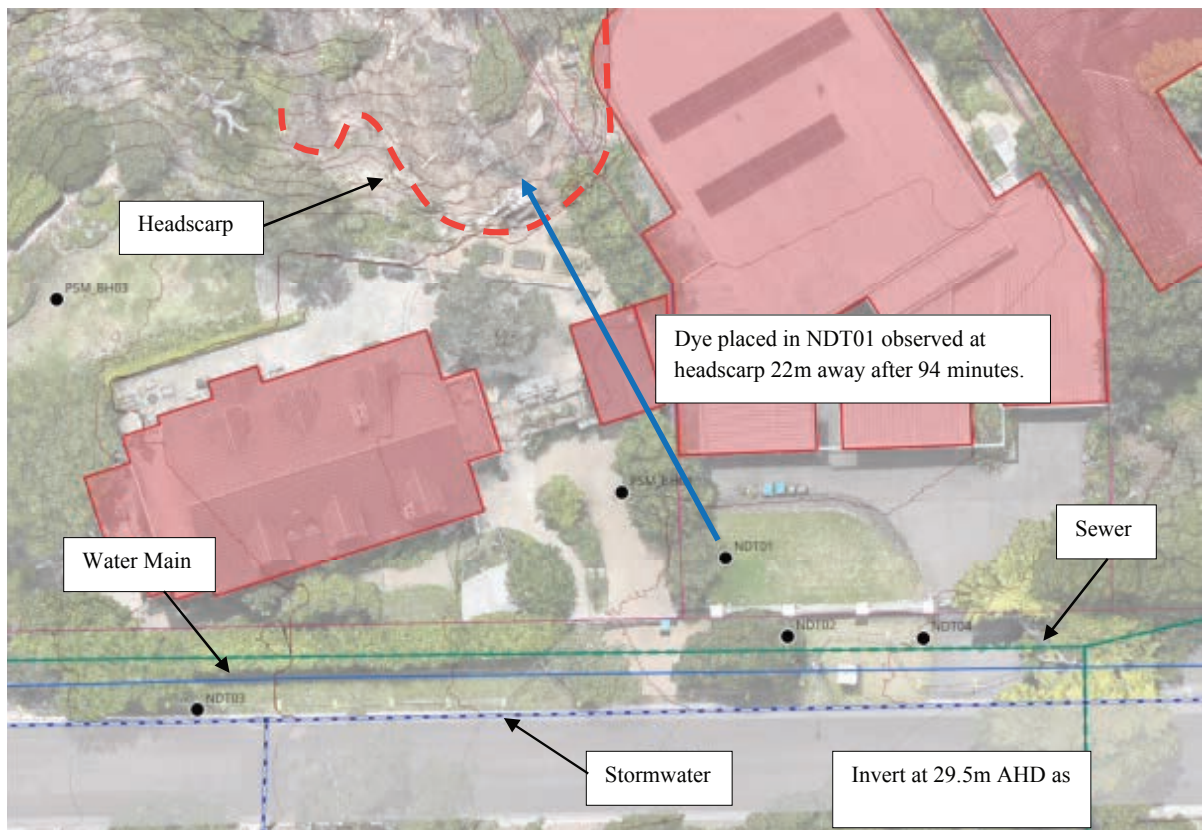
FIGURE 4.17: WATER INFRASTRUCTURE IN THE VICINITY OF THE MCCRAE LANDSLIDE SITE.<sup>162</sup>

- 176 As can be seen from the annotations, all three run down the northern side of View Point Road, with the sewer and stormwater systems being under the nature strip. It is approximately 25 to 30 metres from the sewer and water mains on View Point Road to the headscarp. It follows that the water that managed to reach the Coburn Avenue Branch would have had a direct path through the sewer embedment materials to within 25 to 30 metres of the landslide site.

- 206 In any event, there is other evidence of hydraulic conductivity from the area around View Point Road to the escarpment. Figure 4.17 referred to earlier shows the results of a dye test conducted on 12 February 2025.<sup>192</sup> Dye was placed by Mr Pope into a borehole labelled NDT01, located within the private sewer trench at 6 View Point Road.<sup>193</sup> After 94 minutes, the dye appeared in the headscarp, demonstrating at least one connective path between the services infrastructure and the observed seepage in the colluvium at the headscarp.

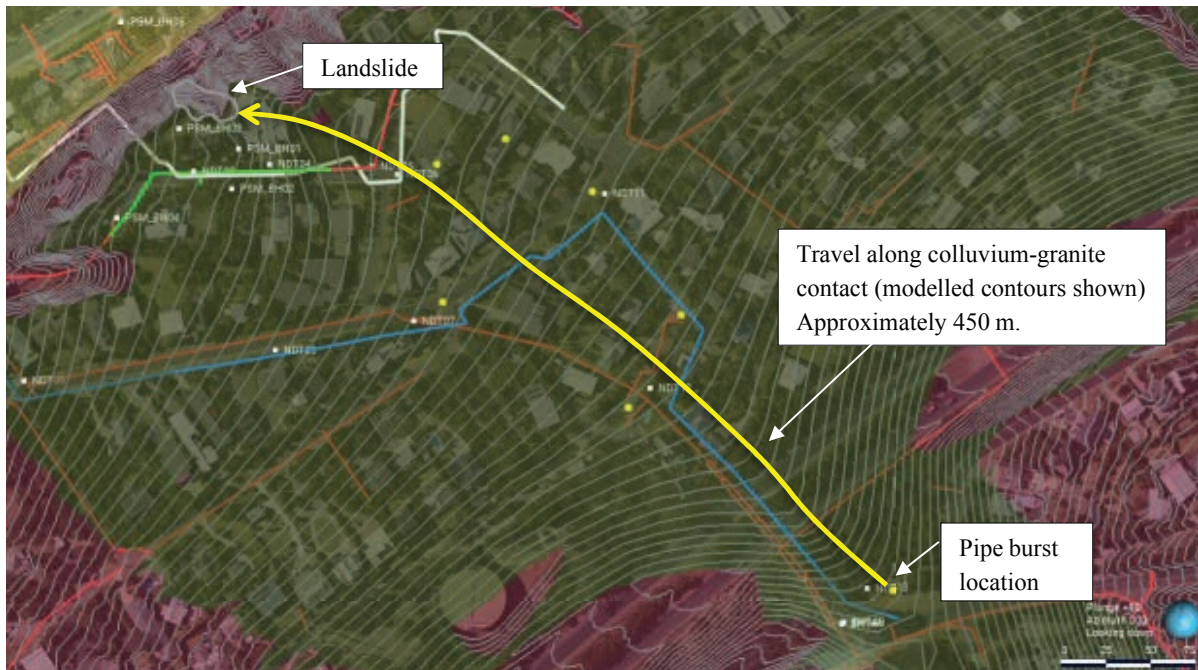
FIGURE 4.18: MR PAUL'S DEPICTION OF THE COLLUVIUM FLOW PATH.<sup>163</sup>

- 179 Turning then to the colluvium flow path, which describes the flow of water from the burst site towards the site of the January 2025 landslides through natural soils and the shallow aquifer.
- 180 Mr Paul depicted that path as follows:

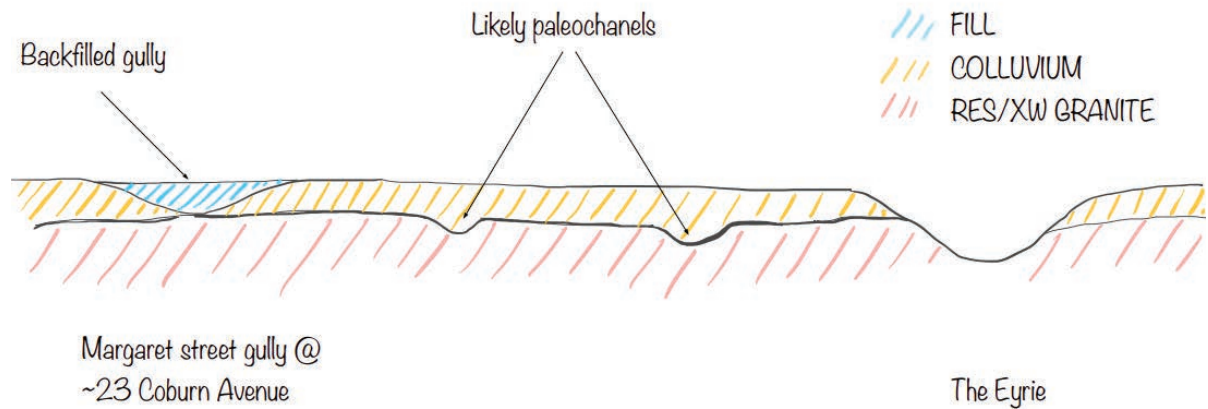
FIGURE 4.19: CROSS SECTION OF THE GULLY AT MARGARET STREET.<sup>167</sup>

184 Within that colluvial layer, changes in topography create preferential pathways for water in the form of “paleochannels”. These are areas which are relatively lower than the surrounding colluvium, as depicted by Mr Pope in the following section diagram, with the section running across the slope looking downhill:

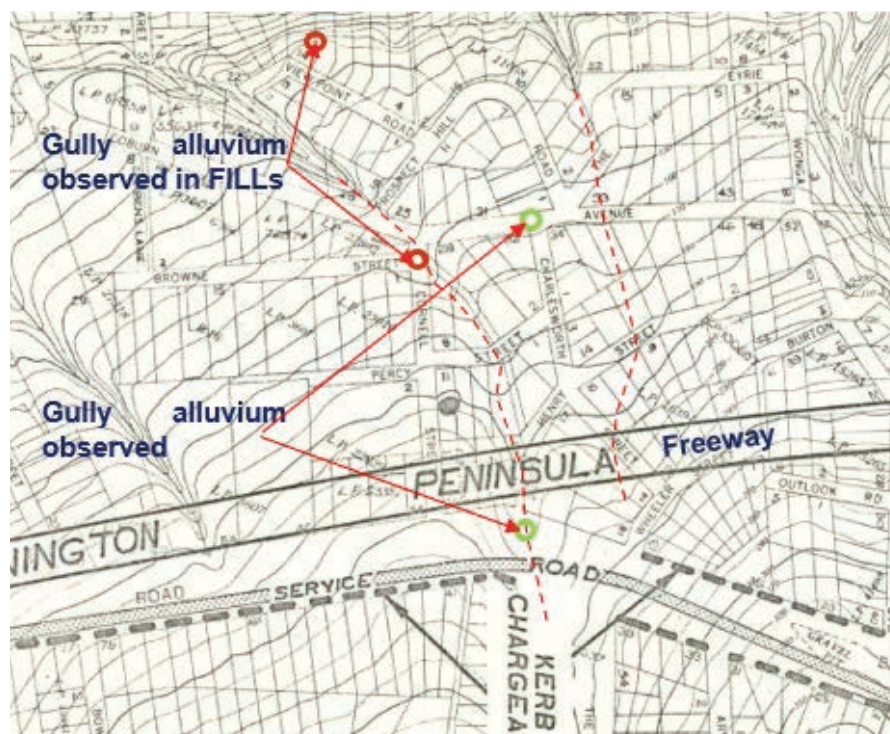
FIGURE 4.20: TOPOGRAPHICAL MAP OF THE MCCRAE AREA.<sup>168</sup>

185 Mr Pope’s interpretation of the natural channels that follow the topography from the Boulevard Reserve on Bayview Road down to the gully formerly running to the north of Coburn Avenue, are graphically represented at Inset 41 of his report (reproduced as Figure 4.20 below). The topographical lines on this figure show how there are natural low spots forming gullies. The left hand red dotted line is the Margaret Street Gully as labelled in Figure 4.19 above, and the right hand red dotted line is The Eyrie.

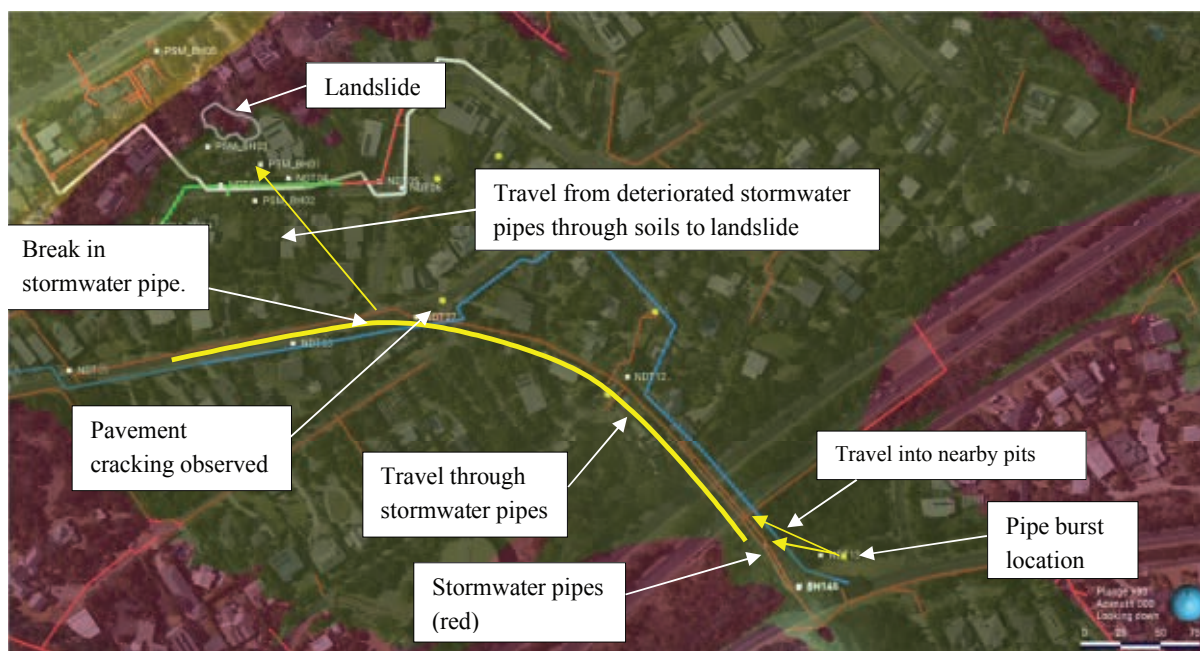
**FIGURE 4.21: MR PAUL’S DEPICTION OF THE STORMWATER FLOW PATH.<sup>175</sup>**

- 189 Turning to the last potential flow path – the stormwater flow path – which describes the flow of water from the burst site towards the site of the January 2025 landslides via the stormwater system and any breaches or defects within it.
- 190 Mr Paul depicted that path as follows:

- 192 Mr Paul hypothesised that water may have escaped through breaches or defects in the stormwater pipes, recharging the shallow aquifer and potentially reaching the landslide site.<sup>176</sup>

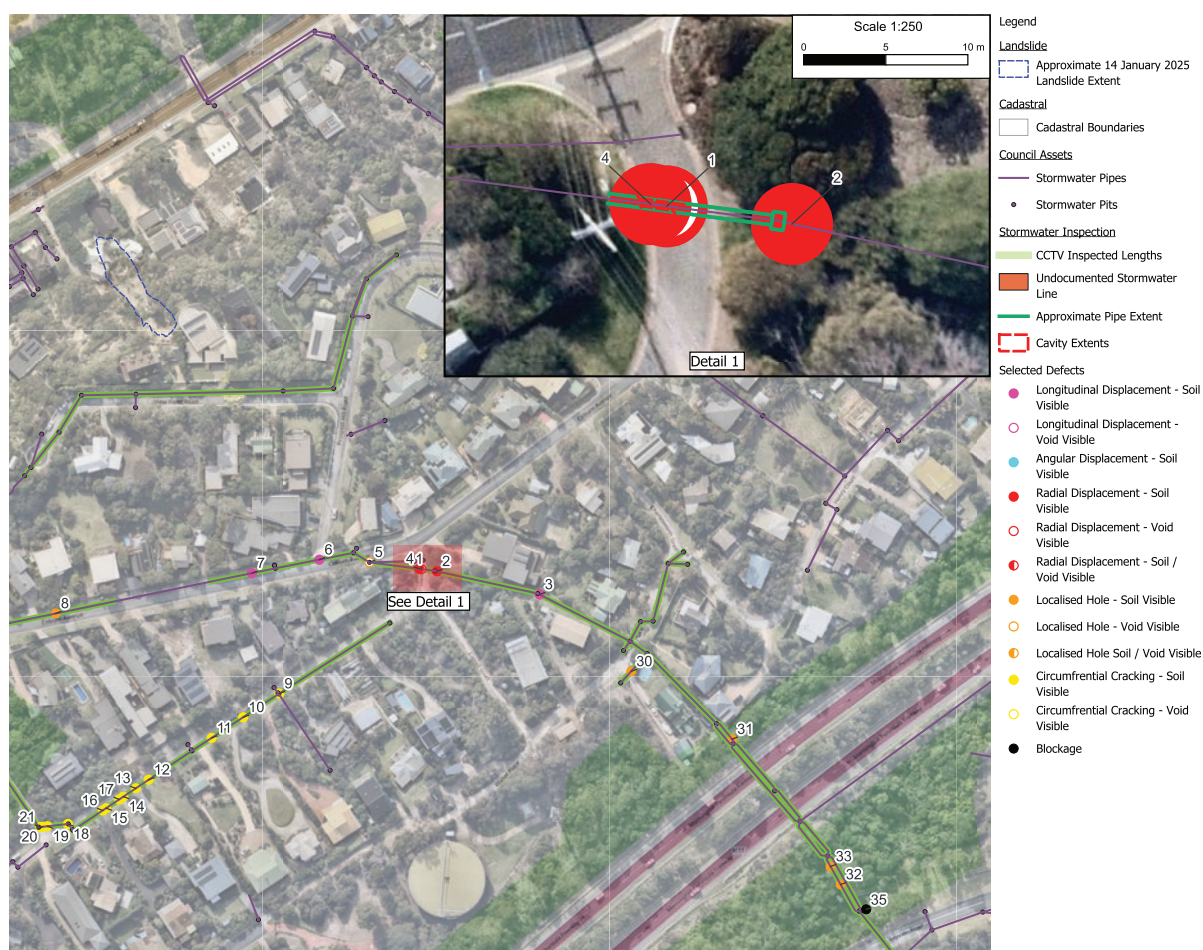
**FIGURE 4.22: ANNOTATED MAP DEPICTING THE LOCATIONS OF VARIOUS STORMWATER DEFECTS.<sup>179</sup>**

- 193 There is evidence of breaches in the 600 millimetre stormwater pipe.<sup>177</sup> Closed-circuit television cameras were fed through the stormwater pipe to inspect the condition of the pipe.<sup>178</sup> Various defects were identified, ranging from holes to displaced joints through which soil and voids were visible.

- 194 Mr Pope provided an annotated map showing the locations of these defects indicated by numbers one through to seven, a portion of which is extracted and annotated with arrows and comments below:

195 The stormwater defects identified by Mr Pope are depicted by the numerals. Extracted below are the images of defect numbers 1 and 4 referred to at Figure 4.22, showing the extent of damage to the stormwater pipe located at Browne Street:

196 The extent of the damage is significant. Plainly, water could, and did, exit the stormwater system through those cracks and holes in the stormwater pipe. Mr Pope estimated that the total leakage volume from the damage at the intersection of Browne Street and Coburn Avenue was in the order of 75 to 1,200 litres per day.<sup>181</sup> In oral evidence, Mr Pope explained that he had not conducted a complete analysis of the entire stormwater channel, rather his focus was on two of the defects at the Browne Street corner.<sup>182</sup> It follows that Mr Pope's estimate is conservative and at least reasonably likely to underestimate the total water loss through the stormwater defects.

197 The experts were unable to give a definitive answer to that question. As can be seen from the annotations on the map of stormwater defects above in Figure 4.22, the majority of the defects are close to the location of the 23 Coburn Avenue burst considered in respect of the November 2022 landslides. As previously noted, Mr Paul was unable to give an opinion about the relative contribution of the 23 Coburn Avenue burst to the November 2022 landslides.<sup>183</sup> Similarly, although the joint expert conclave report regarded the stormwater flow path to be plausible, none of Mr Paul, Mr Pope or Mr Hitchcock were able to give an opinion about whether water from the breaches in stormwater did in fact contribute to the water that triggered the January 2025 landslides.<sup>184</sup>

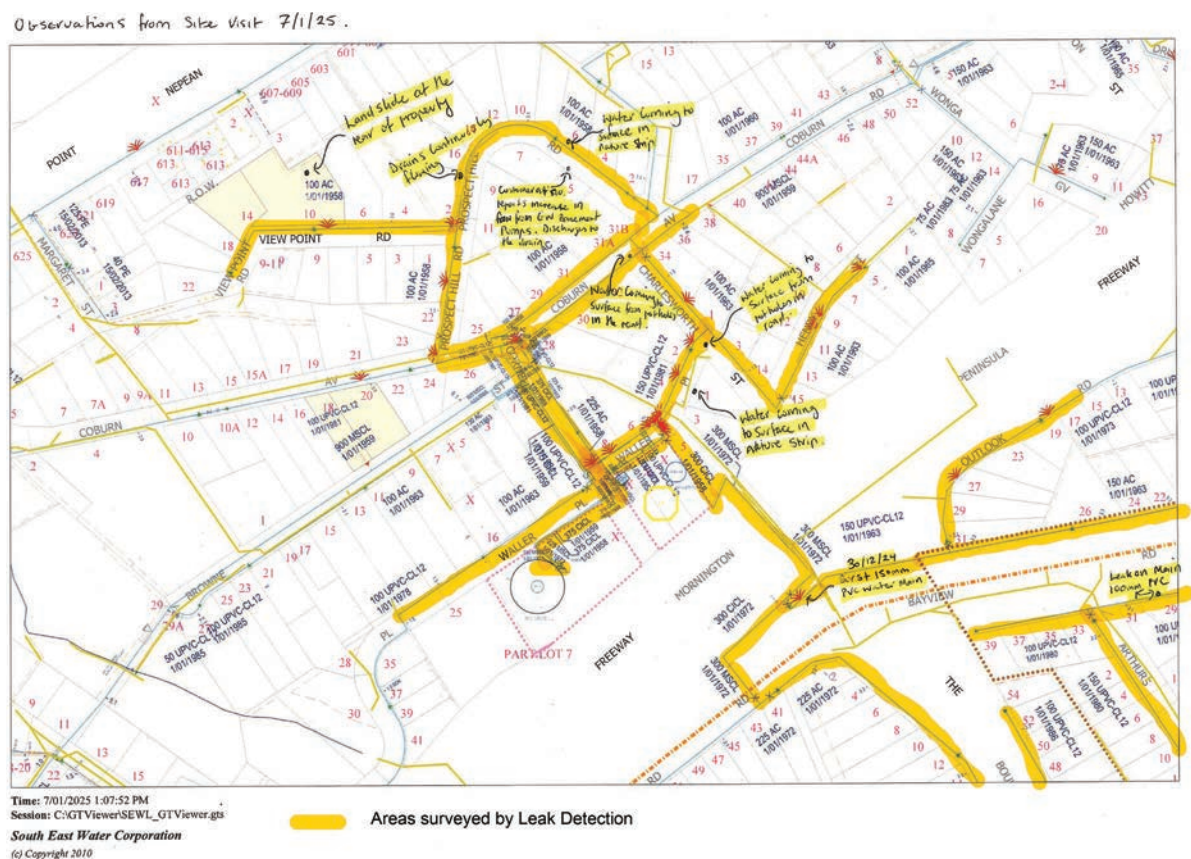
**FIGURE 4.24: ANNOTATED MAP DEPICTING AREAS SURVEYED BY LEAK DETECTION.<sup>186</sup>**

- 201 Both the timing and location of these observations is also important. Mr Pope provided an annotated map at Figure 5 of his report showing observations made by PSM staff from site-walks on various dates between 6 January and 16 June 2025.<sup>185</sup> Similarly, a SEW staff member, who conducted a site visit on 7 January 2025, prepared a hand-annotated map of his observations, which also track the service trench flow path. The map is shown below.

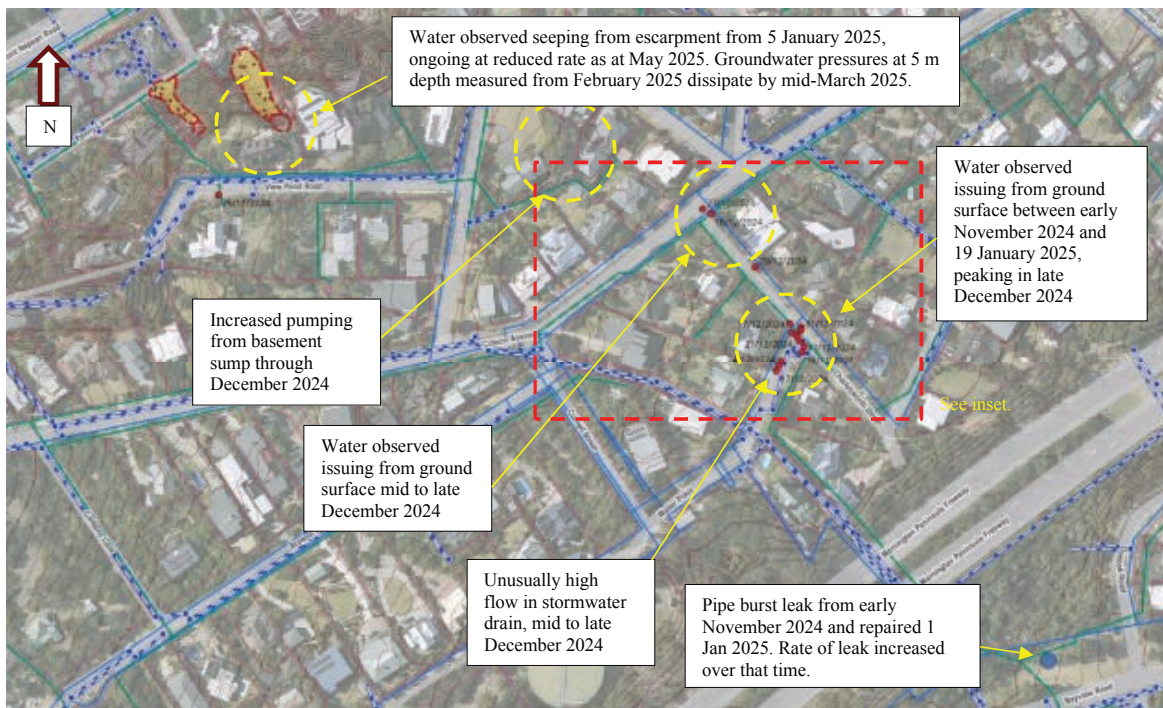
**FIGURE 4.25: MR PAUL'S CHRONOLOGY OF SURFACE WATER OBSERVATIONS.**<sup>188</sup>

202 Mr Paul set out a chronology of the instances of excessive water in his report.<sup>187</sup> He then showed how the water progressed downslope over time in the following Figure:

203 Drawing from Mr Paul's observations recorded in the Figure above, the following timeline becomes apparent:

- a. The first observation depicted in Figure 4.25 at the corner of Waller Place and Coburn Avenue was made at the top of the hill in around November 2024 (around the time the flow rate markedly increased).

- b. Water in the stormwater pipe running through Waller Place was observed flowing at an unusually high rate a few weeks later, from mid to late December 2024 (around the time the flow rate had increased further).

- c. The ground started upswelling at the Coburn Avenue T-Intersection at a similar time, also in mid-December 2024.
- d. By late December 2024, the water observed rising from the ground on the corner of Coburn Avenue and Waller Place peaked, when the flow rate from the burst water main was also peaking.

- e. On 5 January 2025, after the landslide, and also after the burst water main had been repaired, water was seen seeping from the escarpment in significant volumes.

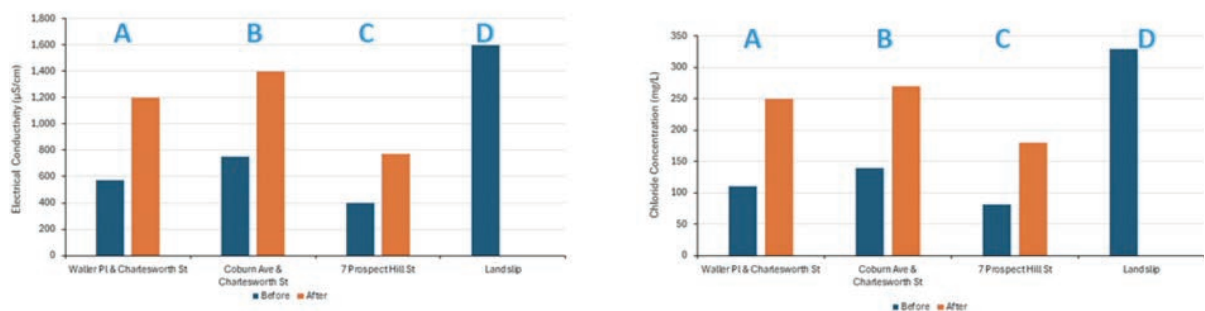
**FIGURE 4.26: GRAPHS DEPICTING THE ELECTRICAL CONDUCTIVITY AND CHLORIDE CONCENTRATION IN WATER SAMPLES.**<sup>217</sup>

- 231 The reasoning underpinning that conclusion requires some explanation. It turned on an analysis of the chemical properties of water tested both before and after the burst water main was repaired from two potholes: the Waller Place/Charlesworth Street pothole and the Coburn Avenue/Charlesworth Street pothole. The short point is that both the salinity and chloride levels of water in those potholes jumped up after the burst water main was repaired.

- 232 What was the significance of this jump? Mr Bolton thought it spoke to the extent to which the water travelled.
- 233 Mr Bolton’s theory was that water from the burst entered the permeable embedment material and then travelled to the Waller Place/Charlesworth Street pothole site (Column A in the graphs below). Testing in December 2024 and early January 2025 showed that water in that pothole initially had a lower electrical conductivity level, which is more consistent with mains water.<sup>214</sup> Then, after the burst main was repaired, “*the [electrical conductivity] level jumps back up again*”, which, on Mr Bolton’s theory, indicated that the mains water had stopped reaching that location and diluting the groundwater.<sup>215</sup> Mr Bolton gave similar evidence in relation to the Coburn Avenue/Charlesworth Street pothole (Column B in the graphs below).<sup>216</sup>

- 234 The water testing results for electrical conductivity and chloride levels for those potholes, as well as water collected at 7 Prospect Hill Road and the landslide site, are depicted in the graphs below:

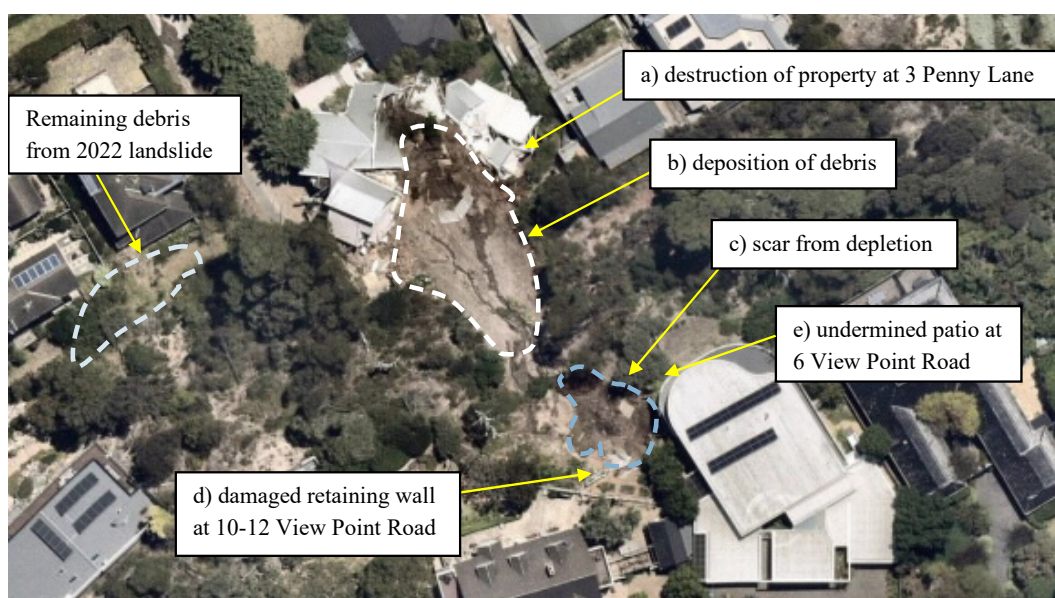
FIGURE 5.1: IMAGE DEPICTING THE IMPACT OF THE LANDSLIDES AT 10–12 VIEW POINT ROAD.<sup>1</sup>

- 4 It is convenient only to begin by briefly identifying the location of the landslides in 2022 and 2025. The November 2022 landslides occurred in the west gully of 10–12 View Point Road, while the 5 January 2025 landslide and the McCrae Landslide occurred in the east gully overlapping 6 and 10–12 View Point Road.
- 5 This aerial photograph usefully depicts the location of the landslides:

- 6 The remaining debris from the November 2022 landslides can be observed to the rear of Mr and Mrs Willigenburg's home at the toe of the escarpment. The debris flow from those landslides as depicted in the photograph, was confined to the west gully, and it ran across what was formerly the continuation of Penny Lane.

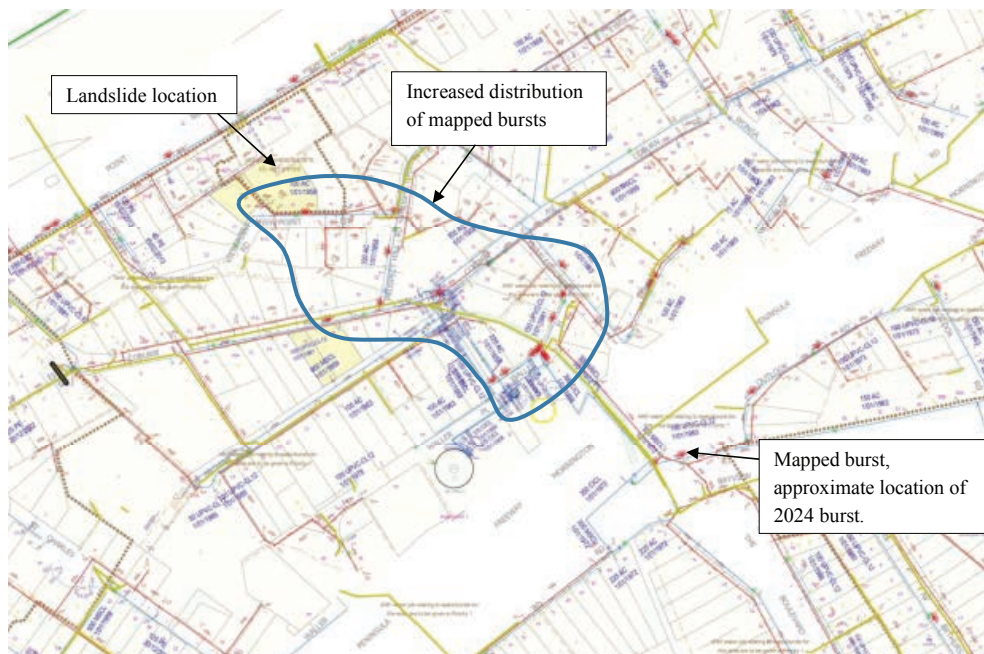
87 This map indicates a zone in the McCrae area where there were an anomalous number of failures:

**FIGURE 5.10: SOUTH EAST WATER PLAN SHOWING FREQUENCY OF WATER LEAKS WITHIN WATER MAINS IN THE MCCRAE AREA WITH ANNOTATIONS.<sup>118</sup>**

88 Mr Paul considered that the asbestos pipes in the area outlined above were aging, brittle, and prone to cracking,<sup>119</sup> and had a higher rate of leakage compared to other areas in McCrae.<sup>120</sup>

#### **Recommendation 4: Assessment of infrastructure**

The Board of Inquiry recommends the Shire and SEW thoroughly assess their water infrastructure in McCrae to identify any need for repair or replacement works to mitigate landslide risk. SEW should also adopt this measure in relation to its sewer system.
