# **Board of Inquiry** into the McCrae landslide Report

September 2025

On 18 March 2025, the Board of Inquiry was established to inquire into, report on, and make recommendations in relation to, amongst other things, the cause of the landslide that occurred on 14 January 2025 in McCrae on the Mornington Peninsula (**McCrae Landslide**), the adequacy of measures taken to prevent and minimise landslides in McCrae, and measures to be taken for the prevention or mitigation of the risk of similar landslide events occurring again in McCrae.

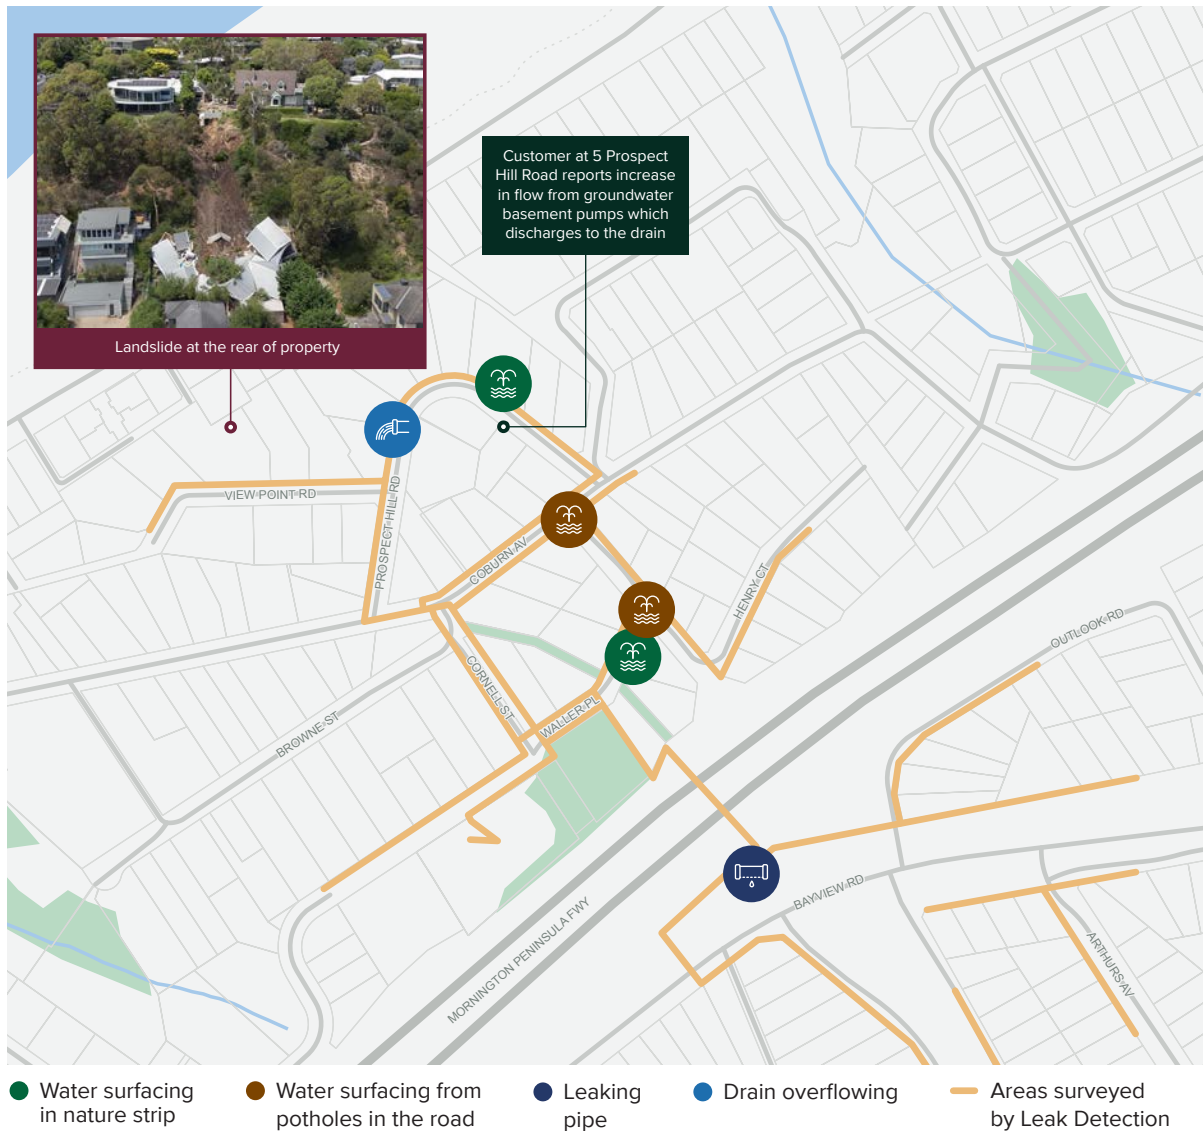
**FIGURE 6.2: SCHEMATIC OF THE WATER NETWORK IN THE MCCRAE AREA ANNOTATED BY MR SWAIN.<sup>286</sup>**

326 It is obvious that in the period between 5 and 14 January 2025, SEW was actively looking for the source of water that was seen emanating from the headscarp. No criticism can be levelled against SEW for trying in that respect. But should they have done more?

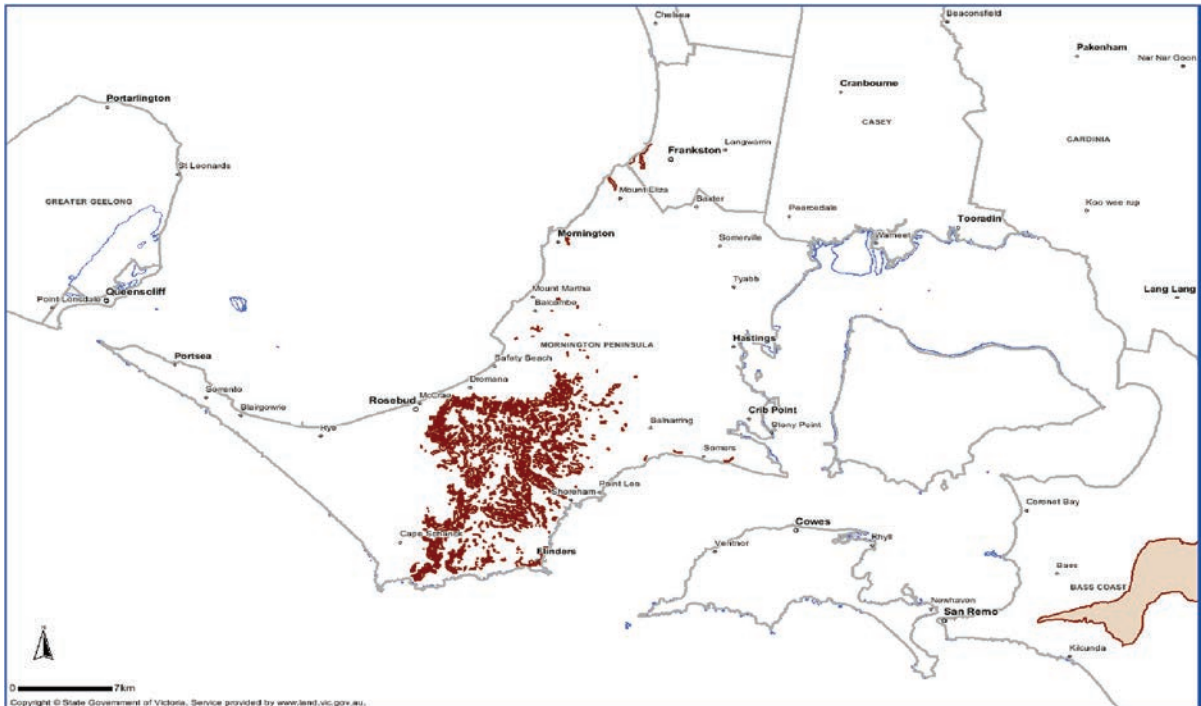
FIGURE 8.2: THE MAP OF SOUTHERN METRO REGION – SHIRE OF MORNINGTON PENINSULA AND CITY OF FRANKSTON COUNCIL DETAILS EMO LOCATIONS, WITH AREAS OF CONCERN HIGHLIGHTED IN RED.<sup>44</sup>

- 43 As can be observed in the map, areas in the Shire that had known landslide susceptibility (including the location of the McCrae Landslide and the November 2022 landslides) are not highlighted in red. This is because those areas are not included in the EMO schedules in the Mornington Peninsula Planning Scheme.
