Visual Impact Assessment

Motorcycle Safety Levy Projects

Mornington Peninsula Shire

15 September 2025

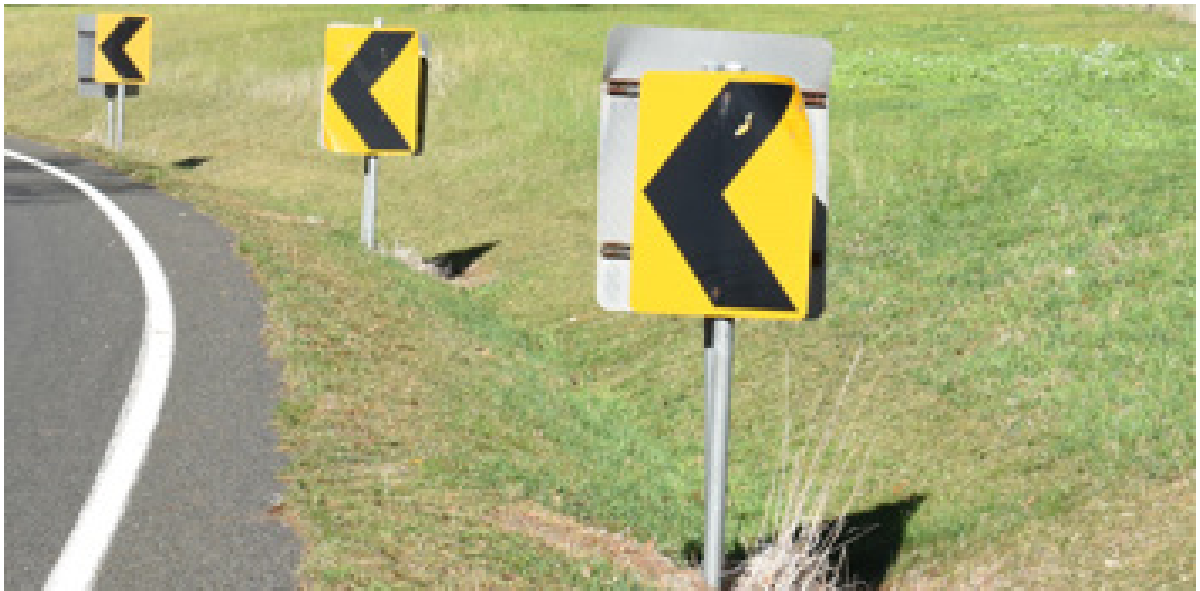
- Curve Alignment Marker (CAM) signs
- Road safety barriers
- Underrun protection on barriers
- Barrier end terminals

Figure 3-2 Curve Alignment Marker (CAM) Signs

Figure 3-2, Figure 3-3, Figure 3-4 and Figure 3-5 show examples of these Project components.

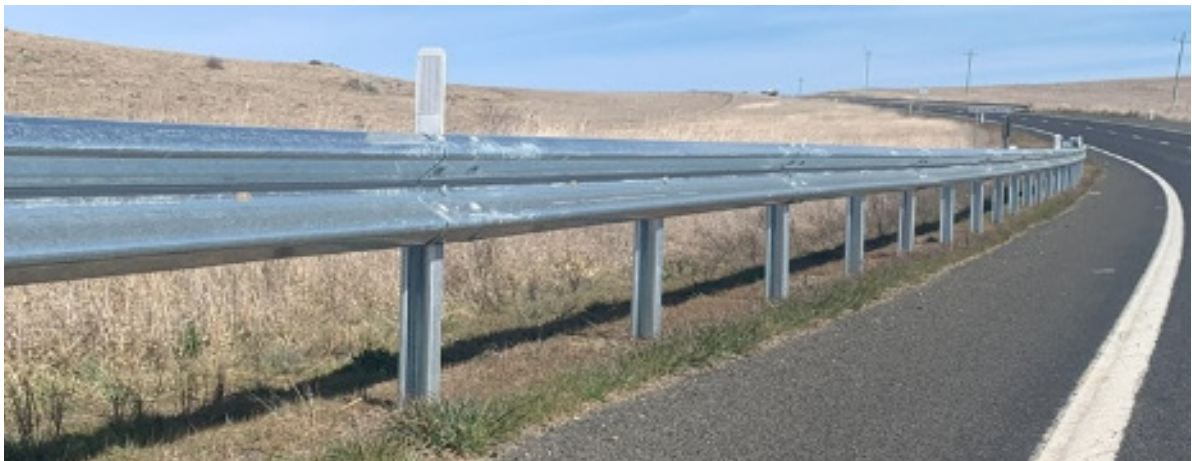
Figure 3-3 Road Barrier

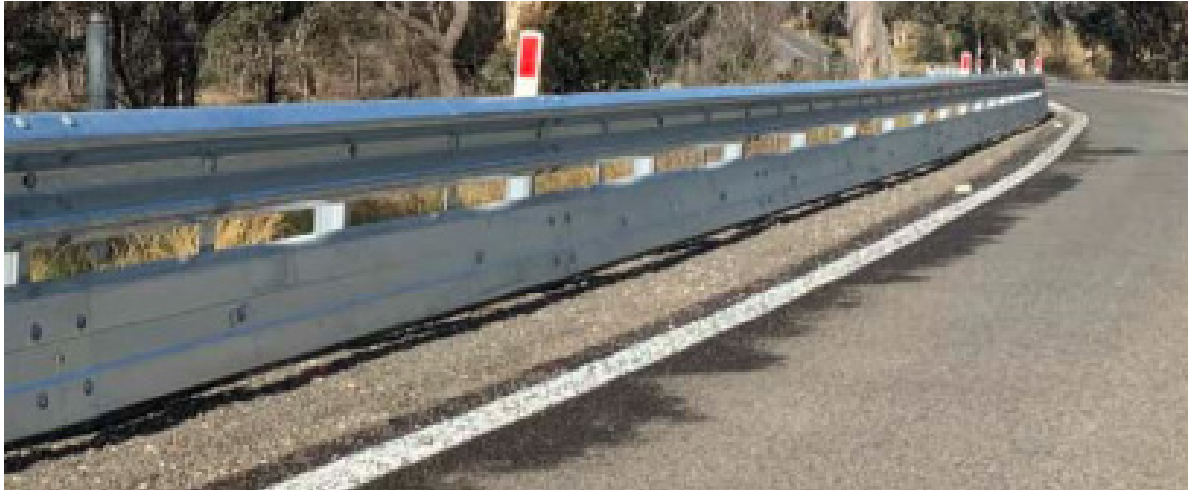
Figure 3-4 Road Barrier with Underrun Protection

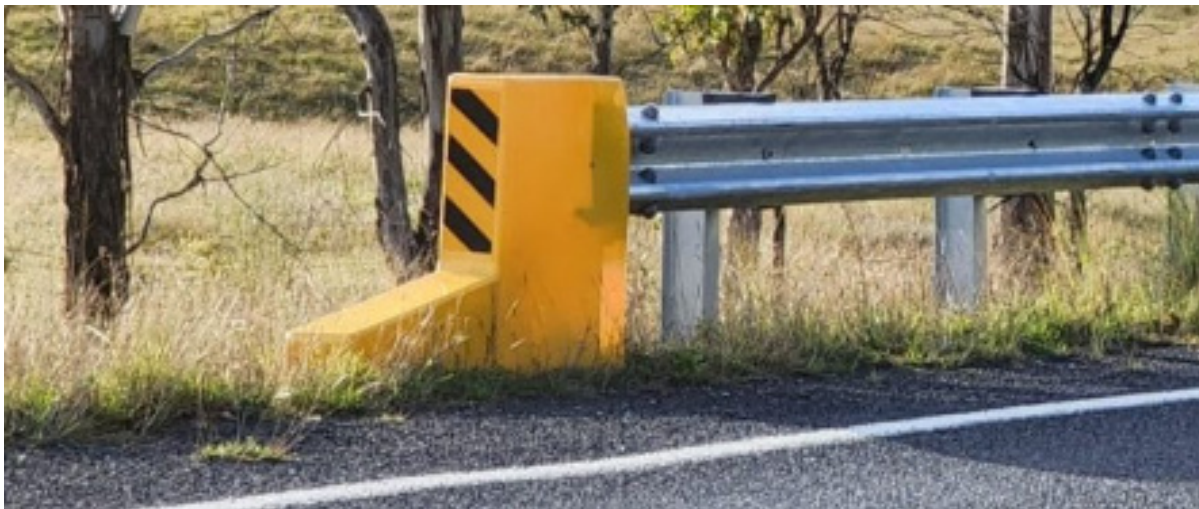
Figure 3-5 End Terminal on Road Barrier

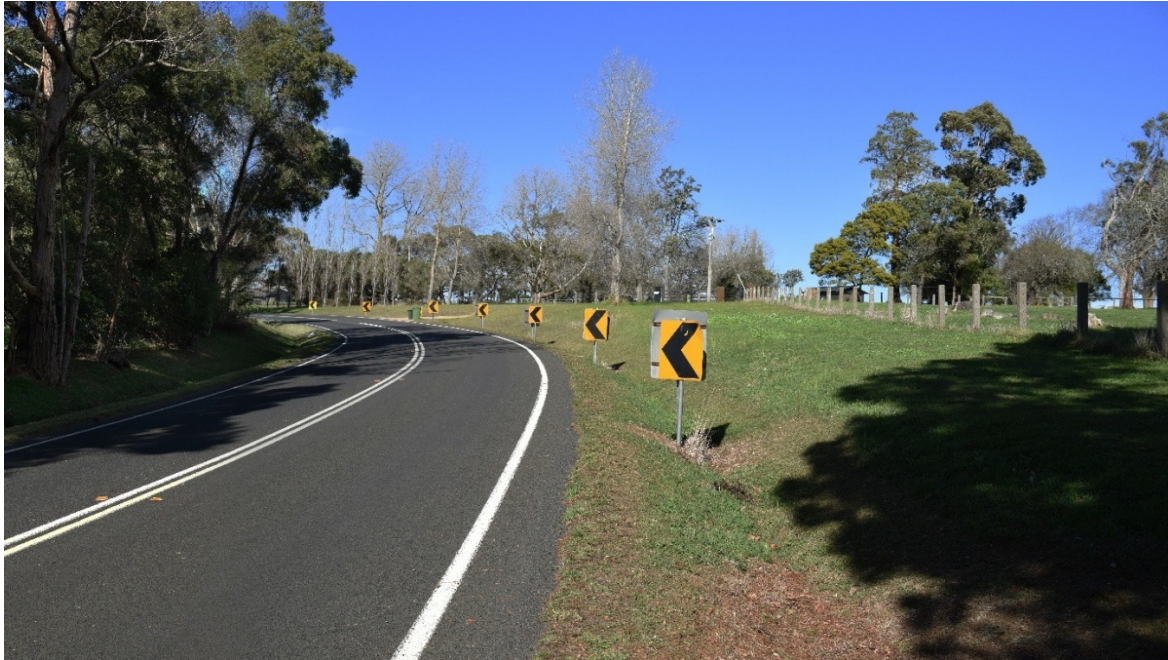
Viewpoint A is located on Baldrys Road within an area of agricultural landscape character. The view is dominated by a curved asphalt carriageway lined with multiple CAM signs. The view from the road is framed by dense clumps of native vegetation with tall eucalypts and formal, managed tree lines from private properties. Figure 5-1 shows the existing view from Baldrys Road #1.

Figure 5-1 Existing view from Baldrys Road

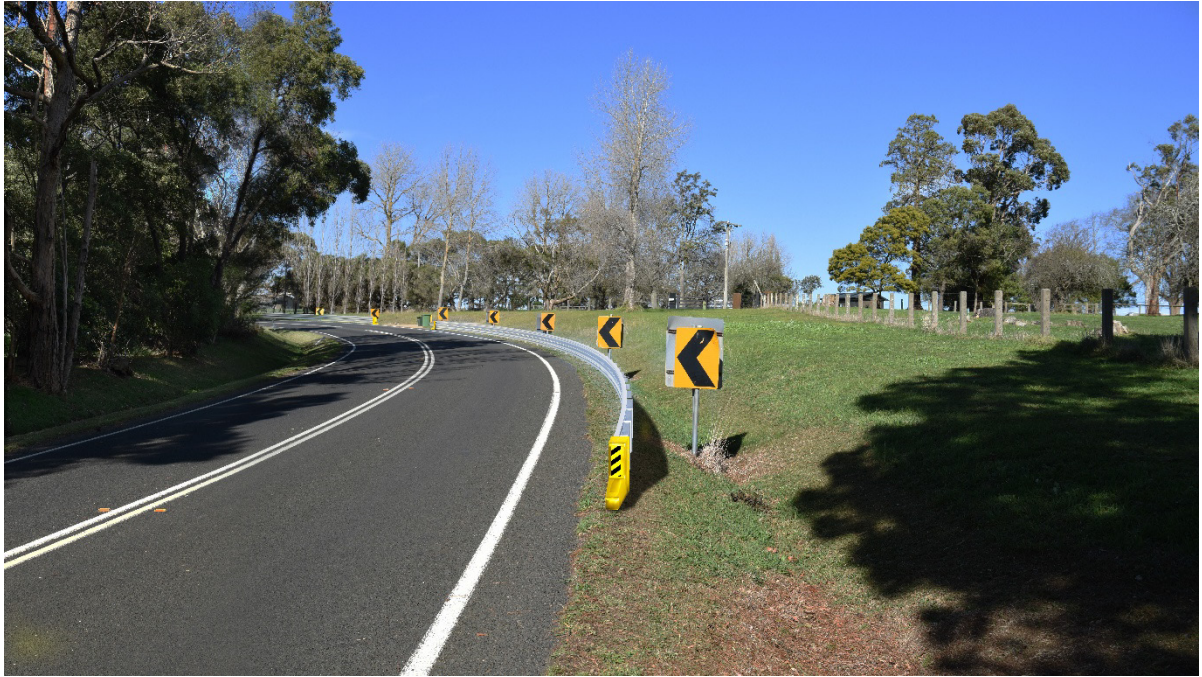
The proposed works include the installation of new road safety barriers with underrun protection, as well as the replacement of existing CAM signs along the curved outer shoulder of the road verge. Figure 5-2 shows an Artist Impression from Viewpoint A.

Figure 5-2 Viewpoint A Artist's impression

The **magnitude** of change is **low** as the CAM signs are existing. The road and surrounding agricultural landscape have capacity to absorb new road infrastructure additions without significant disruption.

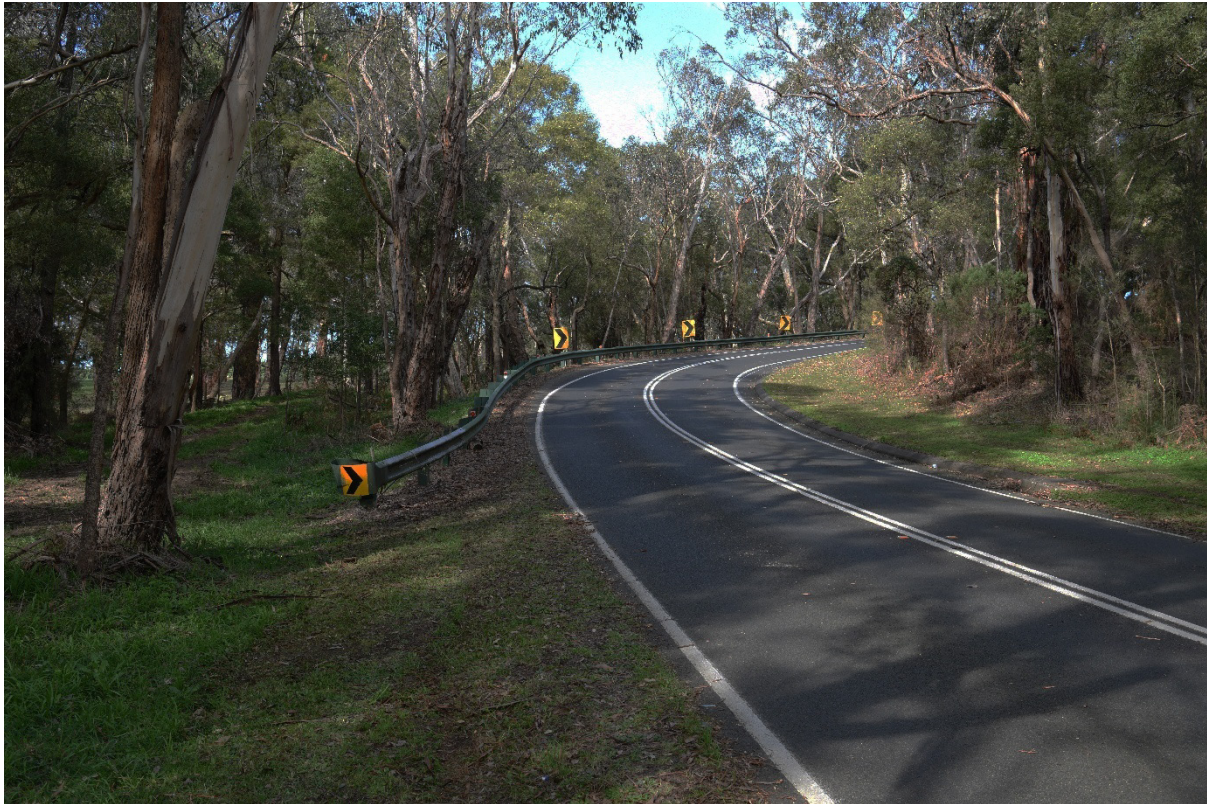
Viewpoint B is located on a section of the local rural road surrounded by a forested landscape. The view is dominated by the asphalt carriageway with road markings and signage. The view from the road is framed by dense native vegetation including grasses and tall eucalypts on both sides. Figure 5-3 shows the existing view from Viewpoint B.

Figure 5-3 Existing view from Baldrys Road

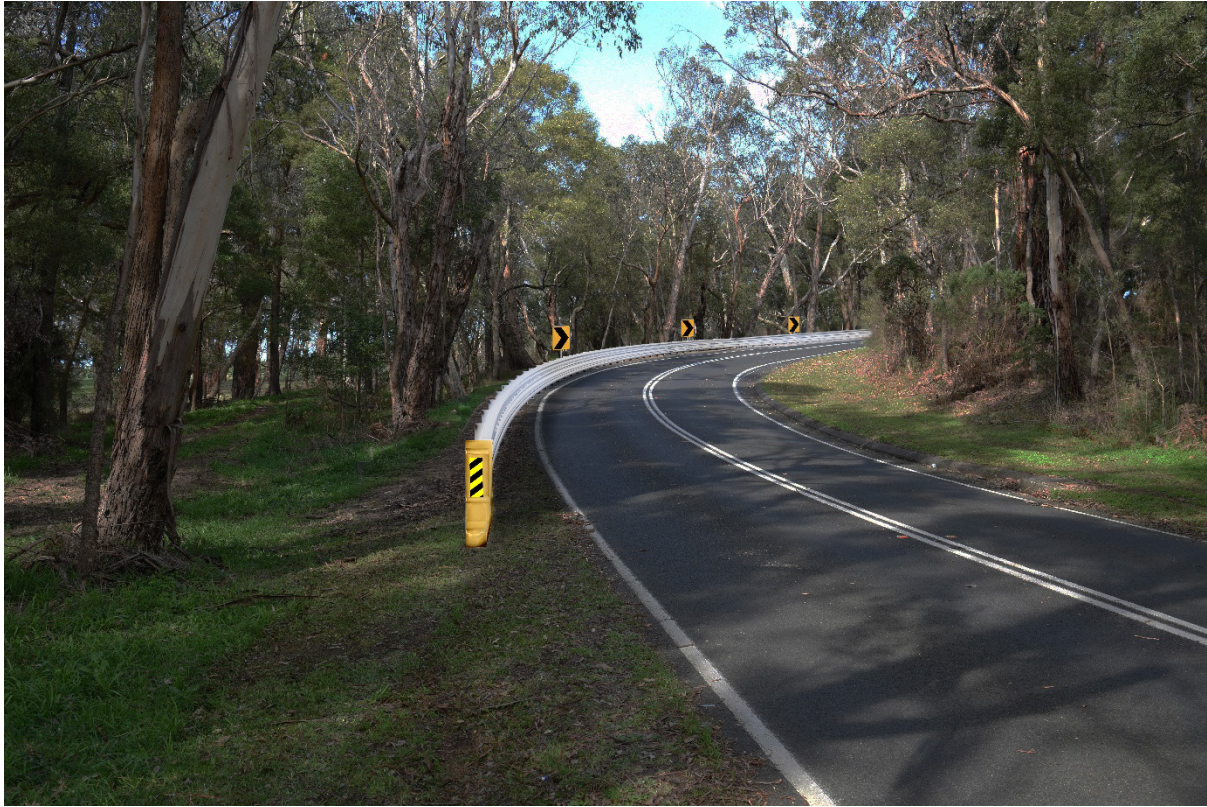
The proposed works include the replacement of the existing road barrier with a new barrier with underrun protection. Figure 5-4 shows an Artist Impression from Viewpoint B.

Figure 5-4 Viewpoint B Artist's impression

The **magnitude** of change is **low** as the Project replaces the existing CAM signs, and the new road safety barrier replaces an existing road safety barrier. The Project involves minor additions and is aligned with the existing road infrastructure.

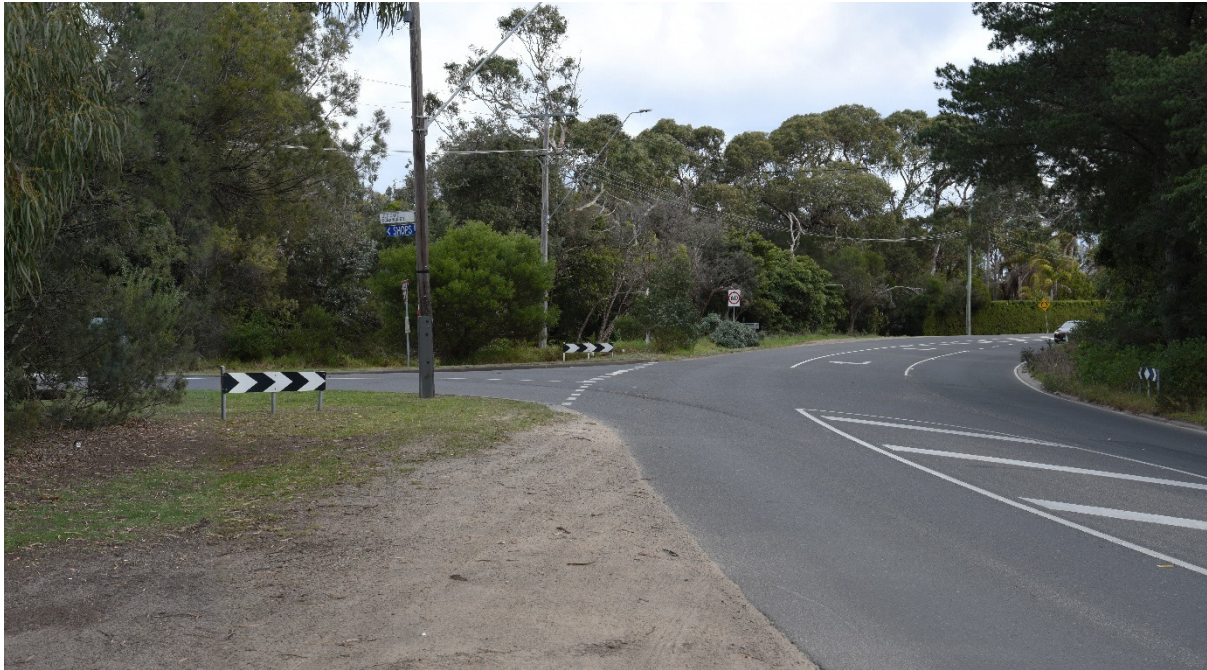
Viewpoint C shows a local road corridor in a residential landscape. The view is dominated by a curved asphalt carriageway with road markings, chevron boards and directional signage guiding traffic through the bend. Native vegetation creates a dense natural backdrop and vegetated screening. Figure 5-5 shows the existing view from Viewpoint C.

Figure 5-5 Existing view from Bayview Road

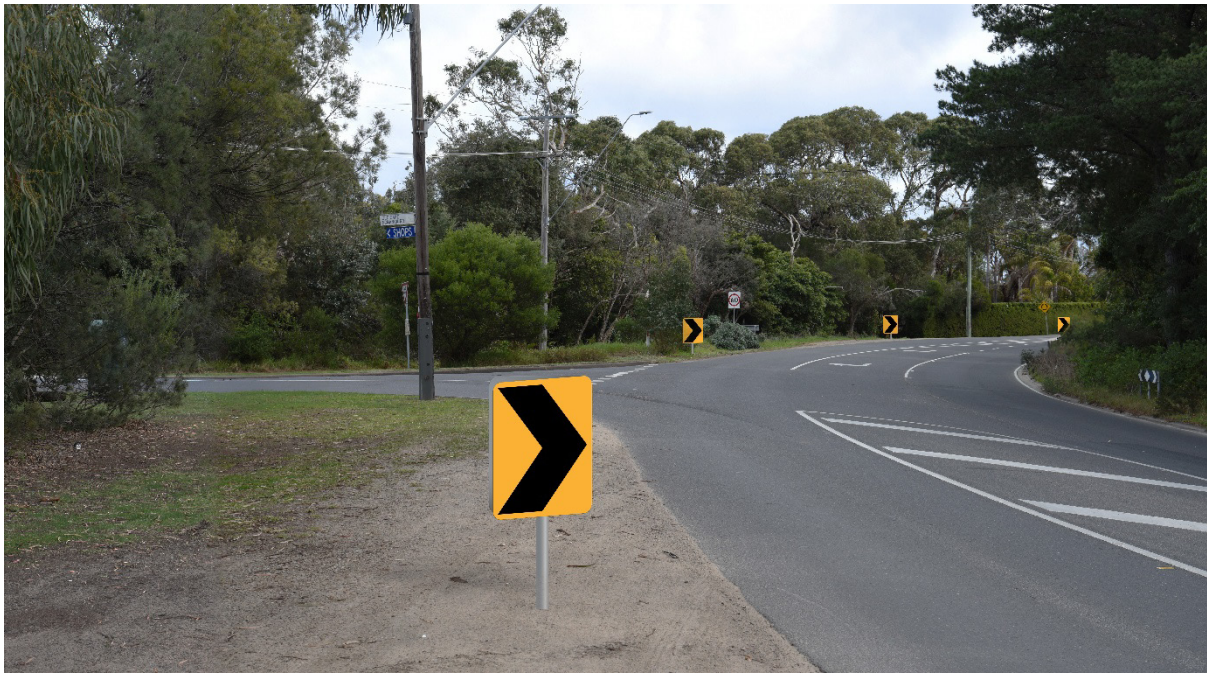
The proposed works include the installation of CAM signs to replace the existing chevron signs. Figure 5-6 shows an Artist Impression from Viewpoint C.

Figure 5-6 Viewpoint C Artist's impression

Although the proposed CAM signs would be a more visually prominent, the proposed upgrades overall would have minimal effect on the viewer's experience. The landscape character would remain visually consistent with the existing character. Therefore, the overall visual impact rating for this site is **low**.

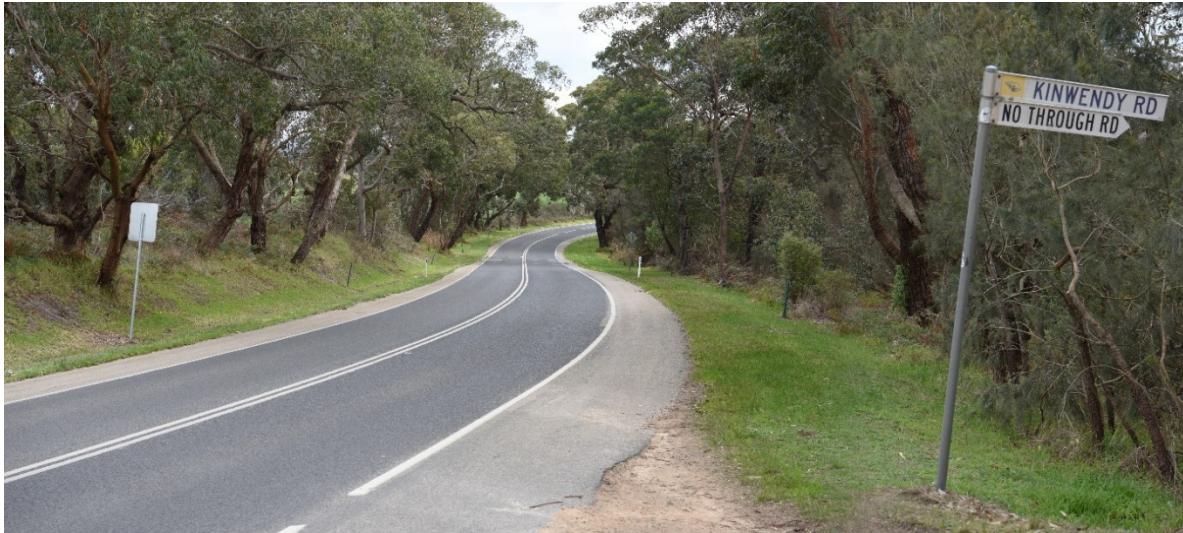
Viewpoint D shows a narrow sealed road curving through a forested landscape. The view is characterised by the asphalt carriageway with road markings and some signage. Native vegetation flanks both sides of the road and screens distant views across the landscape. Figure 5-7 shows the existing view from Viewpoint D.

Figure 5-7 Existing view from Browns Road

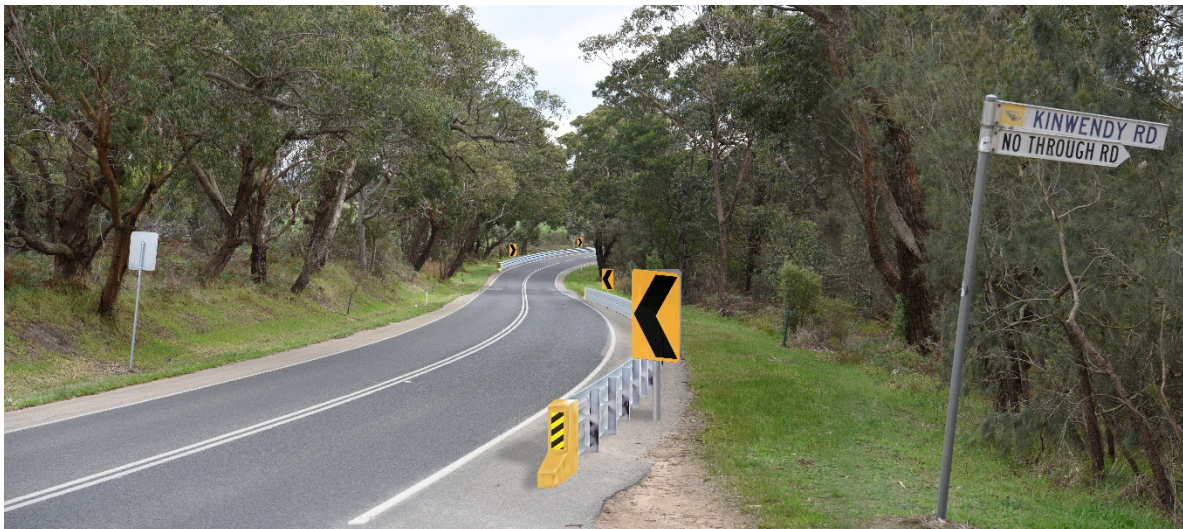
The proposed works include the installation of CAM signs and a new road safety barrier with underrun protection. Figure 5-8 shows an Artist Impression from Viewpoint D.

Figure 5-8 Viewpoint D Artist's impression

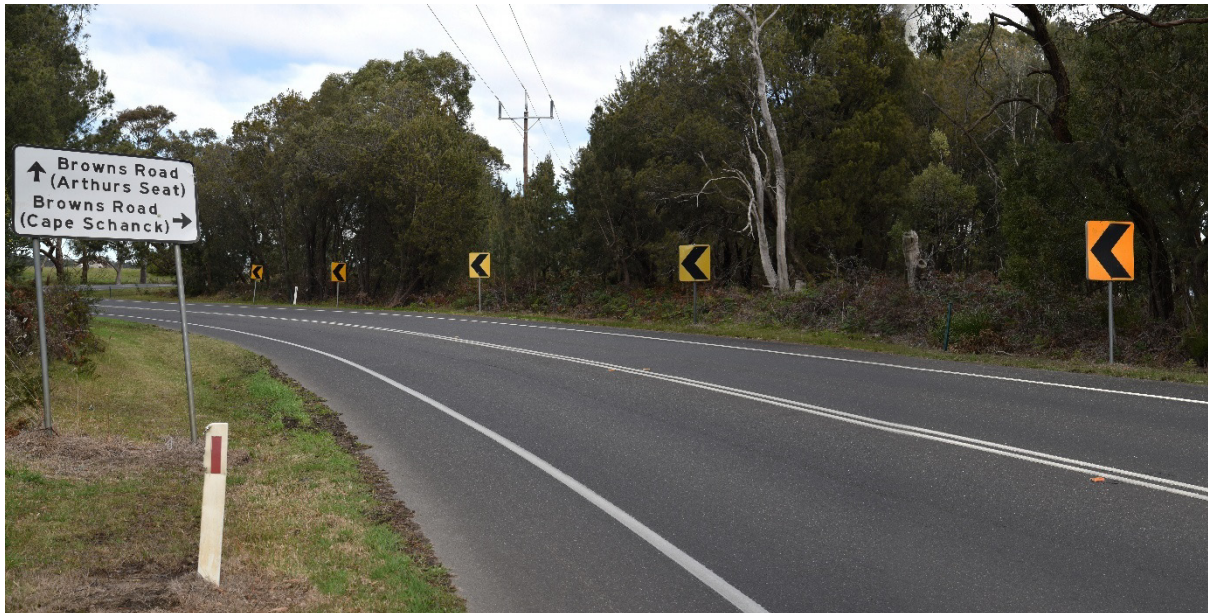
Viewpoint E shows a sealed two-lane road curving through a semi-rural landscape setting. The view is characterised by the asphalt carriageway with road markings and directional signage. Native vegetation flanks both sides of the road and screens distant views across the landscape. Overhead powerlines run perpendicular to the road, adding a linear infrastructure element. Figure 5-9 shows the existing view from Viewpoint E.

Figure 5-9 Existing view near Browns Road and Jetty Road intersection

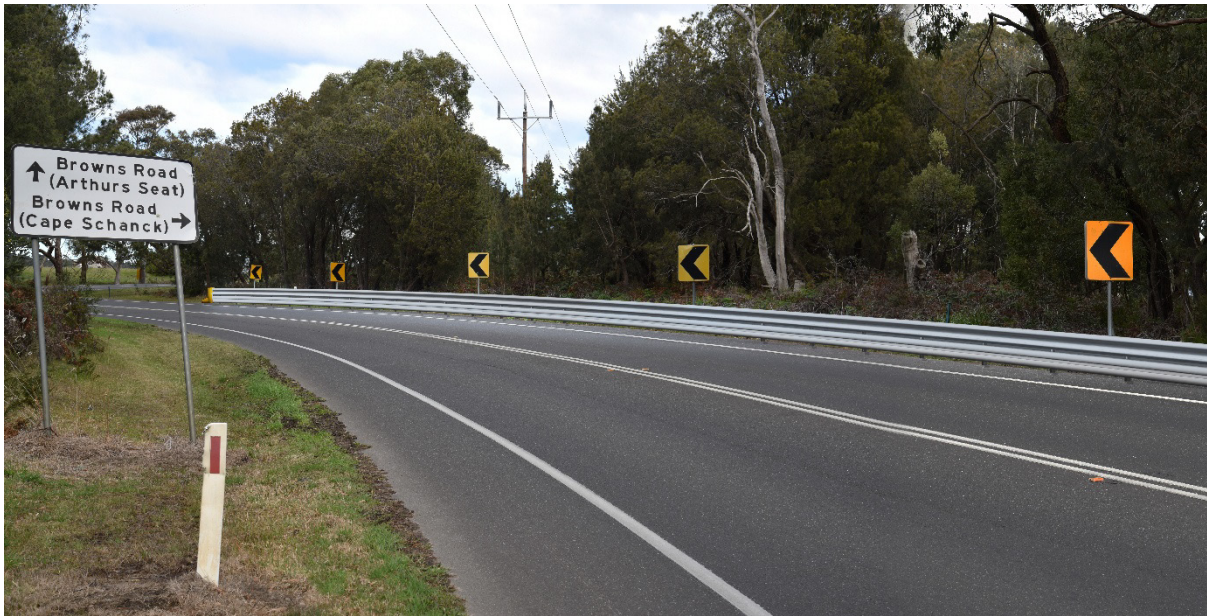
The proposed works include the installation of CAM signs and a new road safety barrier with underrun protection. Figure 5-10 shows an Artist Impression from Viewpoint E.

Figure 5-10 Viewpoint E Artist's impression

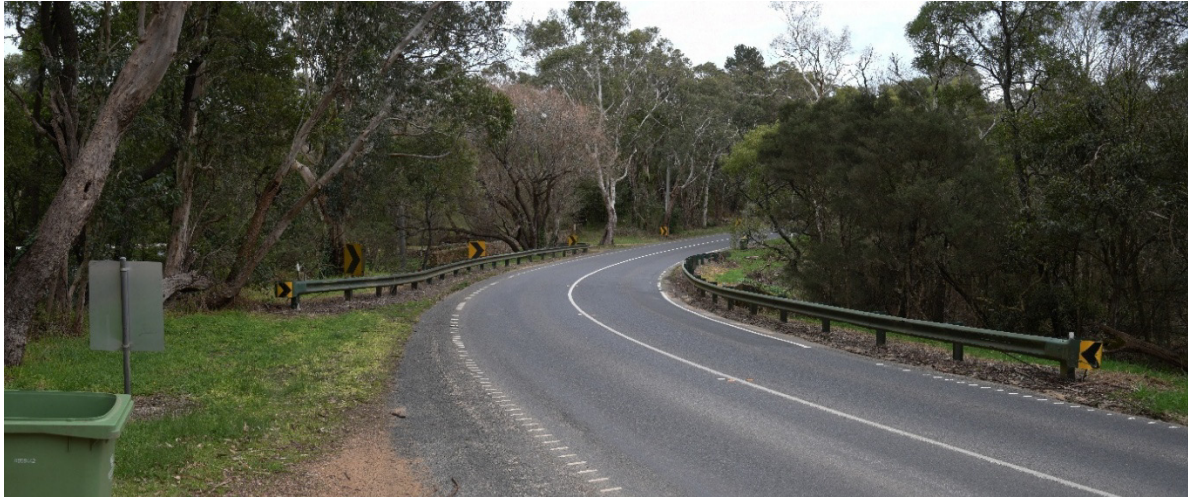
Viewpoint F shows sealed two-lane road curving through a rural residential landscape setting. The view is dominated by the asphalt carriageway with road markings and existing road safety barriers and directional signage. Residential bins, fences and driveways can be seen adjacent to the road. Native vegetation flanks both sides of the road and screens distant views. Figure 5-11 shows the existing view from Viewpoint F.

Figure 5-11 Existing view from Main Creek Road

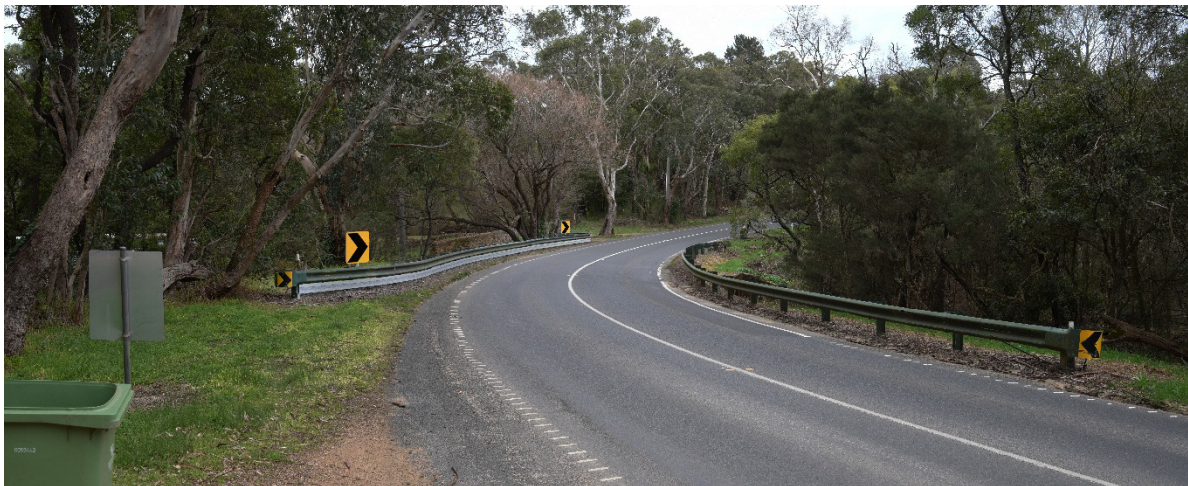
The proposed works include the replacement of CAM signs and adding underrun protection to an existing road safety barrier on the outer curve of the road. Figure 5-12.

Figure 5-12 Viewpoint F Artist's impression

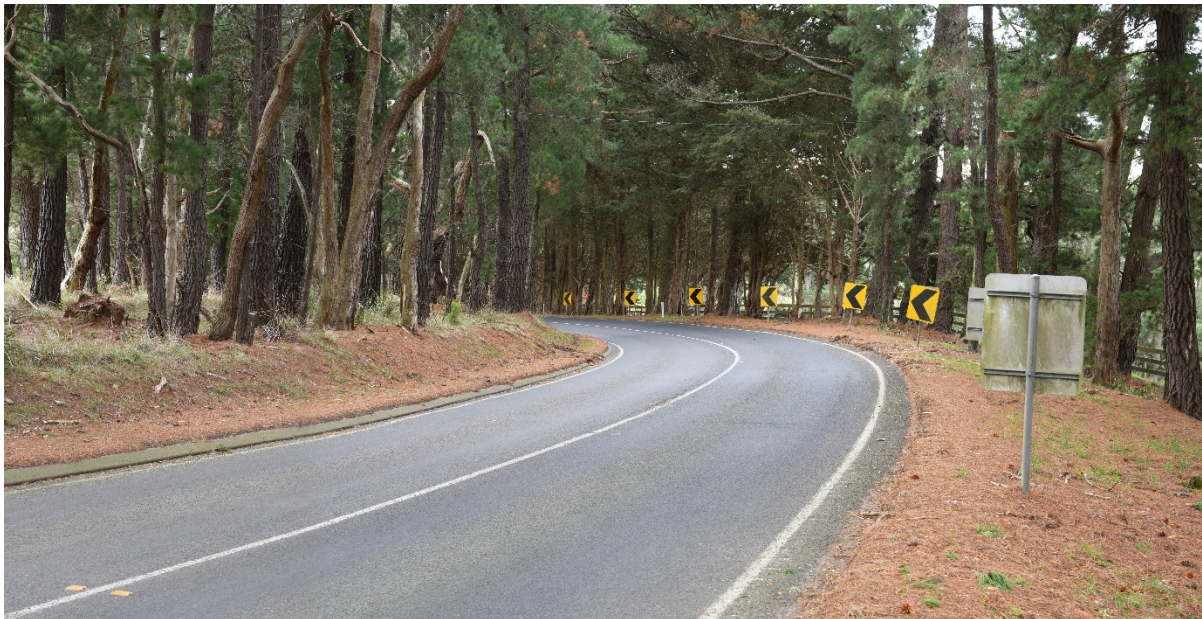
Viewpoint G shows sealed two-lane road curving through a forested landscape setting. While, the view is dominated by the asphalt carriageway, the dense vegetation that flanks both sides of the road inhibits views across the landscape. Figure 5-13 shows the existing view from Viewpoint G.

Figure 5-13 Existing view from Main Creek Road

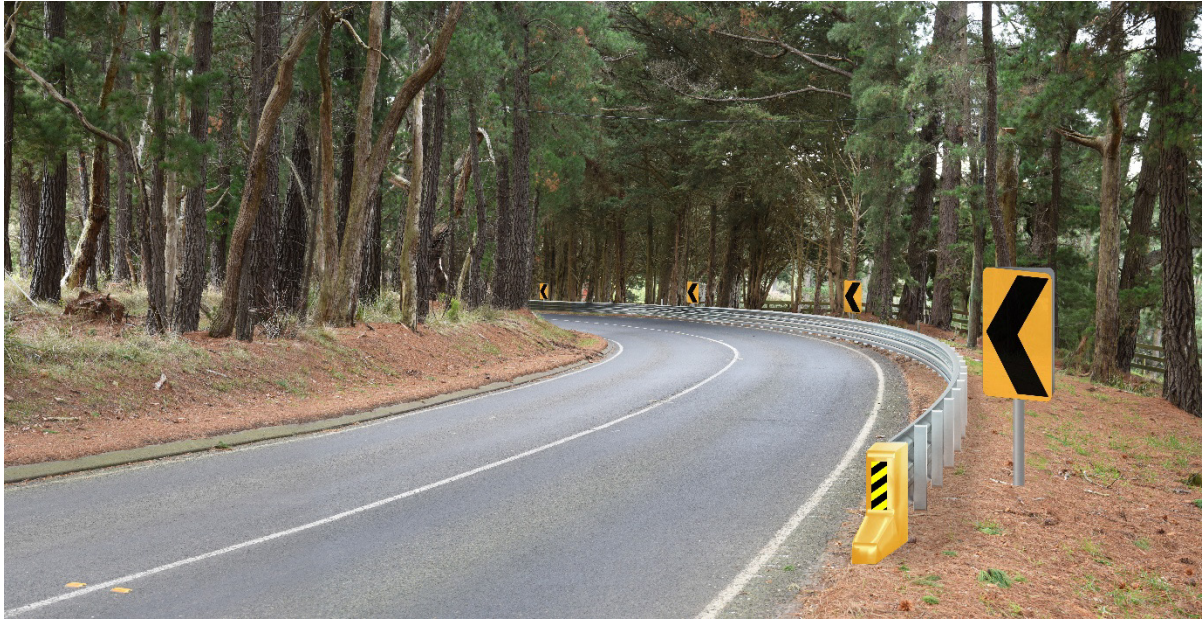
The proposed works include the replacement of CAM signs and a new road safety barrier with underrun protection along the outer curve of the road. Figure 5-14 shows an Artist Impression from Viewpoint G.

Figure 5-14 Viewpoint G Artist's impression

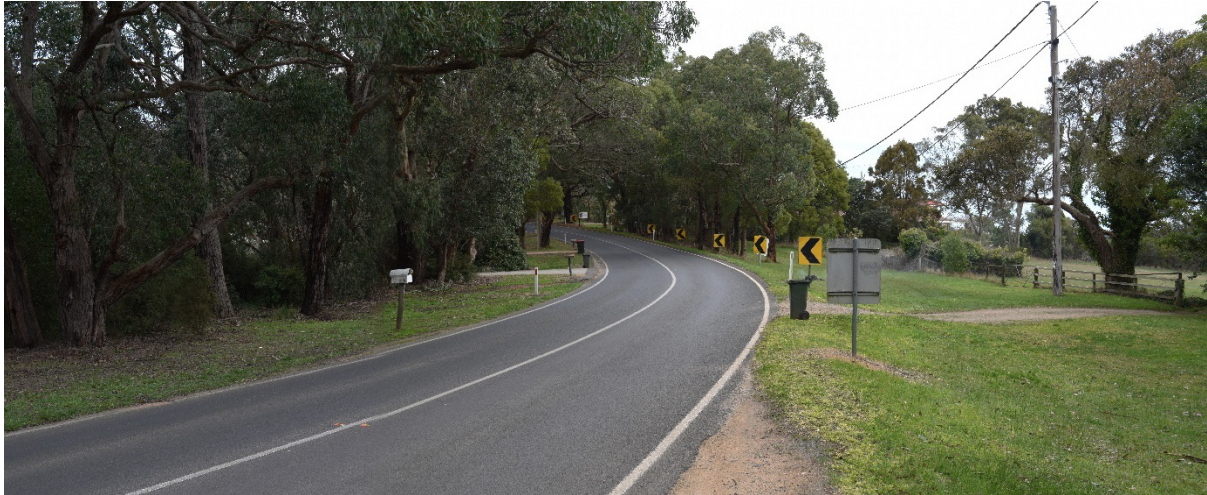
Viewpoint H shows sealed two-lane road curving through a rural residential landscape setting. Several driveways, post boxes and bins can be seen along the road. Vegetation that on both sides of the road mitigate the view with a natural backdrop and screening. Overhead powerlines and pole run parallel to the road, adding a linear infrastructure element. See Figure 5-15 shows the existing view from Viewpoint H.

Figure 5-15 Existing view from Main Creek Road

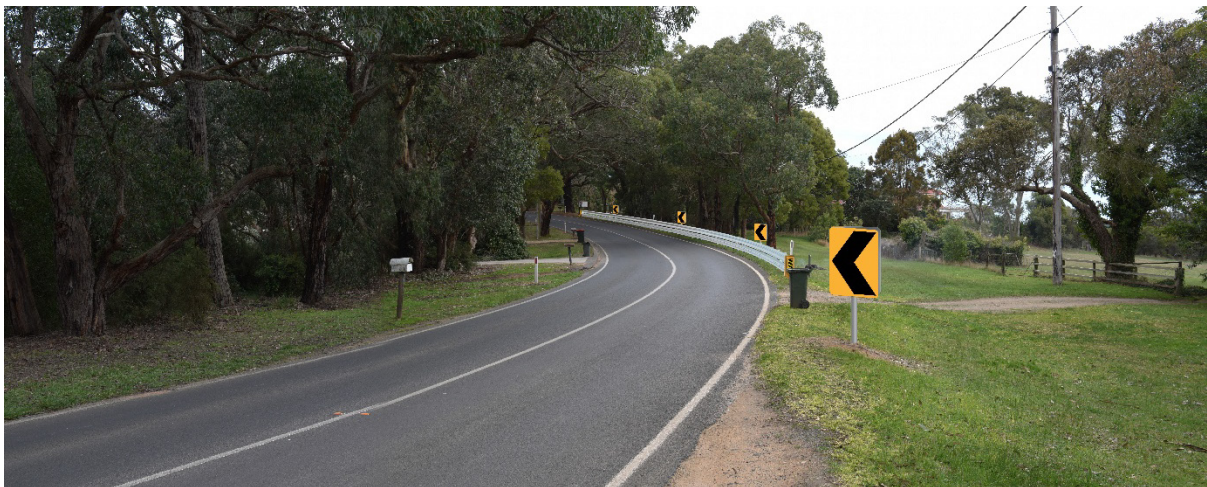
The proposed works include the installation of CAM signs and a new road safety barrier with underrun protection along the outer curve of the road. Figure 5-16 shows an Artist Impression from Viewpoint H.

Figure 5-16 Viewpoint H Artist's impression

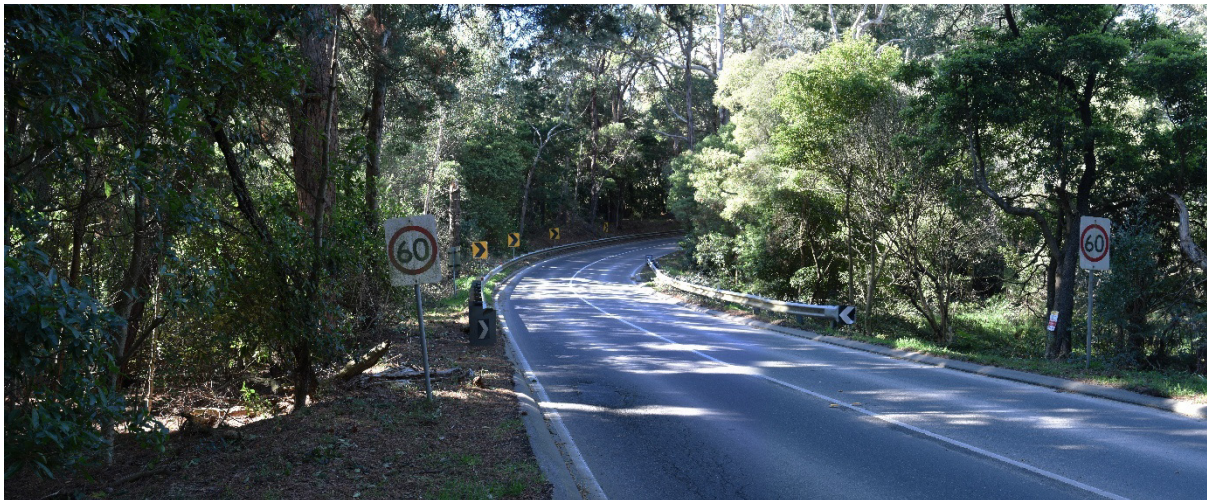
Viewpoint I shows sealed two-lane road curving through a forested landscape setting. While, the view is dominated by the asphalt carriageway, the dense vegetation that flanks both sides of the road partially mitigate the presence of road infrastructure with overshadowing. Figure 5-17 shows the existing view from Viewpoint I.

Figure 5-17 Existing view from Shands Road

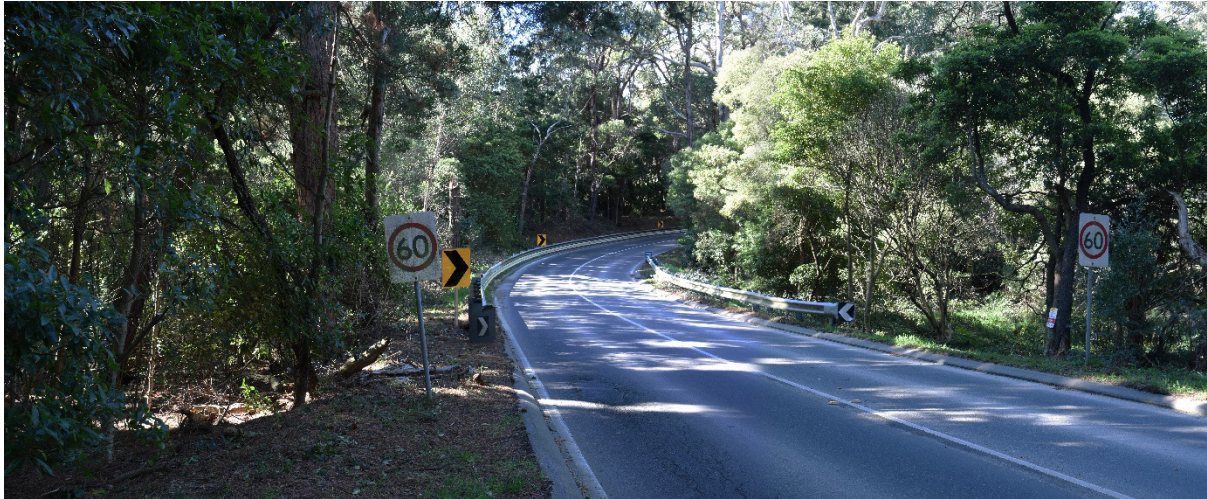
The proposed works include the replacement of existing CAM signs and the addition of underrun protection along the existing road safety barrier that is on the outer curve of the road. Figure 5-18 shows an Artist Impression from Viewpoint I.

Figure 5-18 Viewpoint I Artist's Impression

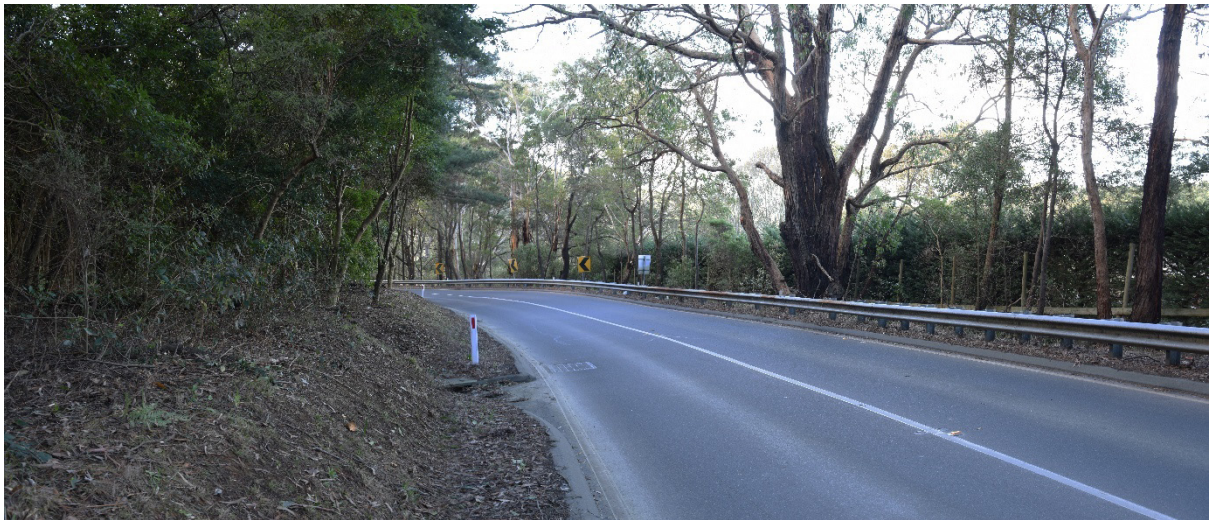
Viewpoint J shows sealed two-lane road curving through a rural residential landscape setting. The view from the road is framed by native vegetation with shrubs and eucalypts and formal, managed screening vegetation from private properties. Figure 5-19 shows the existing view from Viewpoint J.

Figure 5-19 Existing view from Shands Road

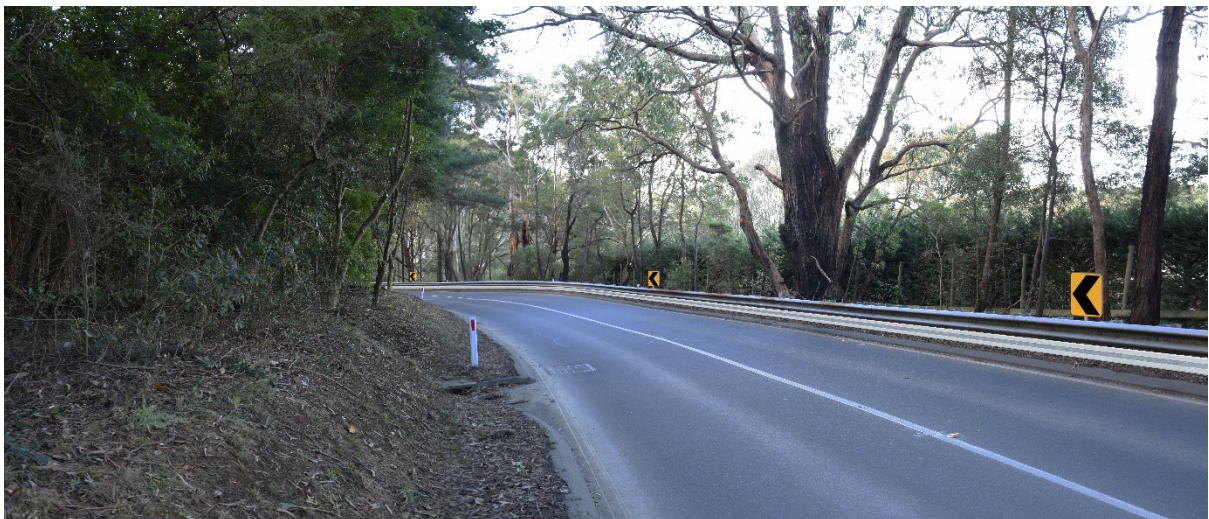
The proposed works include the replacement of existing CAM signs and the addition of underrun protection along the existing road safety barrier. Figure 5-20 shows an Artist Impression from Viewpoint J.

Figure 5-20 Viewpoint J Artist's impression

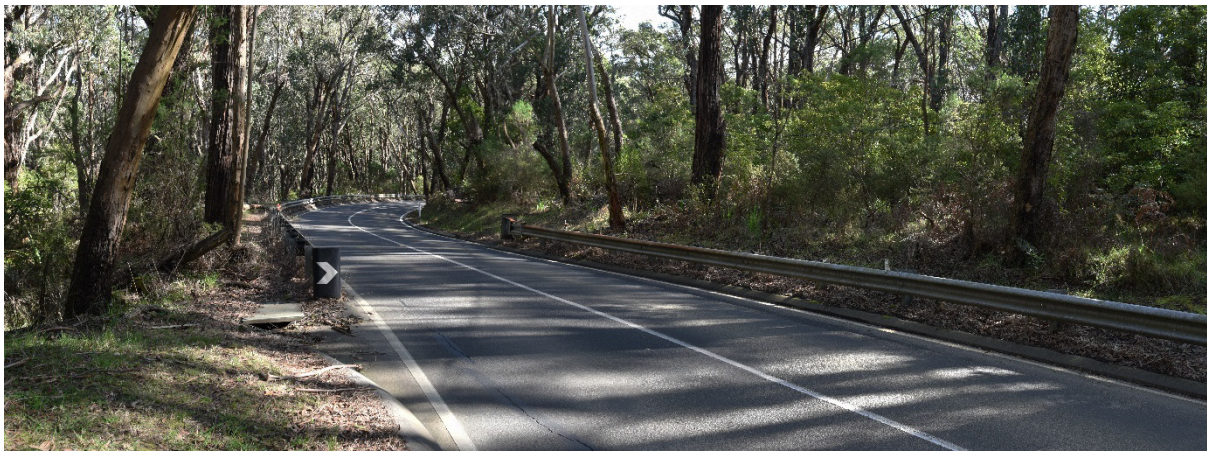
Viewpoint K shows sealed two-lane road curving through a forested landscape setting. While, the view is dominated by the asphalt carriageway, the dense vegetation that flanks both sides of the road mitigate the view with a natural backdrop and overshadowing. Figure 5-21 shows the existing view from Viewpoint K.

Figure 5-21 Existing view from Shands Road

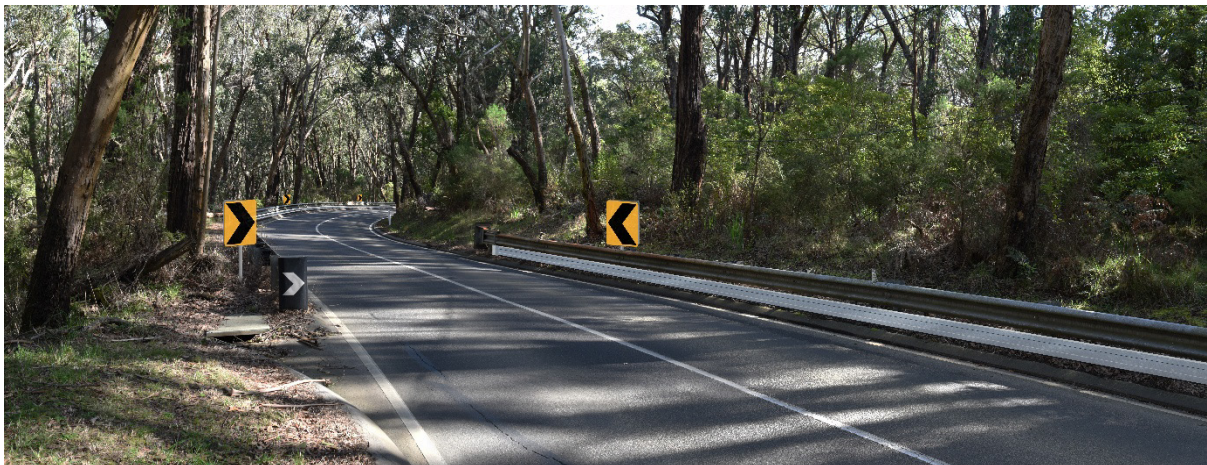
The proposed works include the replacement of existing CAM signs and the addition of underrun protection along the existing road safety barrier that is on the outer curve of the road. Figure 5-22 shows an Artist Impression from Viewpoint K.

Figure 5-22 Viewpoint K Artist's impression

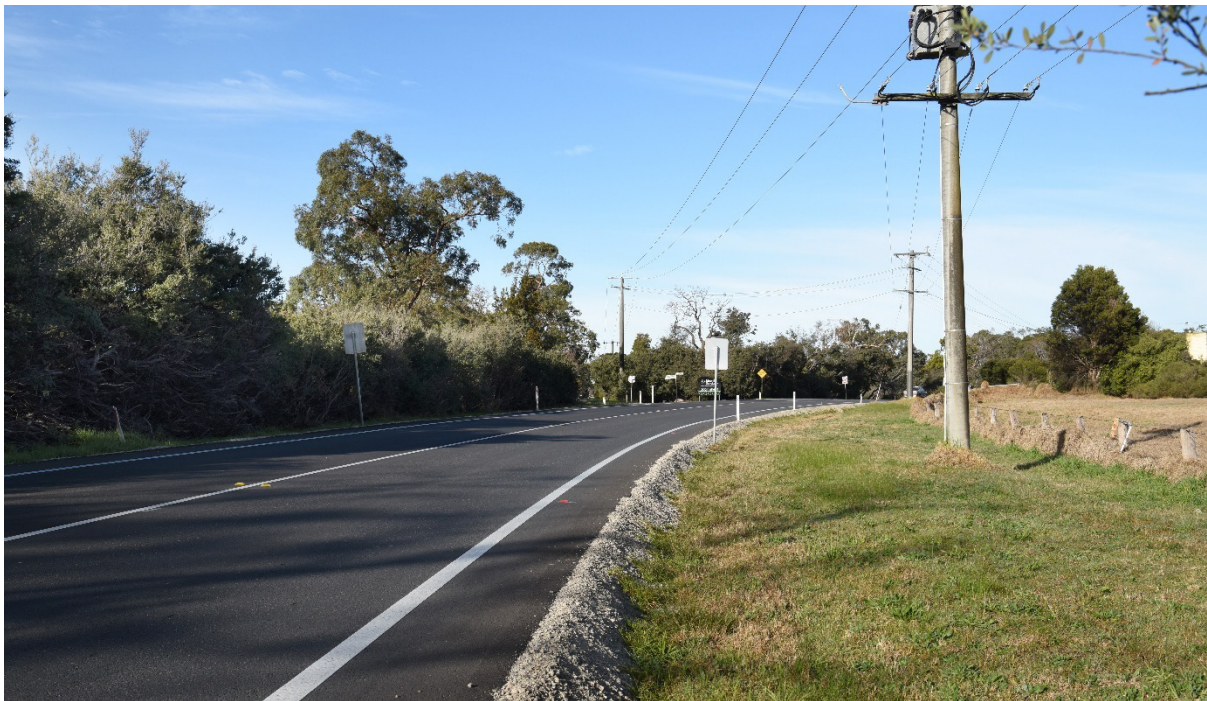
Viewpoint L shows a local road corridor in an agricultural and peri-urban landscape setting. The view is dominated by a curved asphalt carriageway with road markings and road signage. Native vegetation creates a dense natural backdrop and screens distant views. Overhead powerlines and pole run parallel to the road, adding a linear infrastructure element. Figure 5-23 shows the existing view from Viewpoint L.

Figure 5-23 Existing view from Tyabb-Tooradin Road

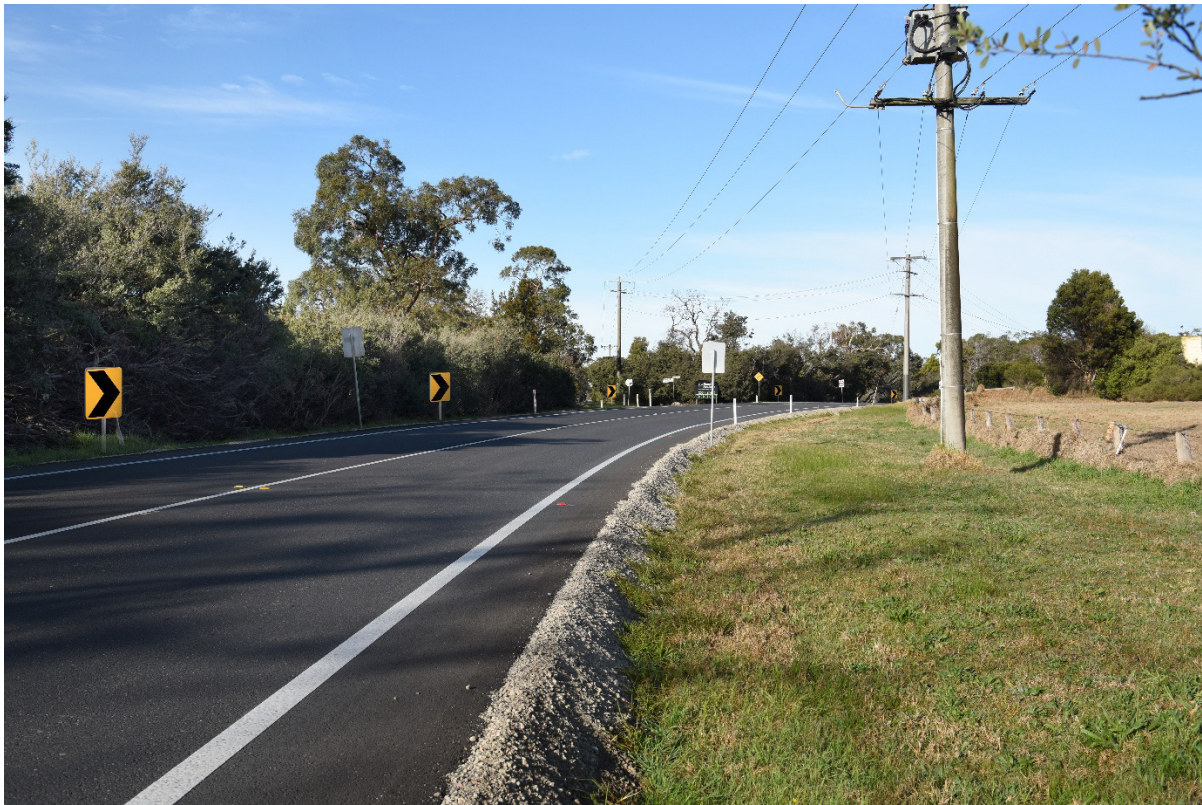
The proposed works include the addition of CAM signs along the outer curve of the road. Figure 5-24 shows an Artist Impression from Viewpoint L.

Figure 5-24 Viewpoint L Artist's impression

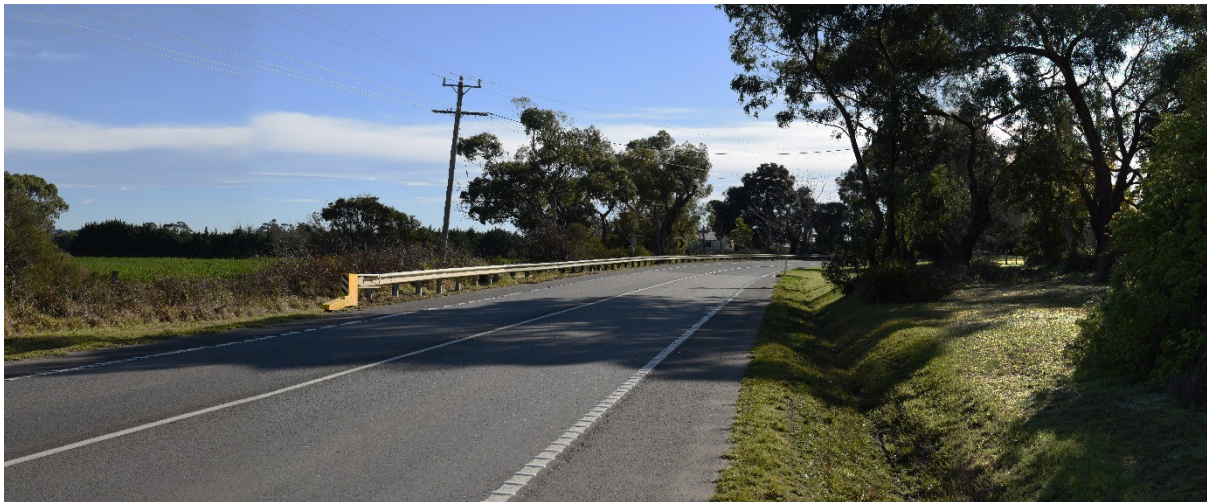
Viewpoint M shows a local road corridor in an agricultural and peri-urban landscape setting. The view is dominated by a wide asphalt carriageway with a road safety barrier. The verges to the side of the road have clumps of native vegetation that provides a natural backdrop and screens distant views. Overhead powerlines and a transmission pole run parallel to the road, adding a linear infrastructure element. Figure 5-25 shows the existing view from Viewpoint M.

Figure 5-25 Existing view from Tyabb-Tooradin Road
