Visual Impact Assessment

Motorcycle Safety Levy Projects

Mornington Peninsula Shire

15 September 2025

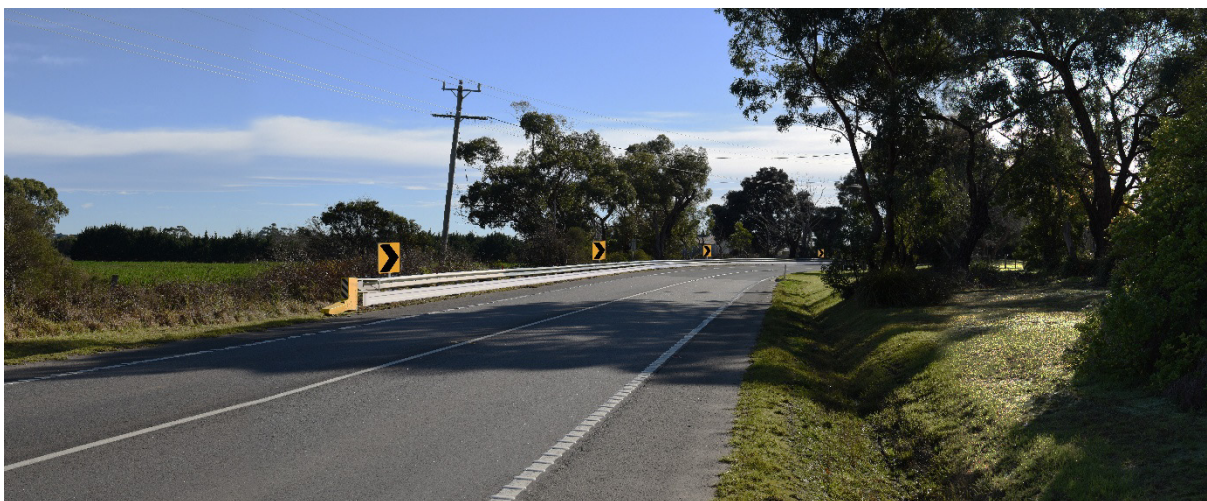
The proposed works include the installation of CAM signs and installation of underrun protection to the existing road safety barrier. Figure 5-26 shows an Artist Impression from Viewpoint M.

Figure 5-26 Viewpoint M Artist's impression

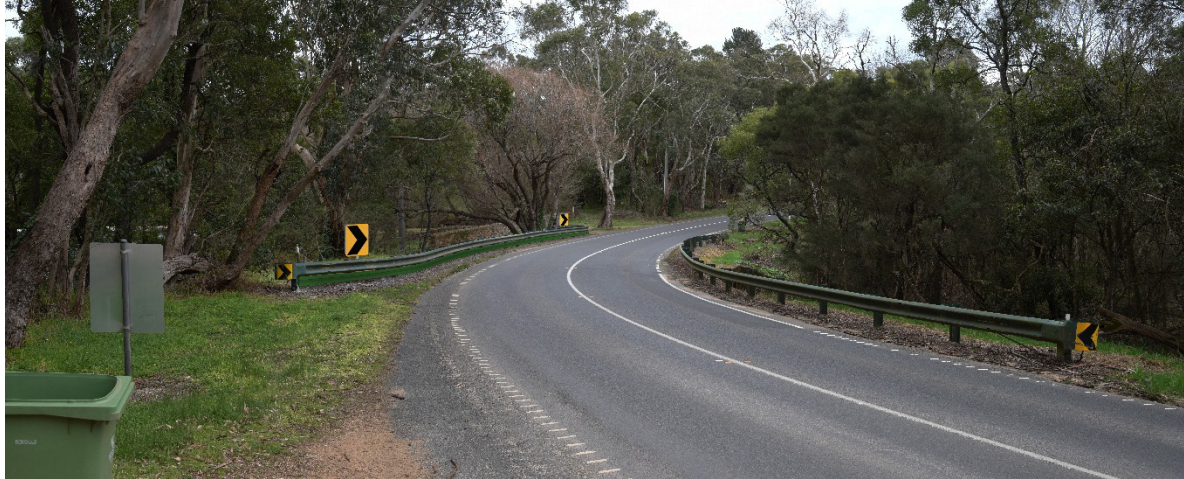
Figure 6-1 Viewpoint F artist's impression with green painted finish underrun protection

A comparative assessment was undertaken at Viewpoint F - Main Creek Road #1 and Viewpoint G - Main Creek Road #2 to evaluate the visual prominence of galvanised steel guardrails against green-painted finishes. Figure 6-1, Figure 6-2, Figure 6-3 and Figure 6-4 show a comparison between galvanised steel and green painted finishes.

While green may seem like a natural choice in vegetated settings, painted finishes often appear more artificial due to their flat, opaque, and uniform colour.

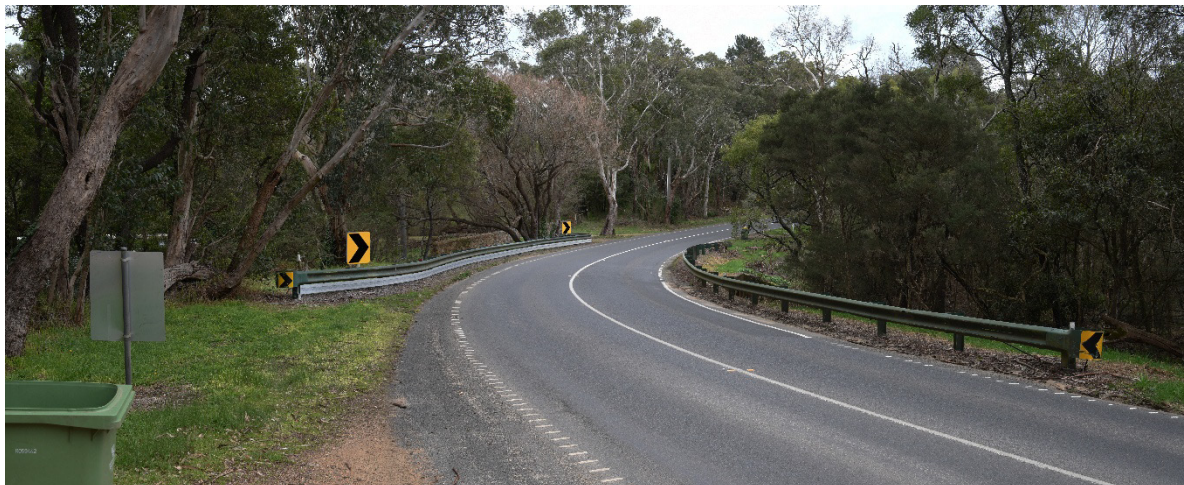
Figure 6-2 Viewpoint F artist's impression with galvanised zinc finish underrun protection

By comparison, galvanised steel initially appears reflective but weathers naturally over time to a matte grey patina. This neutral tone blends better with landscape elements like bark, soil, existing road surfaces and shadow. It also avoids clashing with seasonal vegetation changes and maintains a consistent, low-maintenance finish. Unlike green paint, it does not introduce unnatural contrast or require periodic recoating.

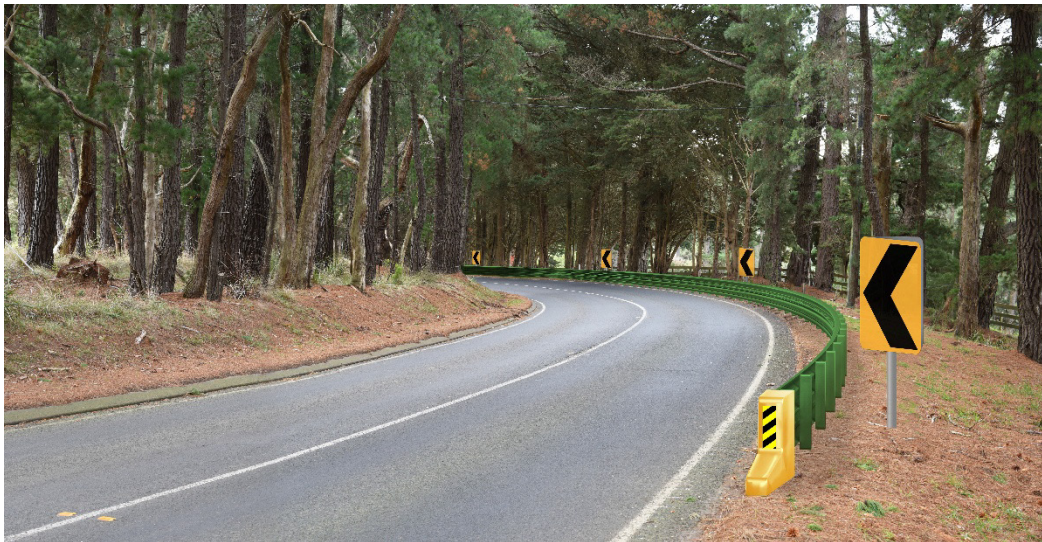
Figure 6-3 Viewpoint G artist's impression with green painted finish road safety barrier

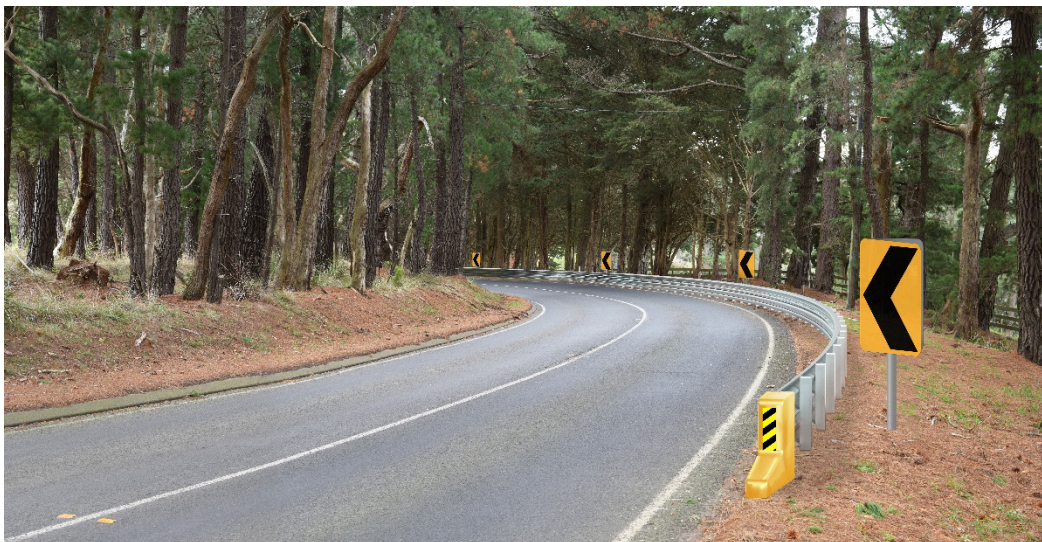
Figure 6-4 Viewpoint G artist's impression with galvanised zinc finish road safety barrier

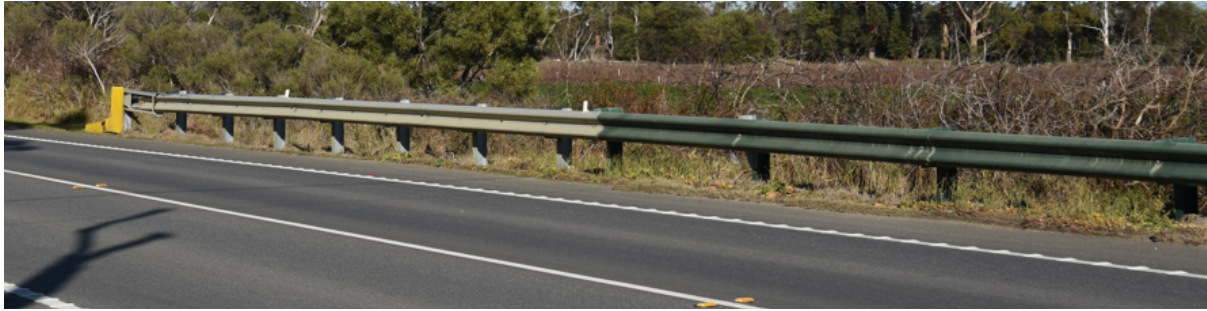
Viewpoint M – Tyabb-Tooradin Road #2 captures a view that illustrates the difference between a green painted and galvanised zinc finish road safety barrier in-situ. Figure 6-5 shows a view of a road safety barrier along Tyabb-Tooradin Road.

Figure 6-5 Road safety barrier along Tyabb-Tooradin Road
