Visual Impact Assessment

Motorcycle Safety Levy Projects

Mornington Peninsula Shire

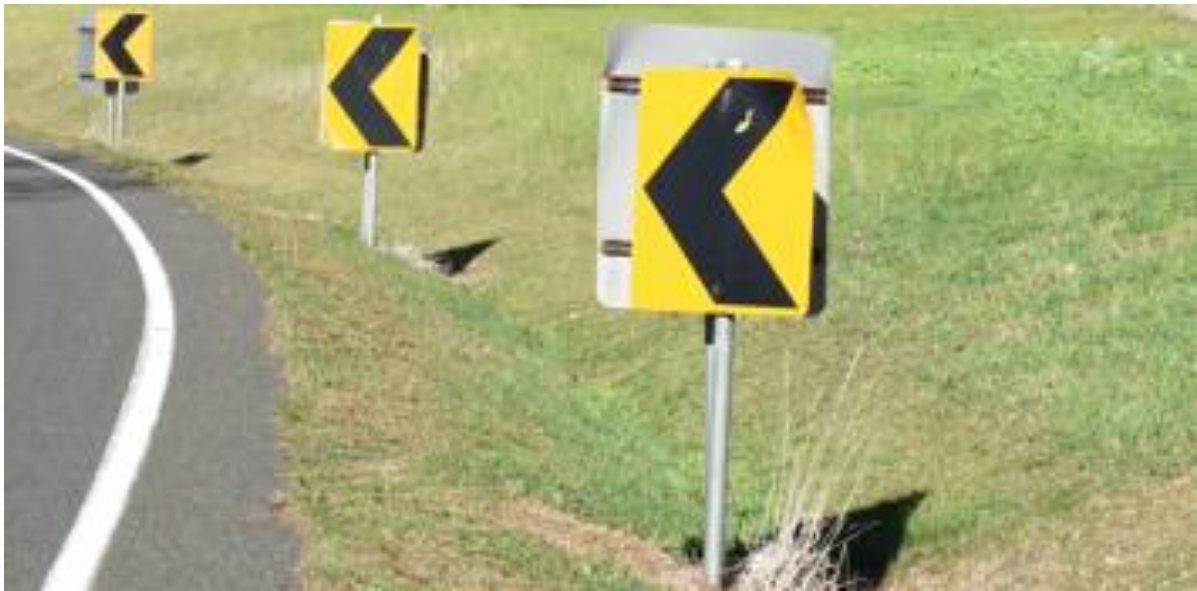
Figure 3-2 Curve Alignment Marker (CAM) Signs

- Curve Alignment Marker (CAM) signs
- Road safety barriers
- Underrun protection on barriers
- Barrier end terminals

Figure 3-2, Figure 3-3, Figure 3-4 and Figure 3-5 show examples of these Project components.

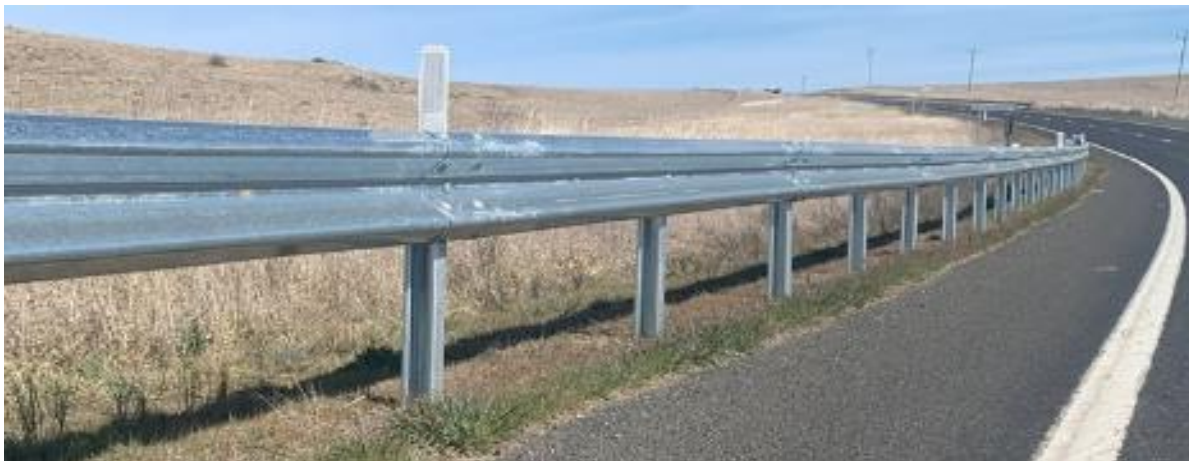
Figure 3-3 Road Barrier

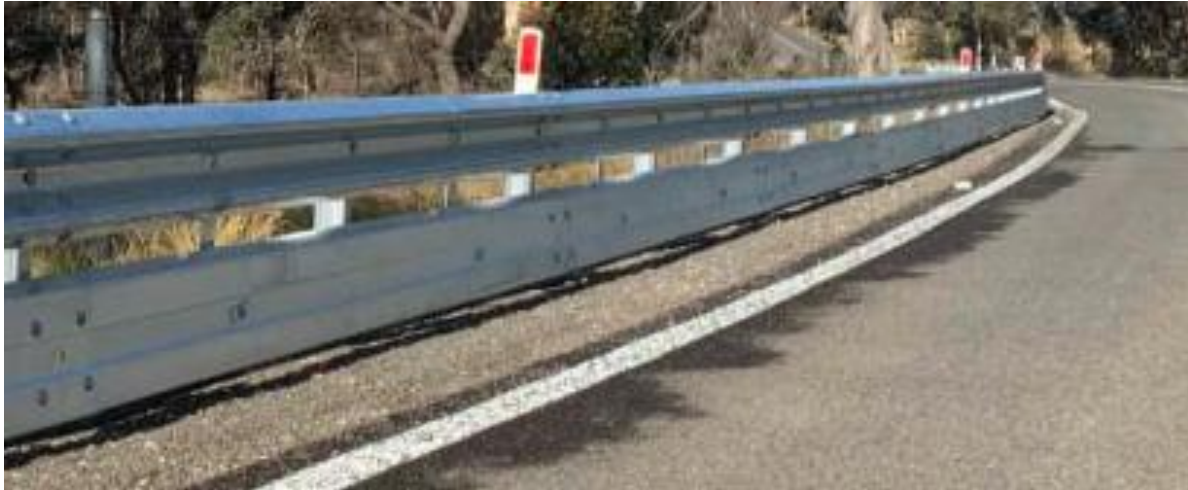
Figure 3-4 Road Barrier with Underrun Protection

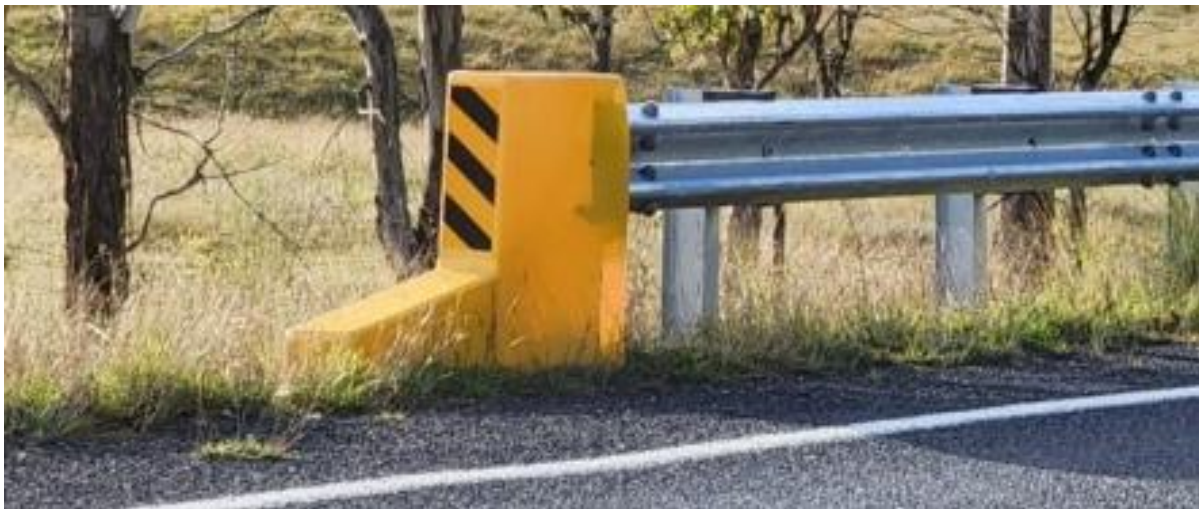
Figure 3-5 End Terminal on Road Barrier

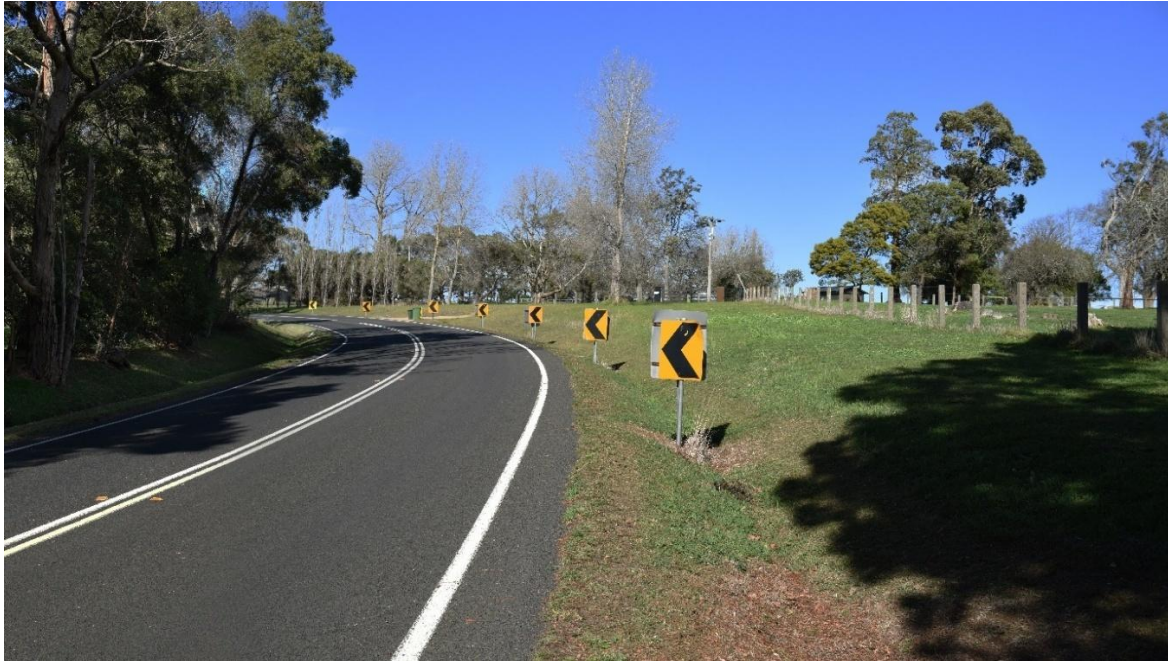
Viewpoint A is located on Baldrys Road within an area of agricultural landscape character. The view is dominated by a curved asphalt carriageway lined with multiple CAM signs. The view from the road is framed by dense clumps of native vegetation with tall eucalypts and formal, managed tree lines from private properties. Figure 6-2 shows the existing view from Baldrys Road #1.

Figure 6-2 Existing view from Baldrys Road

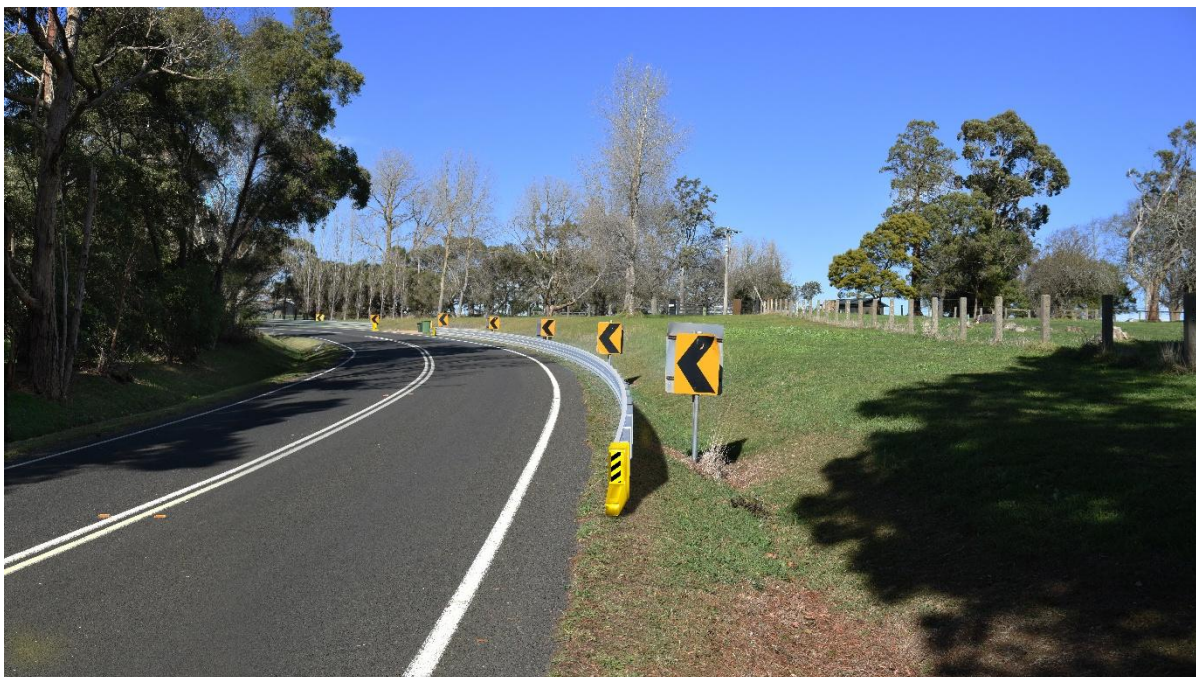
The proposed works include the installation of new road safety barriers with underrun protection, as well as the replacement of existing CAM signs along the curved outer shoulder of the road verge. Figure 6-3 shows an Artist Impression from Viewpoint A.

Figure 6-3 Viewpoint A Artist's impression

The **magnitude** of change is **low** as the CAM signs are existing. The road and surrounding agricultural landscape have capacity to absorb new road infrastructure additions without significant disruption.

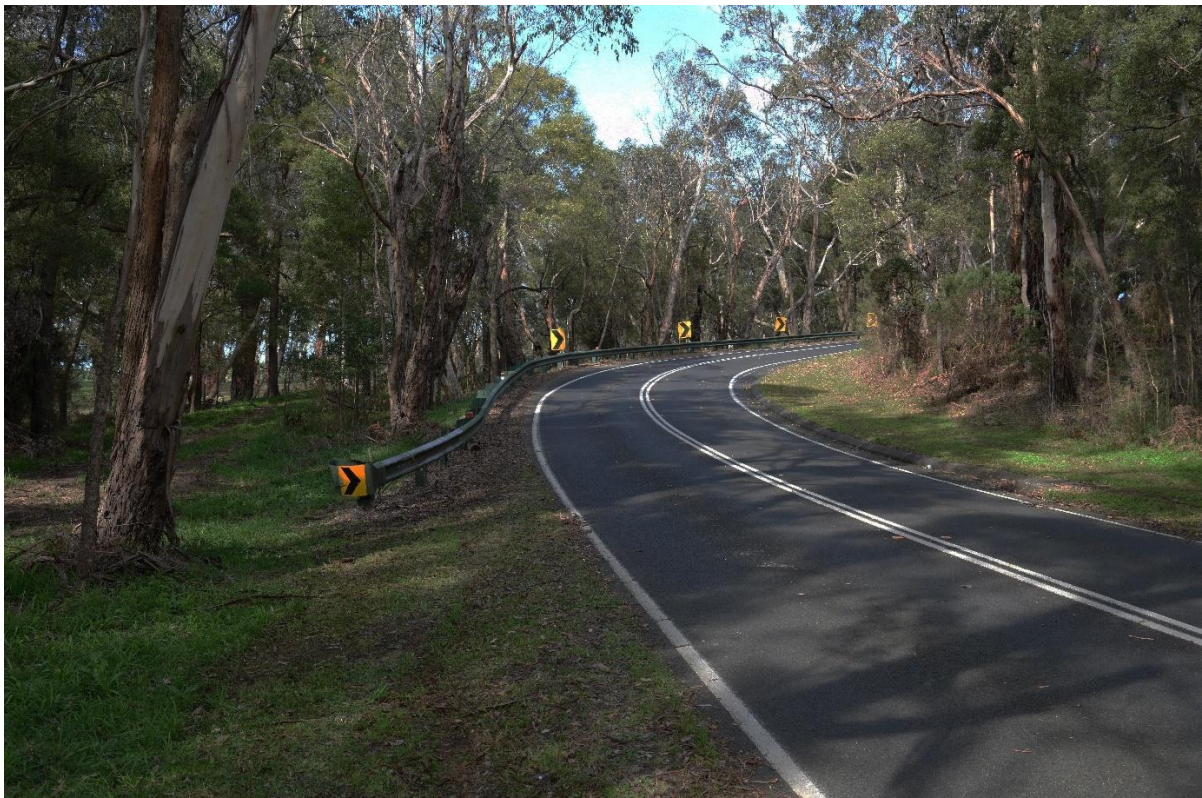
Viewpoint B is located on a section of the local rural road surrounded by a forested landscape. The view is dominated by the asphalt carriageway with road markings and signage. The view from the road is framed by dense native vegetation including grasses and tall eucalypts on both sides. Figure 6-4 shows the existing view from Viewpoint B.

Figure 6-4 Existing view from Baldrys Road

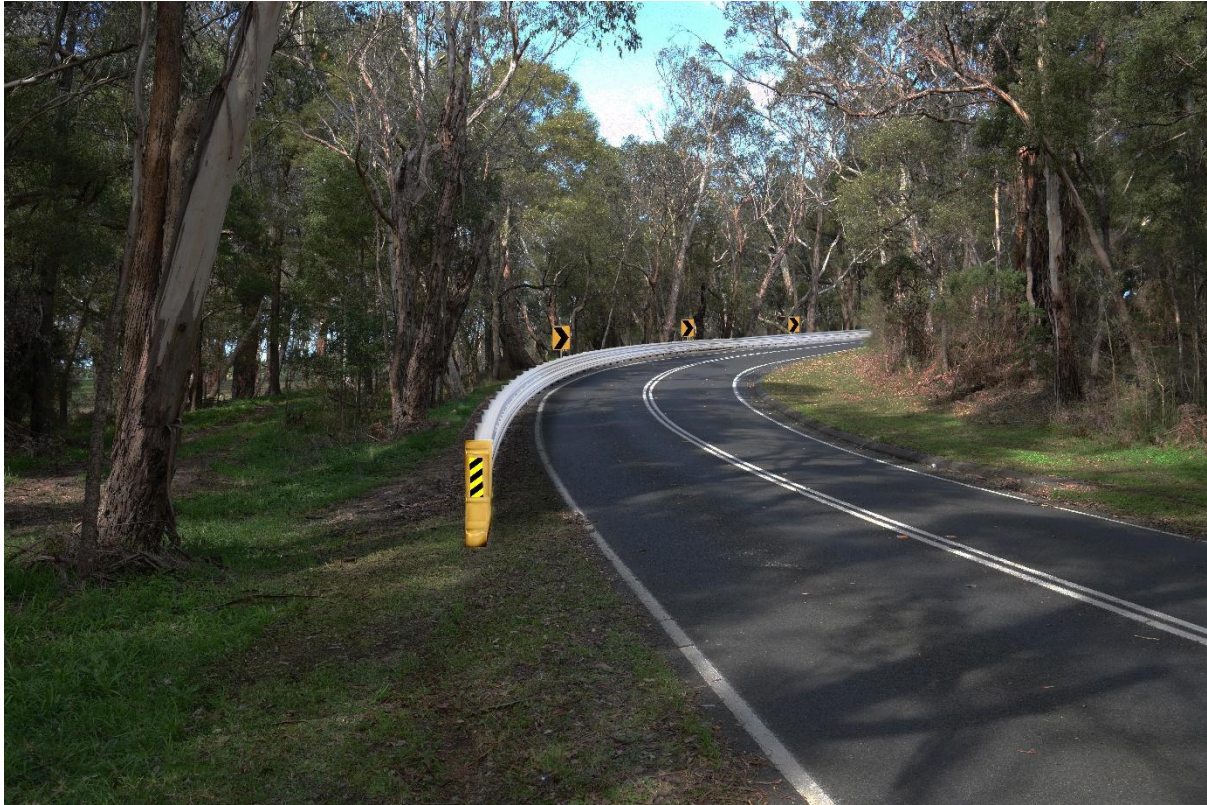
The proposed works include the replacement of the existing road barrier with a new barrier with underrun protection. Figure 6-5 shows an Artist Impression from Viewpoint B.

Figure 6-5 Viewpoint B Artist's impression

The **magnitude** of change is **low** as the Project replaces the existing CAM signs, and the new road safety barrier replaces an existing road safety barrier. The Project involves minor additions and is aligned with the existing road infrastructure.

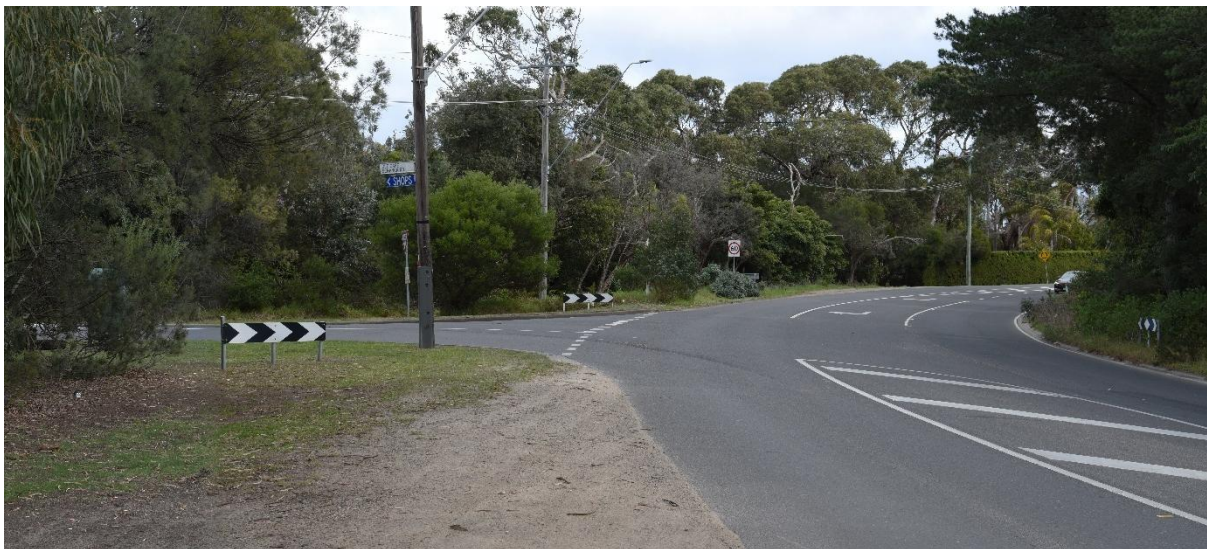
Viewpoint C shows a local road corridor in a residential landscape. The view is dominated by a curved asphalt carriageway with road markings, chevron boards and directional signage guiding traffic through the bend. Native vegetation creates a dense natural backdrop and vegetated screening. Figure 7-2 shows the existing view from Viewpoint C.

Figure 7-2 Existing view from Bayview Road

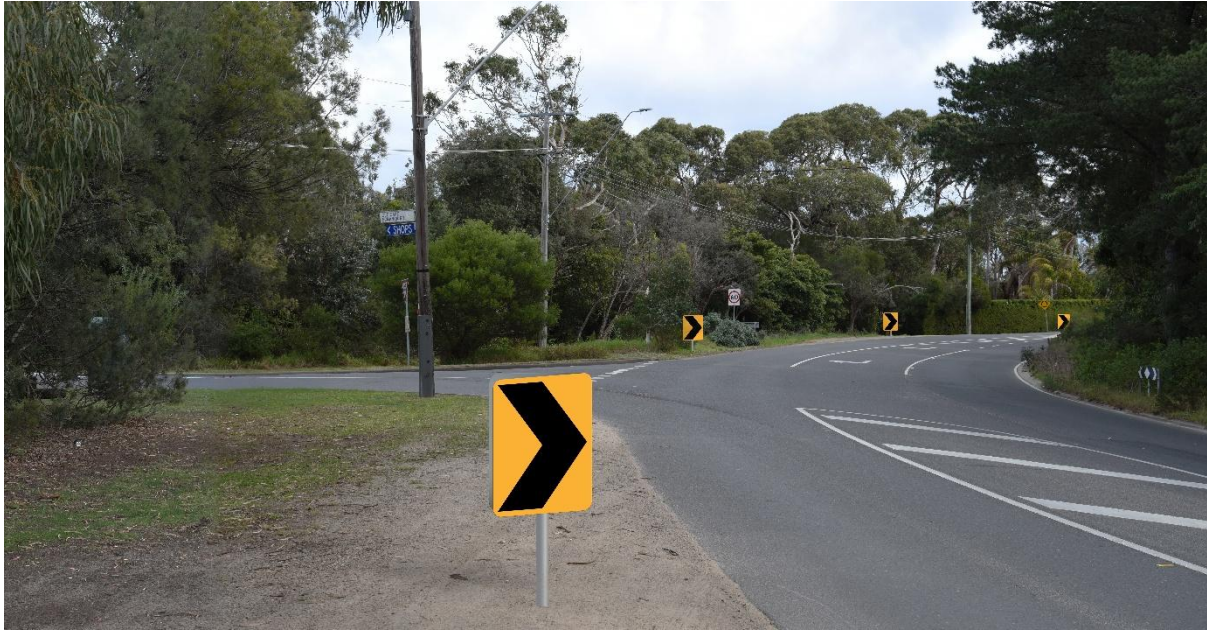
The proposed works include the installation of CAM signs to replace the existing chevron signs. Figure 7-3 shows an Artist Impression from Viewpoint C.

Figure 7-3 Viewpoint C Artist's impression

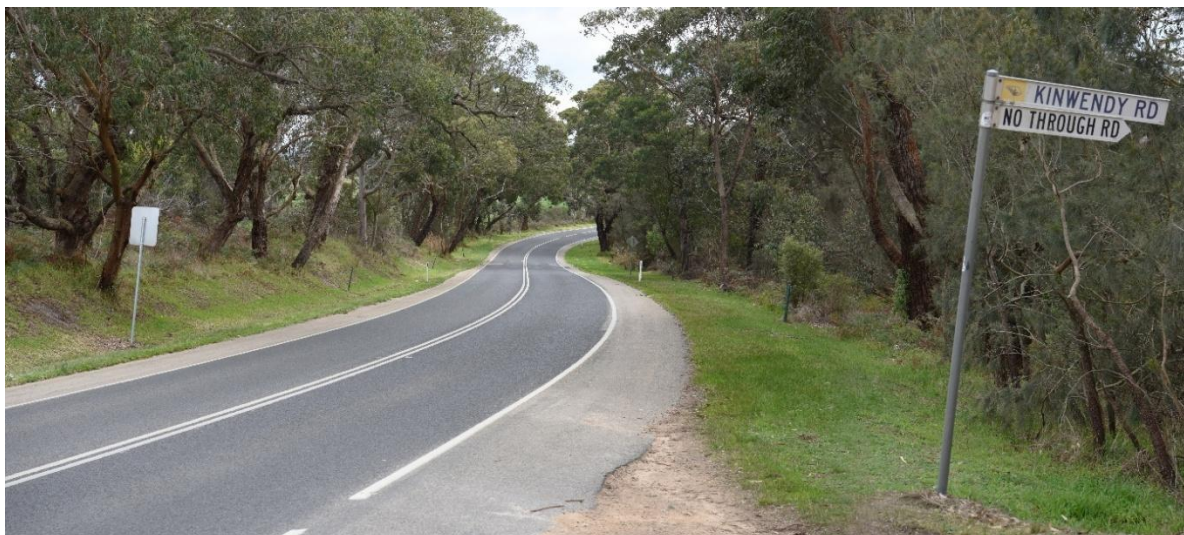
Viewpoint D shows a narrow sealed road curving through a forested landscape. The view is characterised by the asphalt carriageway with road markings and some signage. Native vegetation flanks both sides of the road and screens distant views across the landscape. Figure 8-2 shows the existing view from Viewpoint D.

Figure 8-2 Existing view from Browns Road

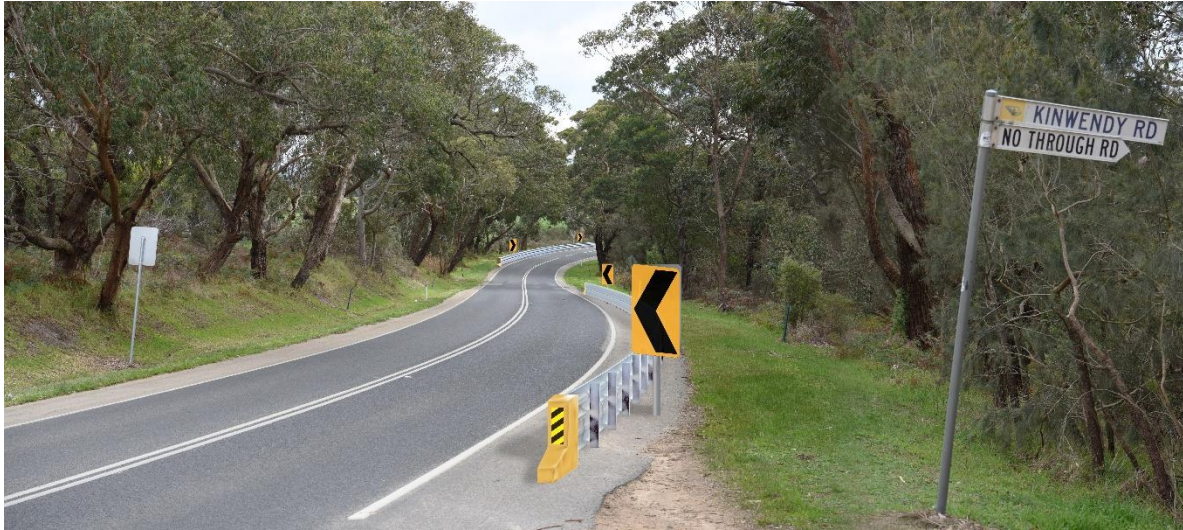
The proposed works include the installation of CAM signs and a new road safety barrier with underrun protection. Figure 8-3 shows an Artist Impression from Viewpoint D.

Figure 8-3 Viewpoint D Artist's impression

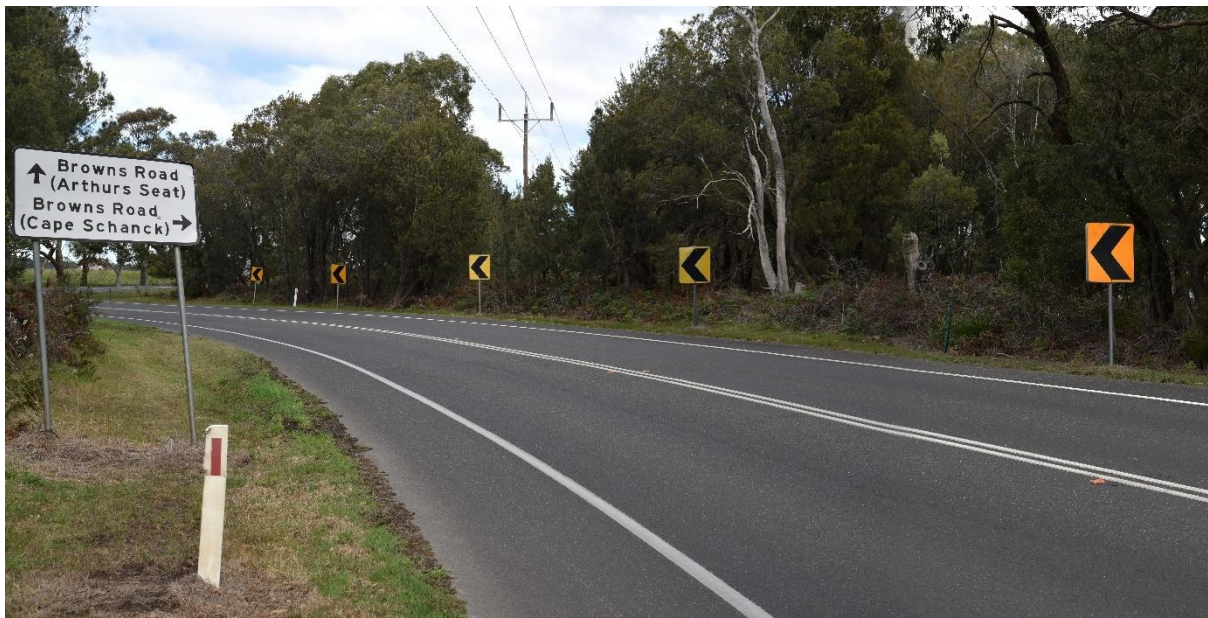
Viewpoint E shows a sealed two-lane road curving through a semi-rural landscape setting. The view is characterised by the asphalt carriageway with road markings and directional signage. Native vegetation flanks both sides of the road and screens distant views across the landscape. Overhead powerlines run perpendicular to the road, adding a linear infrastructure element. Figure 8-4 shows the existing view from Viewpoint E.

Figure 8-4 Existing view near Browns Road and Jetty Road

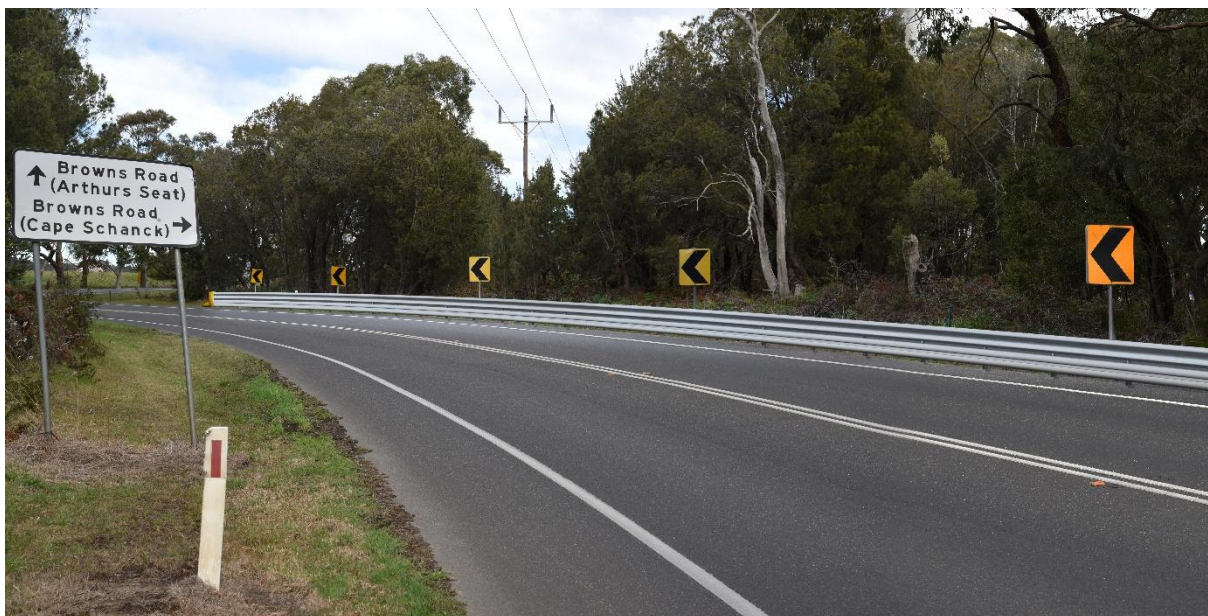
The proposed works include the installation of CAM signs and a new road safety barrier with underrun protection. Figure 8-5 shows an Artist Impression from Viewpoint E.

Figure 8-5 Viewpoint E Artist's impression

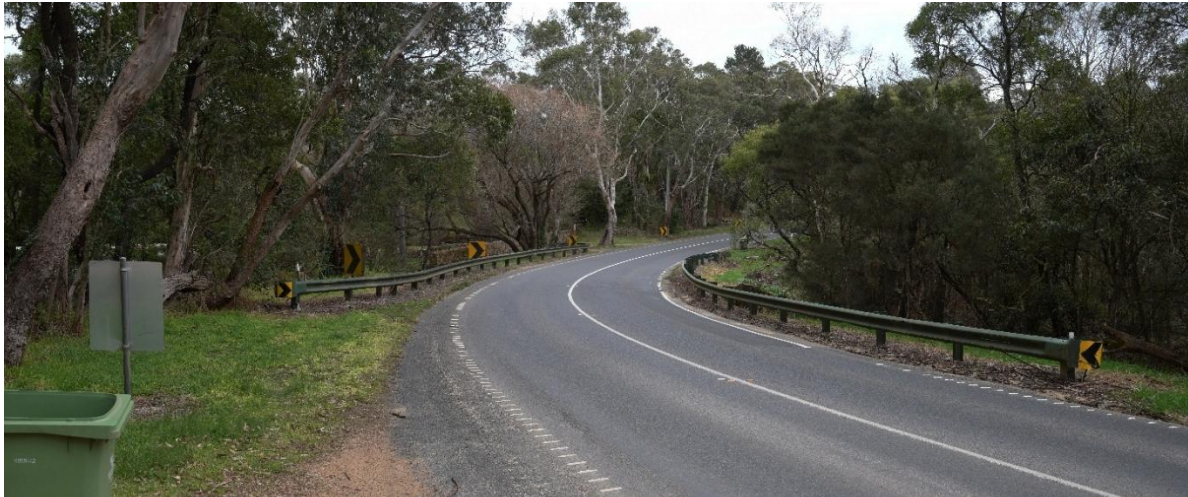
Viewpoint F shows sealed two-lane road curving through a rural residential landscape setting. The view is dominated by the asphalt carriageway with road markings and existing

road safety barriers and directional signage. Residential bins, fences and driveways can be seen adjacent to the road. Native vegetation flanks both sides of the road and screens distant views. Figure 9-3 shows the existing view from Viewpoint F.

Figure 9-3 Existing view from Main Creek Road

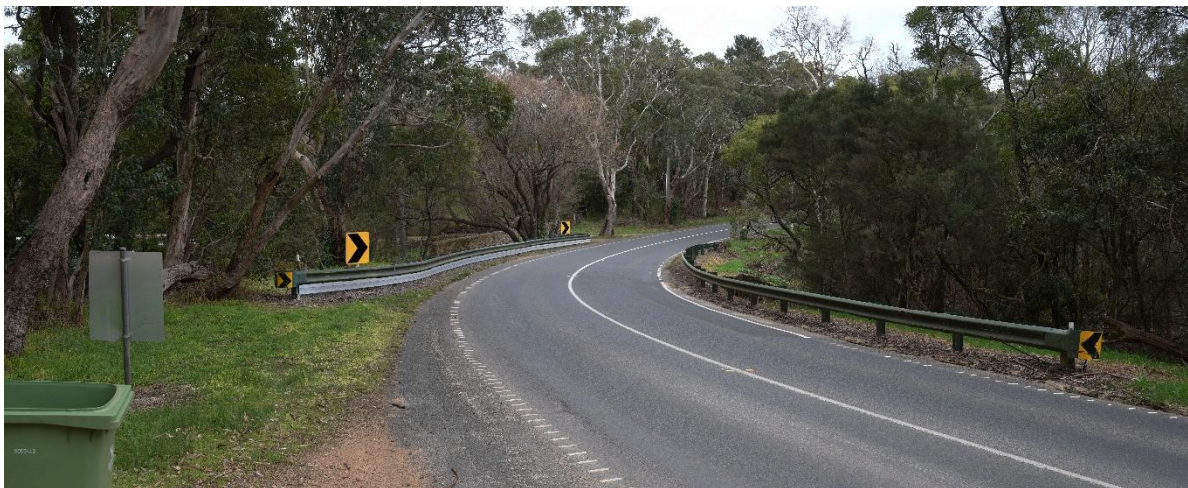
The proposed works include the replacement of CAM signs and adding underrun protection to an existing road safety barrier on the outer curve of the road. Figure 9-4.

Figure 9-4 Viewpoint F Artist's impression

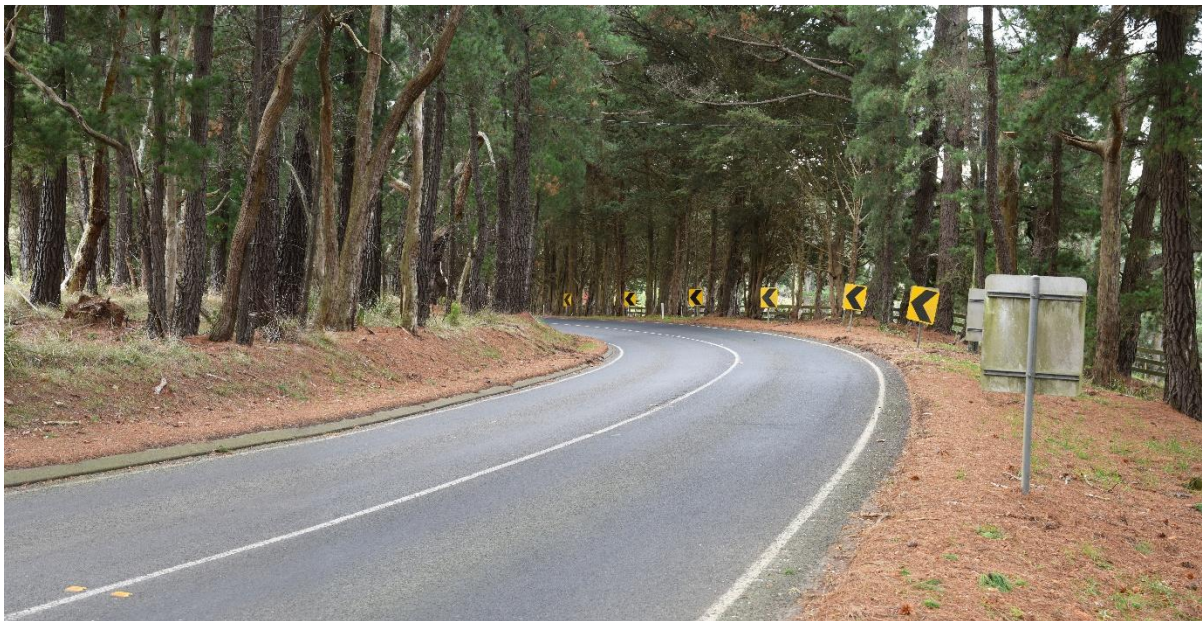
Viewpoint G shows sealed two-lane road curving through a forested landscape setting. While, the view is dominated by the asphalt carriageway, the dense vegetation that flanks both sides of the road inhibits views across the landscape. Figure 9-5 shows the existing view from Viewpoint G.

Figure 9-5 Existing view from Main Creek Road

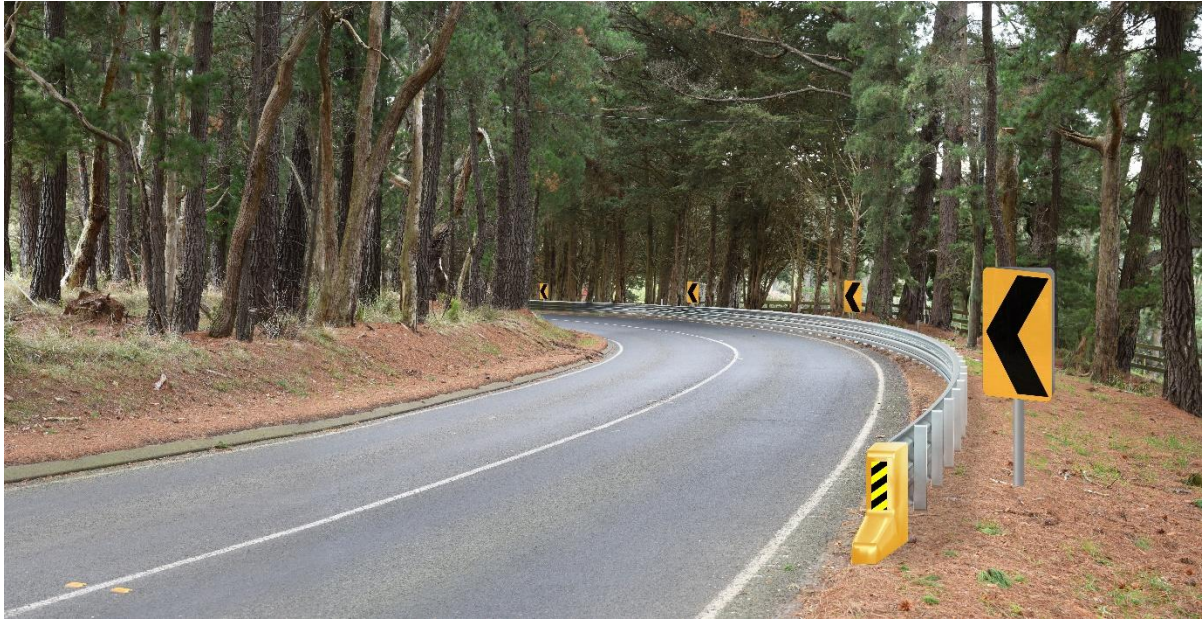
The proposed works include the replacement of CAM signs and a new road safety barrier with underrun protection along the outer curve of the road. Figure 9-6 shows an Artist Impression from Viewpoint G.

Figure 9-6 Viewpoint G Artist's impression

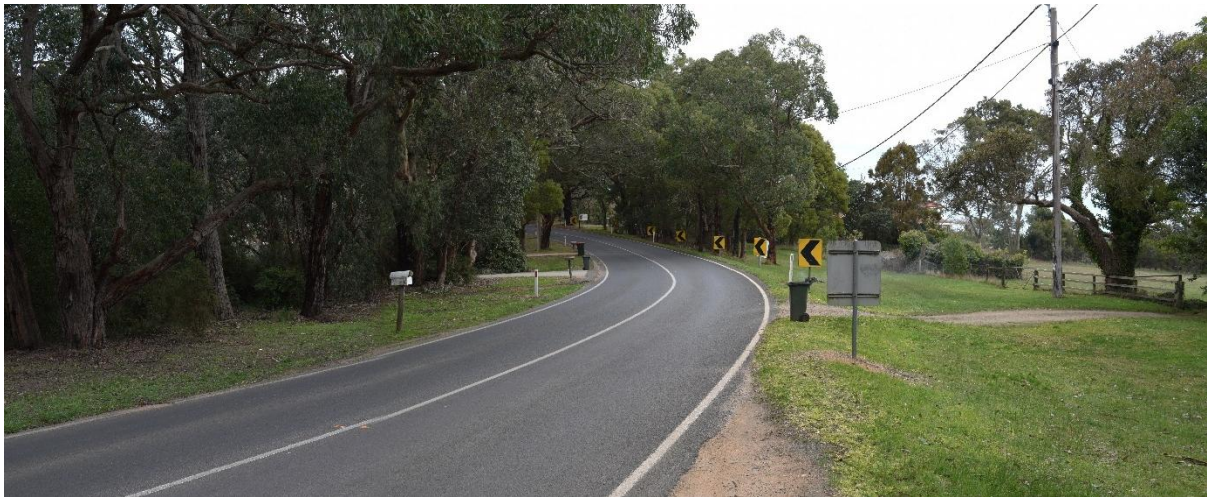
Viewpoint H shows sealed two-lane road curving through a rural residential landscape setting. Several driveways, post boxes and bins can be seen along the road. Vegetation that on both sides of the road mitigate the view with a natural backdrop and screening. Overhead powerlines and pole run parallel to the road, adding a linear infrastructure element. See Figure 9-7 shows the existing view from Viewpoint H.

Figure 9-7 Existing view from Main Creek Road

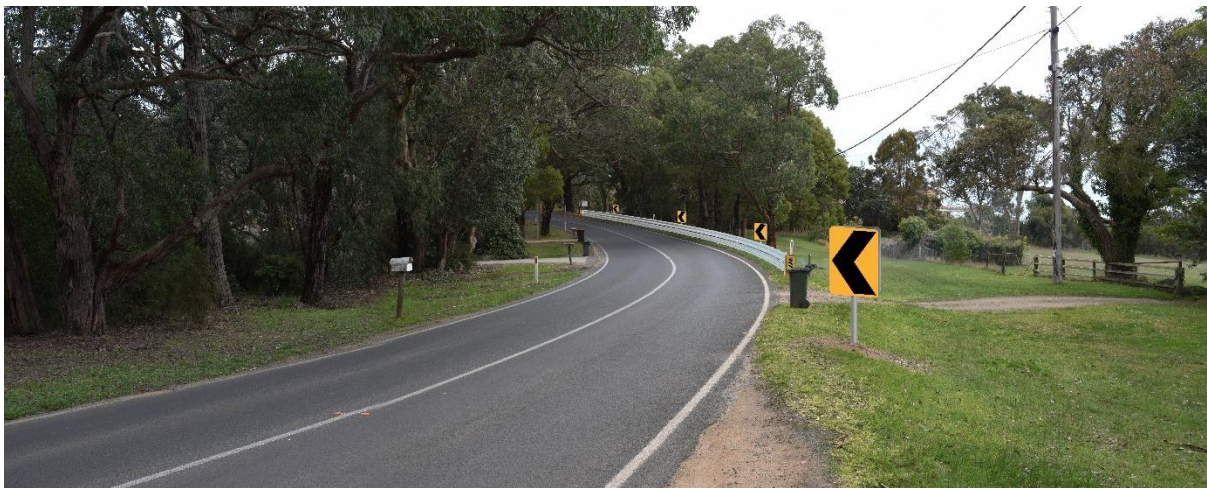
The proposed works include the installation of CAM signs and a new road safety barrier with underrun protection along the outer curve of the road. Figure 9-8 shows an Artist Impression from Viewpoint H.

Figure 9-8 Viewpoint H Artist's impression

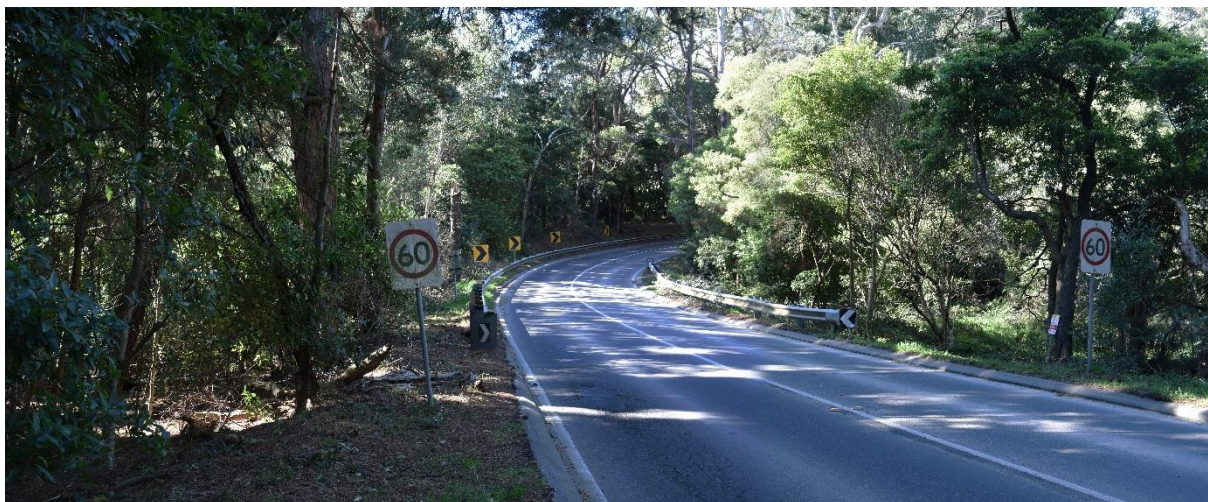
Viewpoint I shows sealed two-lane road curving through a forested landscape setting. While, the view is dominated by the asphalt carriageway, the dense vegetation that flanks both sides of the road partially mitigate the presence of road infrastructure with overshadowing. Figure 10-2 shows the existing view from Viewpoint I.

Figure 10-2 Existing view from Shands Road

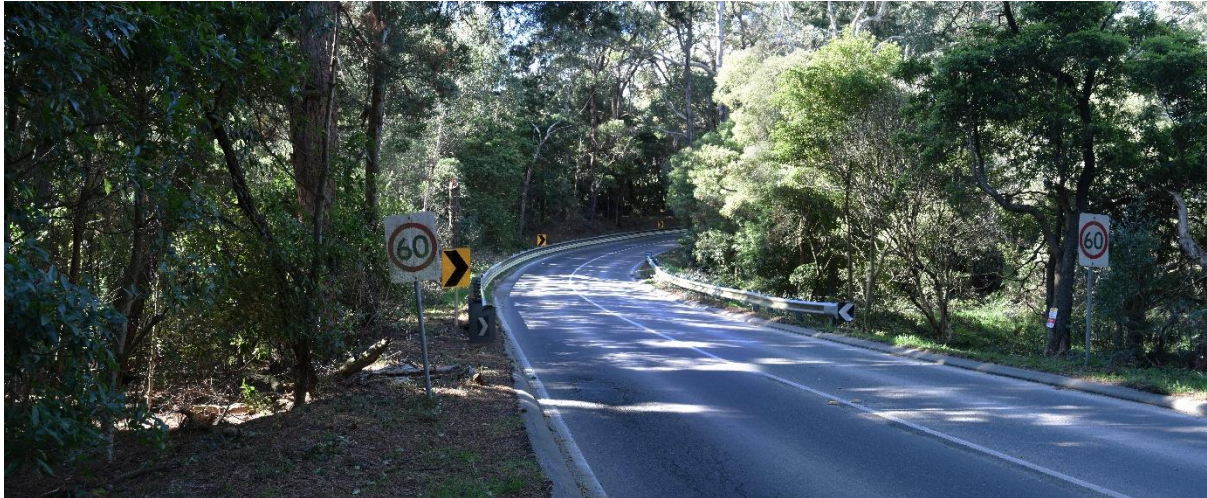
The proposed works include the replacement of existing CAM signs and the addition of underrun protection along the existing road safety barrier that is on the outer curve of the road. Figure 10-3 shows an Artist Impression from Viewpoint I.

Figure 10-3 Viewpoint I Artist's Impression

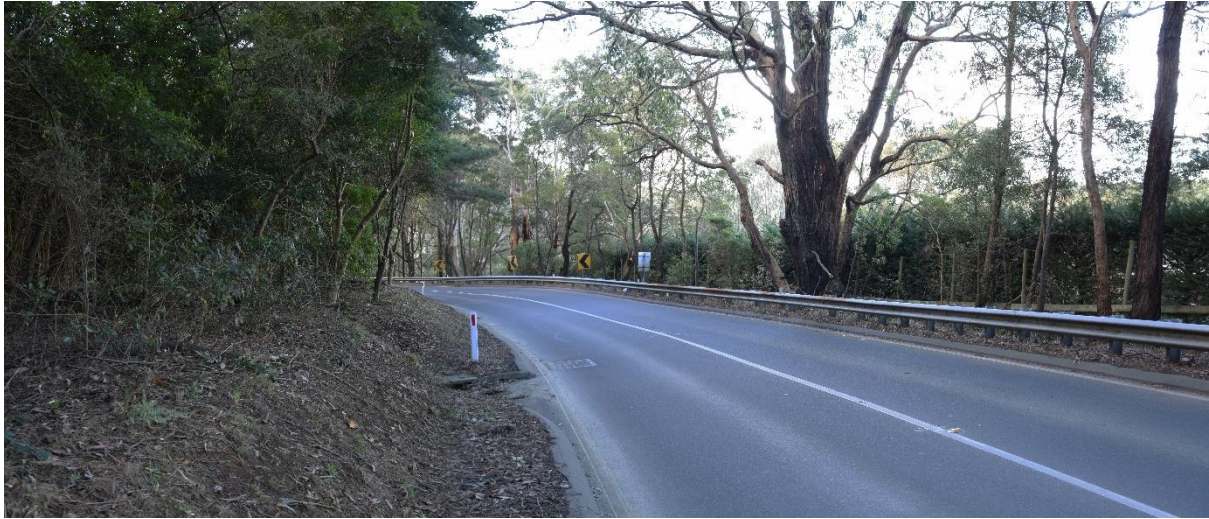
Viewpoint J shows sealed two-lane road curving through a rural residential landscape setting. The view from the road is framed by native vegetation with shrubs and eucalypts and formal, managed screening vegetation from private properties. Figure 10-4 shows the existing view from Viewpoint J.

Figure 10-4 Existing view from Shands Road

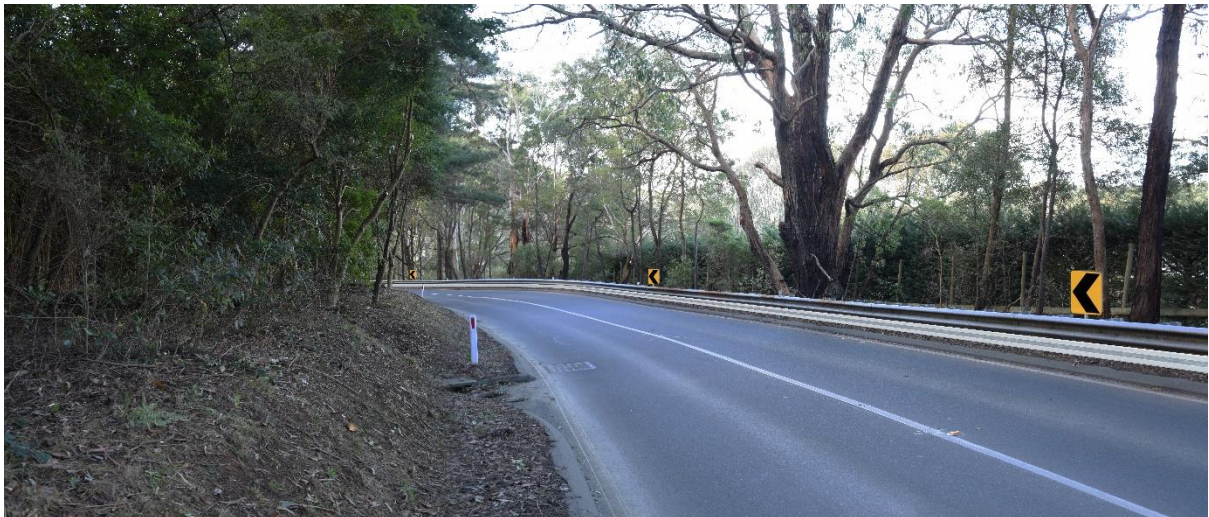
The proposed works include the replacement of existing CAM signs and the addition of underrun protection along the existing road safety barrier. Figure 10-5 shows an Artist Impression from Viewpoint J.

Figure 10-5 Viewpoint J Artist's impression

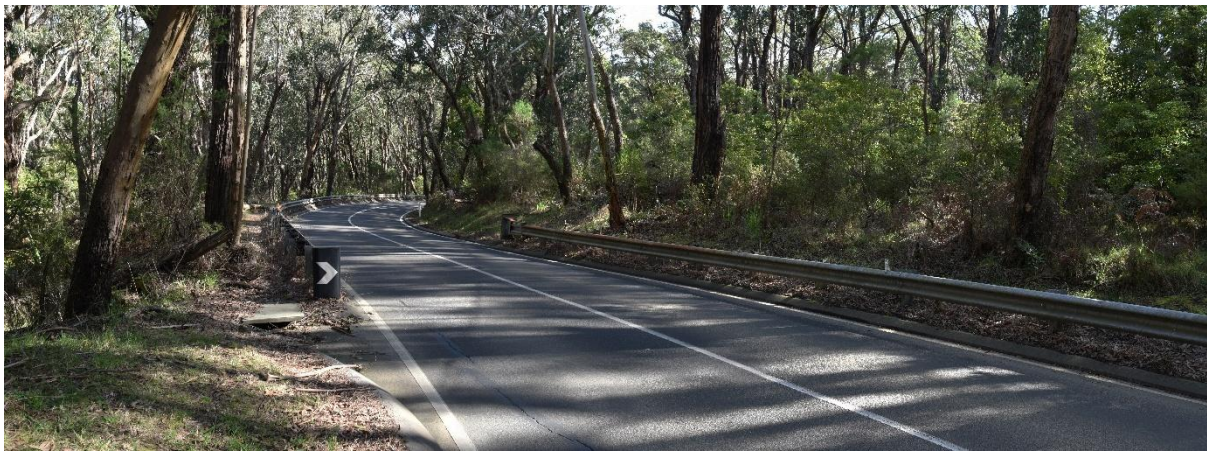
Viewpoint K shows sealed two-lane road curving through a forested landscape setting. While, the view is dominated by the asphalt carriageway, the dense vegetation that flanks both sides of the road mitigate the view with a natural backdrop and overshadowing. Figure 10-6 shows the existing view from Viewpoint K.

Figure 10-6 Existing view from Shands Road

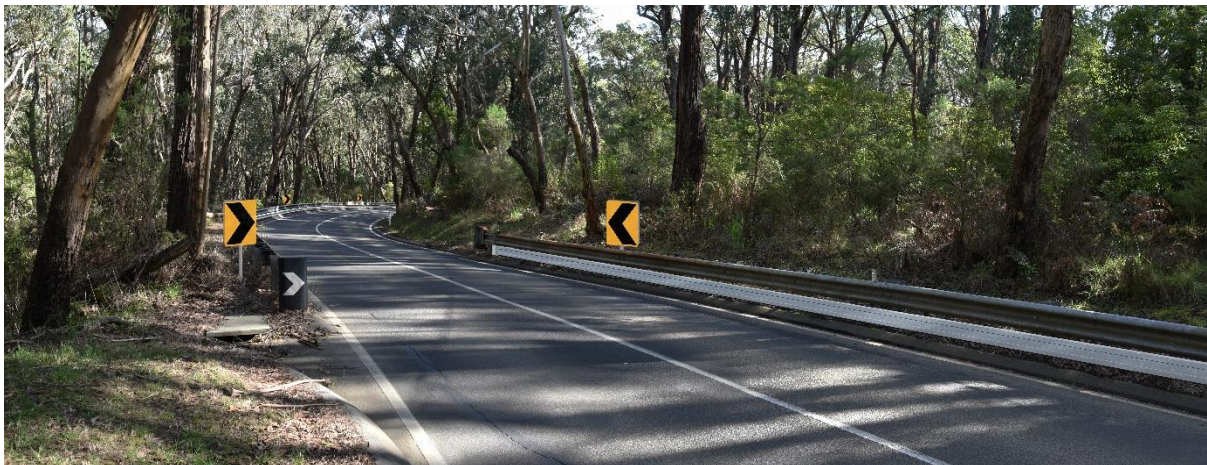
The proposed works include the replacement of existing CAM signs and the addition of underrun protection along the existing road safety barrier that is on the outer curve of the road. Figure 10-7 shows an Artist Impression from Viewpoint K.

Figure 10-7 Viewpoint K Artist's impression

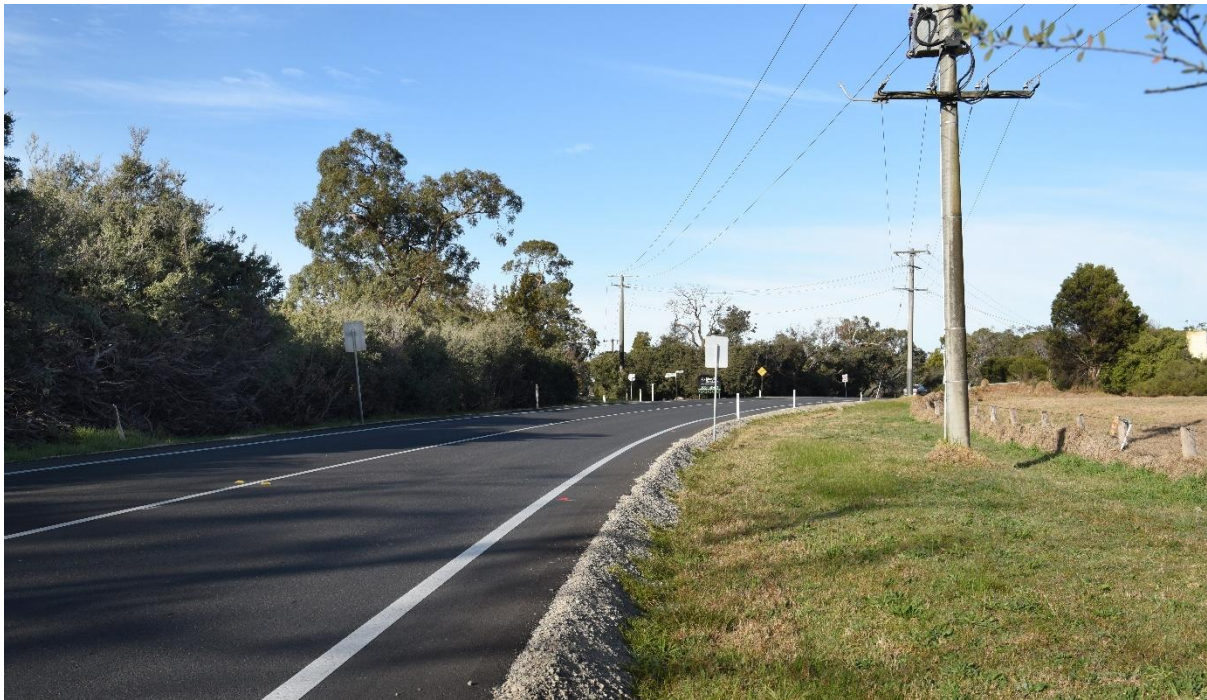
Viewpoint L shows a local road corridor in an agricultural and peri-urban landscape setting. The view is dominated by a curved asphalt carriageway with road markings and road signage. Native vegetation creates a dense natural backdrop and screens distant views. Overhead powerlines and pole run parallel to the road, adding a linear infrastructure element. Figure 11-2 shows the existing view from Viewpoint L.

Figure 11-2 Existing view from Tyabb-Tooradin Road

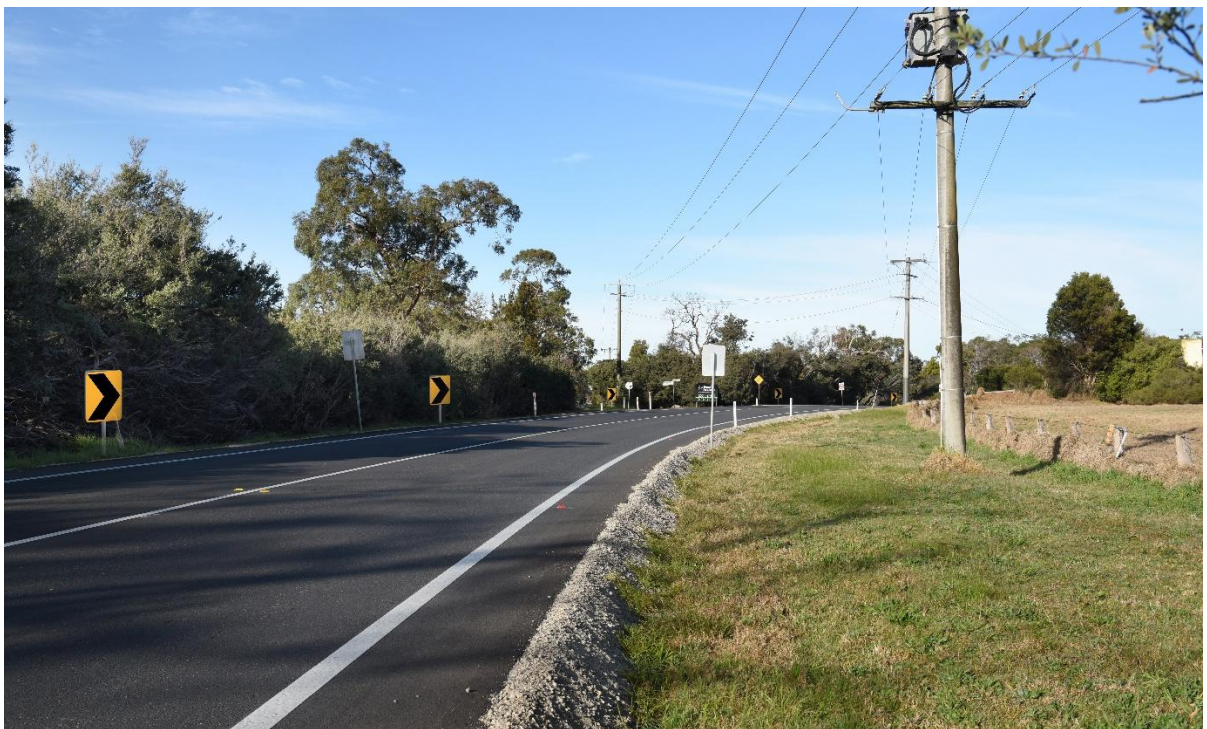
The proposed works include the addition of CAM signs along the outer curve of the road. Figure 11-3 shows an Artist Impression from Viewpoint L.

Figure 11-3 Viewpoint L Artist's impression

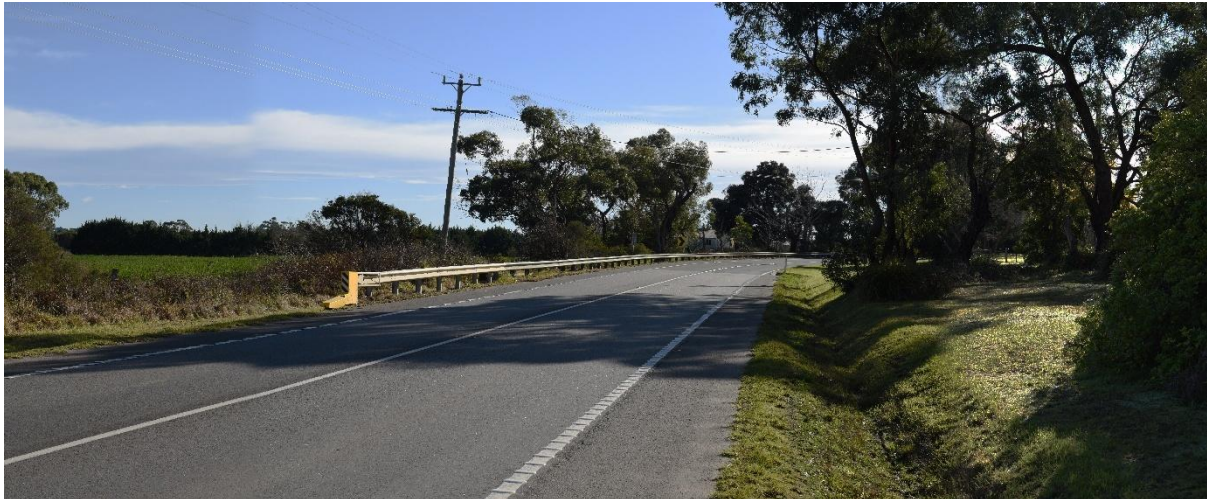
Viewpoint M shows a local road corridor in an agricultural and peri-urban landscape setting. The view is dominated by a wide asphalt carriageway with a road safety barrier. The verges to the side of the road have clumps of native vegetation that provides a natural backdrop and screens distant views. Overhead powerlines and a transmission pole run parallel to the road, adding a linear infrastructure element. Figure 11-4 shows the existing view from Viewpoint M.

Figure 11-4 Existing view from Tyabb-Tooradin Road

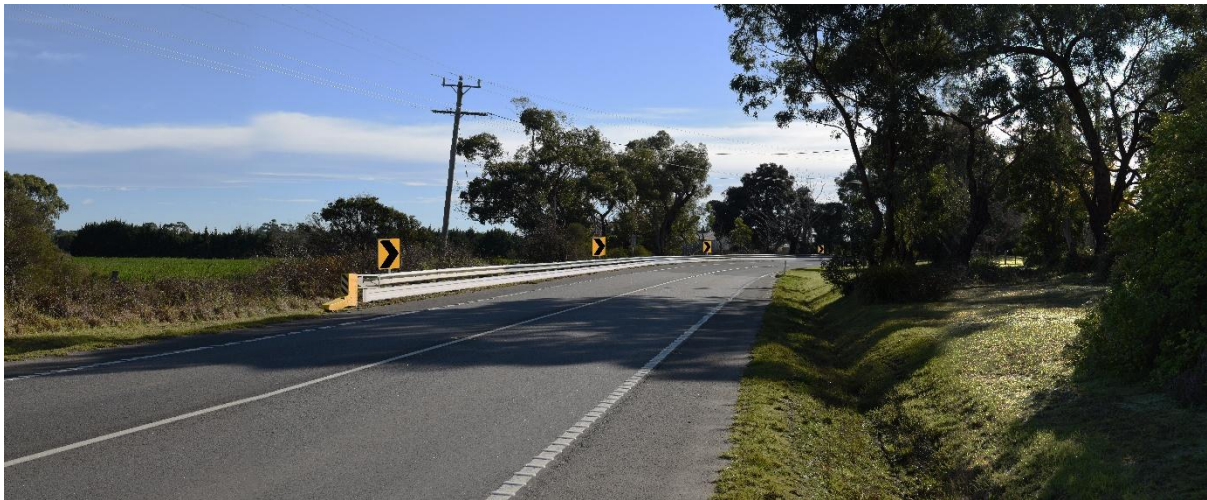
The proposed works include the installation of CAM signs and installation of underrun protection to the existing road safety barrier. Figure 11-5 shows an Artist Impression from Viewpoint M.

Figure 11-5 Viewpoint M Artist's impression
