Visual Impact Assessment

Motorcycle Safety Levy Projects

Mornington Peninsula Shire

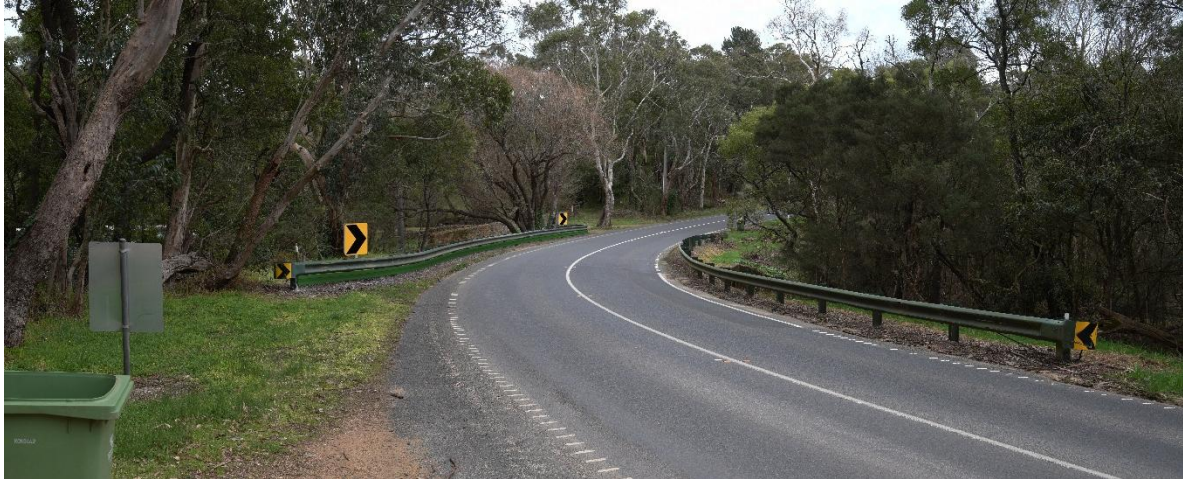
A comparative assessment was undertaken at Main Creek Road - Viewpoint and Viewpoint G - Main Creek Road #2 to evaluate the visual prominence of galvanised steel guardrails against green-painted finishes. Figure 13-1, Figure 13-2, Figure 13-3 and Figure 13-4 show a comparison between galvanised steel and green painted finishes.

Figure 13-1 Viewpoint F artist's impression with green painted finish underrun protection

- **Natural Weathering:** Over 6–18 months, galvanised steel develops a matte grey patina (zinc carbonate layer) that significantly reduces reflectivity and developed a textural finish influenced by the local environment.
- **Colour Matching and Texture:** The dulled finish blends with landscape tones found in bark, gravel, and foliage shadows.
- **Reduced Glare:** Unlike painted or glossy finishes, weathered steel has low visual shine, particularly effective in sequential or panoramic views.

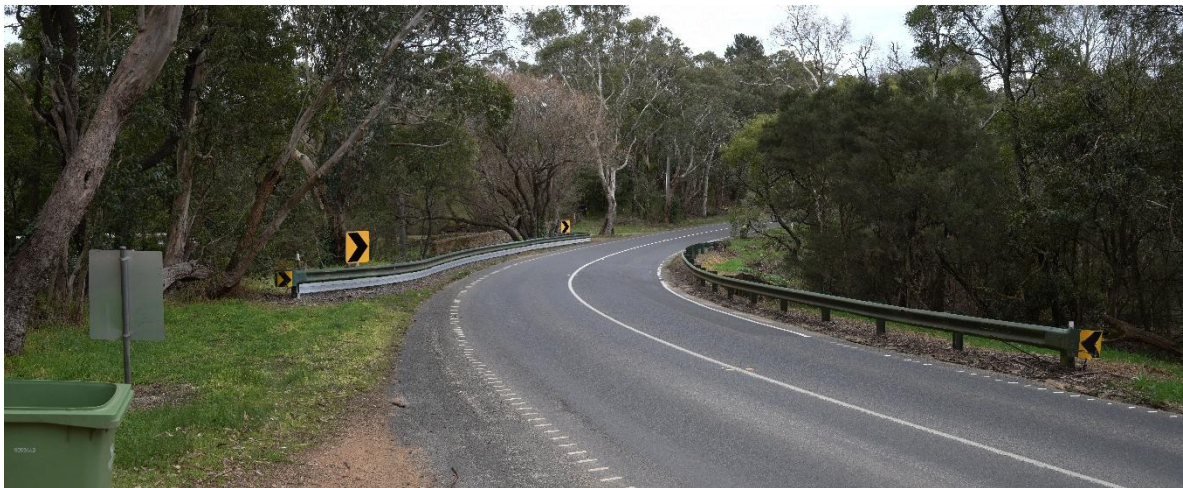
Figure 13-2 Viewpoint F artist's impression with galvanised zinc finish underrun protection

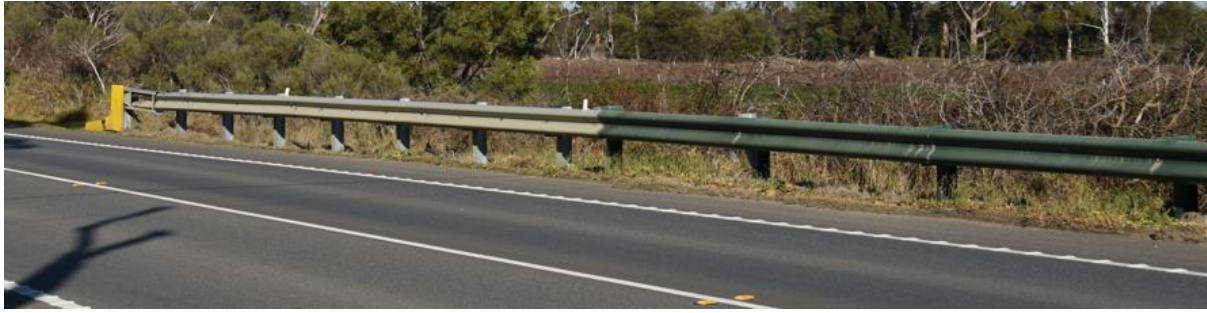
Figure 13-5 Road safety barrier along Tyabb-Tooradin Road

Viewpoint M – Tyabb-Tooradin Road #2 captures a view that illustrates the difference between a green painted and galvanised zinc finish road safety barrier in-situ. Figure 13-5 shows a view of a road safety barrier along Tyabb-Tooradin Road.

By comparison, galvanised steel initially appears reflective but weathers naturally over time to a matte grey patina. This neutral tone blends better with landscape elements like bark, soil, existing road surfaces and shadow. It also avoids clashing with seasonal vegetation changes and maintains a consistent, low-maintenance finish. Unlike green paint, it does not introduce unnatural contrast or require periodic recoating.
