Emergency works complete

The Department of Environment, Land, Water and Planning (DELWP) completed emergency cliff protection works at Mount Martha North in October, making the cliff safe and protecting the toe from further erosion from high tides and storm surge.

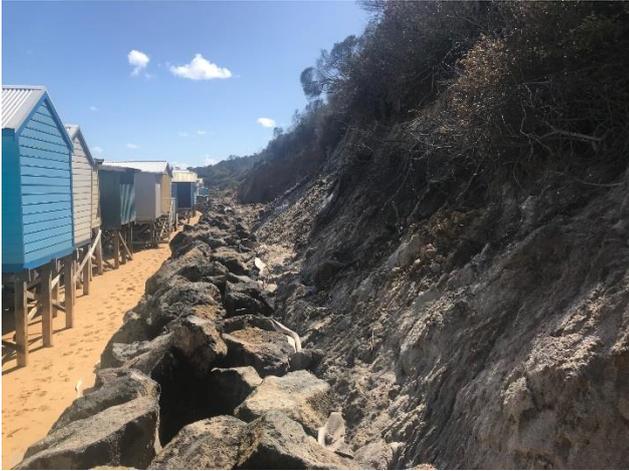
Storms eroded most of the sand on the beach over June and July 2018, forcing DELWP to amend the design of the emergency works. The geotextile sand-tube component was removed as it would have been difficult to construct it within the short, low-tide periods with so little sand on the beach. Instead, the revetment was constructed entirely of rock, with geotextile underneath to prevent tides from eroding the sand out from behind it. About 150m³ of sand was placed in front of the revetment at the southern end where the Balcome clay layer had become exposed.
