# Major repairs to Portsea beach seawall

Project Update – 17 June 2020

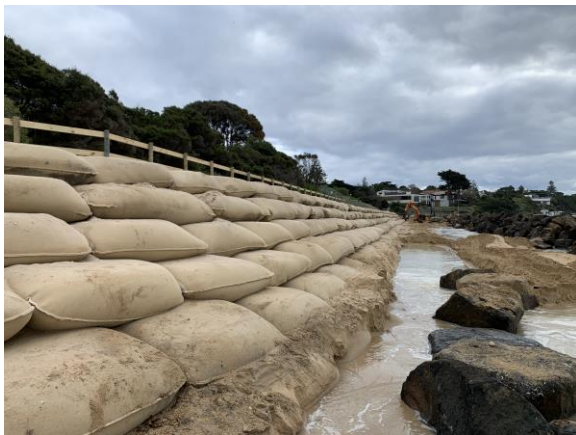
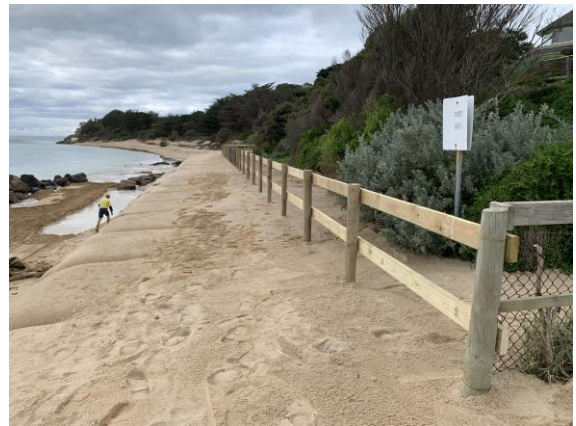
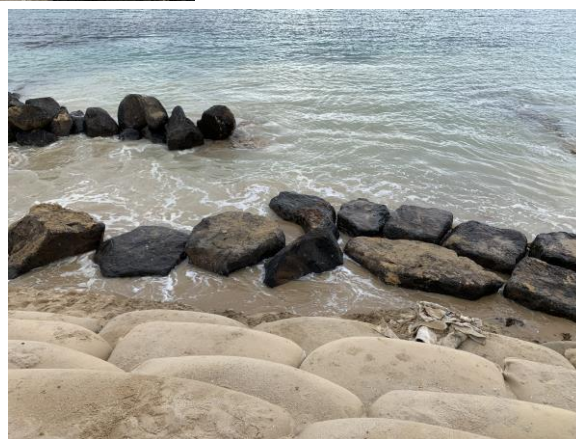
With the sandbag seawall nearing completion, toe rocks are progressively being reinstated, starting at the eastern end of the beach. These will help to protect the base of the sandbag seawall. The surplus rock from the bund is being removed.
