Landslide Risk Assessment

Beleura Cliff Path, Caraar Creek Road to Mills Beach, Mornington

PREPARED FOR:
Mornington Peninsula Shire

December 11, 2023
RFP: V220152Report02.3

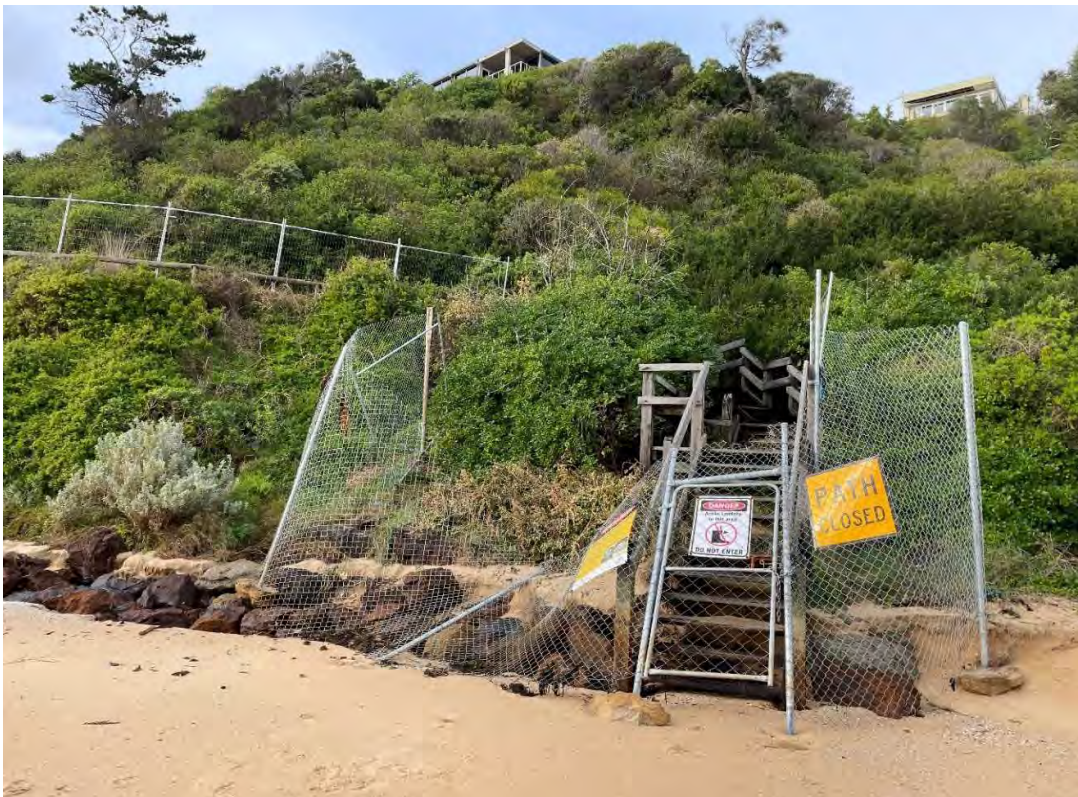
The current risk mitigation approach centres around preventing people from accessing the path. To achieve this, there are significant fences positioned at both the northern and southern extremities of the path. The fencing on the southern end of the path is shown in Figure 6-1.

Figure 6-1 – Fencing at the Southern end of the path

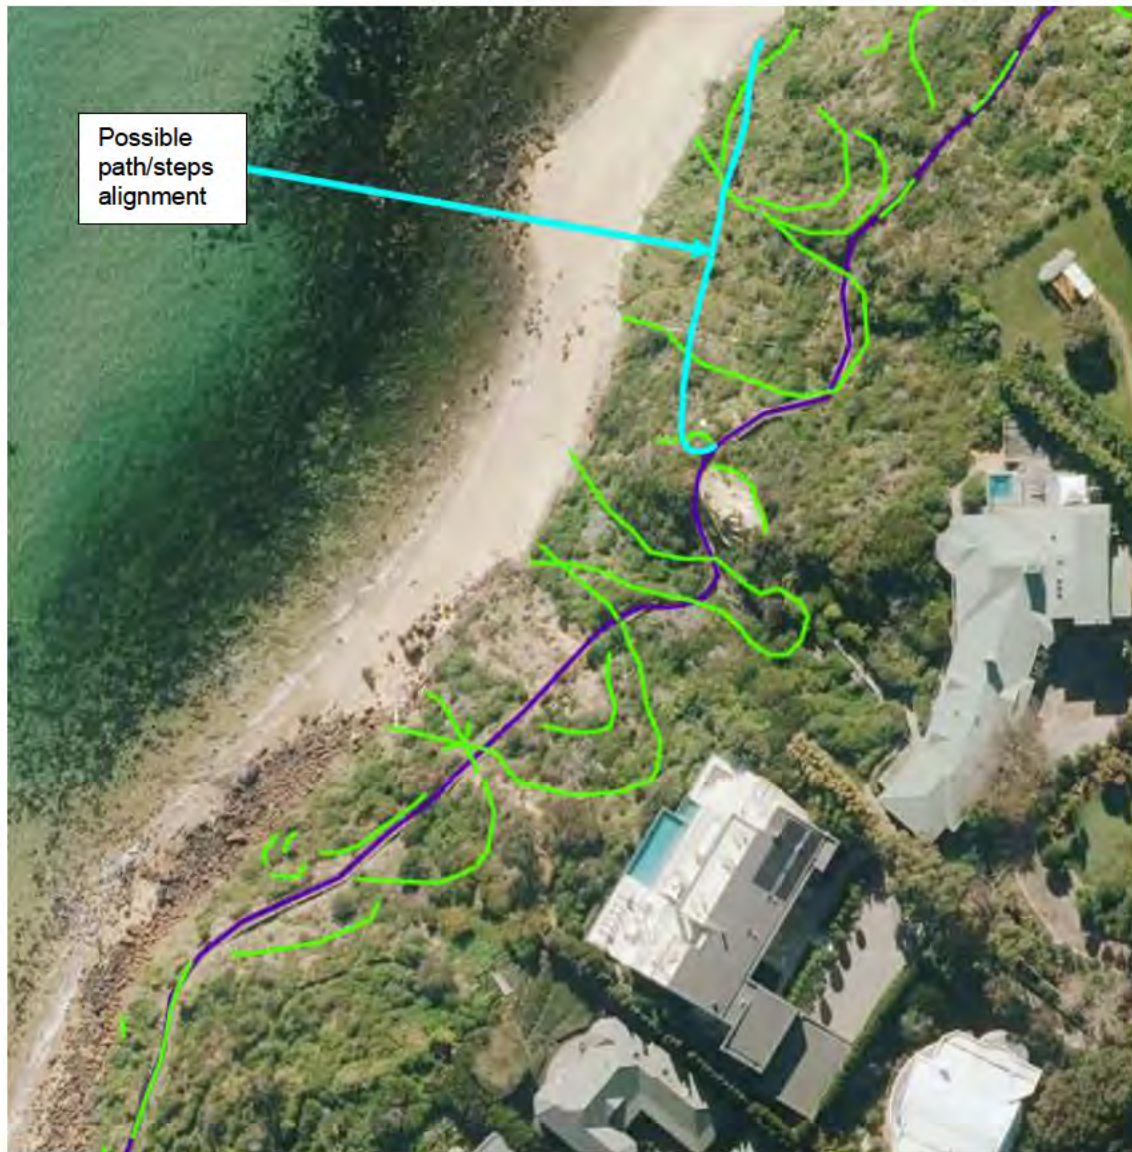
Figure 6-5 – Section 19/20: possible 'soff' path/steps alignment

This option comprises the construction of an engineering solution, such as steps/path down to the beach. This would address the active landslides in both Sections 19 and 20. Refer to Figure 6-5.

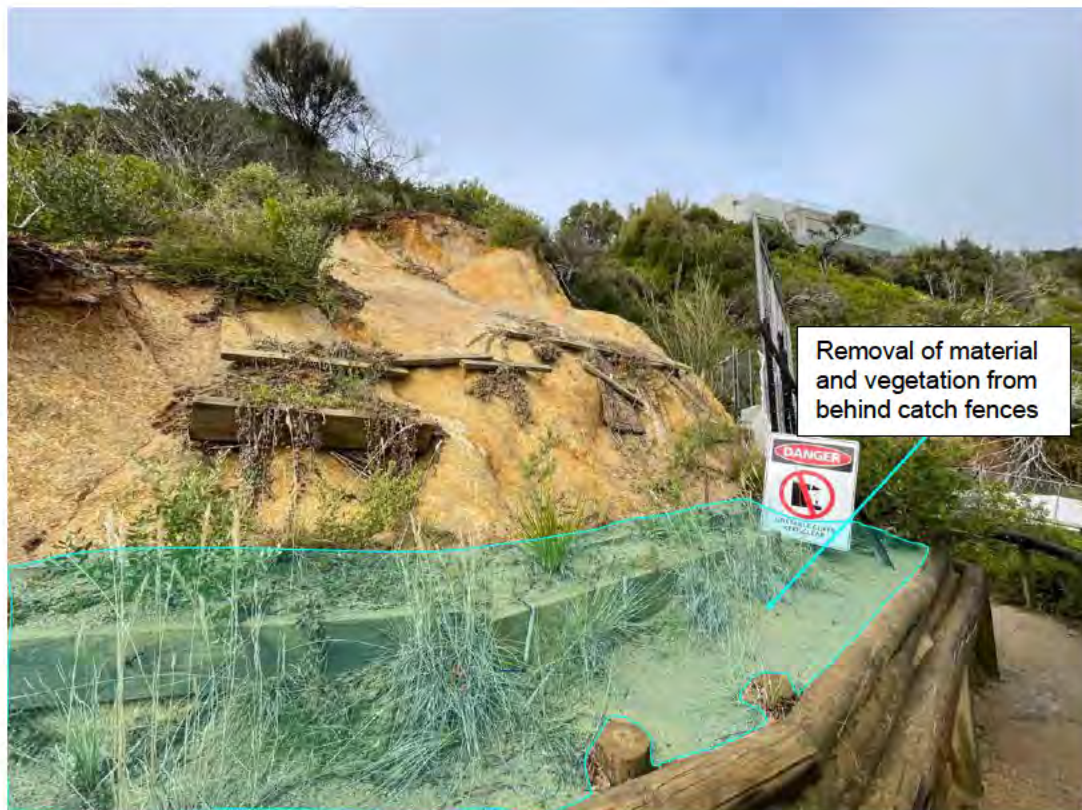
Figure 6-7 – Section 19: material and vegetation to be removed from behind catch wall

Section 19 includes the areas where overhanging material was observed. It is recommended that the overhanging material is removed via mechanical means, and the section of the cliff upslope of the path be battered back to a shallower angle. The current catch wall needs to be emptied of material, such that any future soil material transported by surface run off is prevented from being deposited onto the path. This is illustrated in Figure 6-6 and Figure 6-7 below.

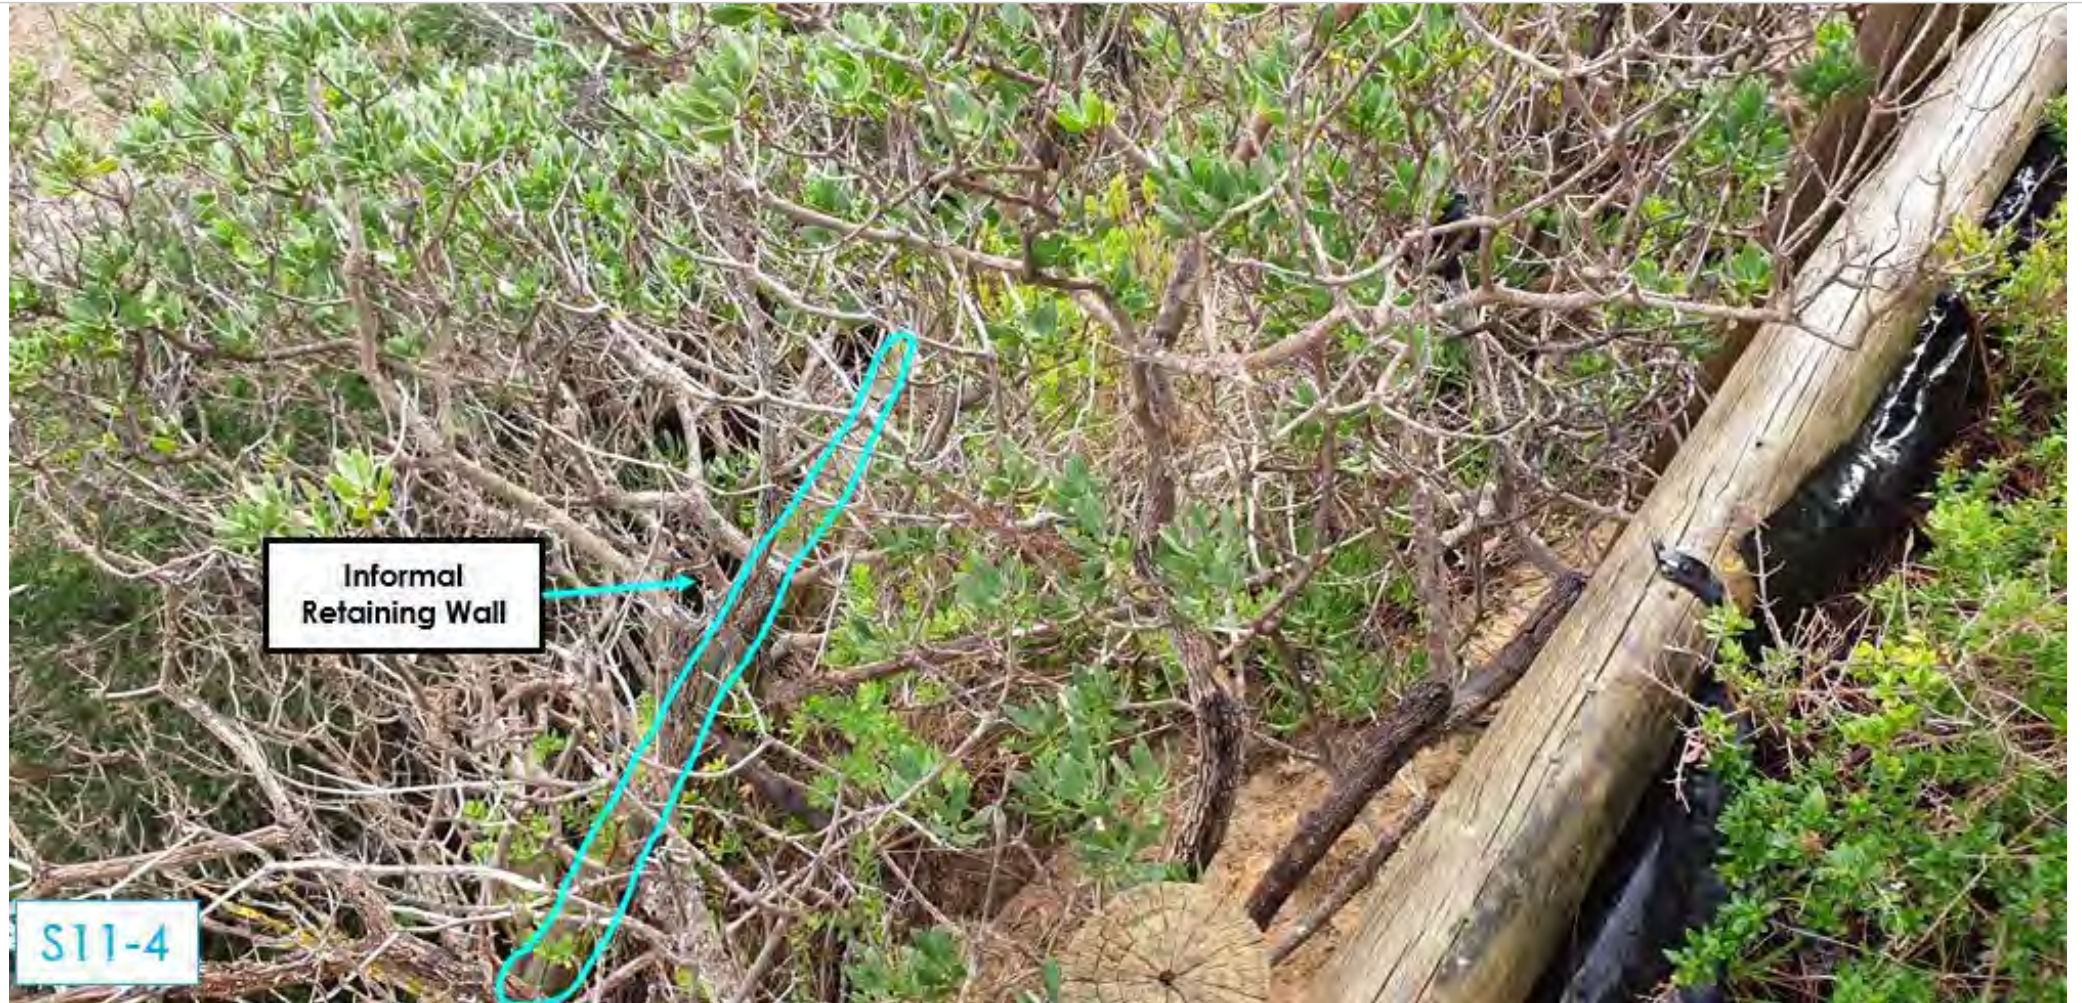
S11-4

Informal Retaining Wall

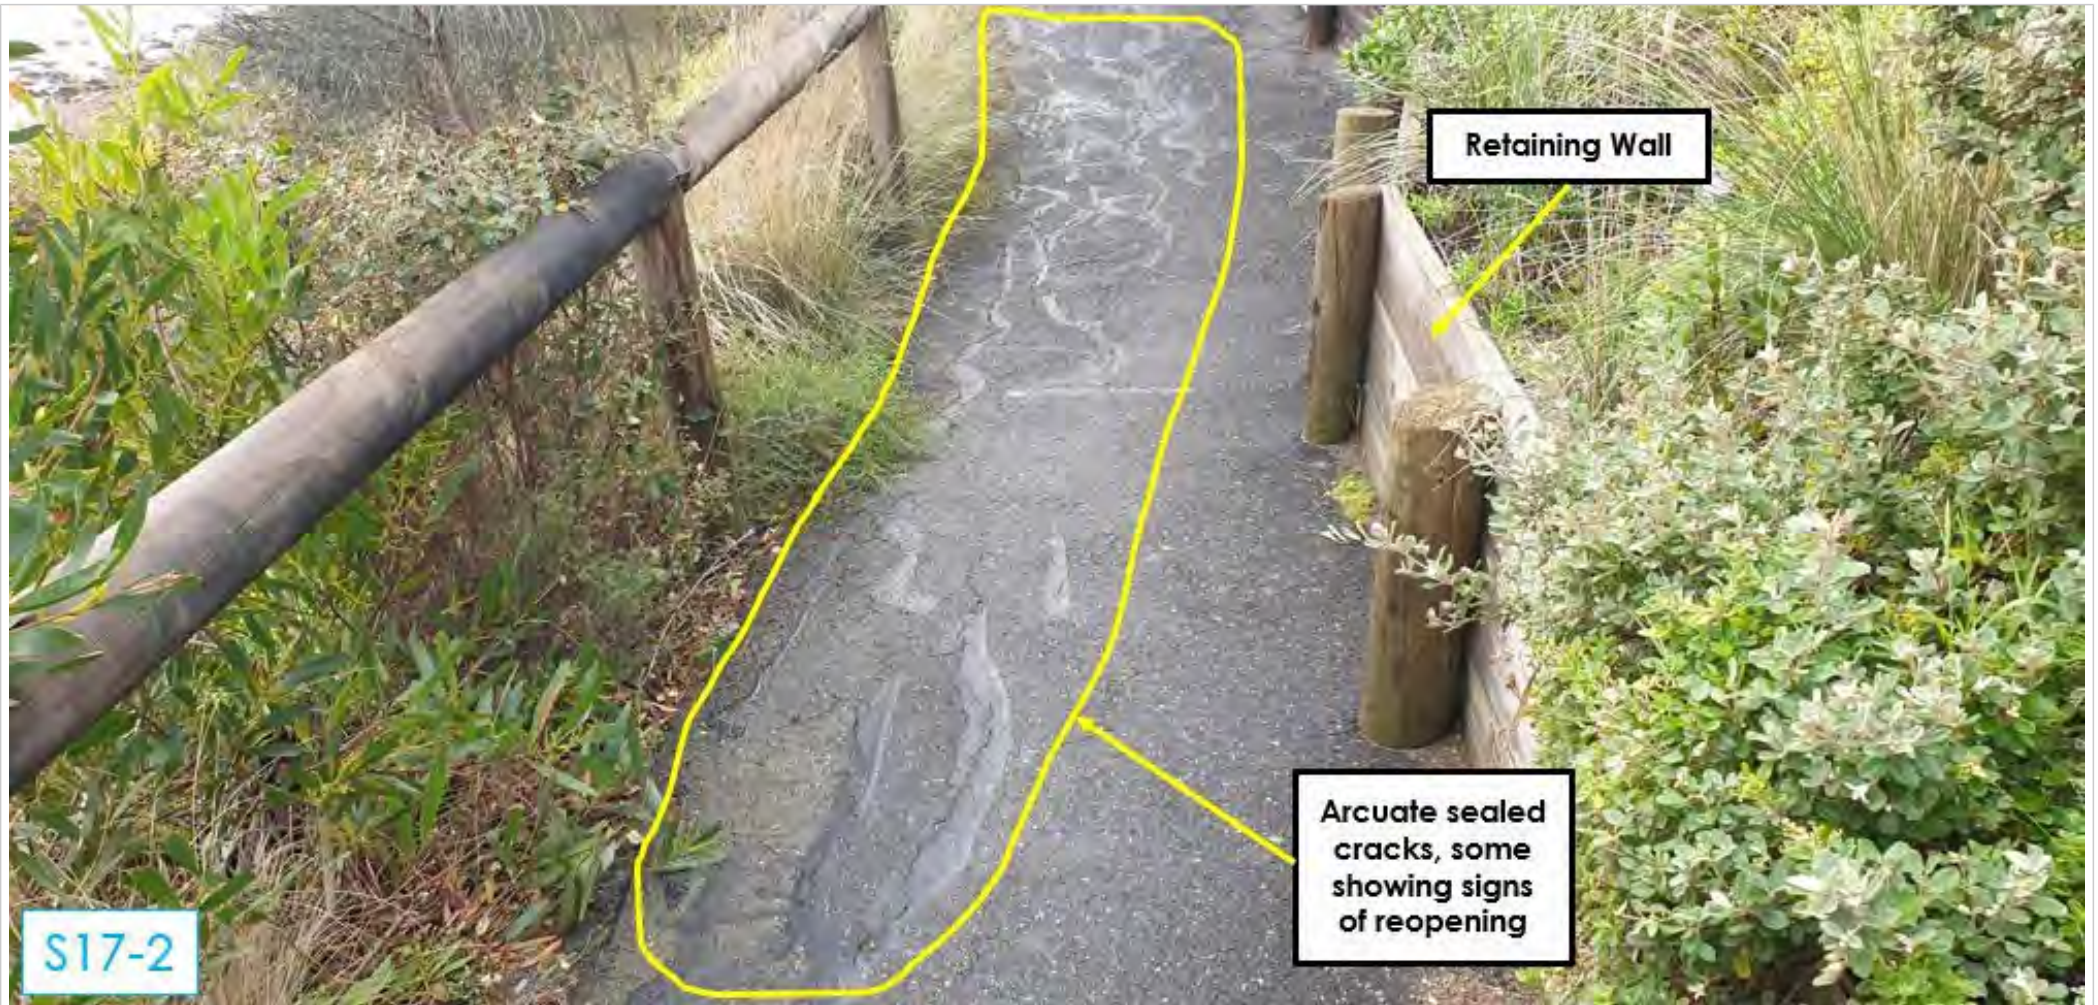
S17-2

Retaining Wall

Arcuate sealed cracks, some showing signs of reopening

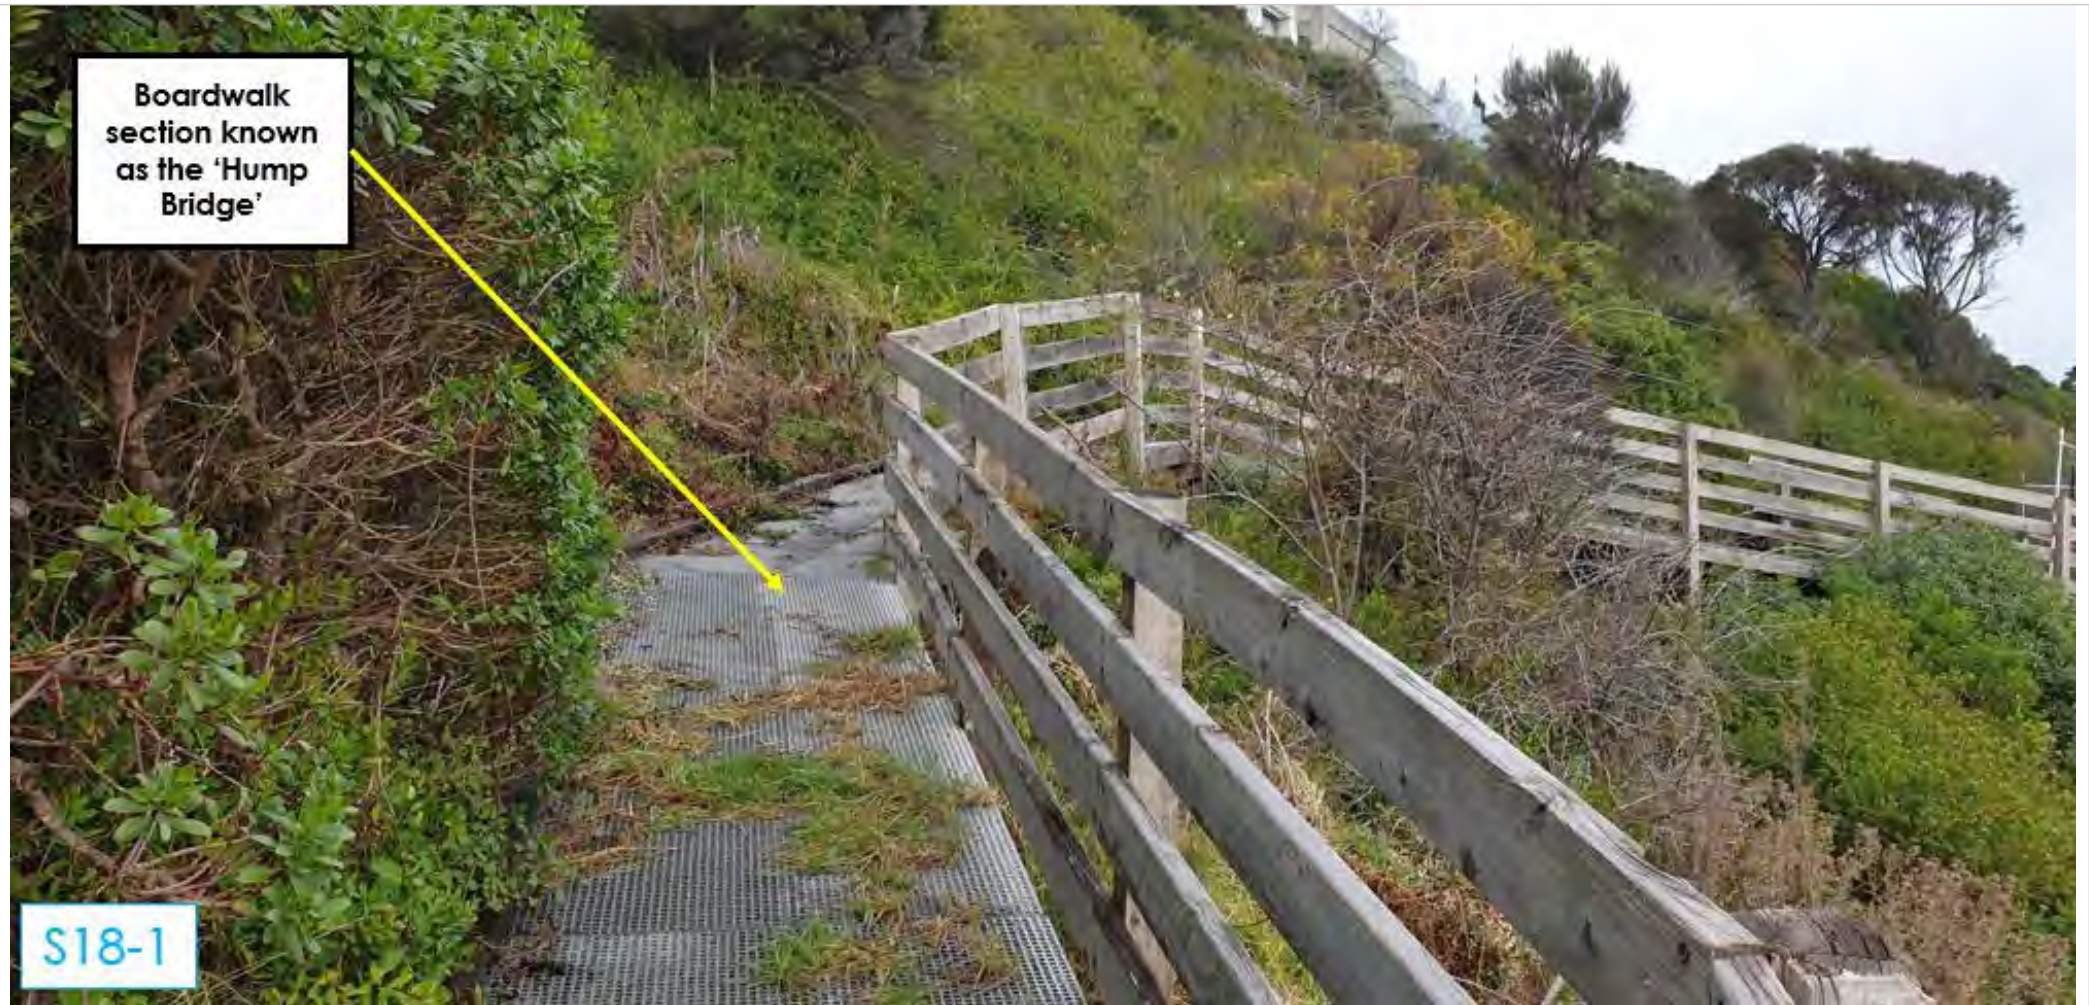
S18-1

Boardwalk section known as the 'Hump Bridge'

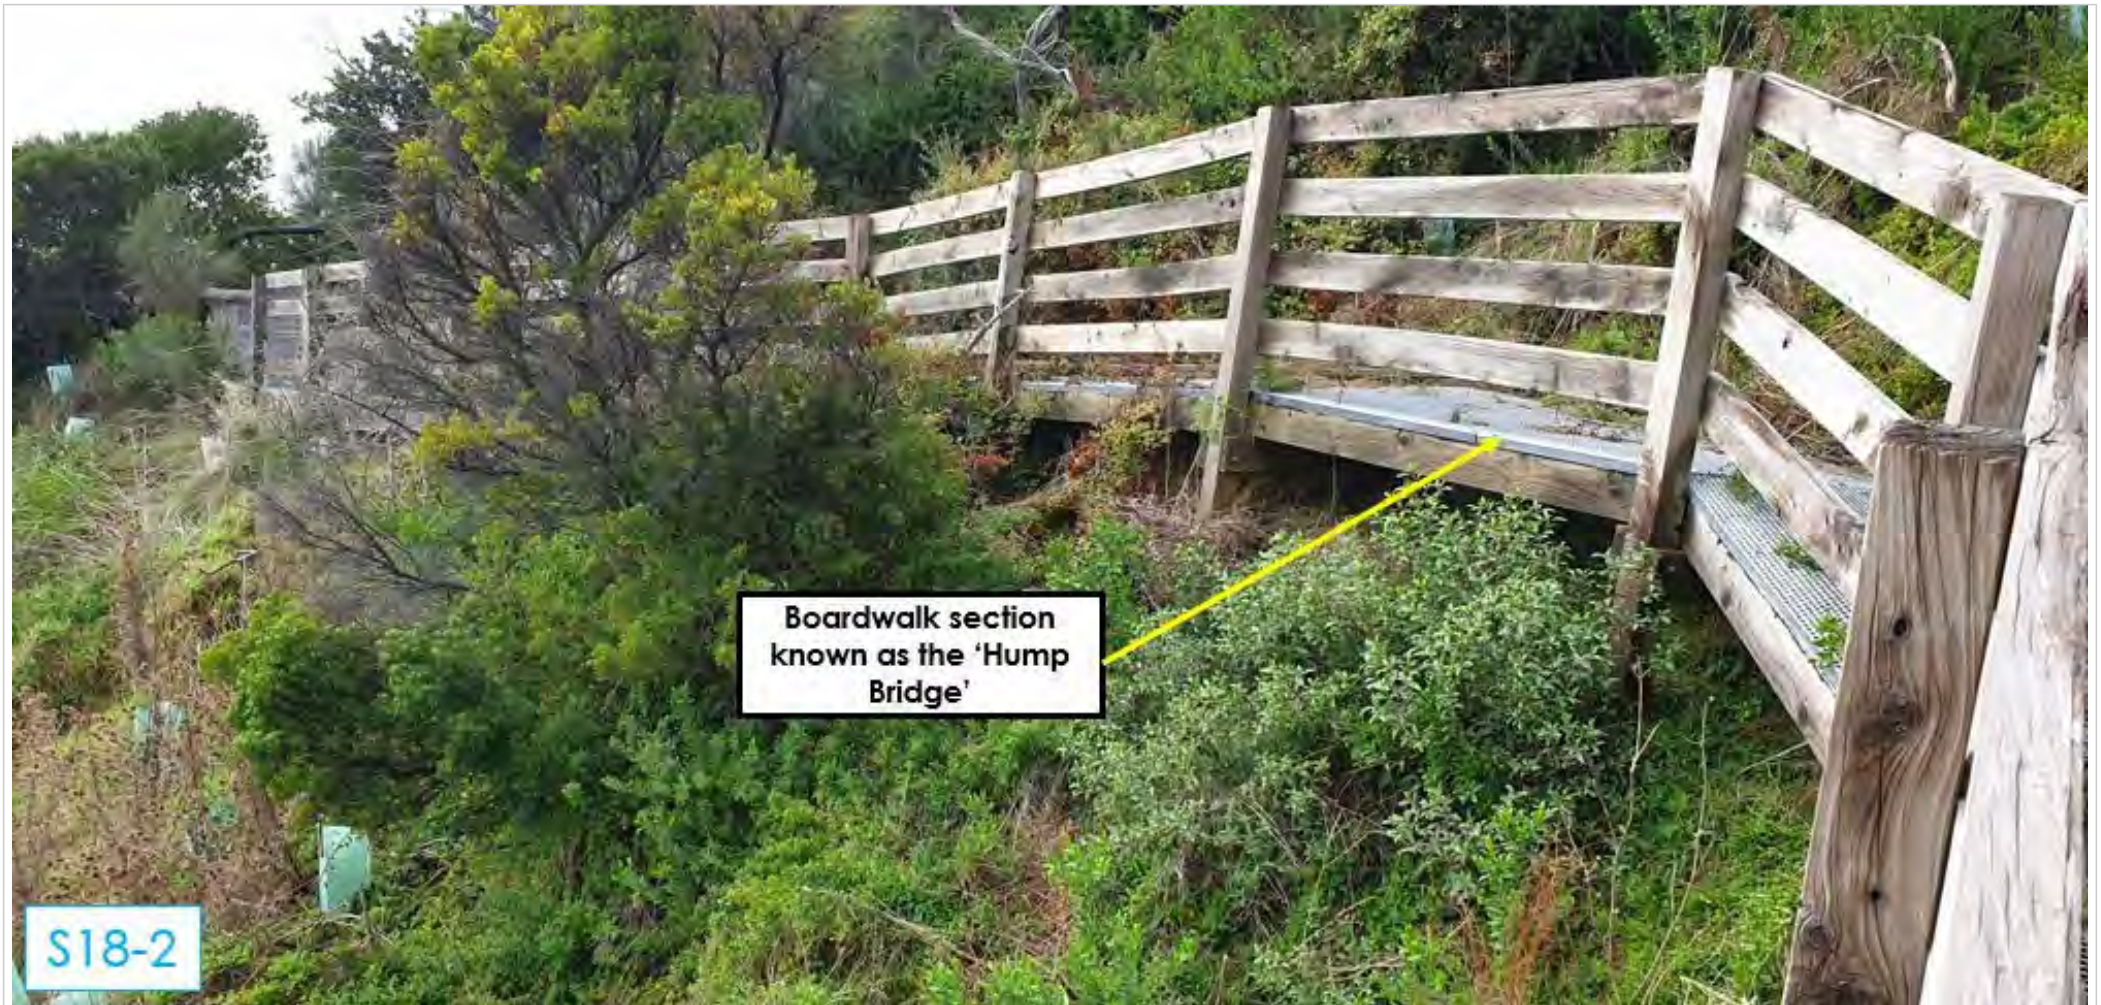
S18-2

Boardwalk section known as the 'Hump Bridge'

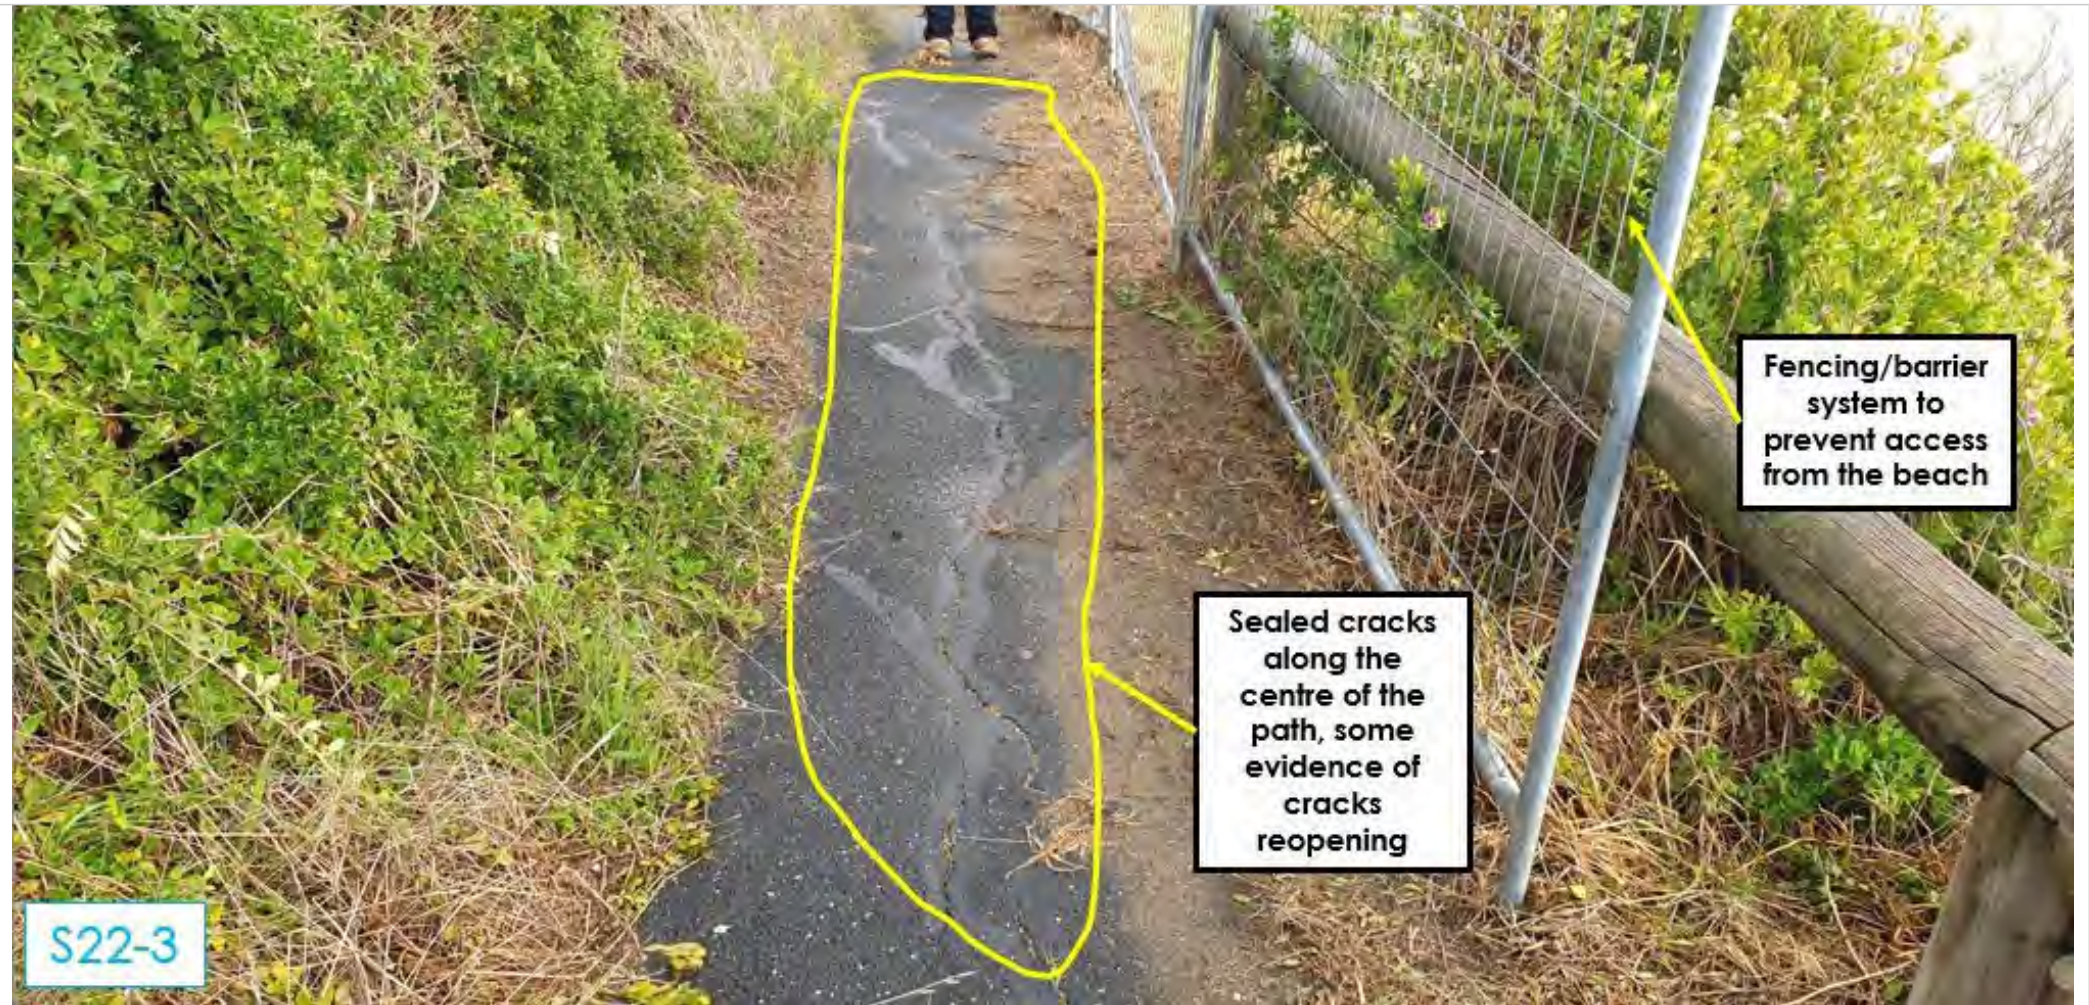
S22-3

Fencing/barrier system to prevent access from the beach

Sealed cracks along the centre of the path, some evidence of cracks reopening

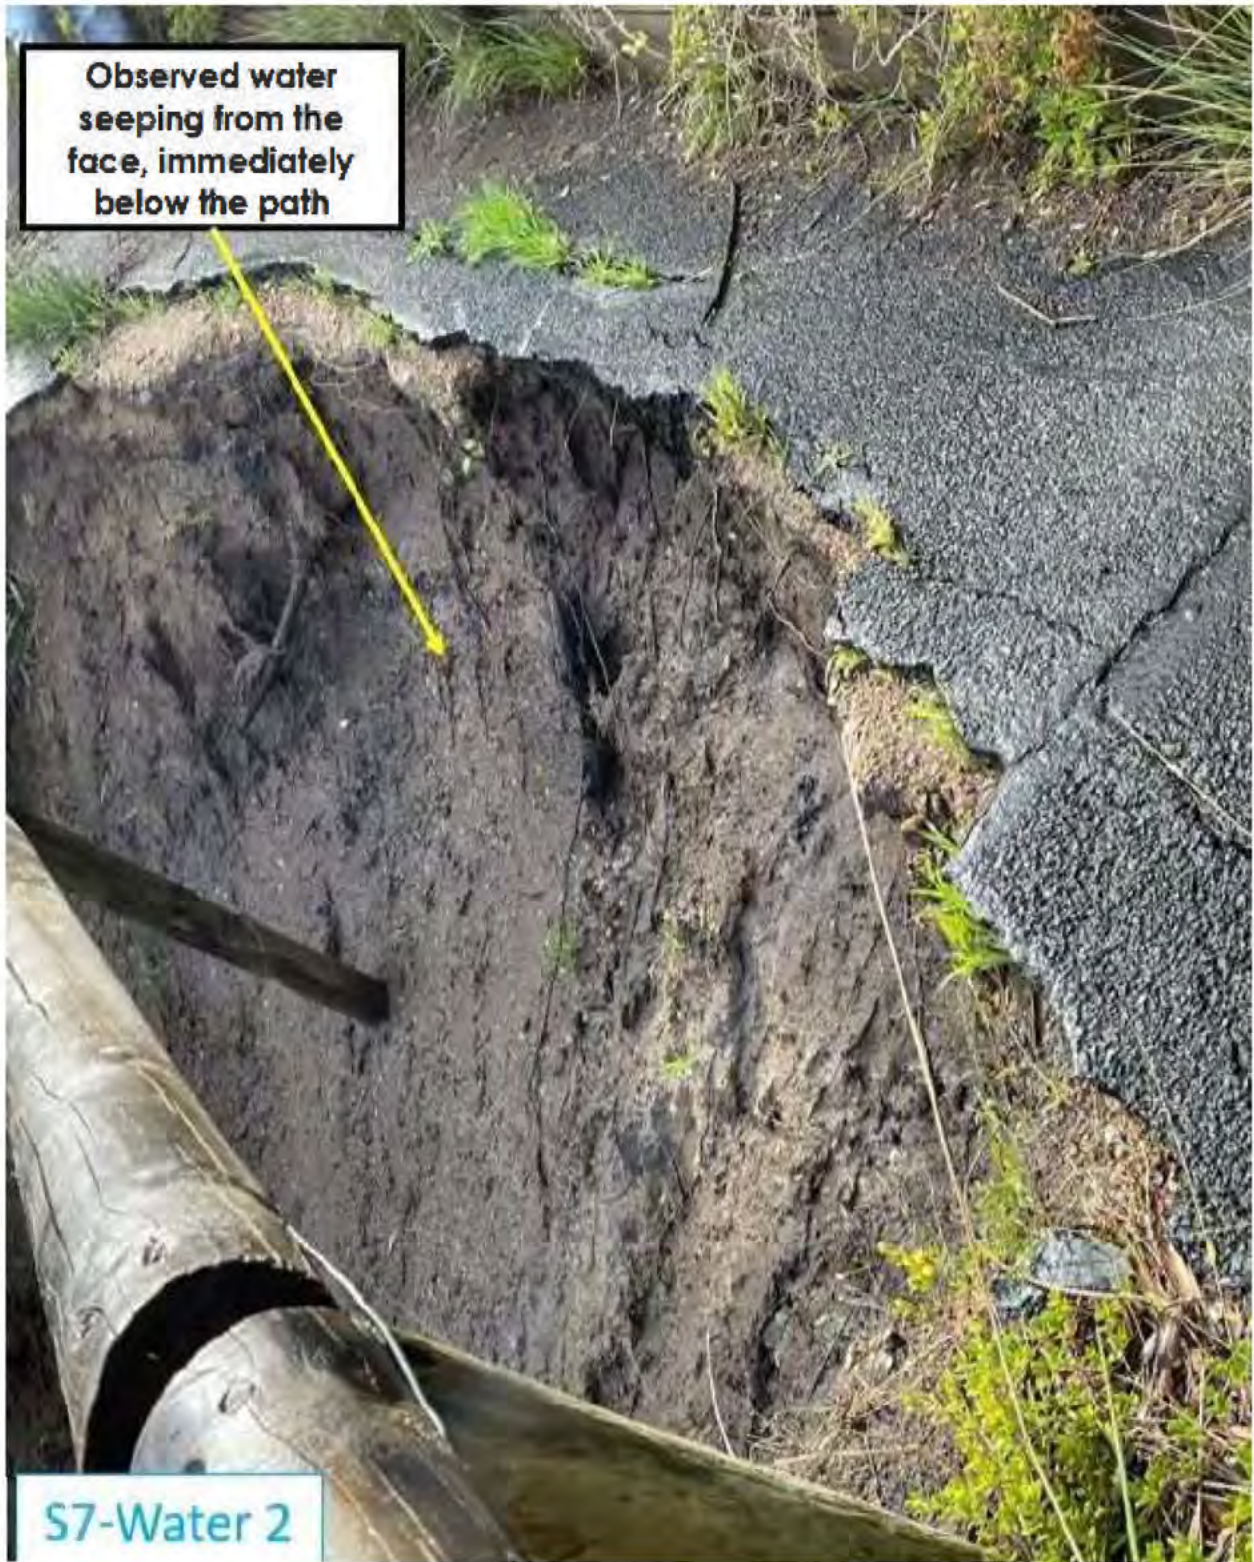
Observed water seeping from the face, immediately below the path

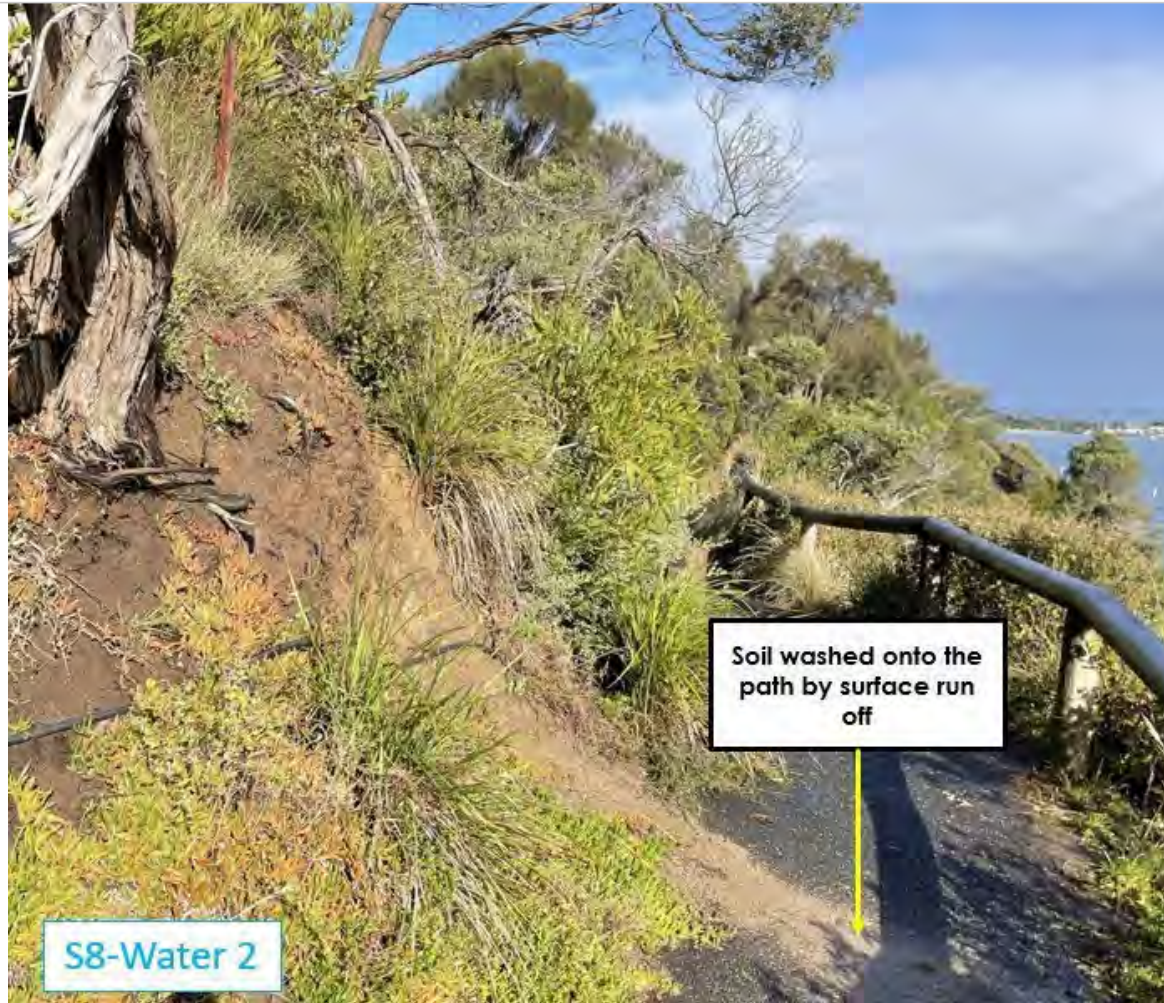
S8-Water 2

Soil washed onto the path by surface run off

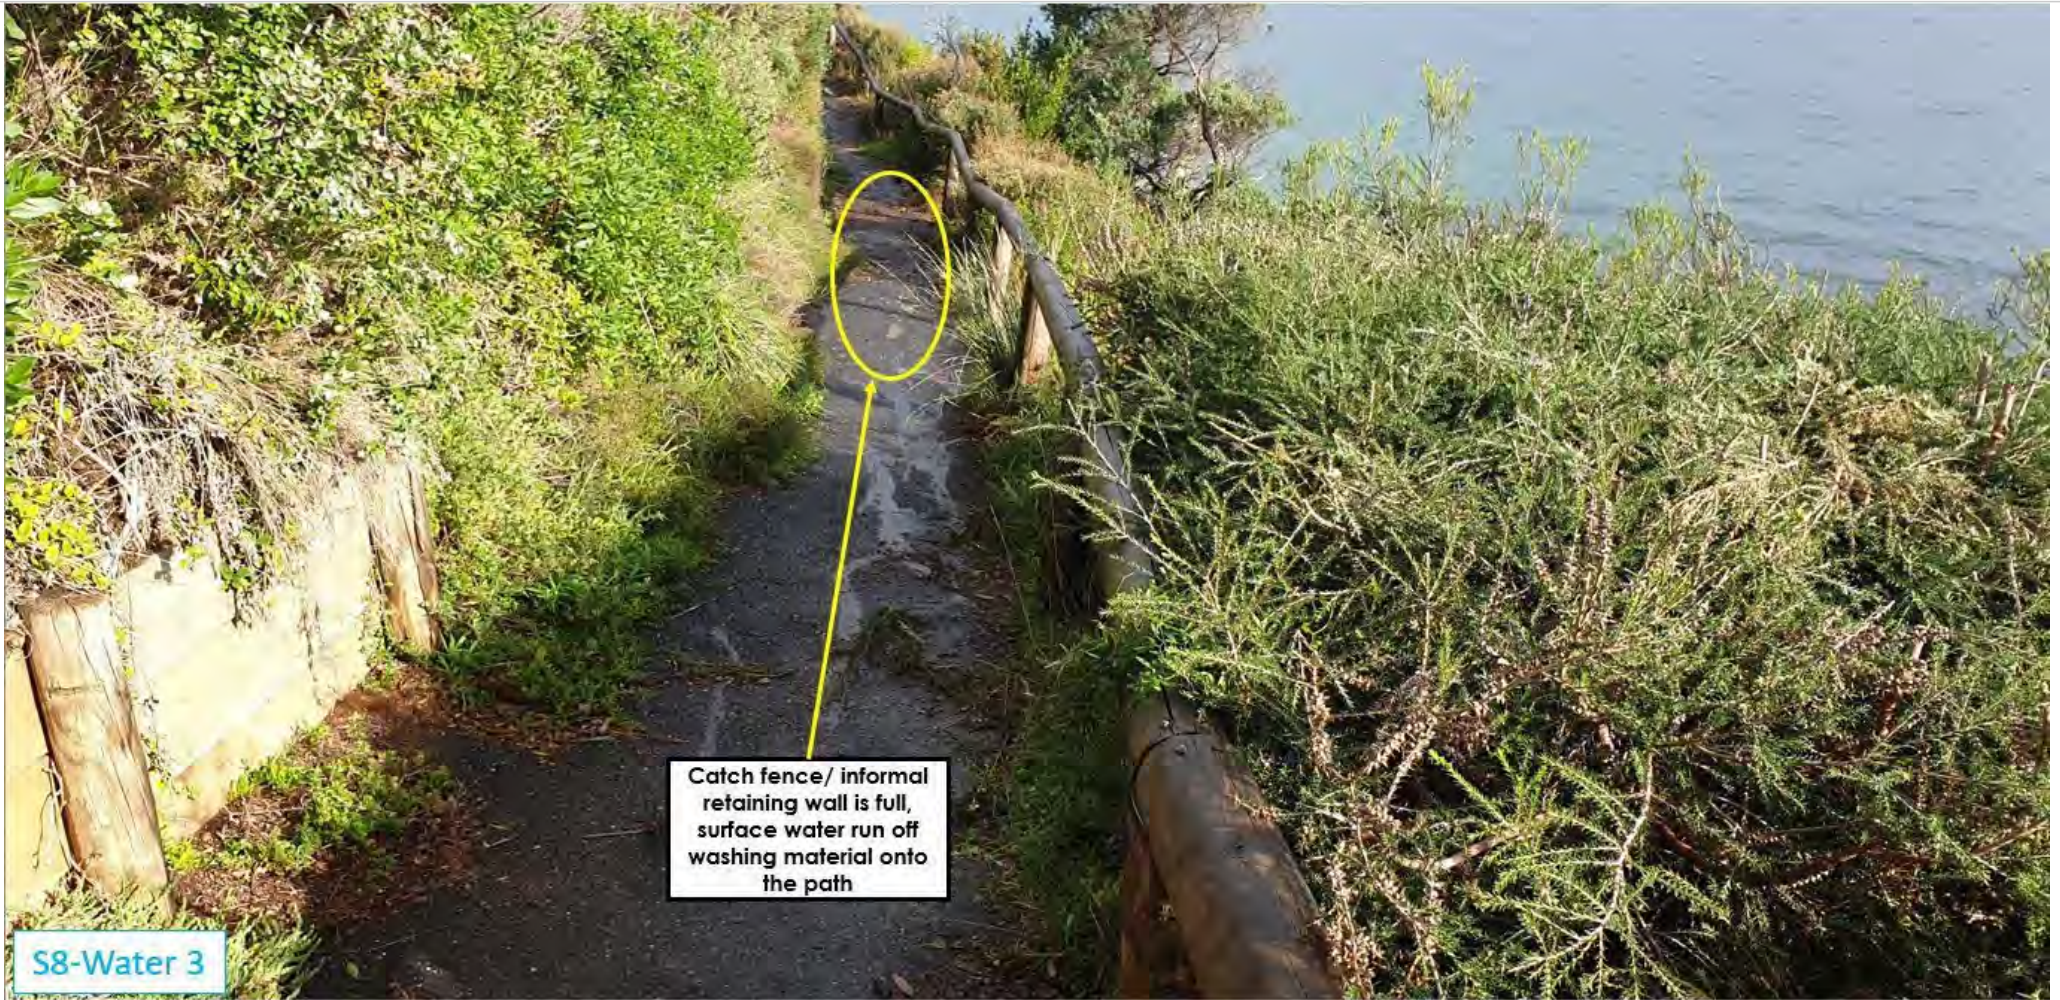
S8-Water 3

Catch fence/ informal retaining wall is full, surface water run off washing material onto the path

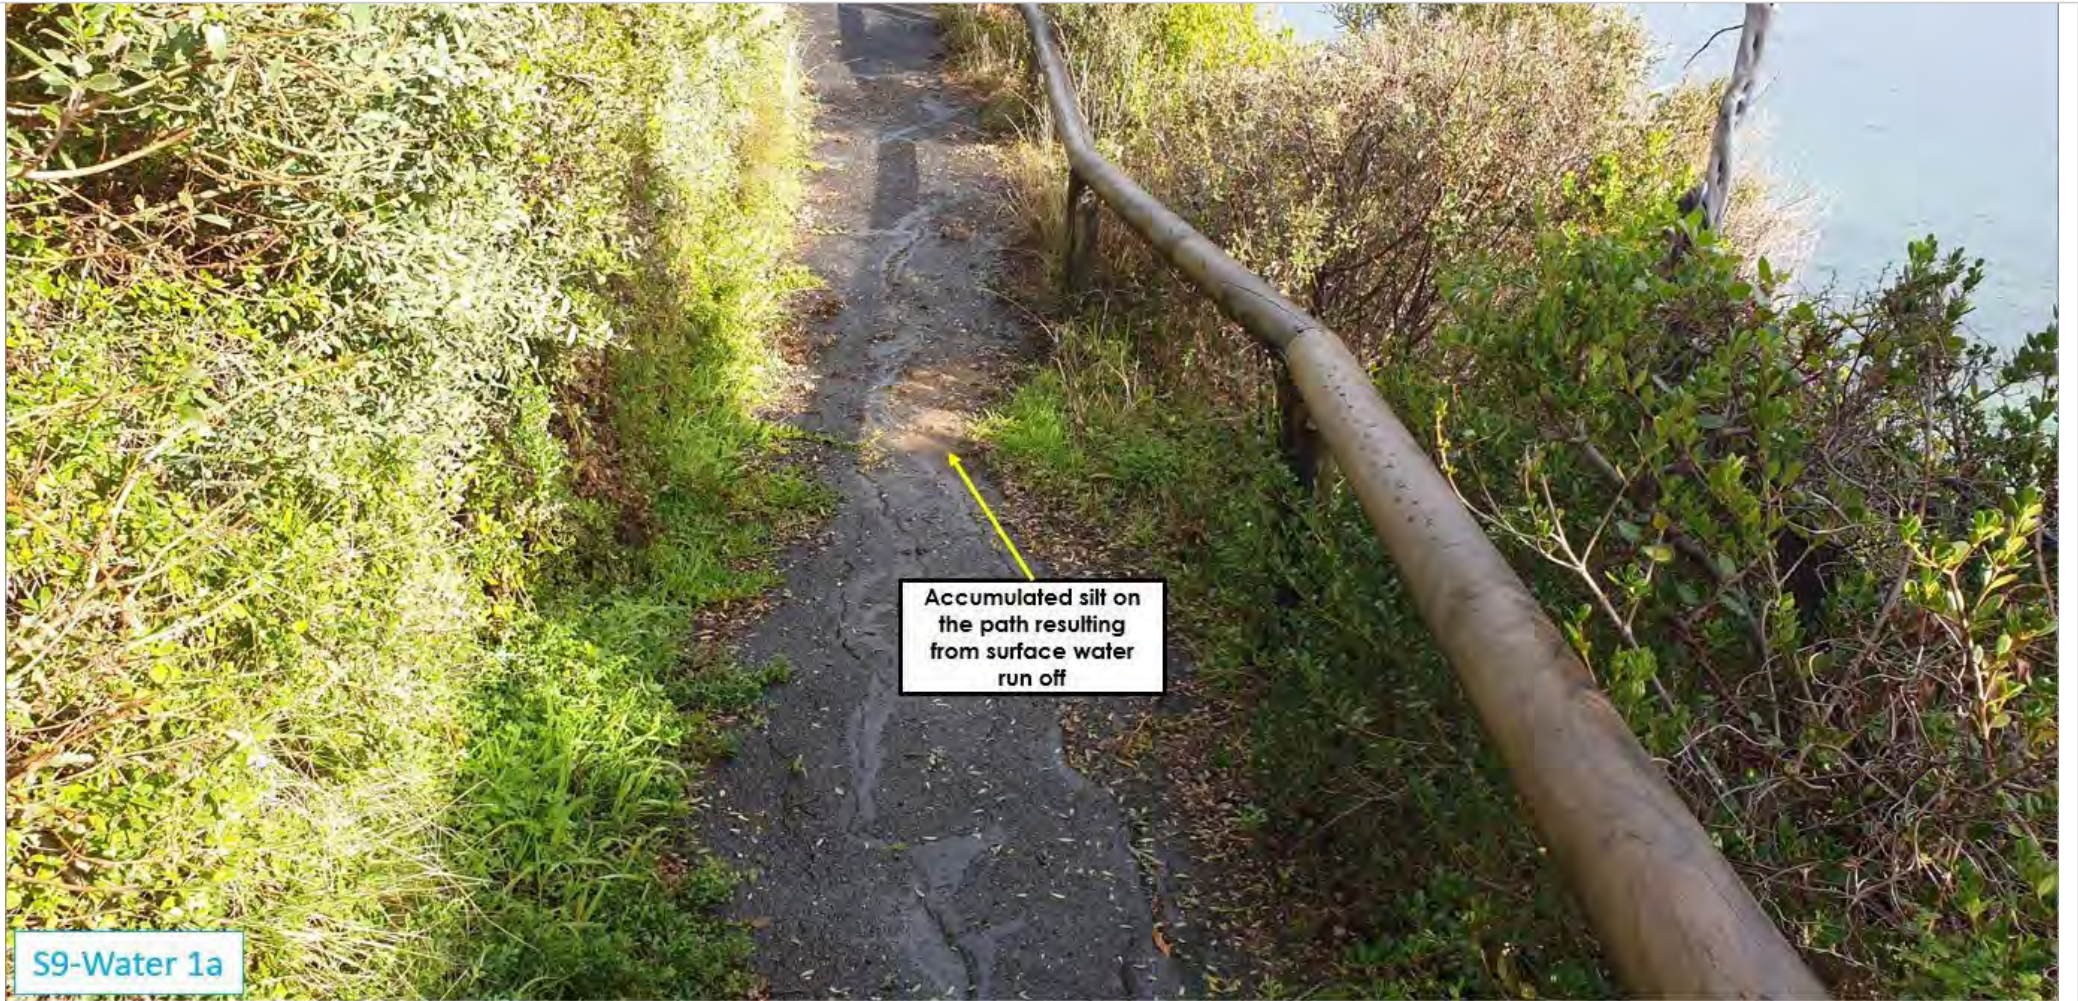
S9-Water 1a

Accumulated silt on the path resulting from surface water run off
