Landslide Risk Assessment

Beleura Cliff Path, Caraar Creek Road to Mills Beach, Mornington

PREPARED FOR:
Mornington Peninsula Shire

December 11, 2023
RFP: V220152Report02.3

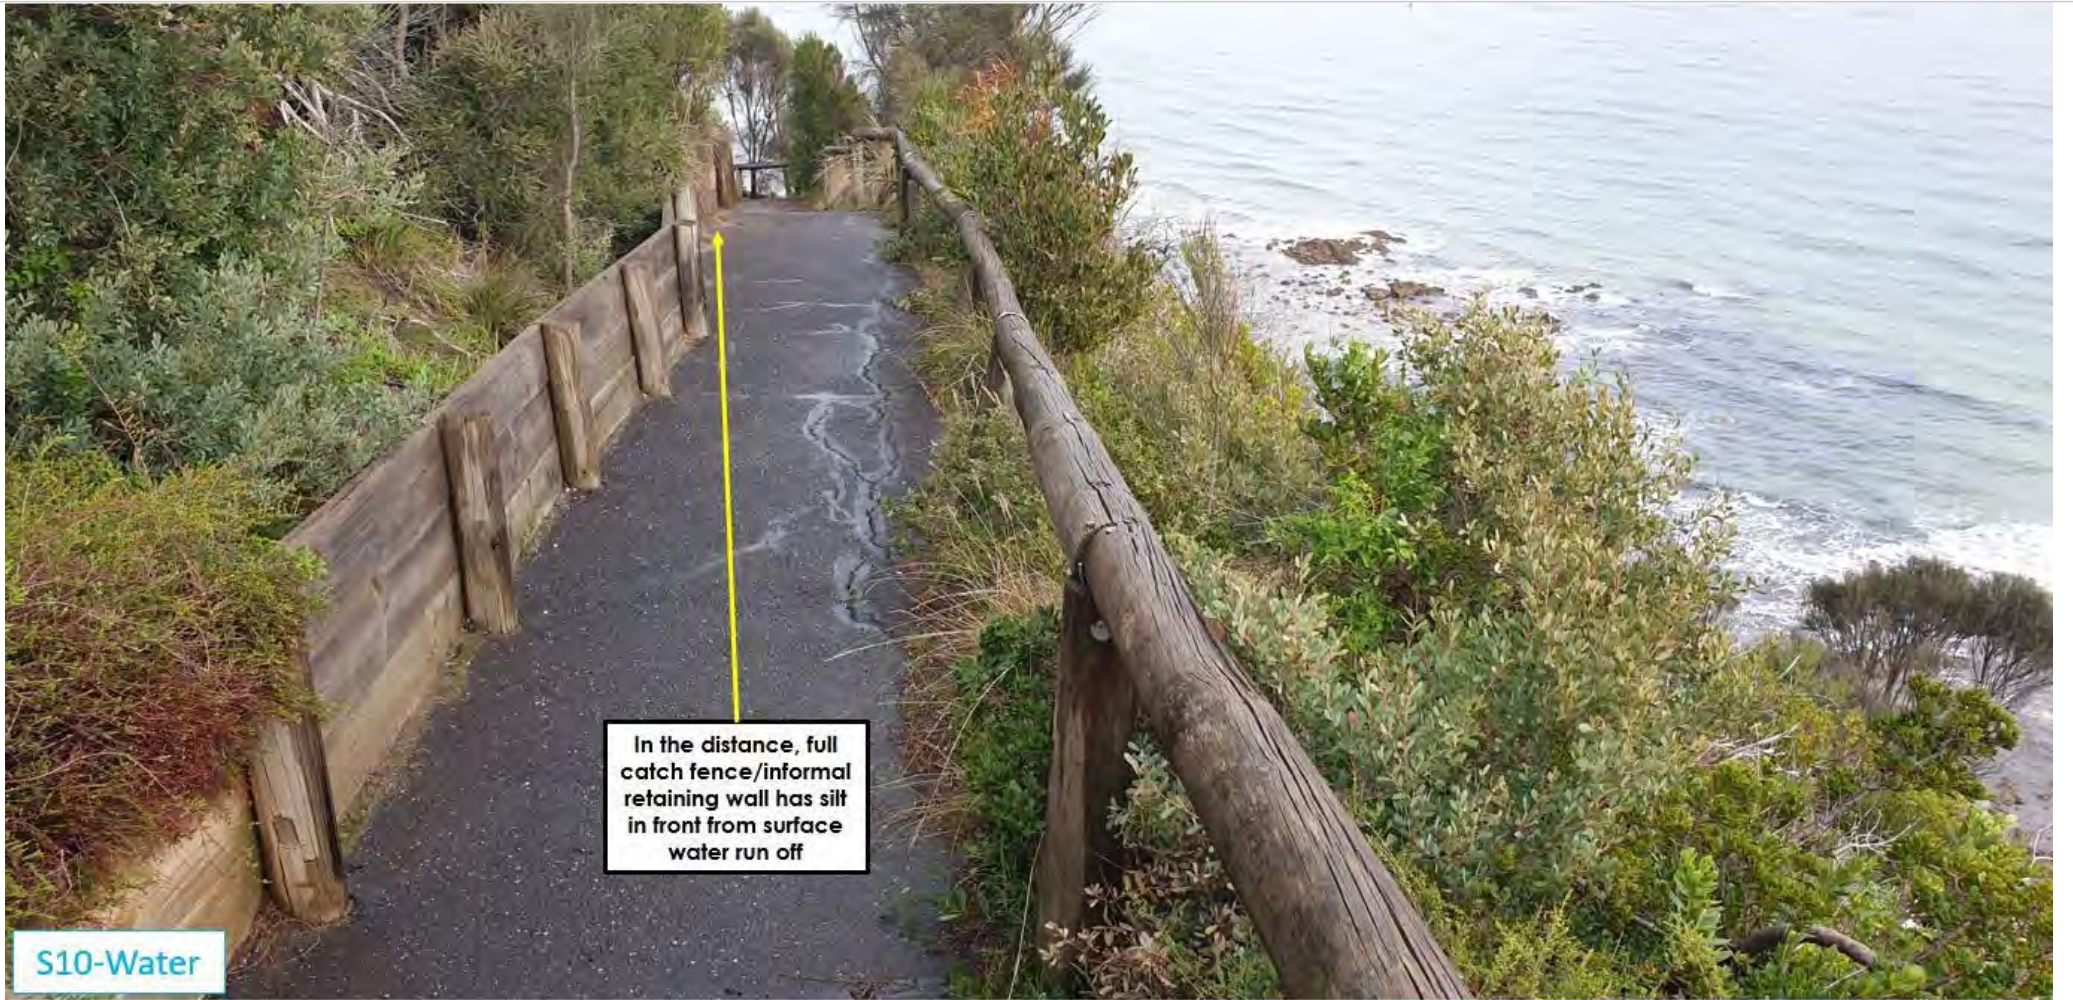
S10-Water

In the distance, full catch fence/informal retaining wall has silt in front from surface water run off

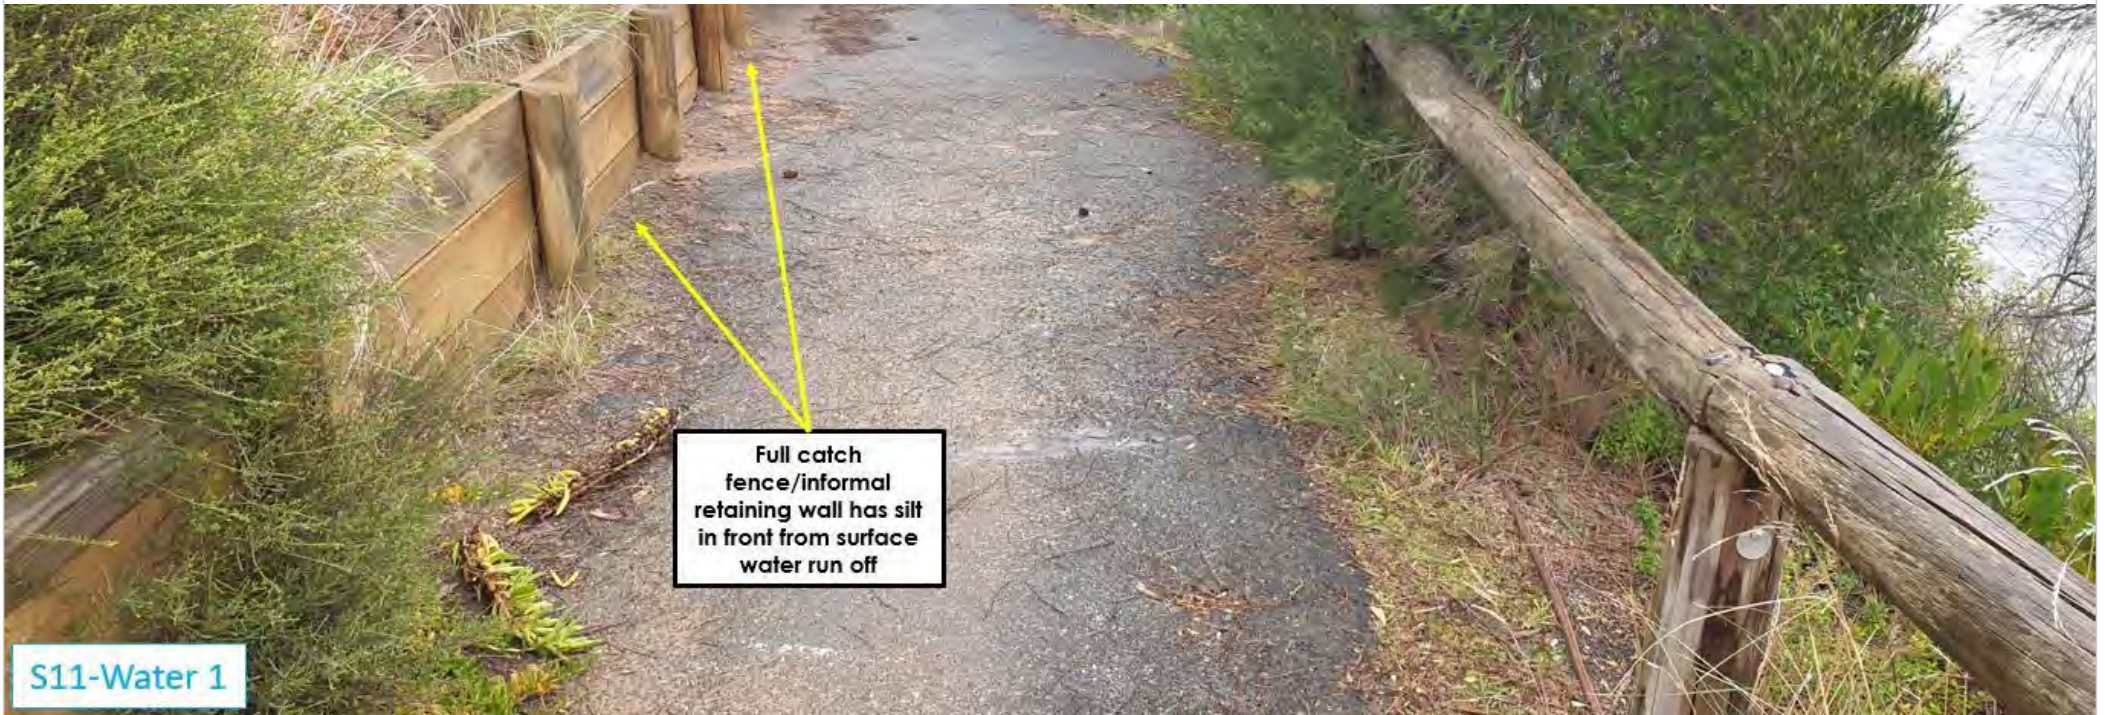
S11-Water 1

Full catch fence/informal retaining wall has silt in front from surface water run off

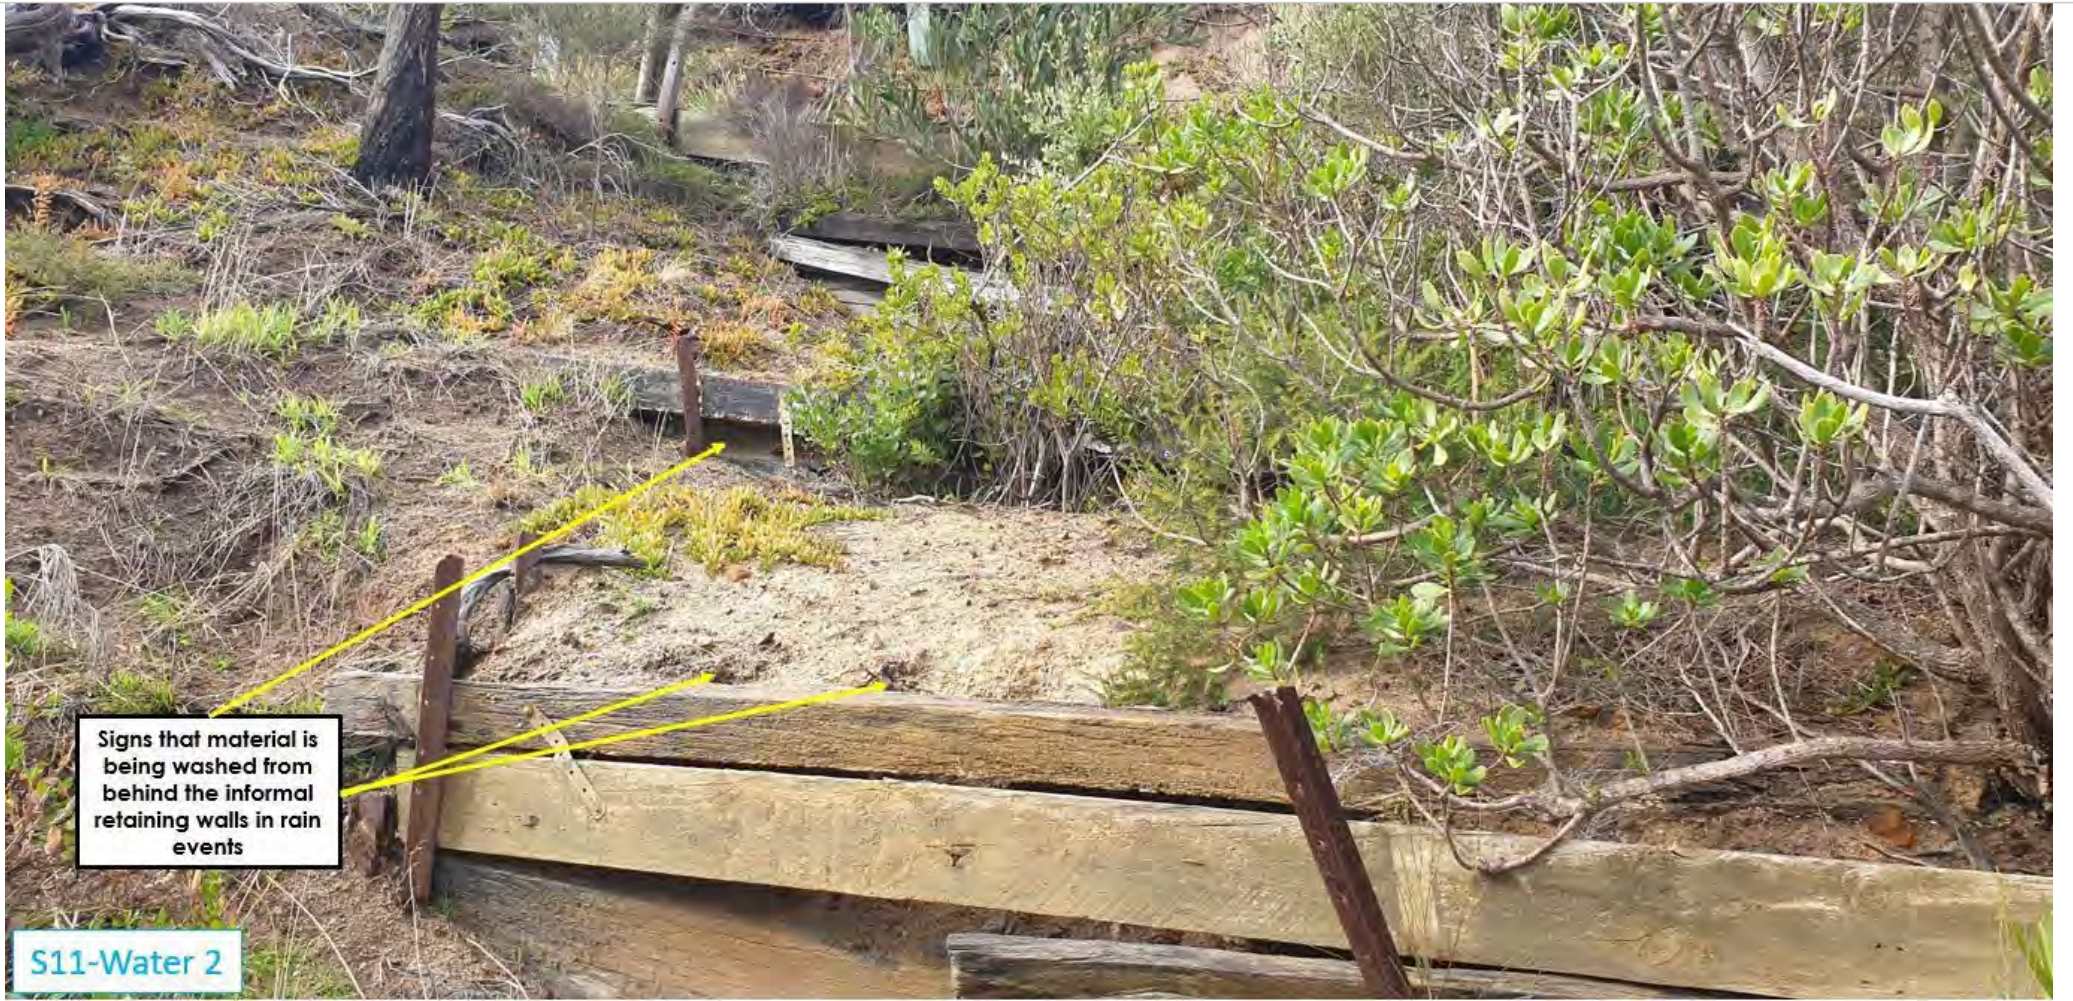
S11-Water 2

Signs that material is being washed from behind the informal retaining walls in rain events

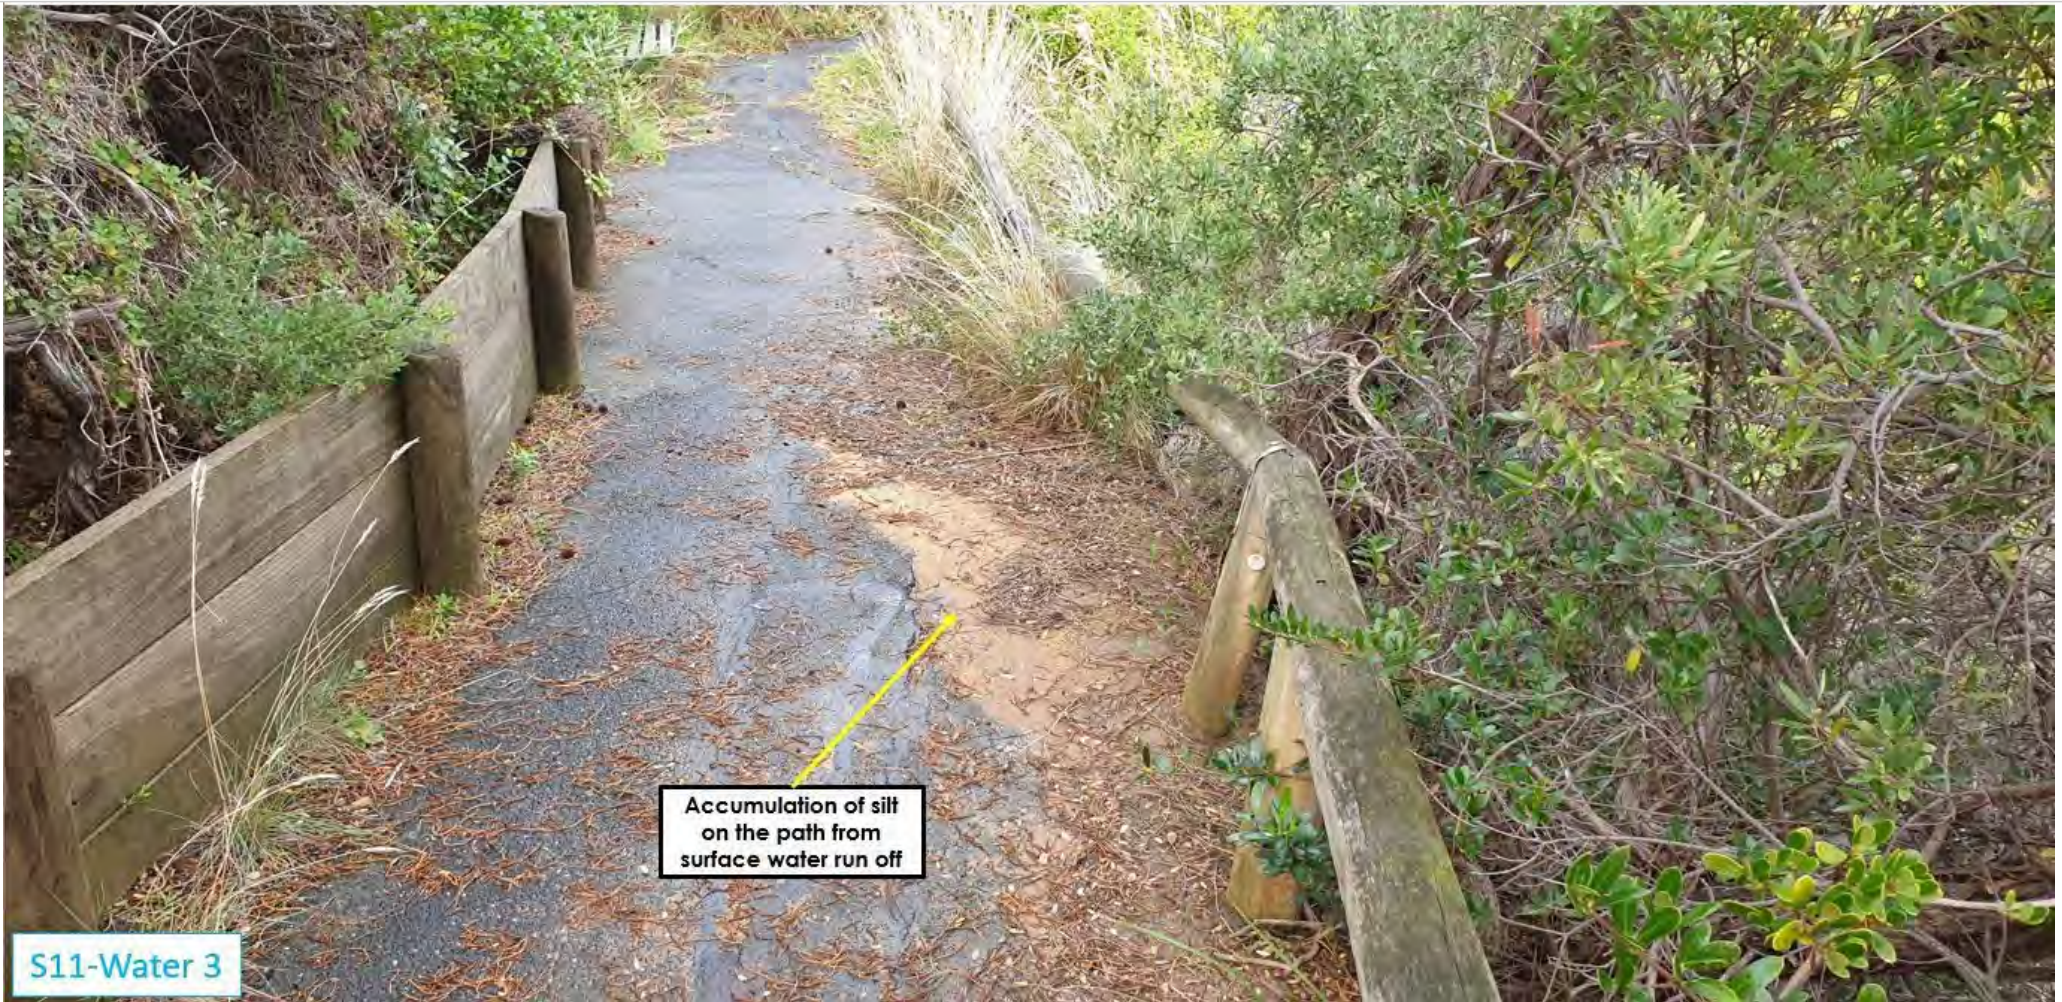
S11-Water 3

Accumulation of silt on the path from surface water run off

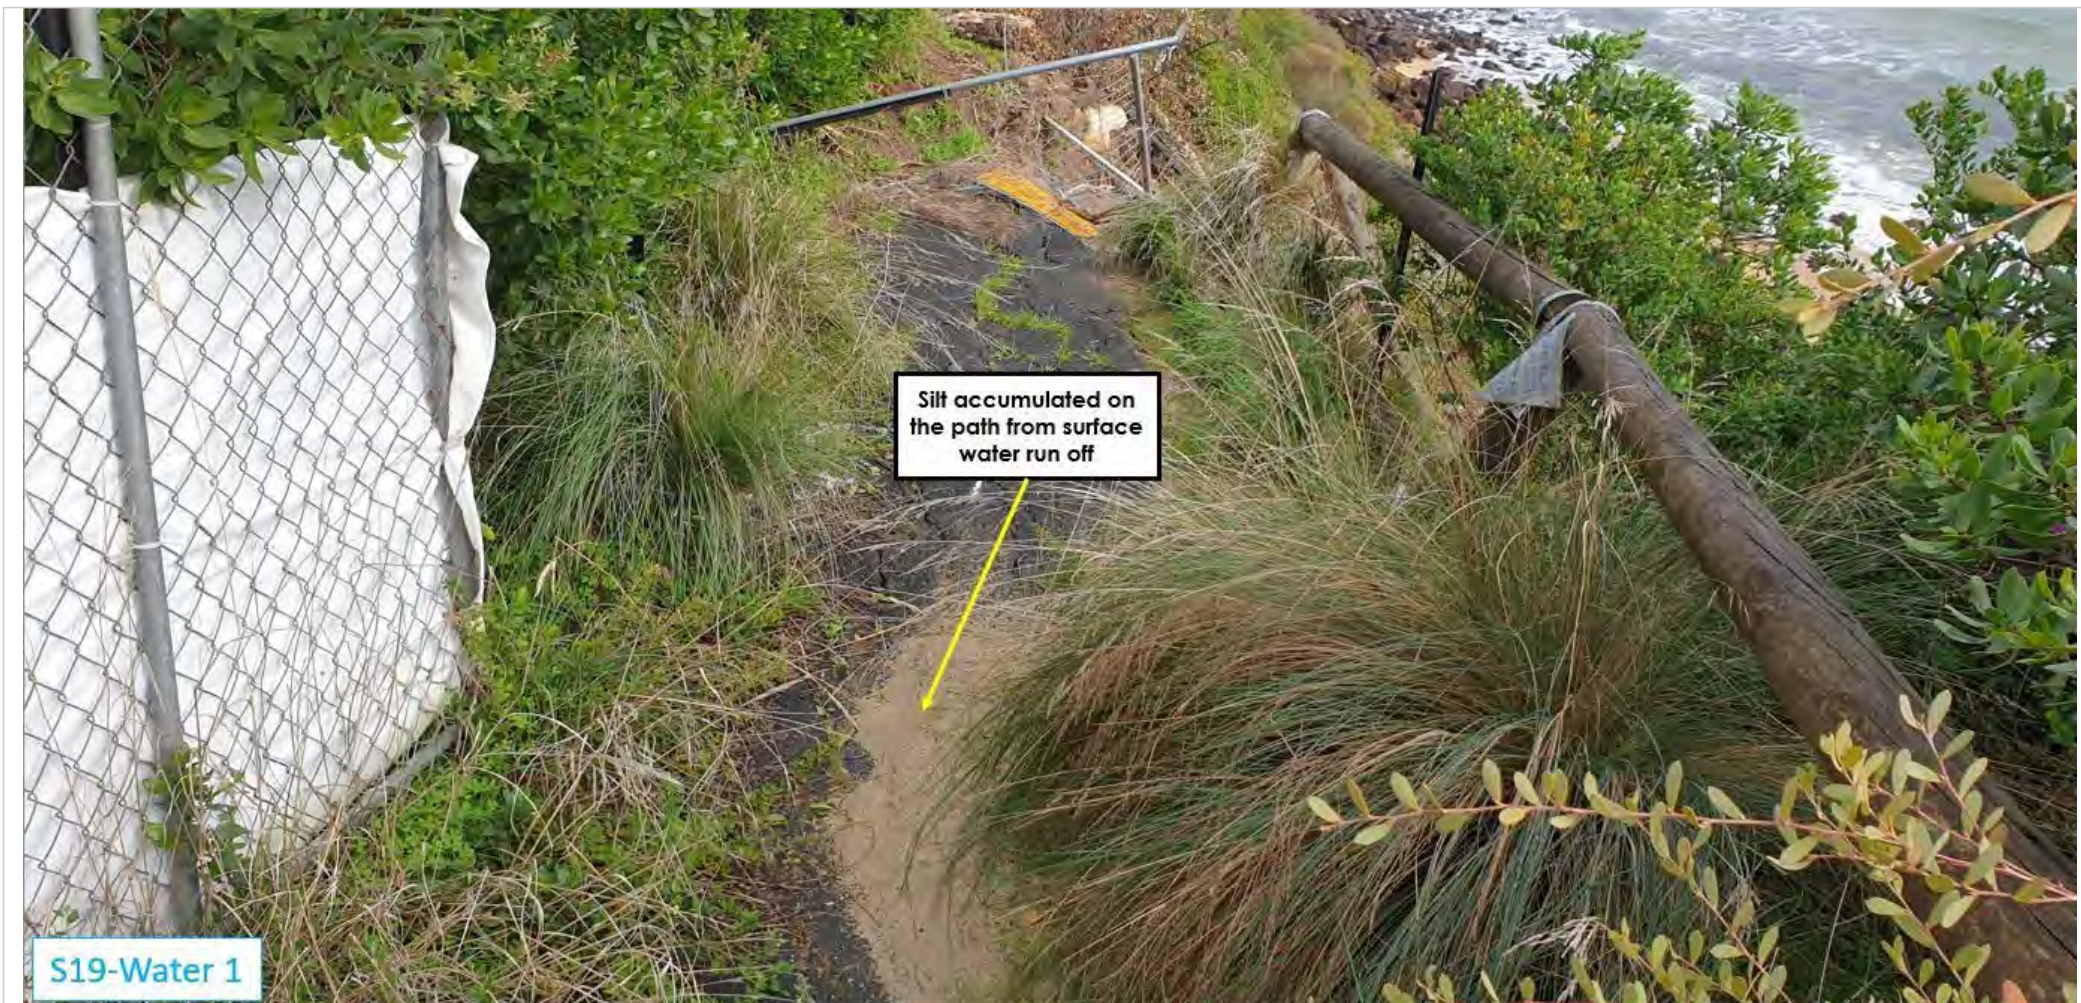
S19-Water 1

Silt accumulated on the path from surface water run off

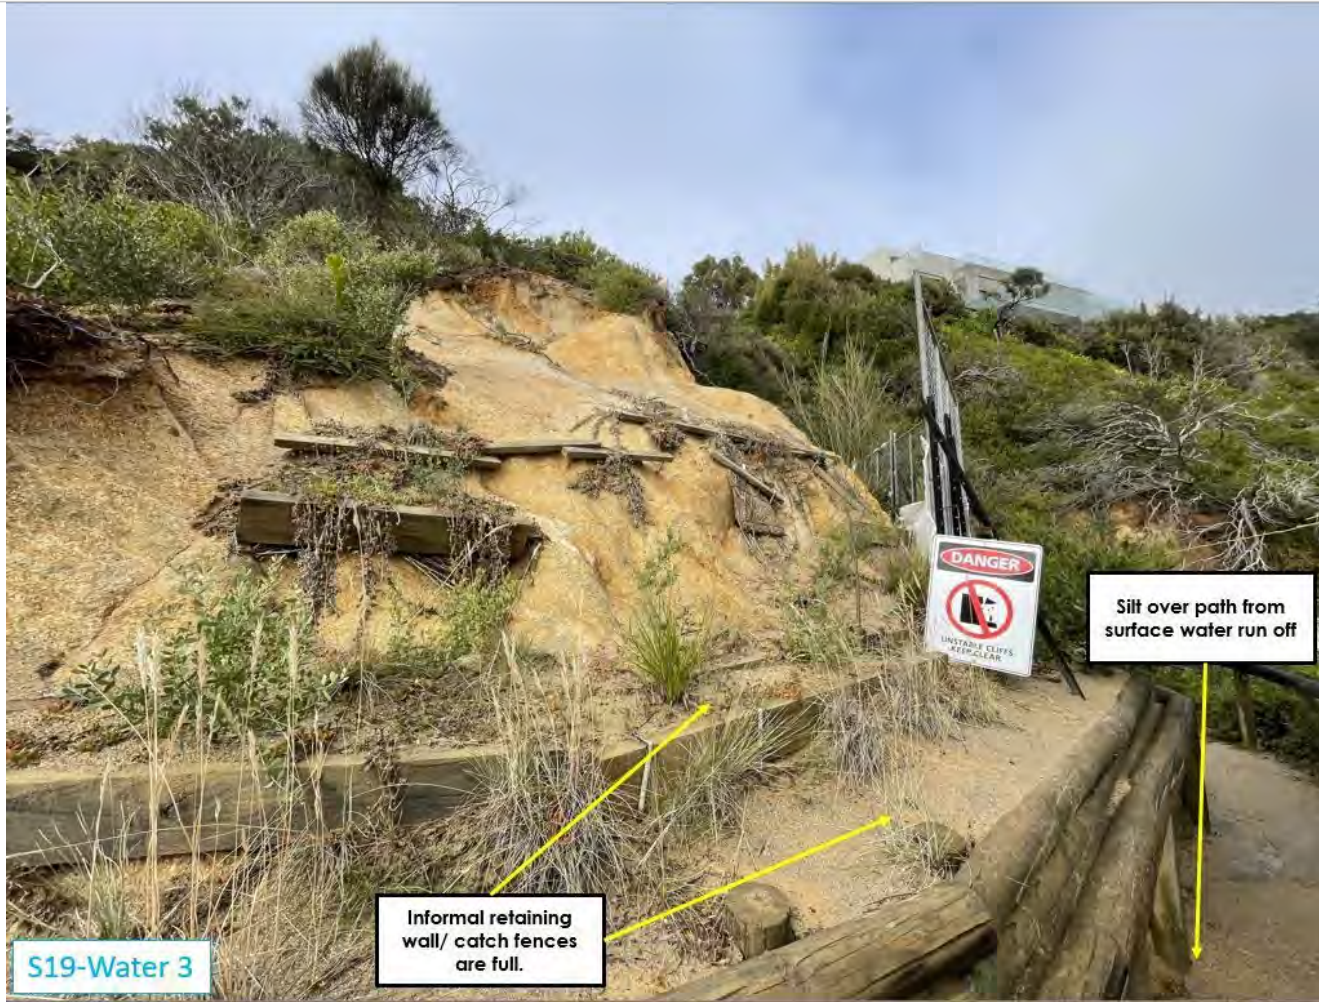
S19-Water 3

Informal retaining wall/ catch fences are full.

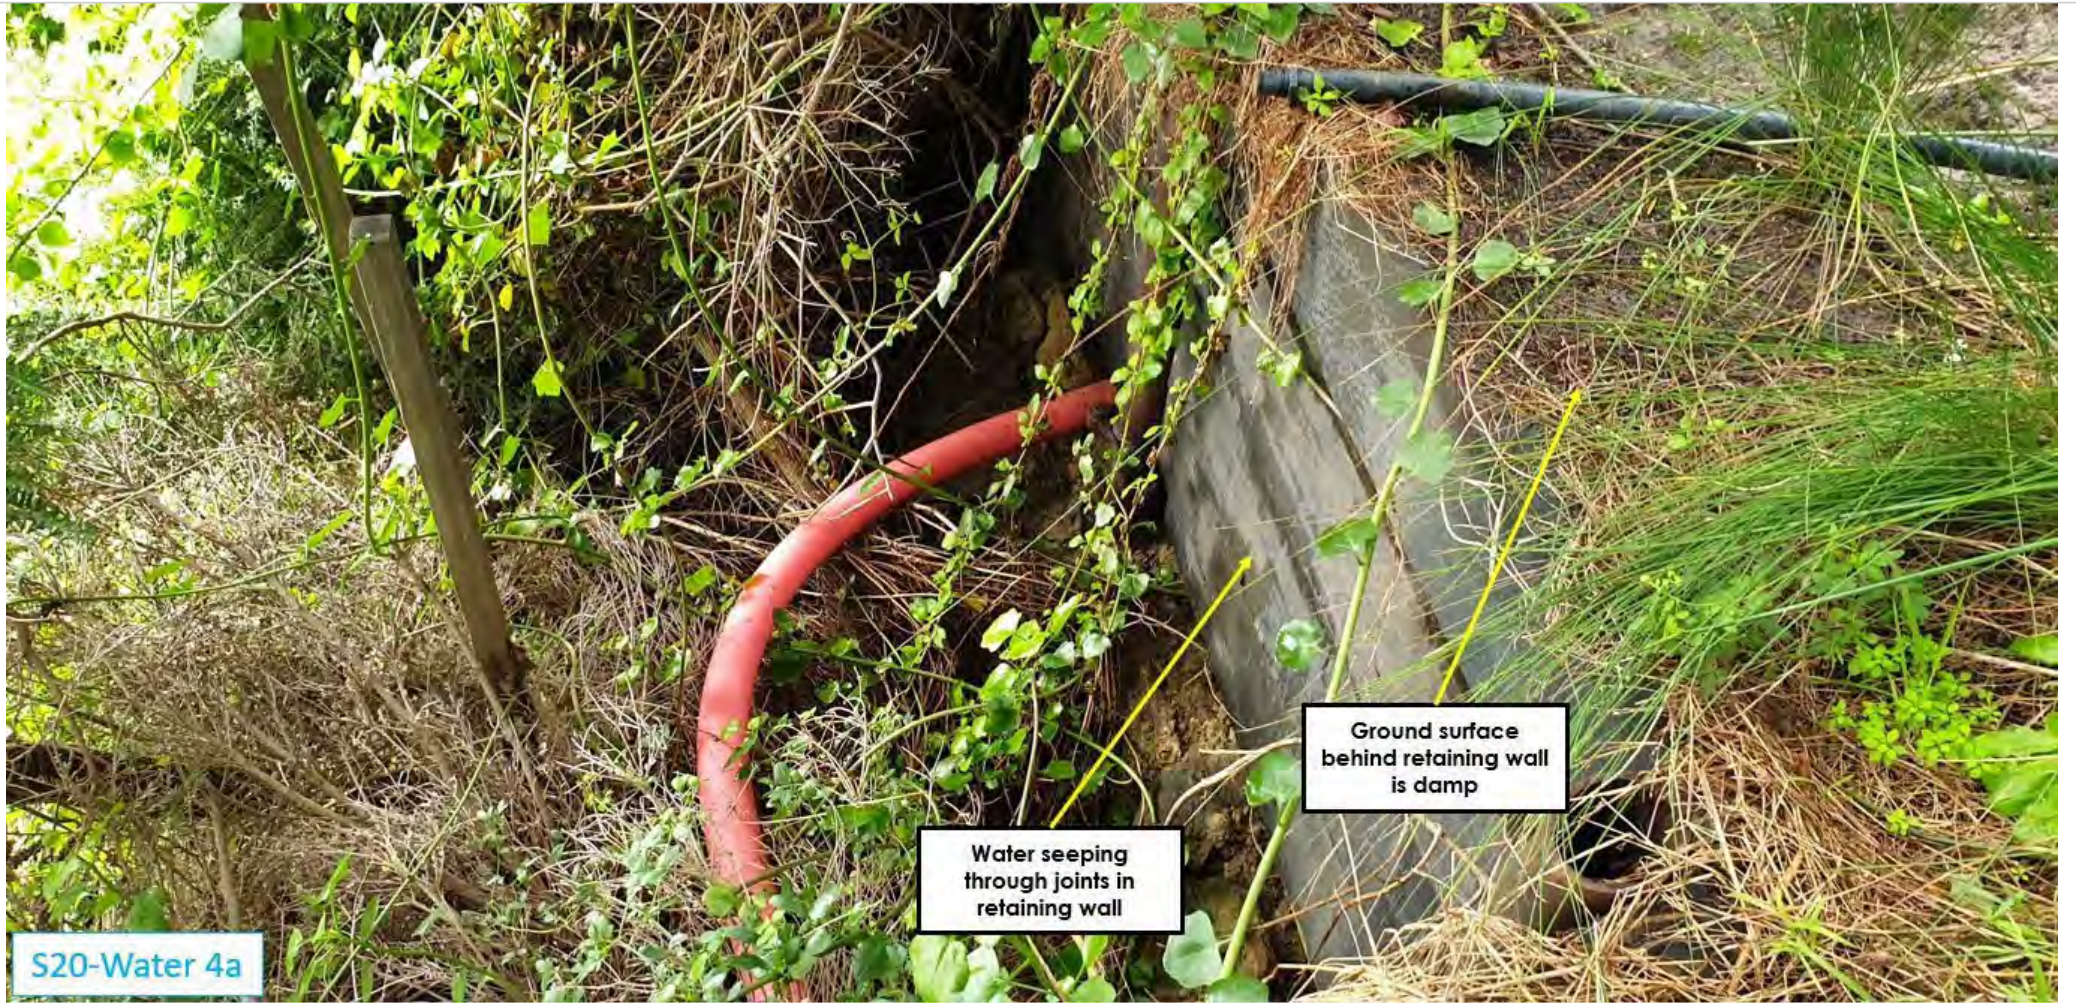
S20-Water 4a

Water seeping through joints in retaining wall

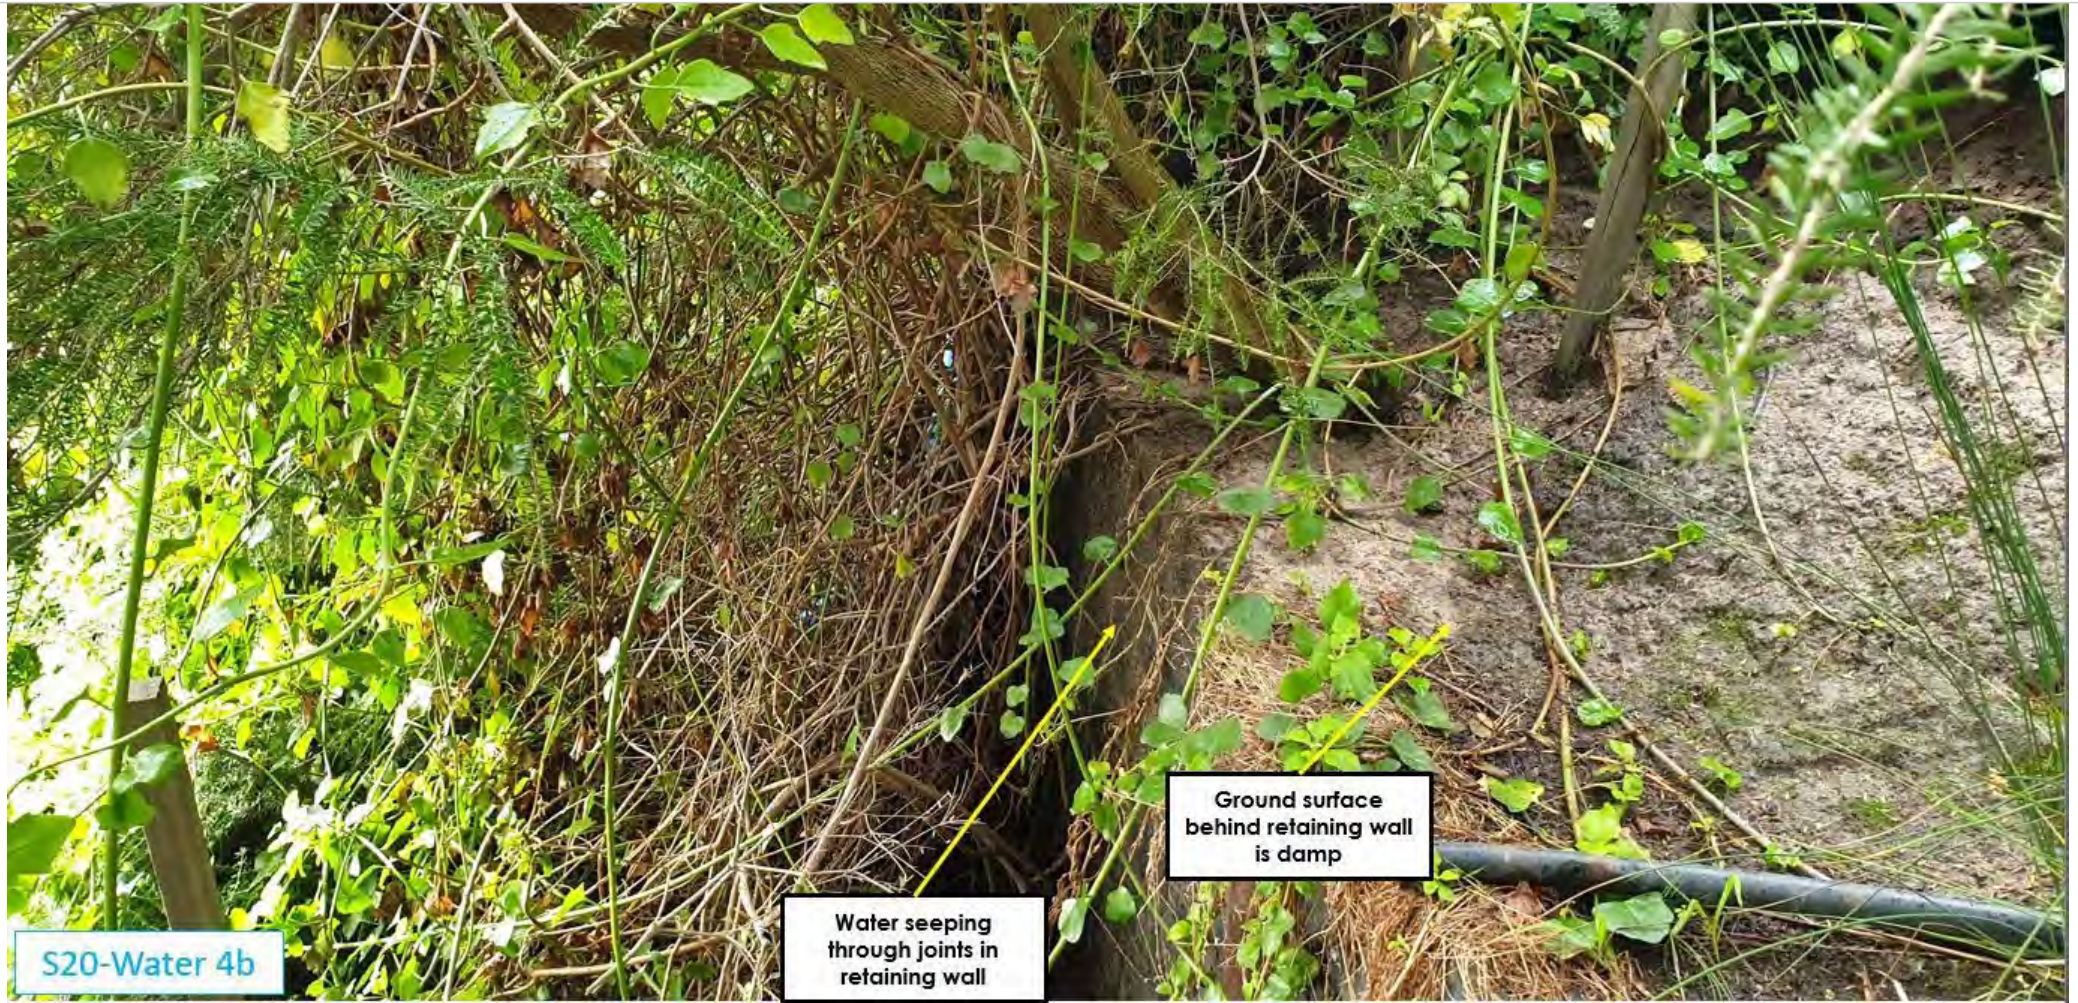
S20-Water 4b

Water seeping through joints in retaining wall
